THE FLORIANA LINES

The Entrenched Bastion on the enceinte composed of St. Philip's Bastion, St. James' Bastion and St. Luke's Bastion.

'The Conservation of the Baroque Heritage'

Denis A. Darmanin

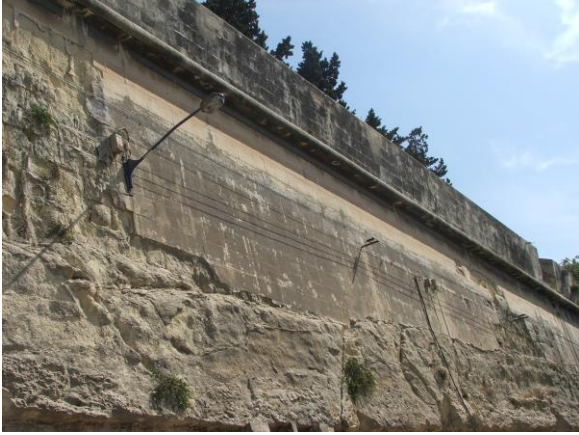
Fig. 12: A replaced section of the left scarp and parapet showing algae growth and encrustation. Or was this section damaged during WW2?

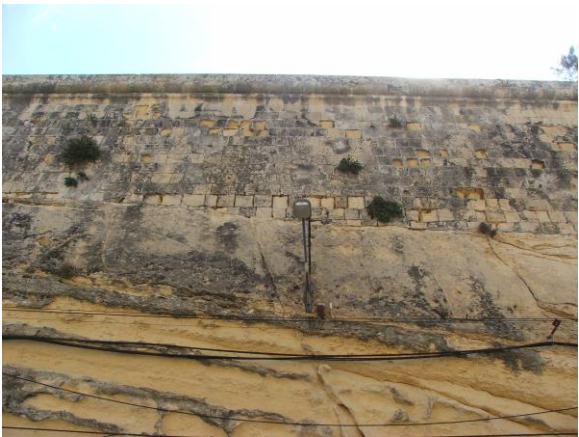
Fig. 14: Rich deposits of encrustation on the right face, which has fallen where the stone or rock is powdering.

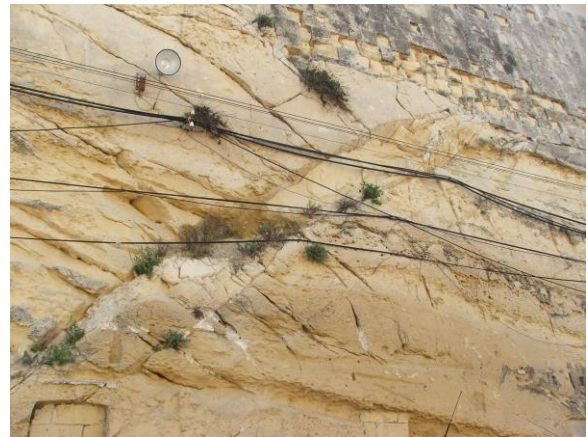
Fig. 15: Faster deteriorating weaker strata and accretions on the rock-hewn lower face.

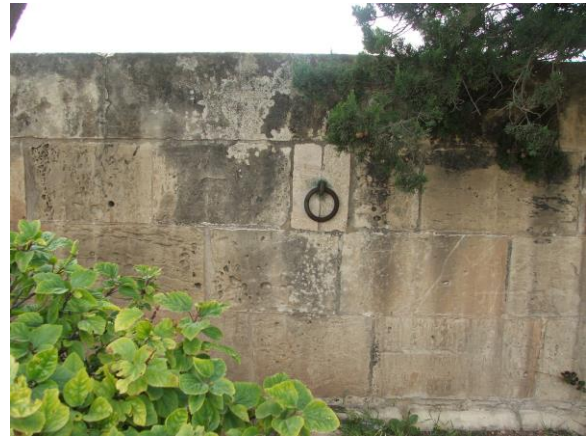
Fig. 14: Algae growth and encrustation within the parapet and gun-ring set in upper coralline limestone.

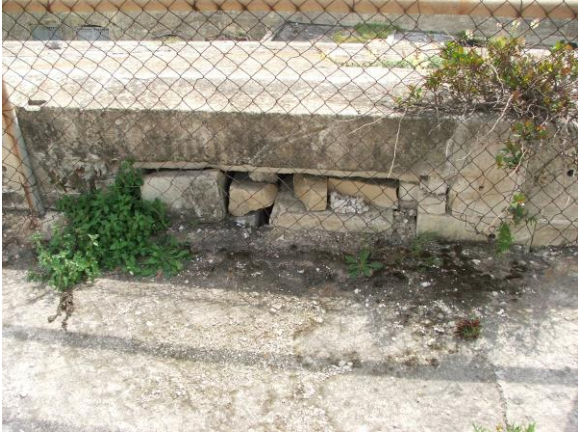
Fig. 15: Concrete and other accretions along the parapet and inside the expense magazine.

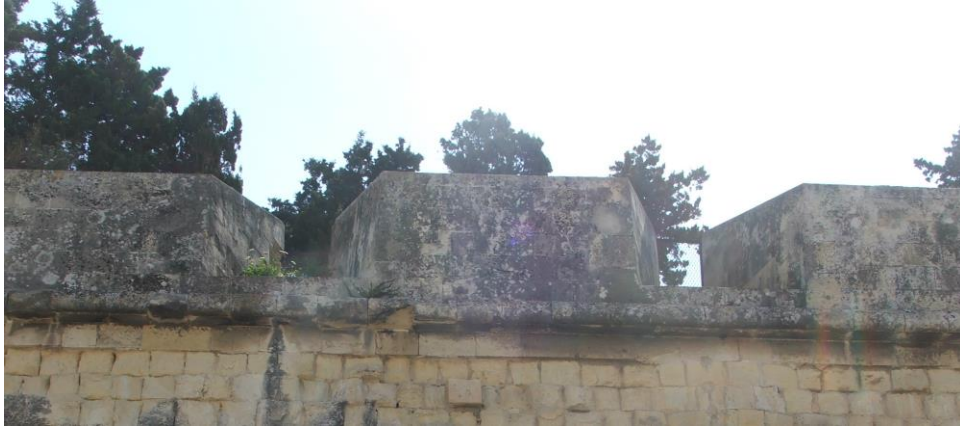
Fig. 23: Right embrasures heavily encrusted with lichens and algae.

The two embrasures on the right are not exposed to traffic as much as those on the left but are also suffering their share of deterioration. The cheeks are heavily encrusted with pollution and also bio-deterioration. Algae and lichen growth is very evident on all the masonry features. The metal mesh once placed for safety has rusted and caused the thin stone at the opening of the crenellations to break. One mesh has fallen off its stays.

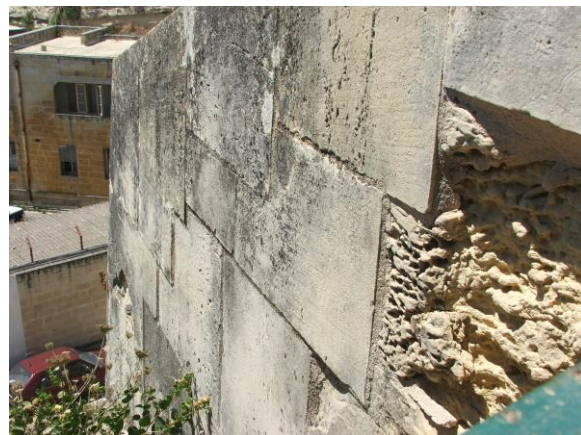
Fig. 25: Alveolar decay, black crust and growth on cheek.

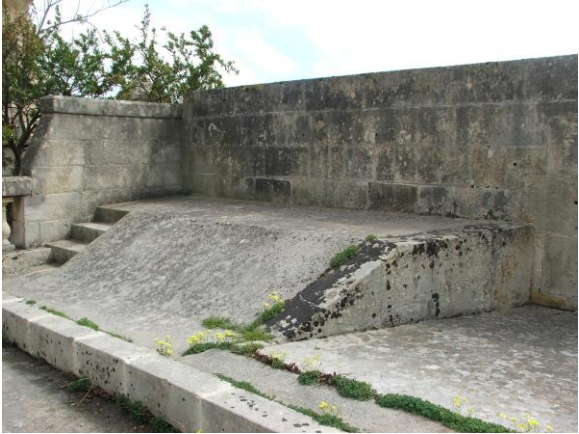
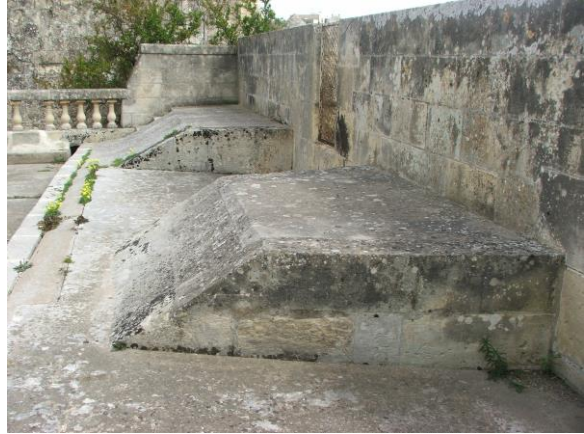
Figs 26 and 27: The banquette with heavy deposits of encrustation, algae, lichens and some growth.

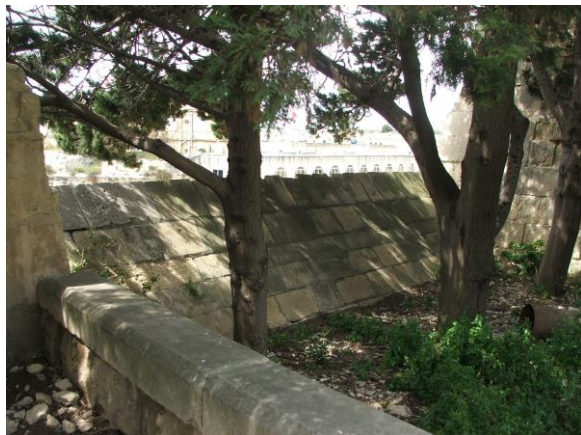
Fig. 29: Trees growing in gorge by batardeau. Heavy powdering and voided mortar joints.

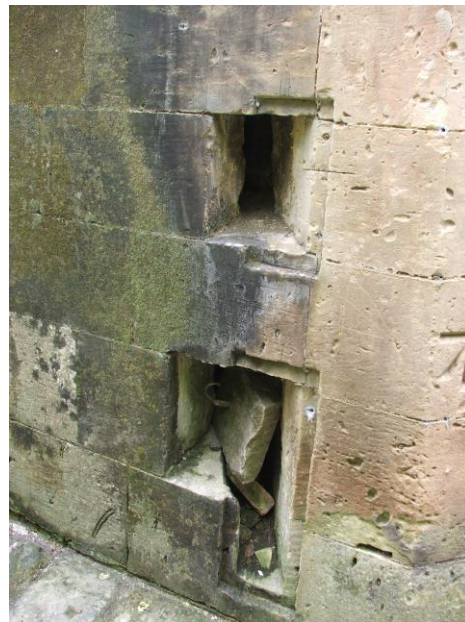
Fig. 42: Algae, lichen and breakage. Also signs of stone discolouration probably due to fires having been lit against the corner.

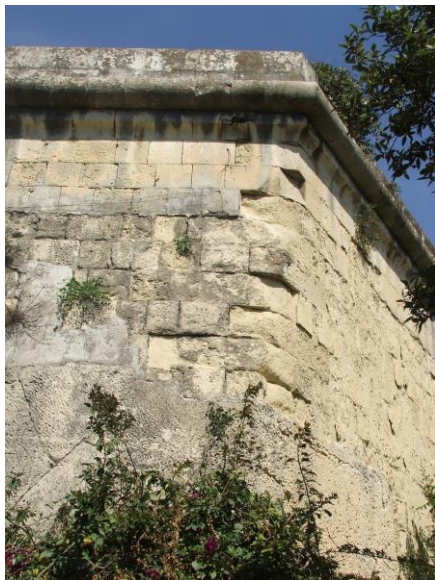
This deterioration process is repeated on the left flank and shoulder of St. Luke's Bastion where a type of parabolic catchment exits and therefore subject to wind, heat and moisture. Hardly any of the original masonry remains unaffected, mainly by powdering or exfoliation. However, the tool marks of the rock face have somehow survived. Quoins on the shoulder have also suffered as once the stone cracks, it falls and becomes lost. This section had once been extensively plastered with a lime base coat, of which a good percentage remains. Most has fallen off but a fair percentage has calcified into the limestone and only lost certain materials.

Fig. 45: Deterioration on flank and shoulder.

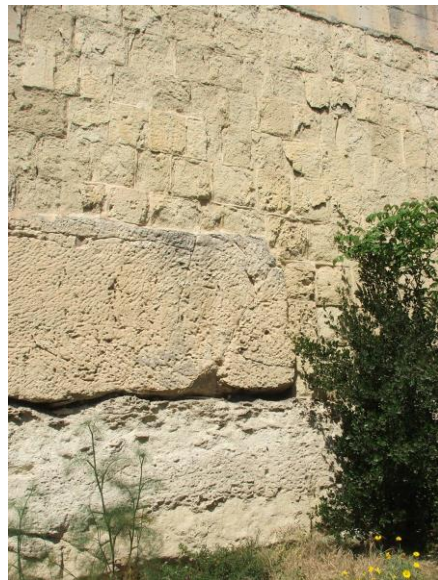
Fig. 46: Exfoliation and powdering.

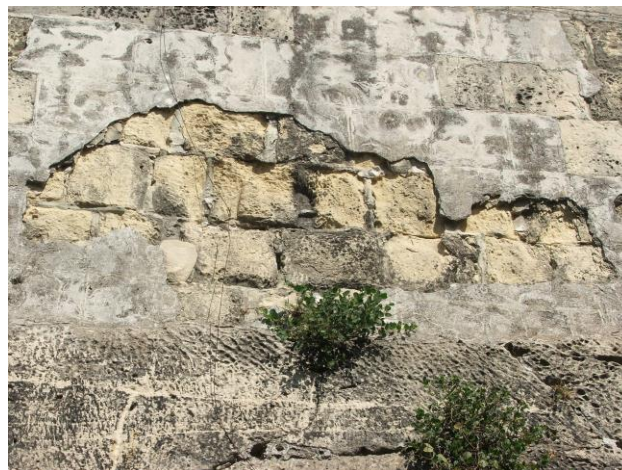
Fig. 47: Old plaster on deteriorated masonry.

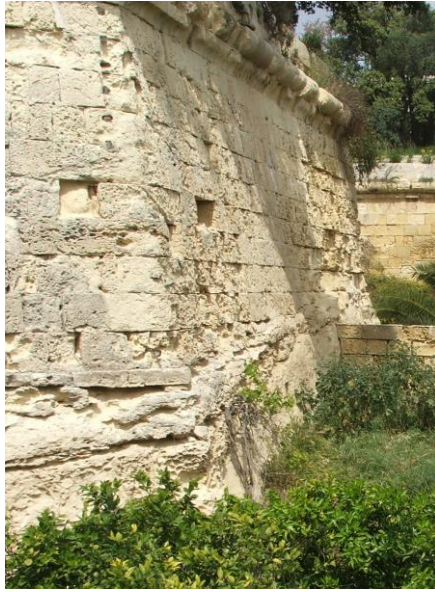
Left flank and shoulder.

The left flank and shoulder are much more deteriorated, possibly because they form a side of the parabolic section of the entrenchment where the tenille is located. Wind is captured in this section and contributes to the deterioration of the fabric.

The lower rock formation here is badly eroded and the strata have a very fragile band. The quoins on the shoulder are either rounded or chipped. Alveolar erosion is much evident on the flank, especially near the orillon, while the cordon has many broken sections. From just below the cordon up to the parapet's crest, black encrustation and some biological soiling is evident.

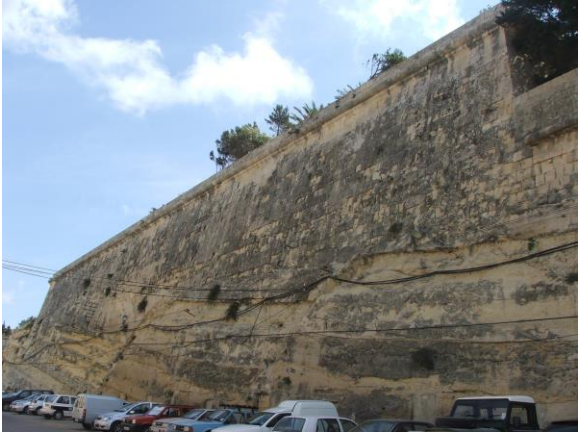
These same conditions are evident in the right scarp where the same atmospheric conditions common to St. Philip's Bastion prevail. The scarp is heavily encrusted with pollution as well as other encrustation, which are difficult to identify due to their high location. However, they are more likely to be caused by omissions as it tends to exist more on the underside of ledges and less evident of the powdering rock face.

St. James' Bastion's heavily polluted right scarp.

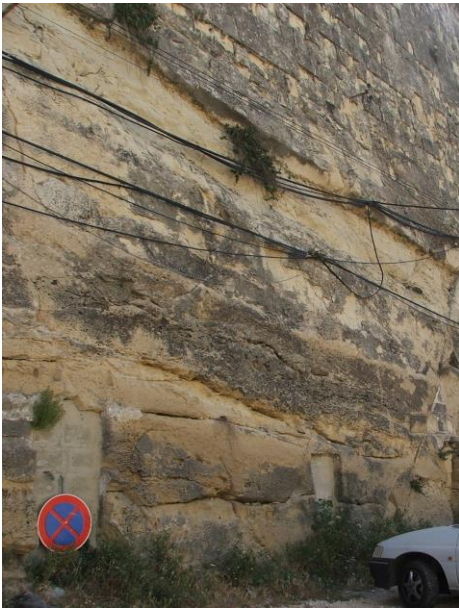
Powdering of the rock formation, pollution from vehicular emissions and electrical cables suspended on rusted metal brackets.

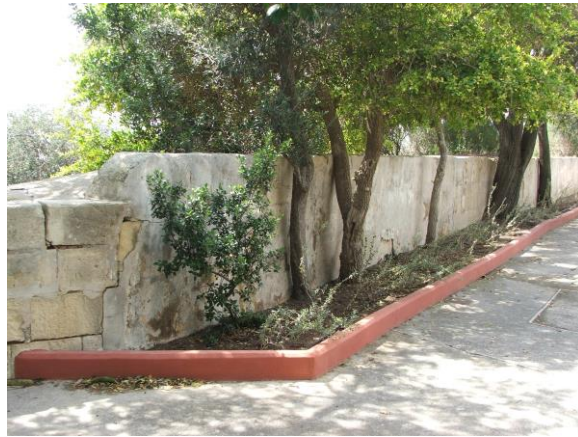
Missing banquette and trees planted in a sensitive location. Parapet is heavily plastered.

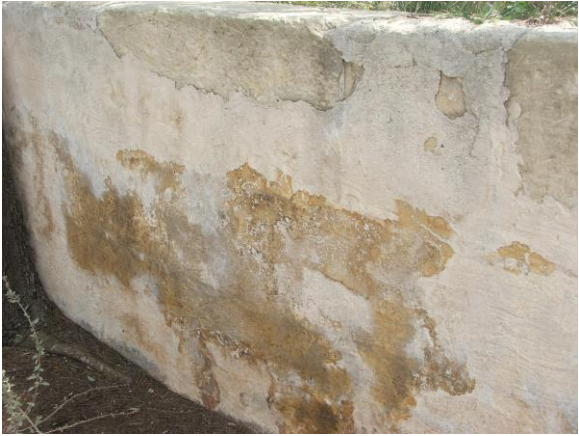
Parapet with heavy plastering and algae growth.

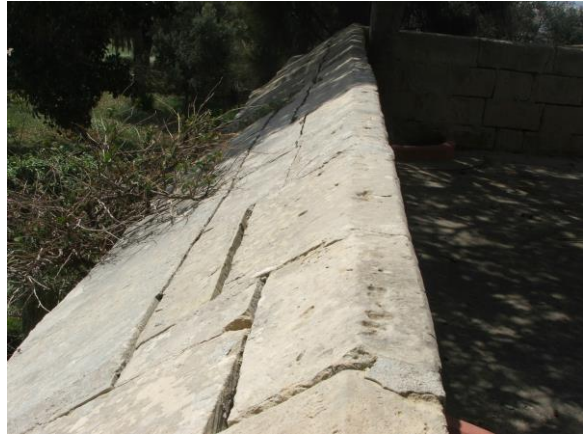
Dislodged quoins and voided mortar joints.

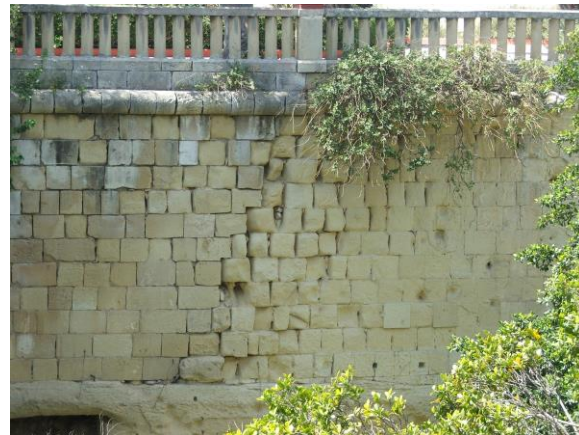
Post war restoration and bulging masonry.

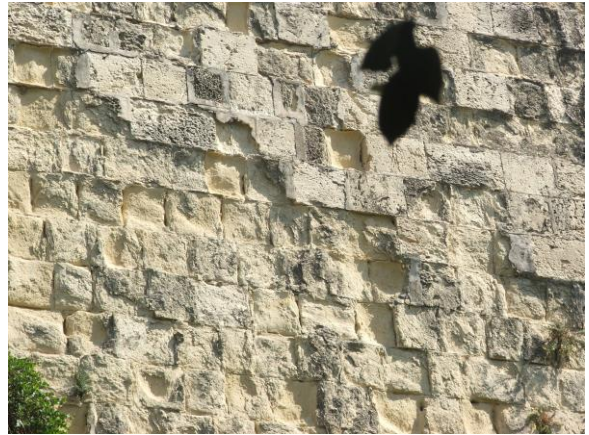
Only few areas of the masonry's patina remain.

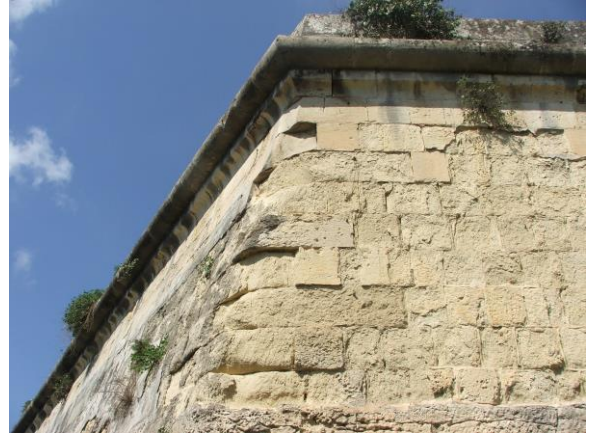
Badly broken and eroded quoins on shoulder.

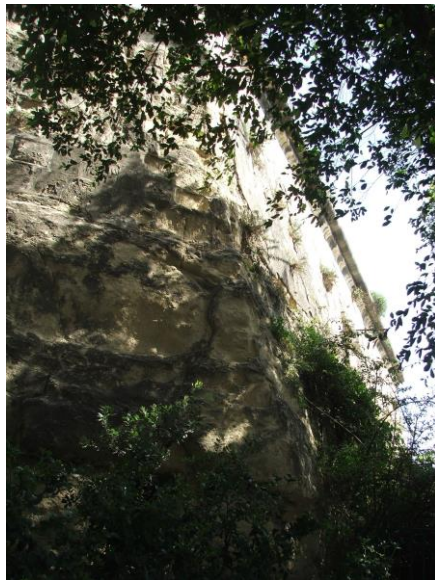
Tree hidden base of shoulder.

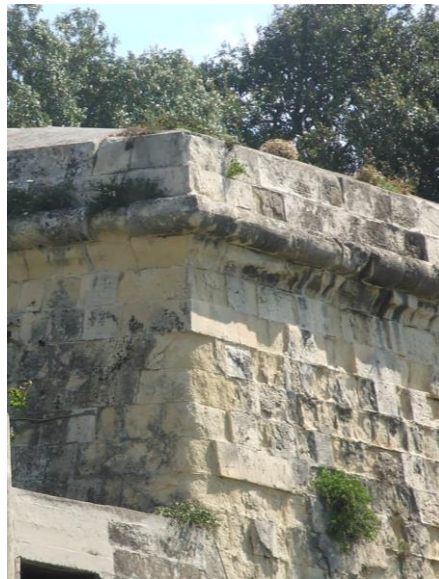
Broken quoins, erosion and crust on salient.

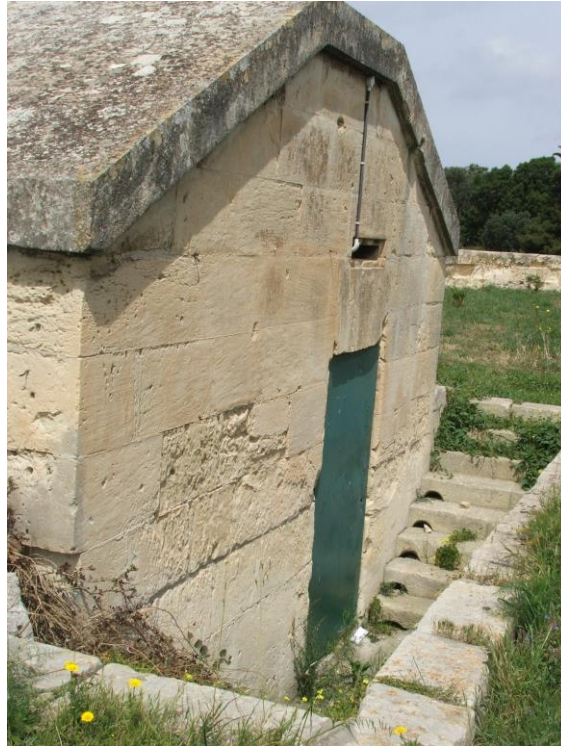
Identical deterioration on the right magazine.

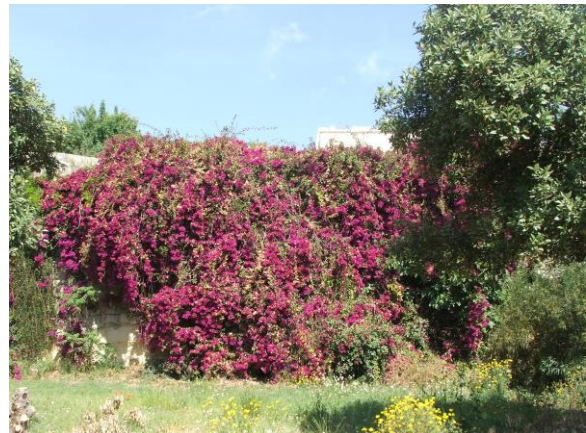
Battery hidden behind growth.

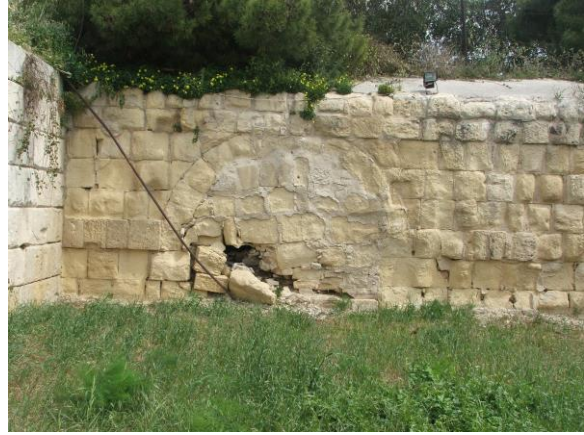
Badly deteriorated wall and blocked doorway.

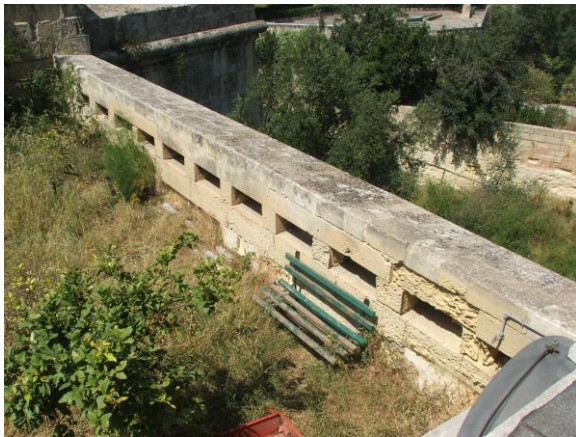
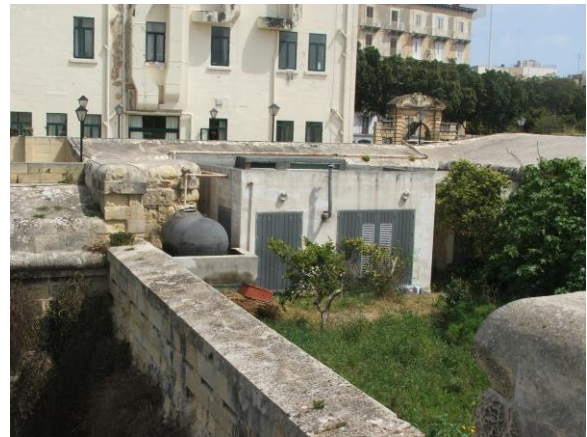
Eroded masonry and biological growth on loopholes. Accretions and extensions to the former utilities.

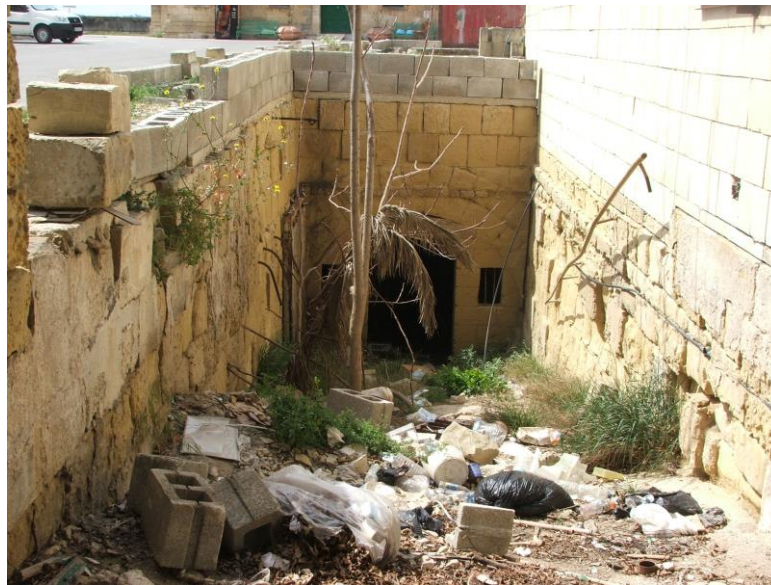
The badly deteriorated and rubbish infested entrance.

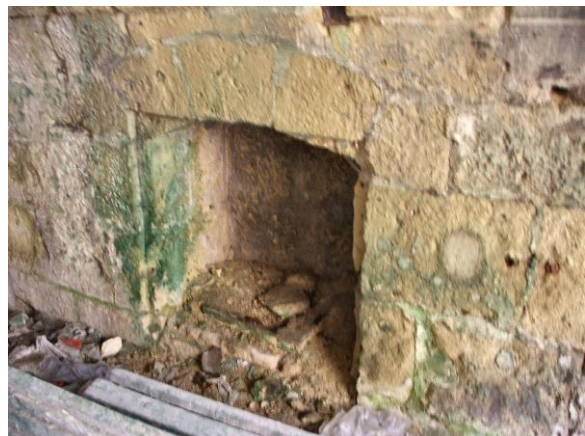
Moss and deterioration on the masonry fabric.

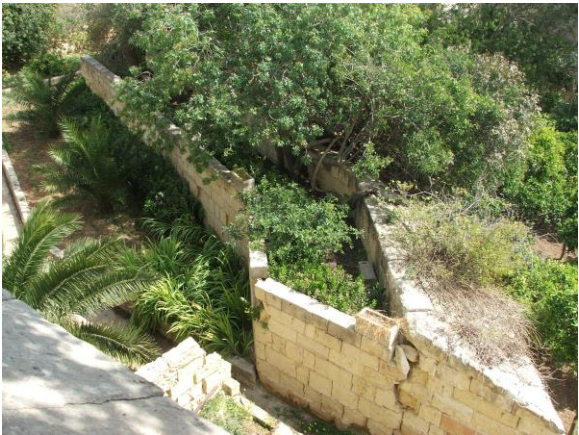
The left claw heavily overgrown with trees.

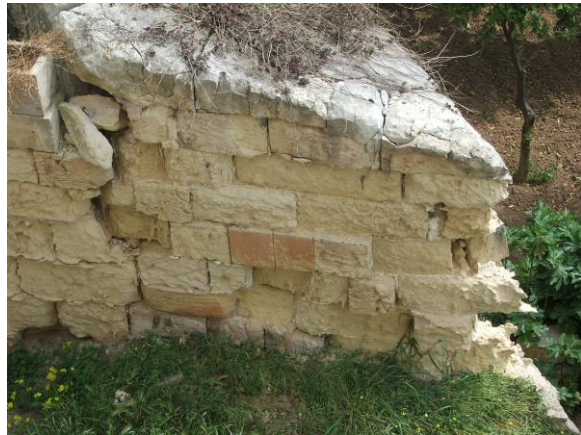
Fissure, broken stone and mass deterioration.

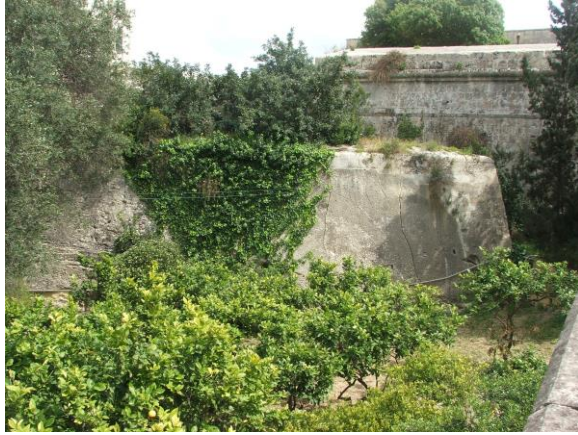
Right claw with plants, crust and biological growth.

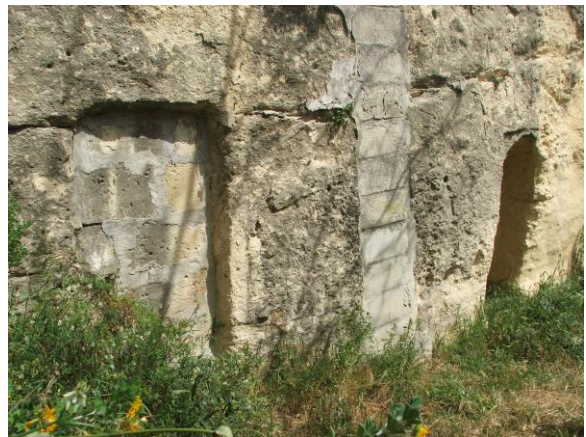
Excavations, trunking, cement and growth.

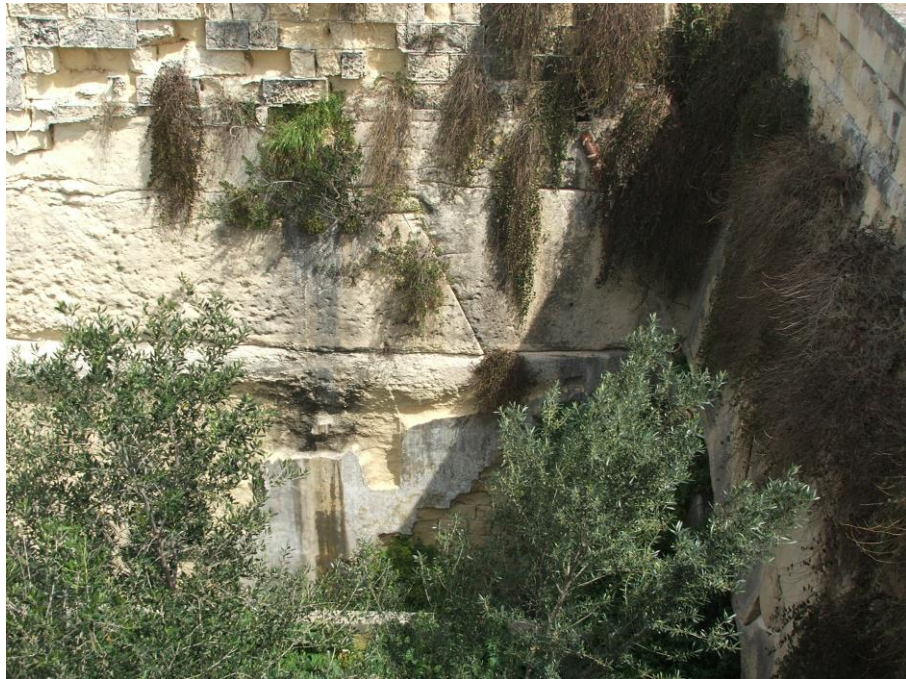
A little of everything; Alveolar erosion, powdering stone and rock face, broken or leaking water drains, concrete rendering and intense plant growth.

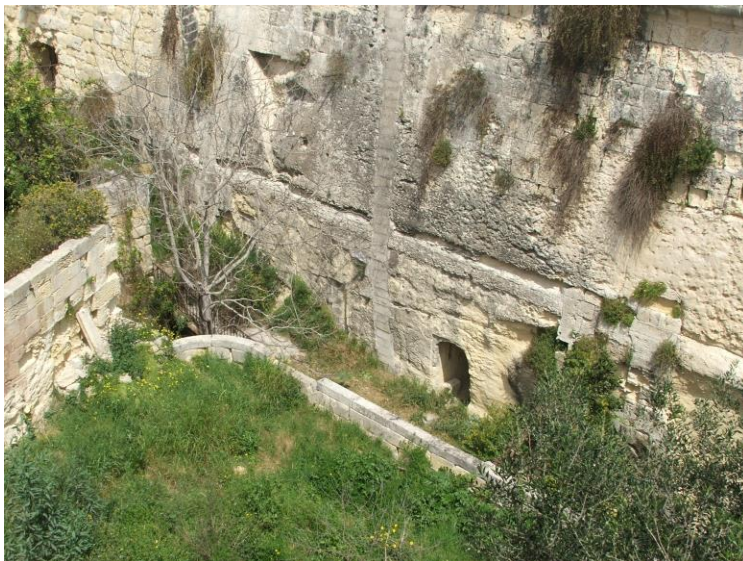
Trunking, black crust, biological and plant growth, excavated shelters and concrete on the rock-hewn face.

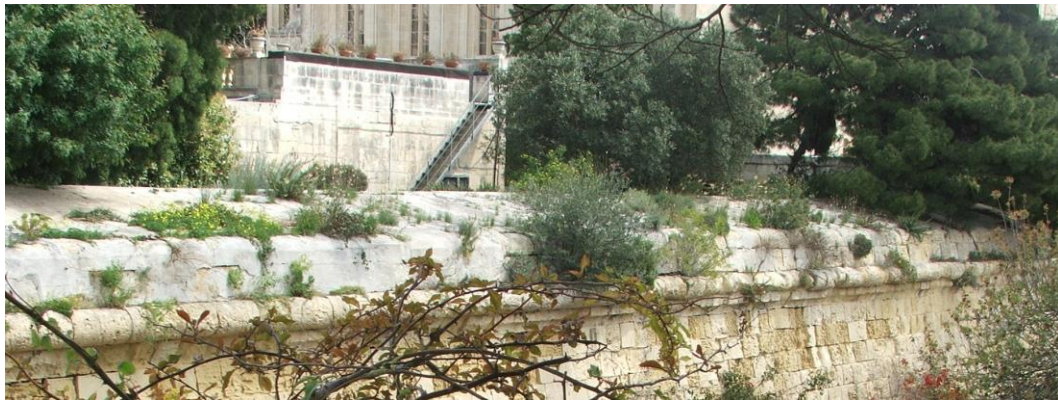
The parapet on curtain; plants, biological growth and stone deterioration.

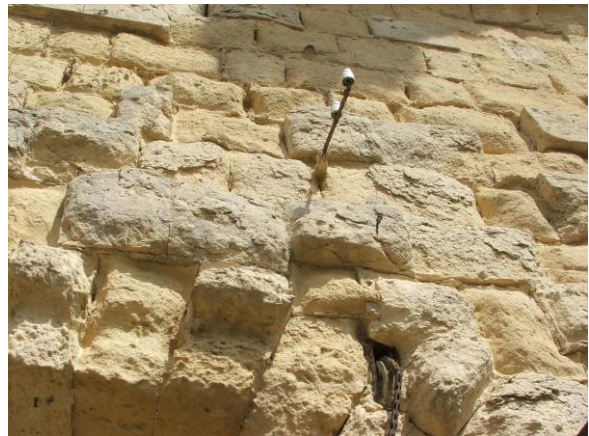
Eroded and broken masonry and accretions on curtain and cordon above the sally port.

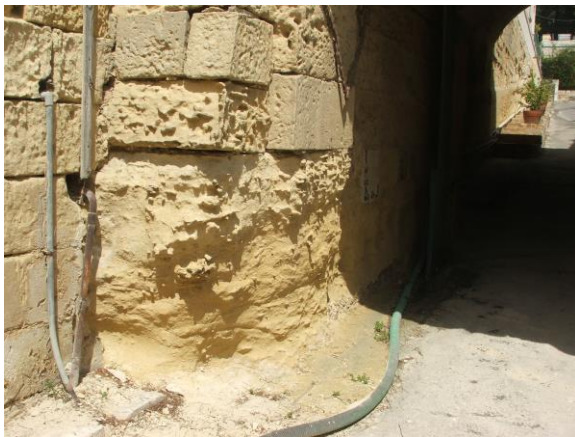
Alveolar erosion and tubular accretions.

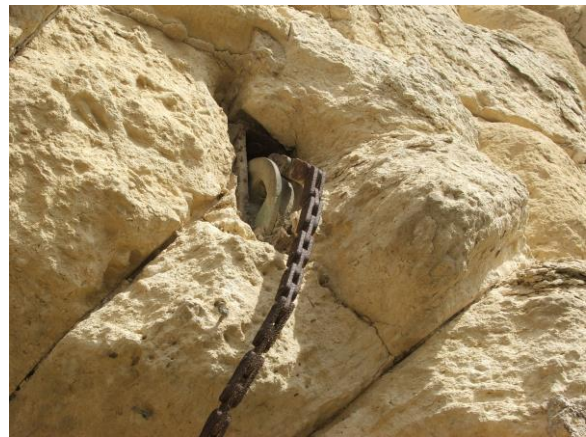
Gate's metal fittings and the powdering voussoirs.

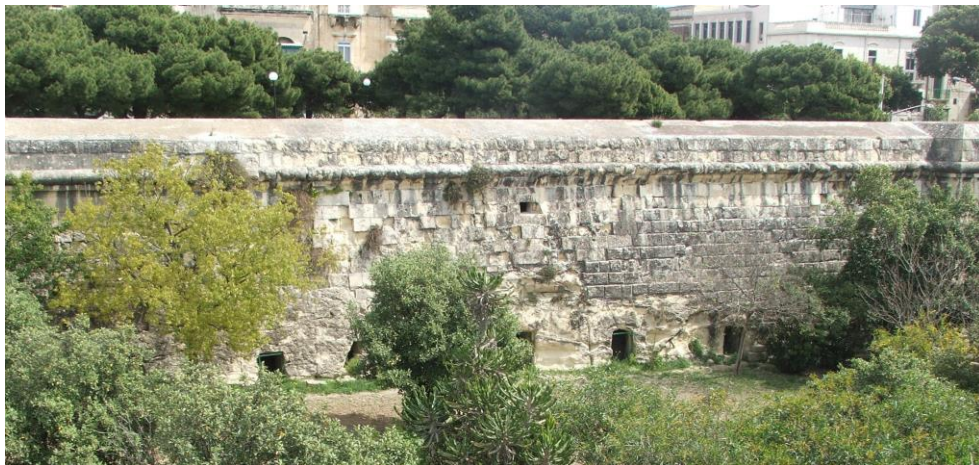
The various interventions and types of deterioration on St. Anne's Curtain.

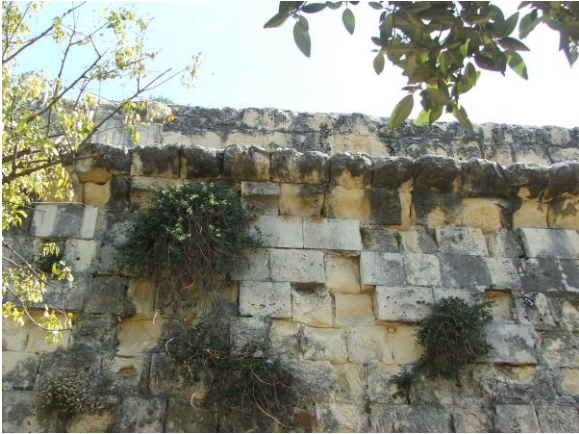
Deteriorated masonry, breakage, heavy black crust and plant growth on face, cordon and parapet.

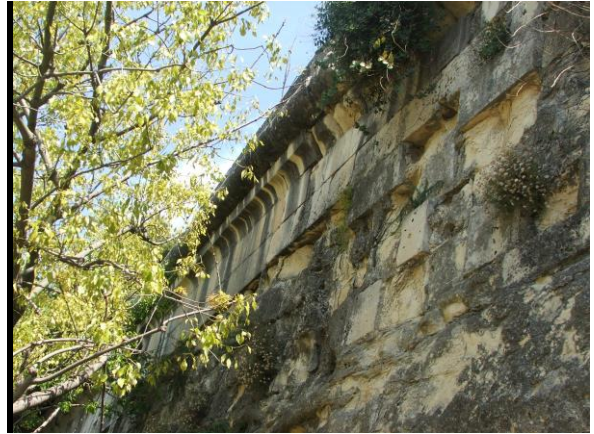
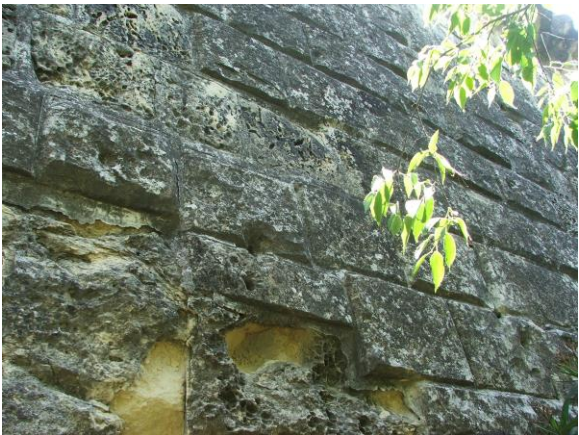
Black crust and biological growth of later stones.

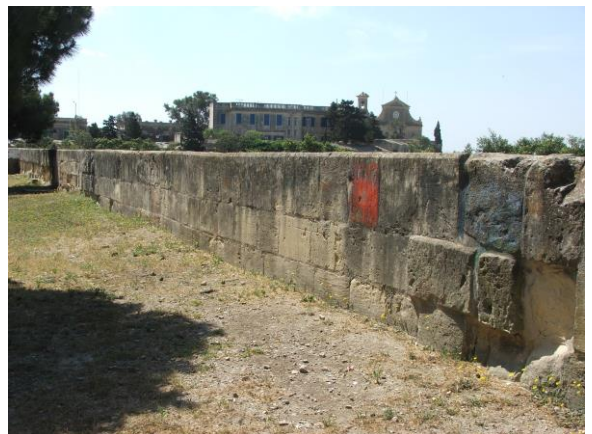
Pollution encrusted recent alterations on parapet.

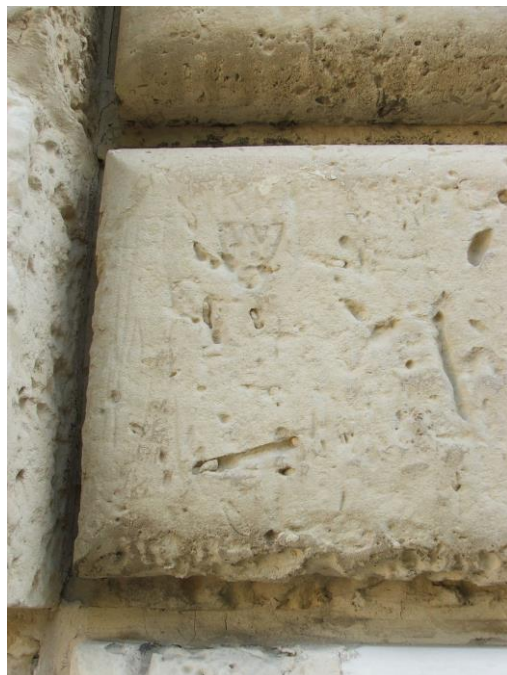
Deterioration and graffiti on masonry.

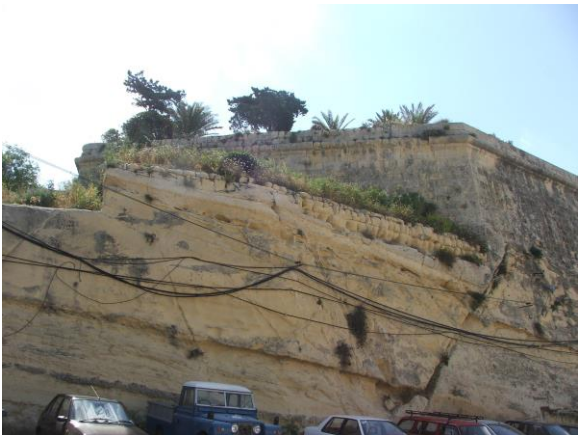
Badly eroded rock hewn face remaining stones.

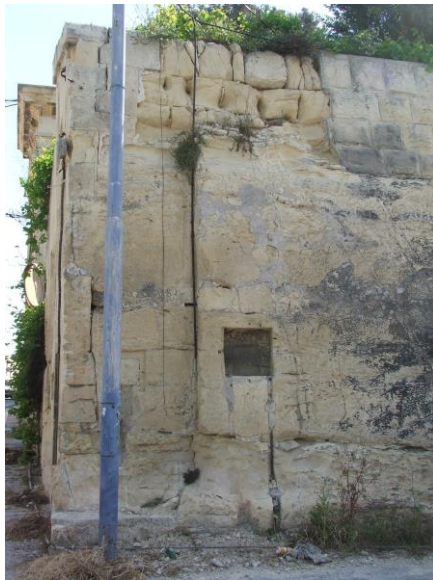
The edge by the road badly requiring maintenance.

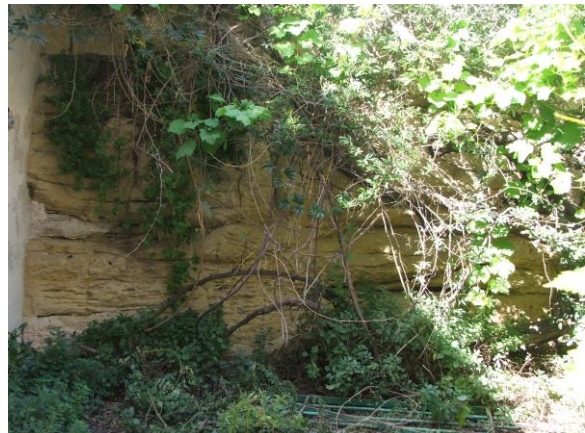
Plants and creepers growing on the friable rock.

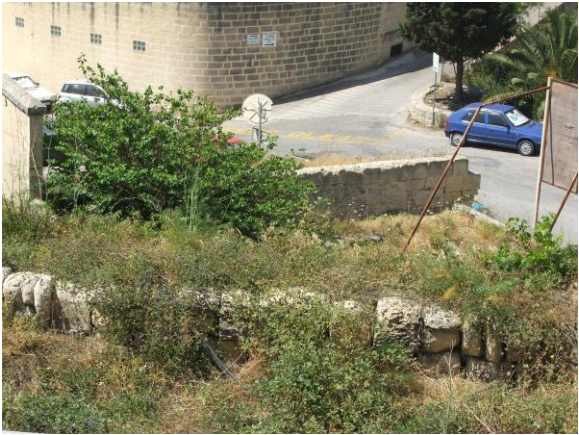
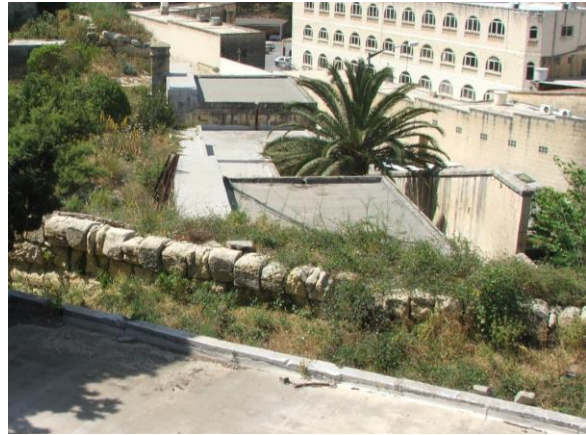
Sections of the plant infested parapet, probably missing some courses, broken stones, and pollution.

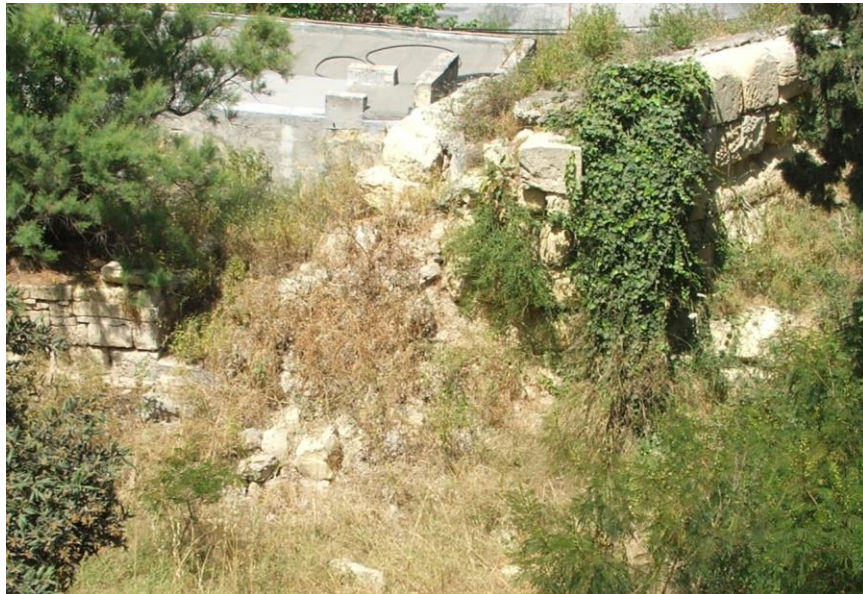
Badly damaged side of parapet by demi-bastion overgrown with plants and trees.

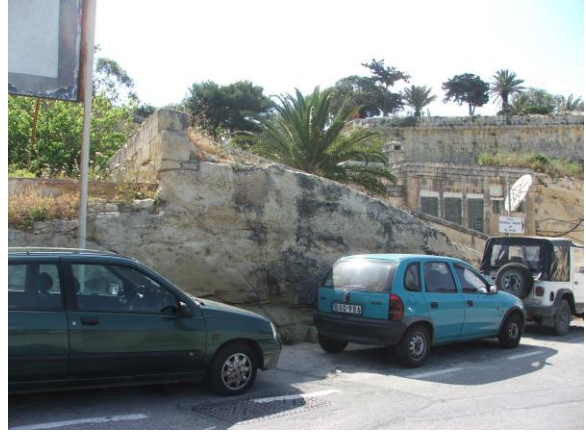
Other to plant growth, the rock and masonry are heavily covered with encrustations from pollution. The masonry on the covered way are cracked and have voided mortar joints. Some lichen growth was detected. The rocky slope is also subject to rubber mark from tires of vehicles that are parked on it, as well as some oil that drips from their engines.
