# Historical Land- Use and Streambank Erosion

Developing a local, process-based  
streambank restoration strategy

Claire Leverne

UNIVERSITY OF MALTA / JAMES MADISON UNIVERSITY

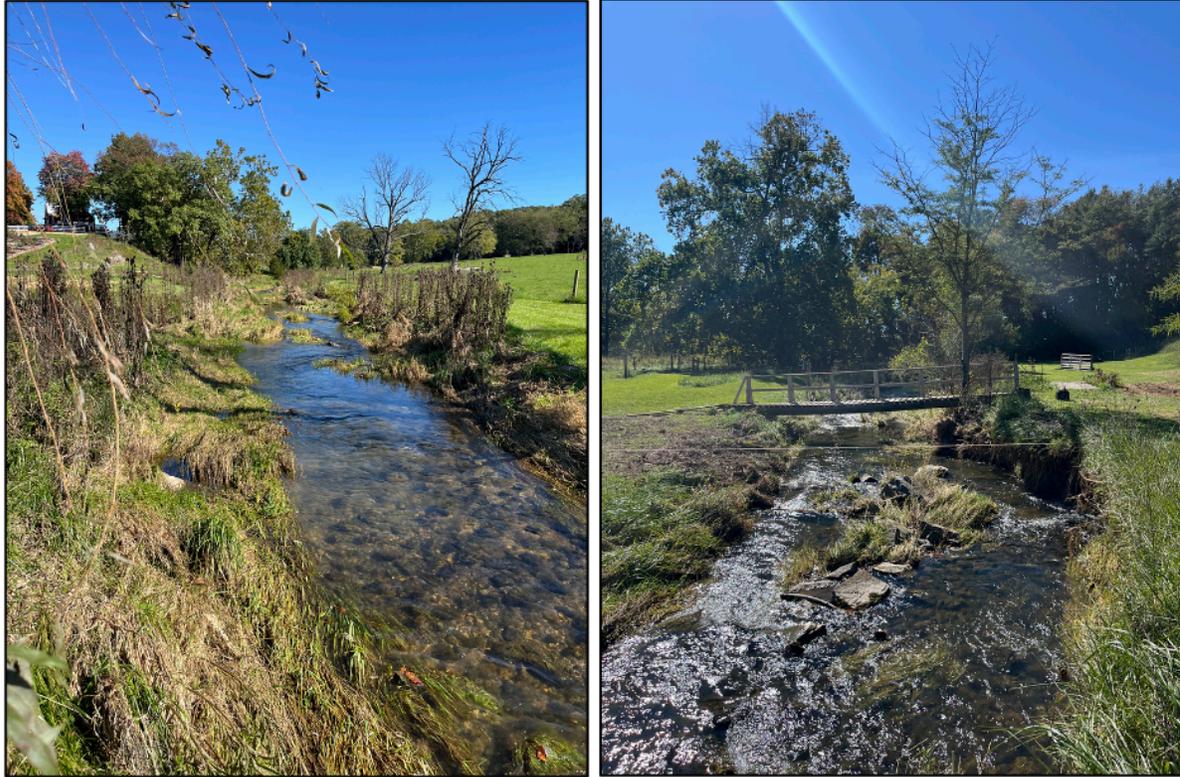
The location of heaviest erosion within the project site shows evidence of prior human intervention. The erosion occurs at a gradual bend in the stream, and there is a small rock island in the middle of this bend. The rocks located here are larger than what appear to be naturally dispersed throughout the streambed and appear to be placed in a manner where they might have lined the streambank at an earlier time in history. These boulders are significantly larger than what can be found throughout the rest of the property; a comparison of this difference is shown in *Figure 2*. The heaviest erosion is on the right bank (facing the direction of flow), indicating that these boulders might have prompted the stream to begin scouring the bank as the water sought the path of least resistance, eventually rerouting more of its flow behind the barrier.

Figure 2: Comparison of upstream streambed rock (left) to in-stream boulders at erosion site (right).

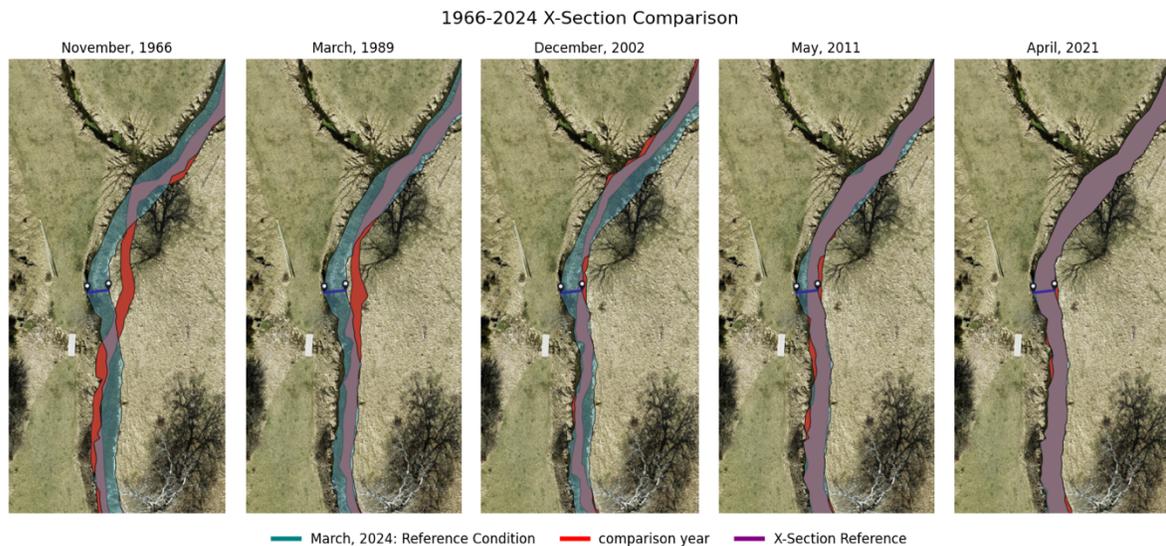
*Figure 6: Comparison of stream migration between 1966 and 2024 (2024 shown in blue).*

Comparing 1989 to 2024, the bank migration distance at the erosion site is slightly over 21 feet. When compared to 1966, this difference is even more substantial; however, the precision of georeferencing was less reliable in this year, as was discussed in the limitations of the methodology.

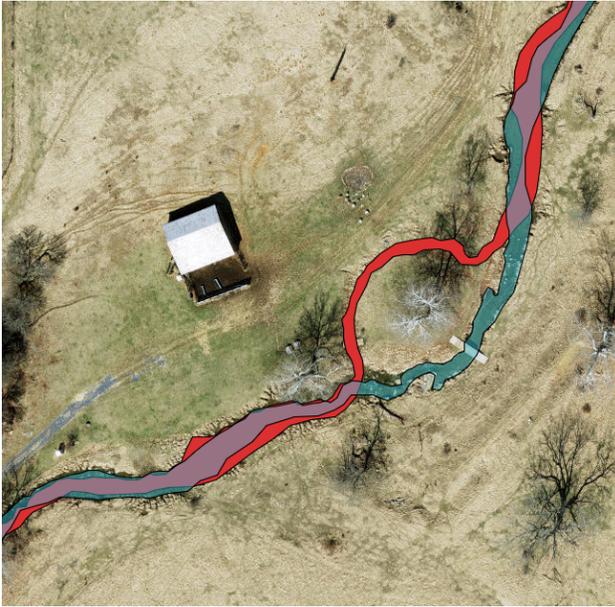
Upstream of the site, historic imagery shows the presence of a mill-race. This difference is highlighted in the comparison of 1989 and 2024 stream profiles, shown in *Figure 7*. Based on available imagery, this race was diverted to a new (and possibly its original) path sometime between the years of 1994 and 2002. Upstream and downstream adjustments in the stream's meander are apparent after this event.

Figure 7: Comparison of stream profiles at mill race diversion, 1989 (red) and 2024 (blue).

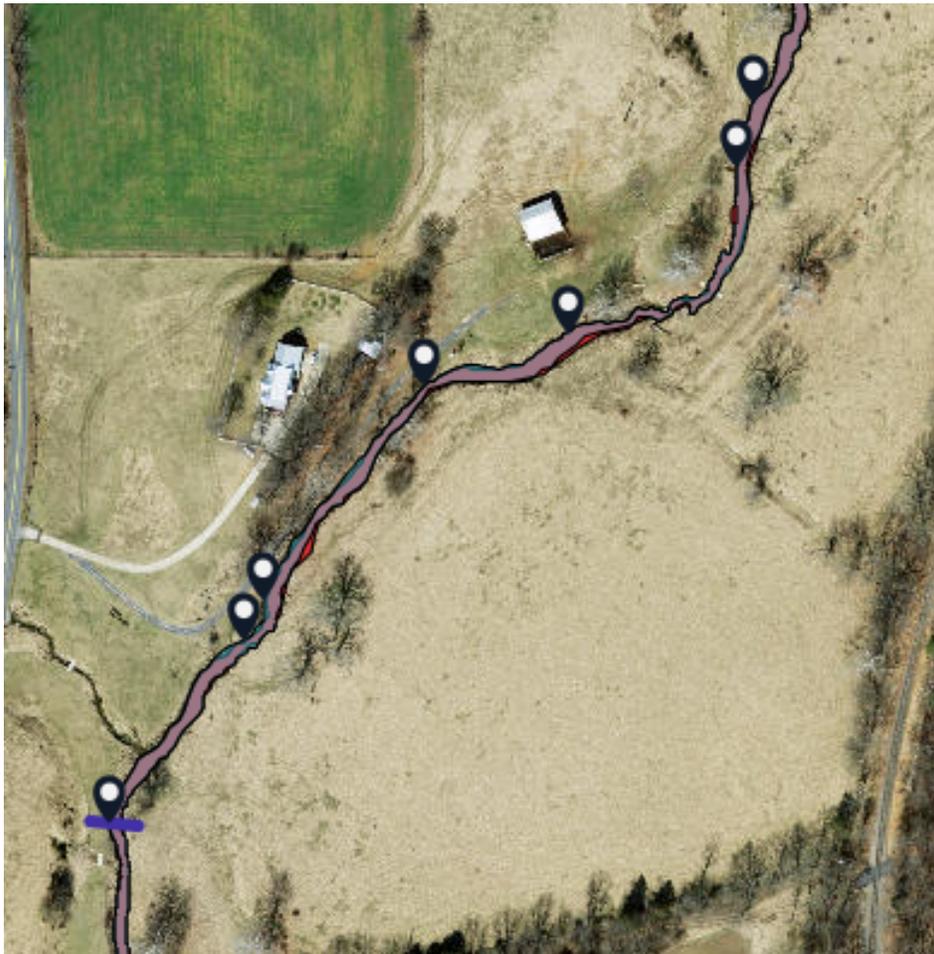
Third, the one location which does not stabilize at the same rate is the erosion site at location #7. There is a jump in bank migration between 1989 and 1994, which may explain the impetus for placing boulders along the toe of the shore – an effort to mitigate erosion. The stream makes additional adjustments between 1994 and 2021, with a mean migration pattern that continues to erode into the right bank. The footbridge was installed sometime around 2021, and this is when another spike in lateral movement is observed, with the bank shifting nearly 6 feet between 2021 and 2024. Site visits between late 2024 and early 2025 also confirm a visible bank migration of between 1-2 feet in just six months.

Figure 8: Location of reference points for lateral migration measurements.

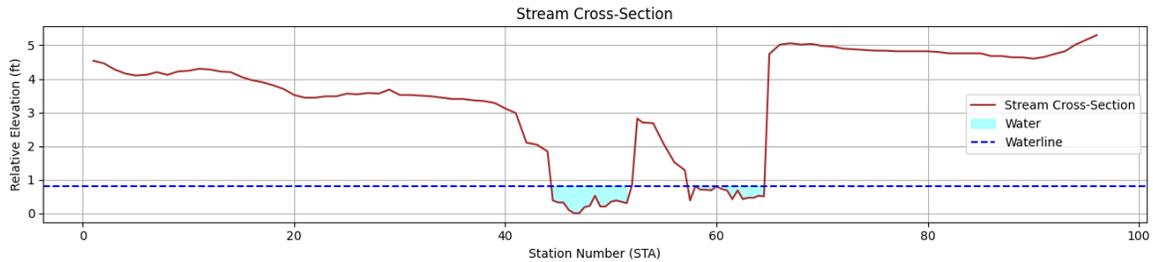
Figure 9: Cross-section of eroded bank. On-the-ground conditions of the vertical bank edge shown has a 1-2 foot undercut.

The cross-section profile of the project site (*Figure 9*) shows an incised channel, with differences on the right and left banks. The left bank is slightly graded but climbs abruptly to its floodplain elevation. The right bank has no grading and immediately jumps from streambed elevation to the floodplain. Bank heights are 4.5 and 5 feet at the top of the measured floodplains, and on the right bank the floodplain slopes away from the stream, dropping from 5 feet to 4.5 feet. The wetted width is 14.5 feet.

Between the banks, the channel is narrow and is divided in the middle by an island; the left channel shows a deeper water profile, indicating slower velocities on the inside of the bend. It shows an unconnected floodplain on the right with streambed conditions that facilitate higher velocities along the right bank, which will continue to exacerbate the existing erosion.

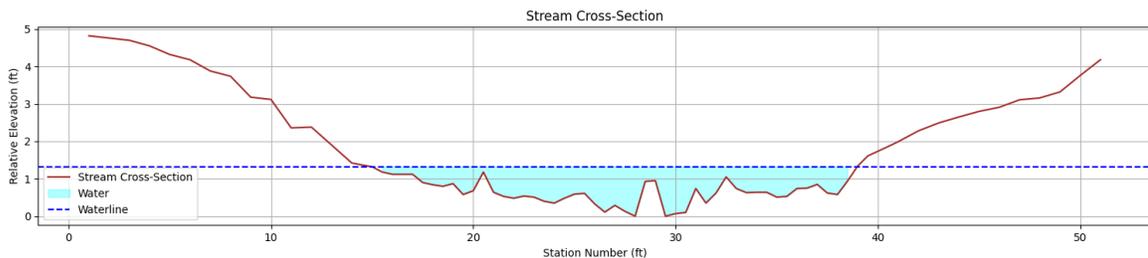
Figure 10: Cross-section of reference condition.

In contrast, the cross-section of the reference condition (*Figure 10*) shows stable, graded streambanks, with water distributed across the streambed. The left bank shows a 25% grade, and the right bank shows a 33% grade. The wetted width at this site is 23 feet, and highest velocities were observed near stream thalweg at the 30-foot mark on the graph. This reference profile is also situated at a bend in the stream (outside edge on the right), so it's unsurprising that the right bank forms a slightly steeper profile, as the topography is driving a

redirection in the stream here. Despite the asymmetry, it can demonstrate stable bank slopes for this stream.

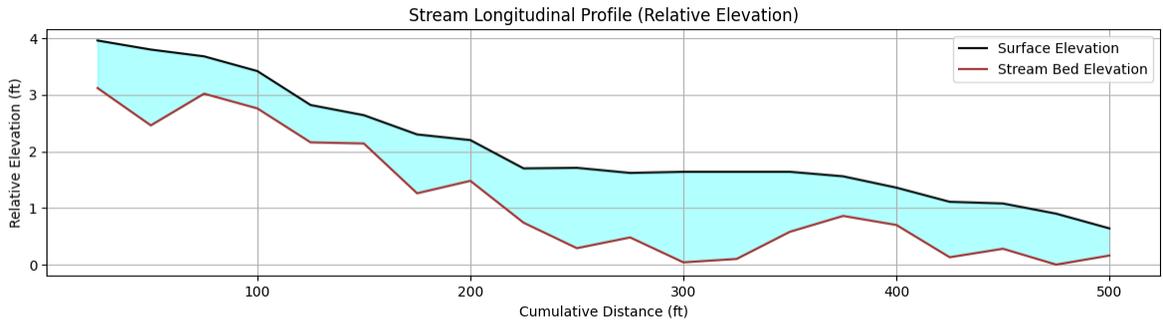
Figure 11: Longitudinal profile 500 feet upstream of erosion site.

The longitudinal profile (Figure 11) returned an average streambed slope of 1.7% in the 500 feet upstream of the erosion site (site is located at the 500-ft mark of the graph). Along this distance, significant drops in elevation are evident in the first 250 feet, with the slope leveling as it approaches the project site. Between 300-400 feet the stream deepens and levels, indicating pooling. Downstream, the average leveling of the slope could mean lower velocities and better energy dispersion; however, at the 500 mark the stream becomes shallow again which could mean higher velocities if the stream does not widen horizontally in this area.

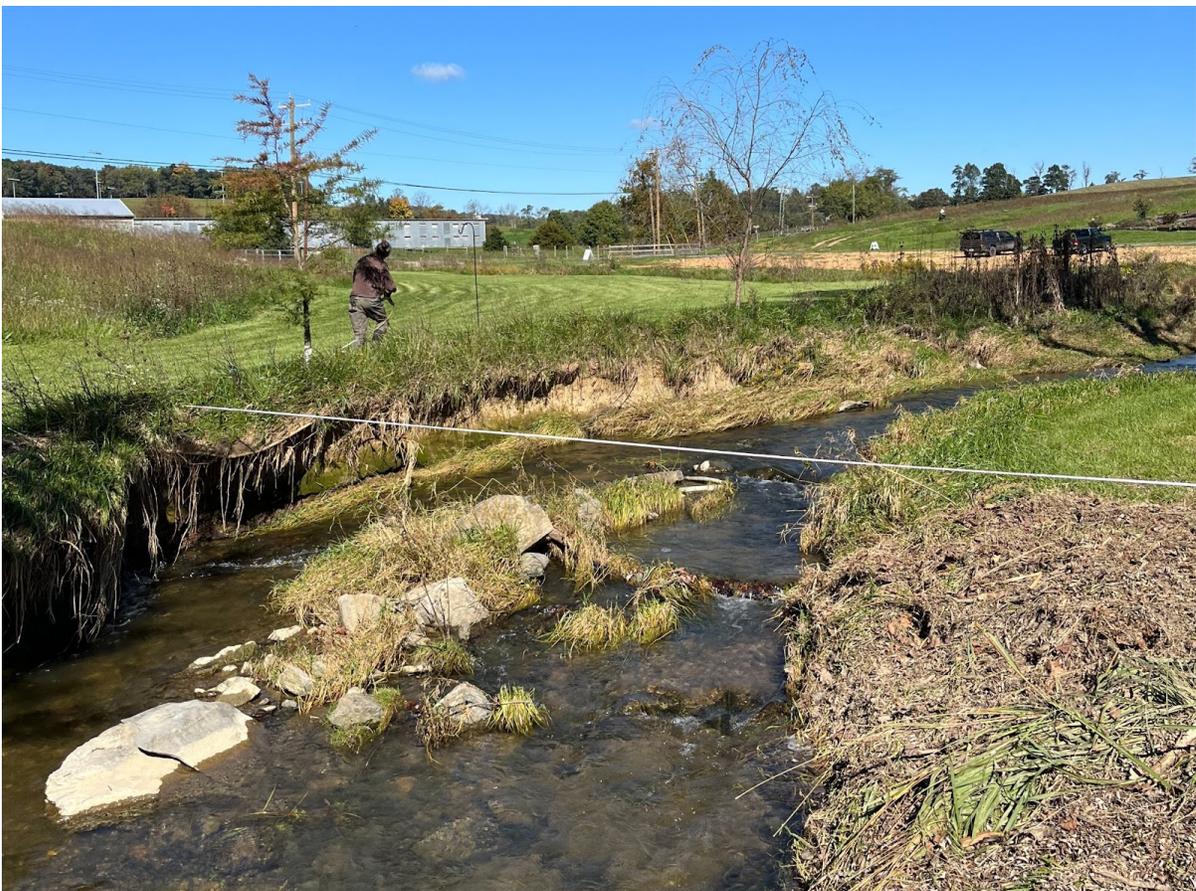
but has had two periods of accelerated erosion: 1989-1994, and 2021-2024. The first period of acceleration could have prompted the placement of these boulders and furthermore could have been a factor in preventing this section from stabilizing in the aftermath of the mill-race removal, where the rest of the stream was able to stabilize over the next decade. Over time, water has scoured behind the boulders as the stream sought the path of least resistance. Velocities are naturally faster along the outside corner of a bend, and as of 2025 the island blocked part of the channel, funneling additional water into the bank (see *Figure 12*).

*Figure 12: Rocky island in stream, October 2024.*

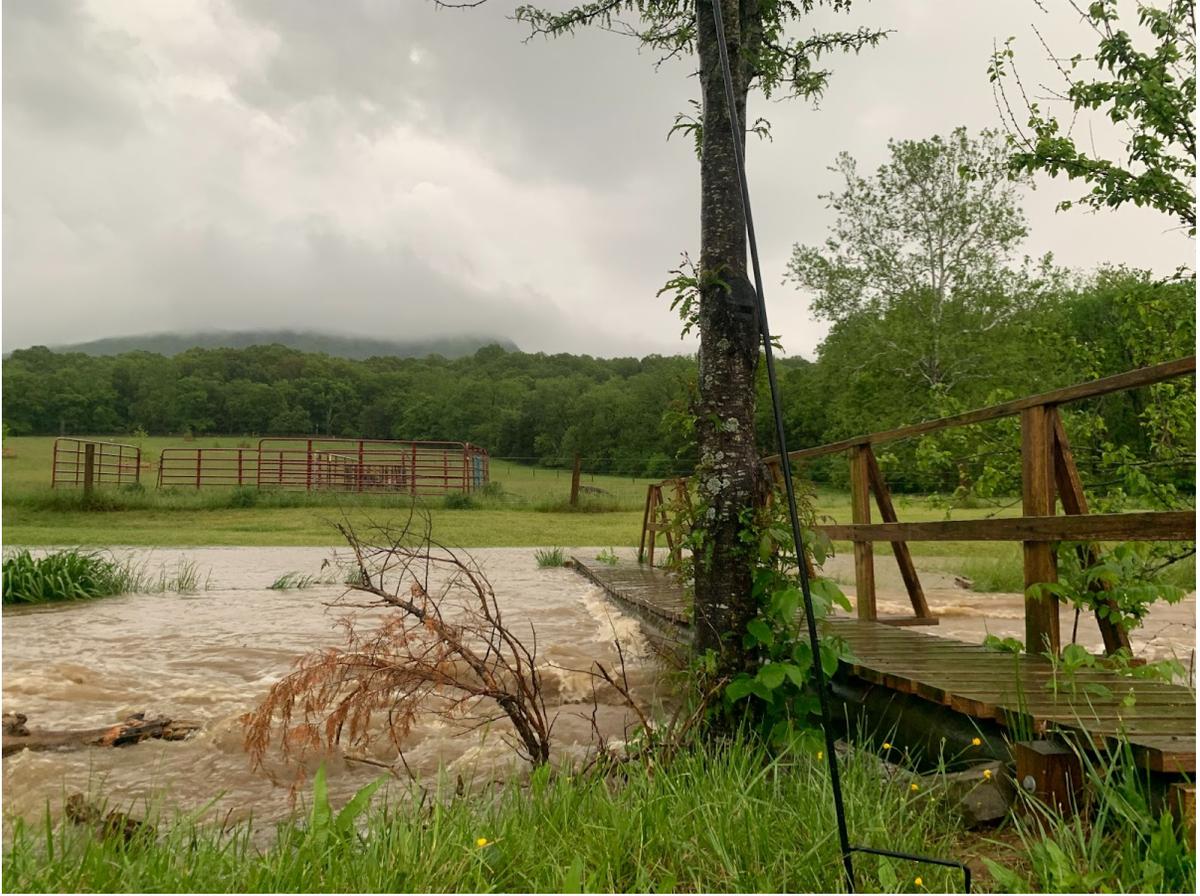
The second period of acceleration is recent, and the timeline aligns with the placement of new footbridge below the project site. The footbridge is creating a hydraulic restriction, both as a lateral pinch-point, and vertically has been observed to act as a dam in storm events. It restricts the stream's floodplain access and impedes its flow, even at the frequency of an average spring storm event. In the discussion of *Figure 8*, it was noted that the right bank sits at a higher elevation than the left, and backslopes to a more natural floodplain elevation. This is also evident when considering the flooded condition shown in *Figure 13*: the footbridge sits at an angle, lower on the left bank and slowing flow, but higher on the right bank which funnels high velocities against the bank to pass under the bridge.

*Figure 13: Downstream footbridge during a spring storm event, May 2025.*

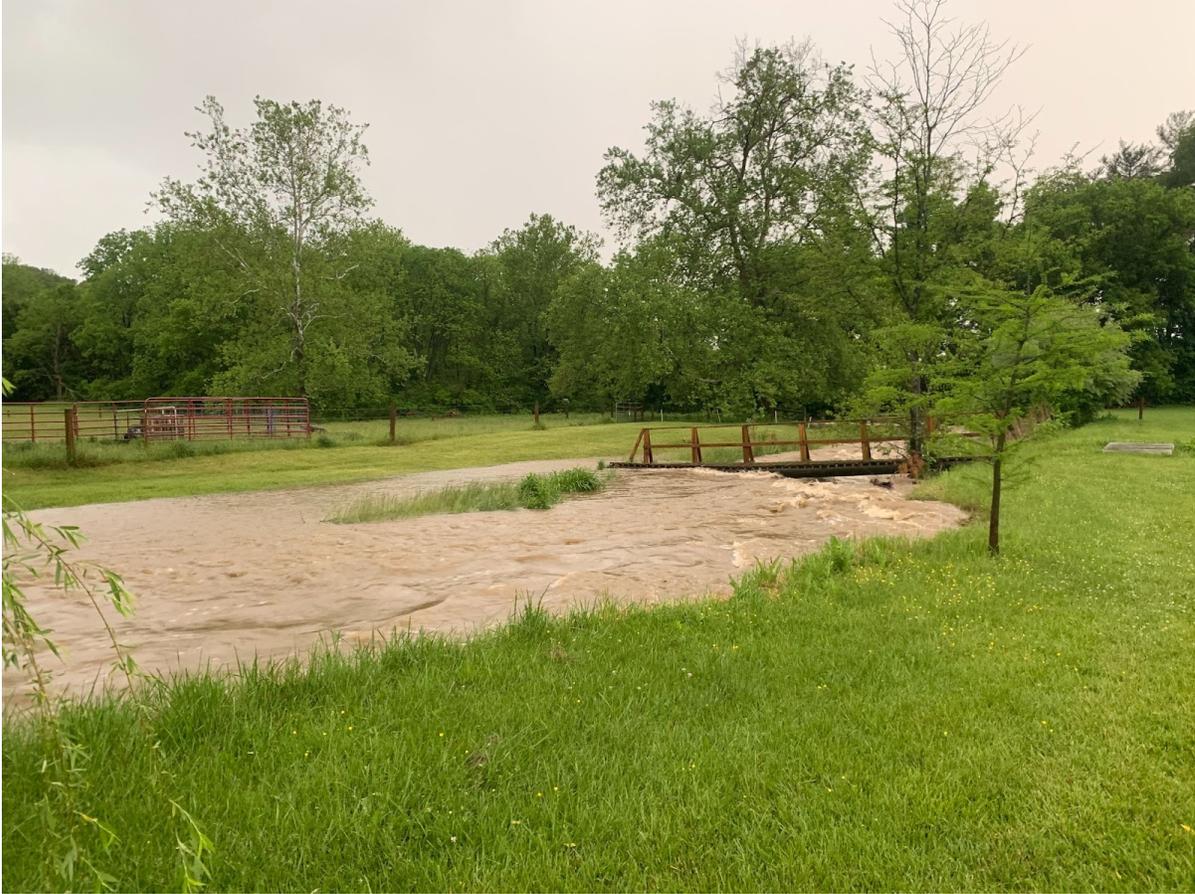
*Figure 14: View from upstream of the project site during a spring storm event, May 2025.*

Another key finding of the survey is that the eroded bank has isolated the stream from the floodplain. Active erosion is ongoing in this area; over the course of this project, between November 2024 to April 2025, the bank was observed to have eroded as much as a foot further within that period. *Figure 14* shows the difference in floodplain access between the two sides. Where the stream can access its floodplain, velocities are slower, and energy is dispersing across the floodplain. On the right where the channel is incised and the stream is isolated from its floodplain, water is moving quickly and forcibly against the bank, turning up soil.

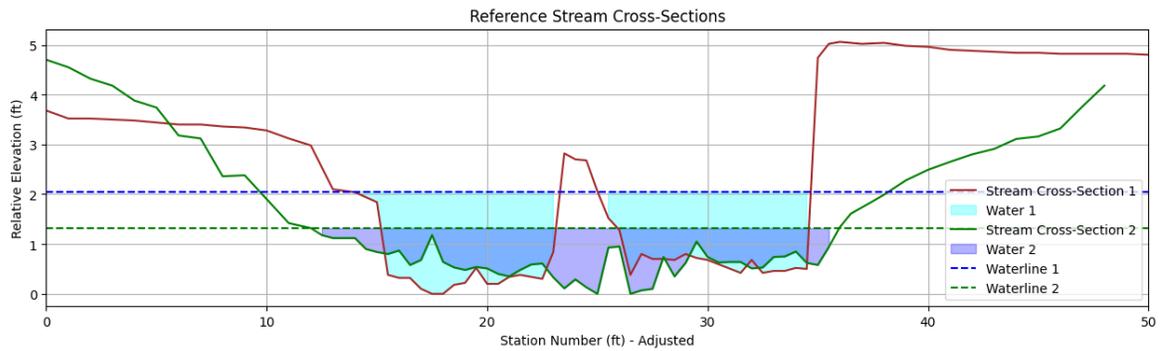
When comparing cross-sections of the eroded bank and its reference reach (*Figure 15*), there are obvious differences. The reference reach shows gentle grading on either side of the stream, whereas the eroded bank is starkly incised on one side, and moderately on the other. The left side shows a concave-down profile, yet it's not so incised that it has lost floodplain access. At the erosion site, the right side of the bank is deeply incised. An incised stream is defined having a bank height ratio greater than 1.0 ft/ft, at which point the bankfull height is below the bank height and is considered unstable (Department of Conservation and Recreation, 2004). Compared to the reference condition, the eroded bank could be graded to a similar slope utilizing roughly 12.5-13 feet of the bank width. Over a vertical rise of 4.5 feet, this would result in an approximate 1:3 rise-over-run slope grading.

Figure 15: Comparison of cross-section profiles. The reference profile (in green) shows an alternative profile to mimic by regrading the incised channel (in red).

To re-establish floodplain connectivity, approximately 70 linear feet of the streambank should be regraded. The regraded area should be a maximum of 12.5 feet wide at the crux of the bend, and at its extents be graded to match the natural slopes of upstream and downstream termini (see *Figure 24*). At its center – the widest point – it should aim to mimic the slope of the reference reach, shown in *Figure 15*. This comparison shows that 12.5-13 horizontal feet are needed to achieve a vertical rise of 4.5 feet; approximately a 1:3 rise-over-run ratio.

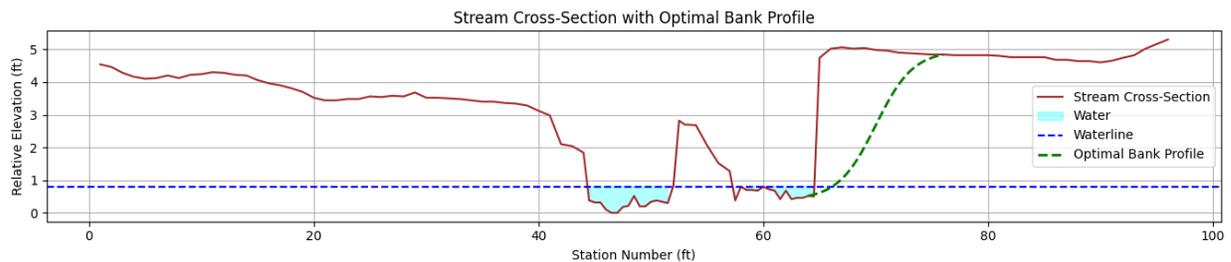
*Figure 23: Visualization of an S-shaped streambank profile.*

The regraded slope should also mimic the non-linear profile of the reference cross-section, resembling a flattened S-curve shape: lower slopes nearest to the water’s toe in a concave-up profile, steeper slopes in the middle and more linear grade, and lower slopes near the crest in a concave-down profile (*Figure 23*). Shear stresses are greater in the lower third of a streambank (Department of Conservation and Recreation, 2004), so creating a more relaxed slope in this section will help facilitate energy dispersion and reduce erosion.

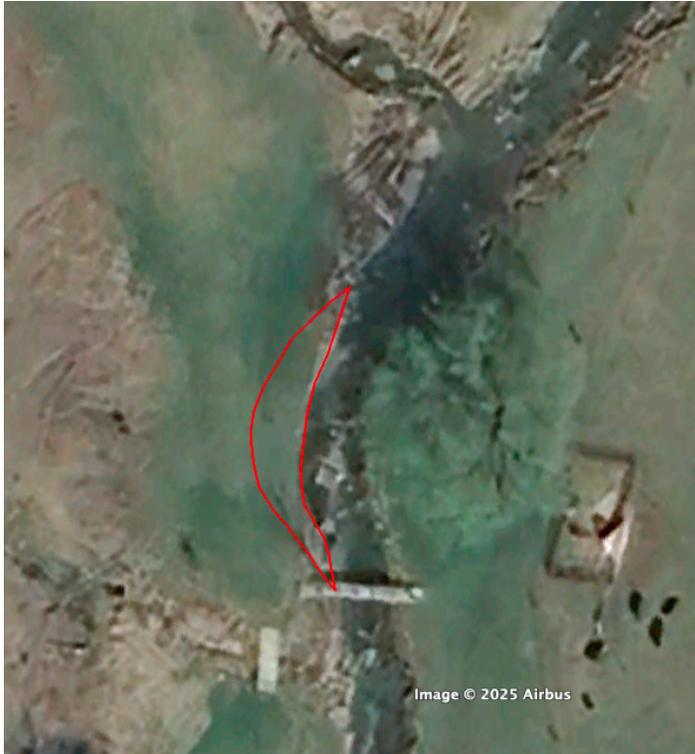
Figure 24: Proposed regrading shown on aerial image

Prior to starting work, a silt fence should be placed between the bank and the stream to protect the stream from undue amounts of sediment deposition during construction. Regrading should be done with bucketed equipment, such as a mini excavator, so that the equipment can stay up on the bank and pull back soil. Equipment should *not* excavate from streamside, as entering and disturbing the stream would be a violation of the legal parameters allowing landowner bank stabilization. Equipment should always use the same point of entry/exit to avoid unnecessary land disturbance. Any disturbed areas outside of the regraded area should be seeded and covered with straw post-construction, allowing grass to revegetate.

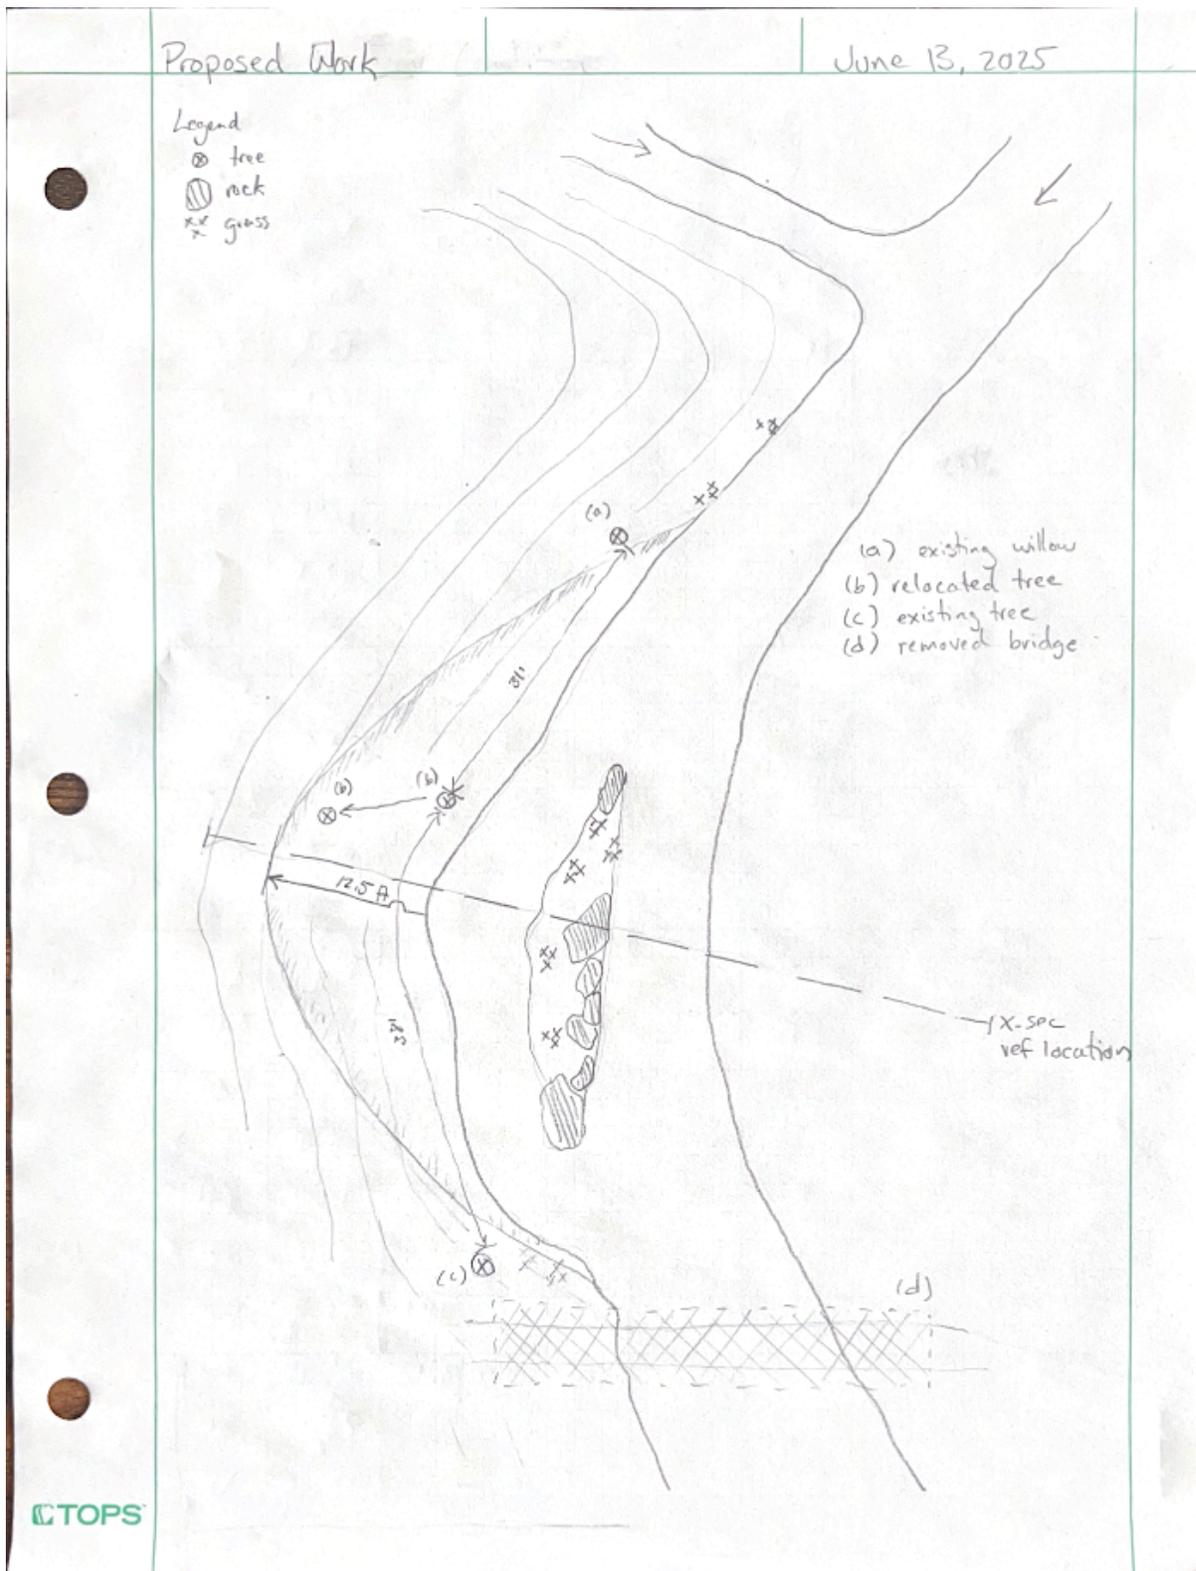
The stream has lost connectivity with its floodplain on the western bank. This causes high velocities and shear stresses along the bank, eroding the soil and carrying sediment downstream. With a connected floodplain, this energy is allowed to disperse laterally into the

floodplain, where slower velocities would allow water to infiltrate the soil for a longer residence time within the watershed.

Prior to starting work, a silt fence should be placed between the bank and the stream to protect the stream from undue amounts of sediment deposition during construction. Regrading should be done with bucketed equipment, such as a mini excavator, so that the equipment can stay up on the bank and pull back soil. Equipment should *not* excavate from streamside, as entering and disturbing the stream would be a violation of the legal parameters allowing landowner bank stabilization. Equipment should always use the same point of entry/exit to avoid unnecessary land disturbance. Any disturbed areas outside of the regraded area should be seeded and covered with straw post-construction, allowing grass to revegetate.
