The Restoration of St Cathaldus Chapel, Rabat

Conrad Thake gives a short history of the ancient chapel and describes the recent restoration of its exterior.

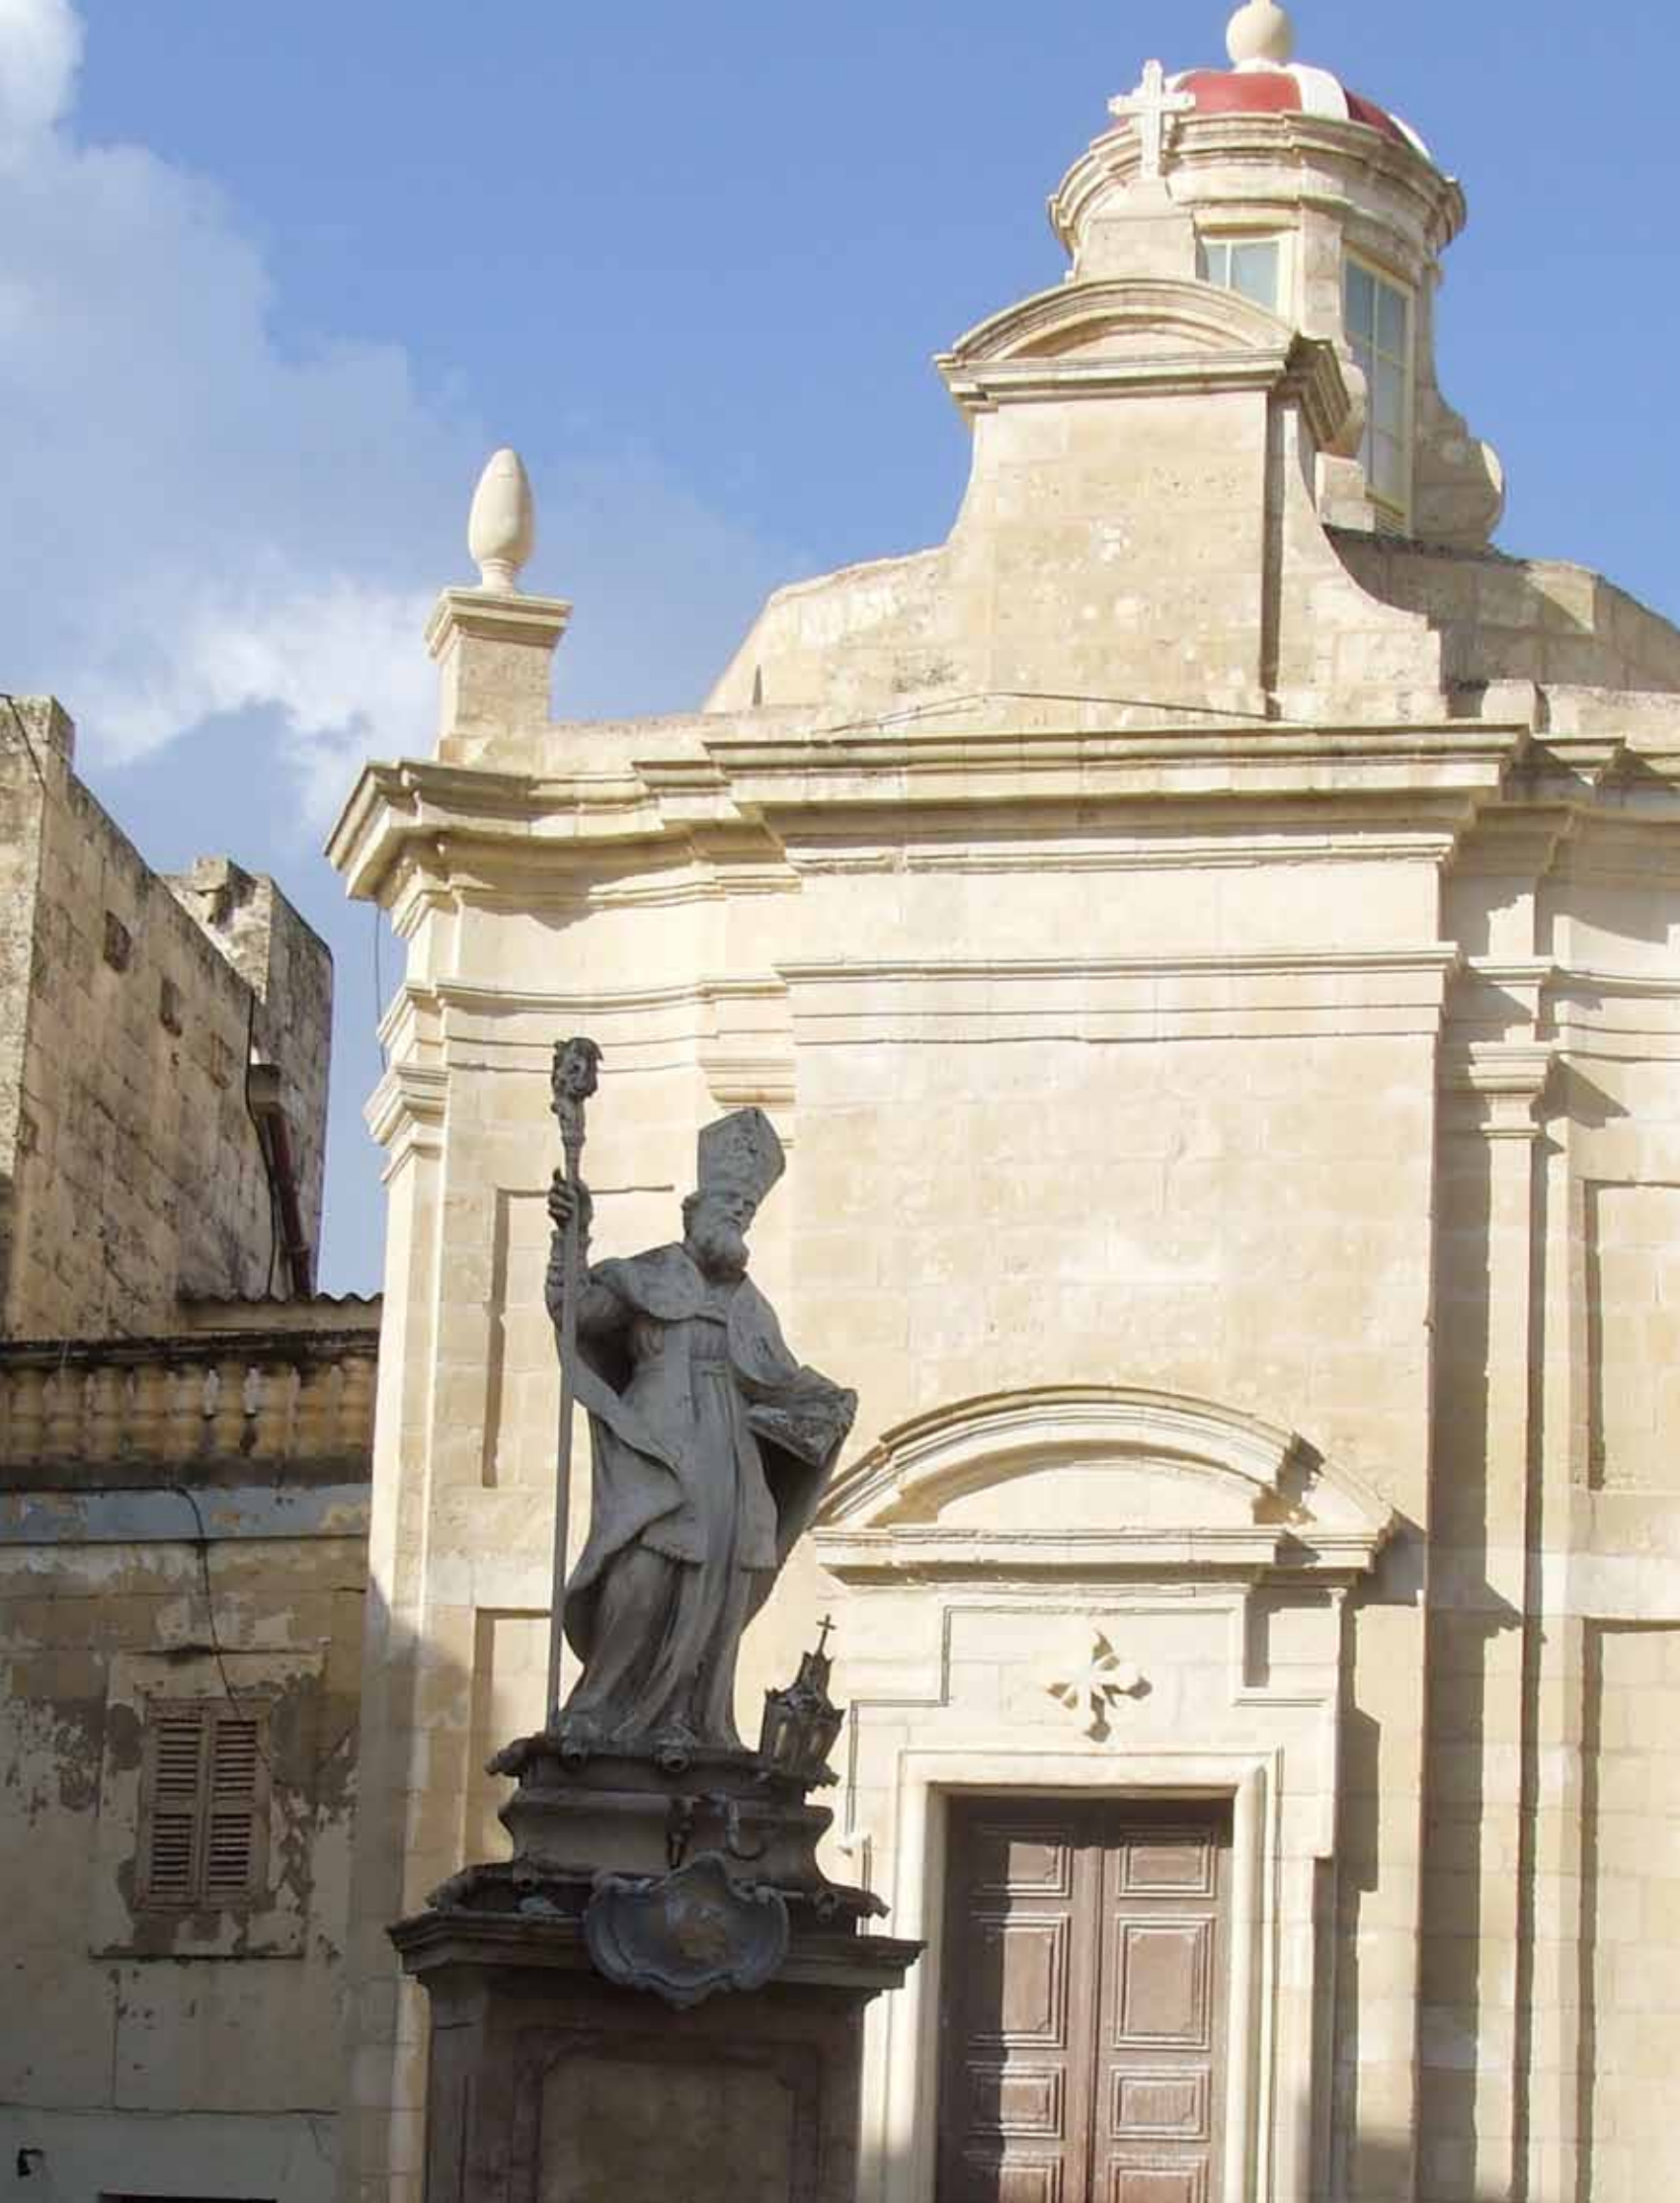
Saint Cathaldus chapel, Rabat (after restoration). (Photo credit Dr. Conrad Thake)

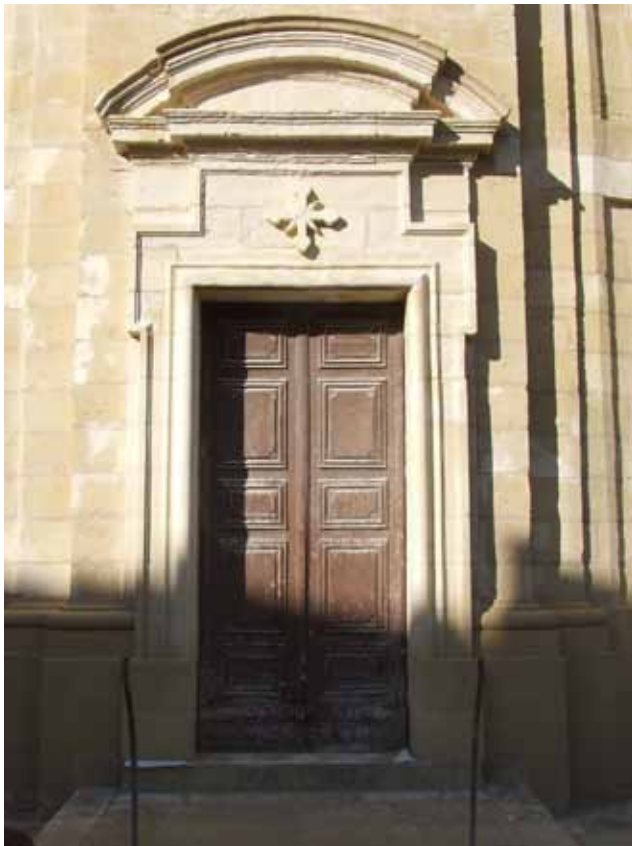
left:
Detail of entrance portal.
(Photo credit Dr. Conrad Thake)

There were instances of severely, deteriorated stonework such as the jambs of the doors with intricate mouldings which warranted substitution by identical stone blocks.

There were also missing elements such as the stone Greek-cross that was inscribed above the stone lintel over the main entrance and a couple of broken finials at roof level, which had to be reconstructed. In instances where the stonework was only superficially affected, plastic repair employing lime-based mortars was utilized. Following the restoration of all the stonework including that of the dome, lantern and bell-cote, the façades were manually cleaned under low-pressure water jets to remove fungal growths and water stains. The joints between the stonework were raked-out manually and re-pointed using hydraulic lime with additives to match the colour of the stonework. The actual physical restoration of the exterior of the chapel was conducted over a period of ten months.⁹
