The conservation project and archaeological excavation of the old Parish Church at Siggiewi – an intermediate report ¹

Paul C. Saliba

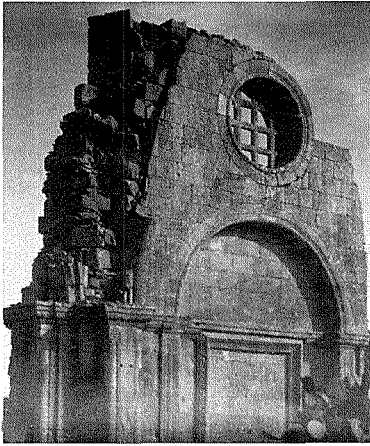
Plate 1. Early 20th century photo showing a wall in the southern transept

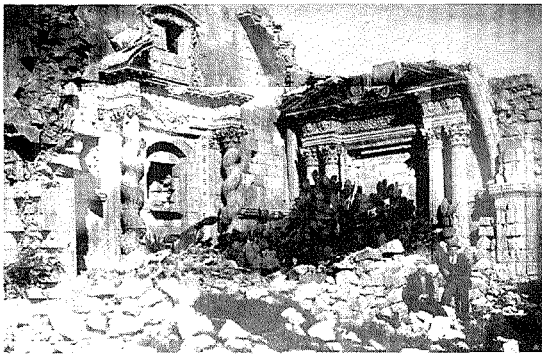
Plate 2. Early 20th century photo showing the ruins of the northern transept

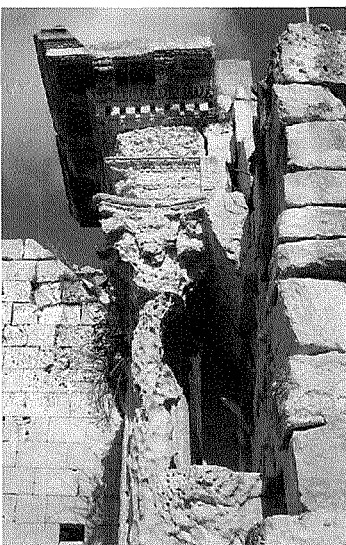
Plate 4. A highly eroded column and architrave

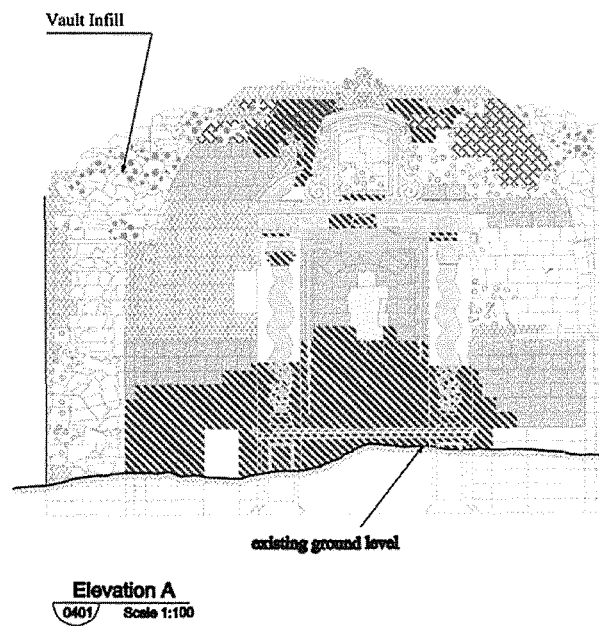
Fig. 2. Elevation of one of the altars showing deterioration mapping

Technical research prior to the works involved the drawing up of detailed surveys and plans, and included the deterioration mapping of all existing structures, carried out from rectified imagery (Fig. 2). Such documentation was also used for the planning application necessary for the conservation works.

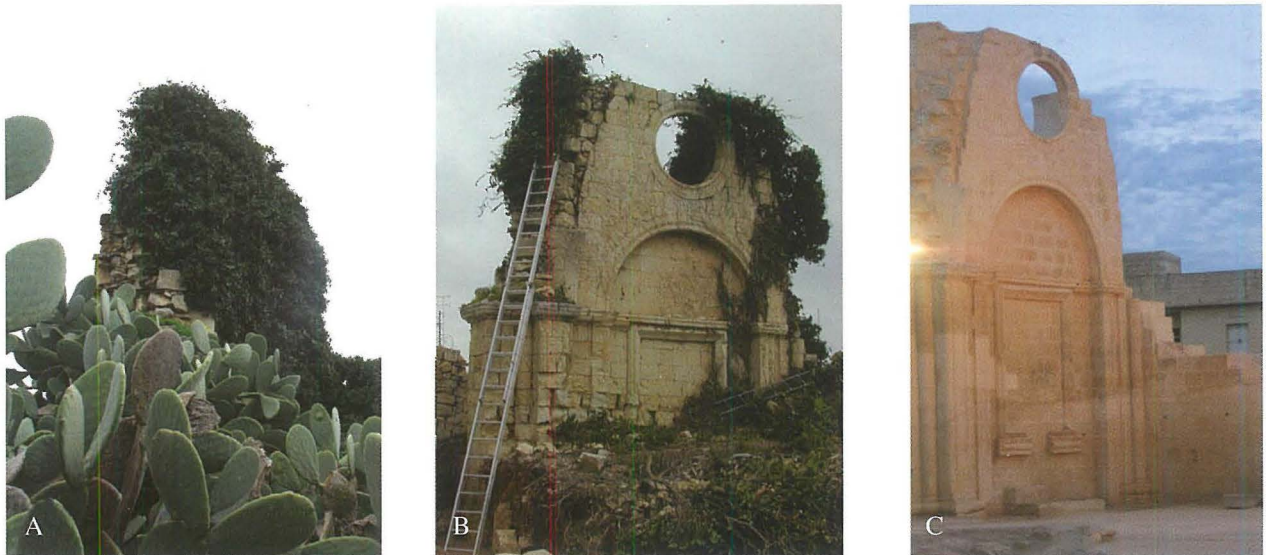
Plate 2

- A. The southern transept before restoration*
- B. The southern transept during restoration*
- C. The southern transept after restoration*

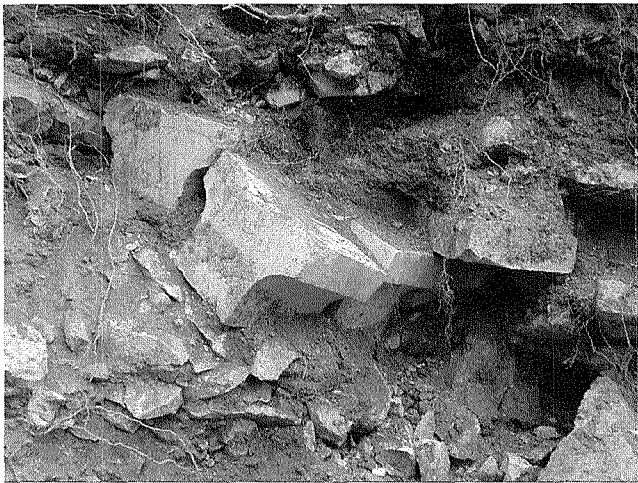
Plate 5. Roof collapse behind the main altar

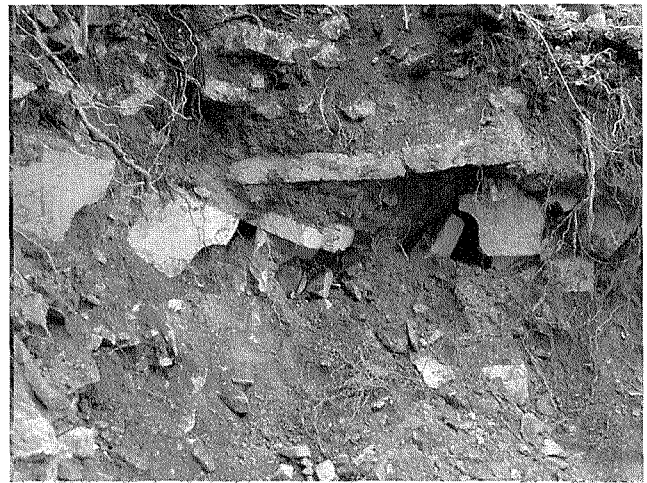
Plate 6. Roof collapse behind the main altar

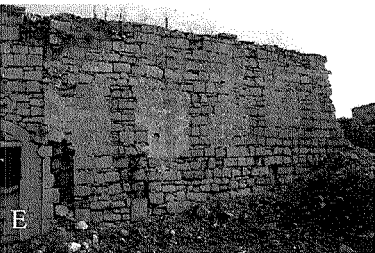
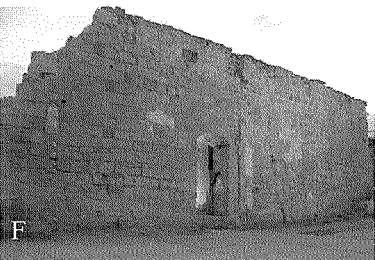
Plate 9.

- A. The northern transept before restoration*
- B. The northern transept during restoration*
- C. The northern transept after restoration*
- D. The wall along the nave before restoration*
- E. The wall along the nave during restoration*
- F. The wall along the nave after restoration*
