THE EFFECTS OF MODERN RESTORATION TECHNIQUES ON THE PREHISTORIC TEMPLES OF THE MALTESE ISLANDS

Gennaro TAMPONE, Dipartimento di Storia dell'Architettura e di Restauro delle Strutture Architettoniche, Università di Firenze, ITALIA.

Sergio VANNUCCI, Istituto di Mineralogia e Petrografia dell'Università di Urbino, ITALIA.

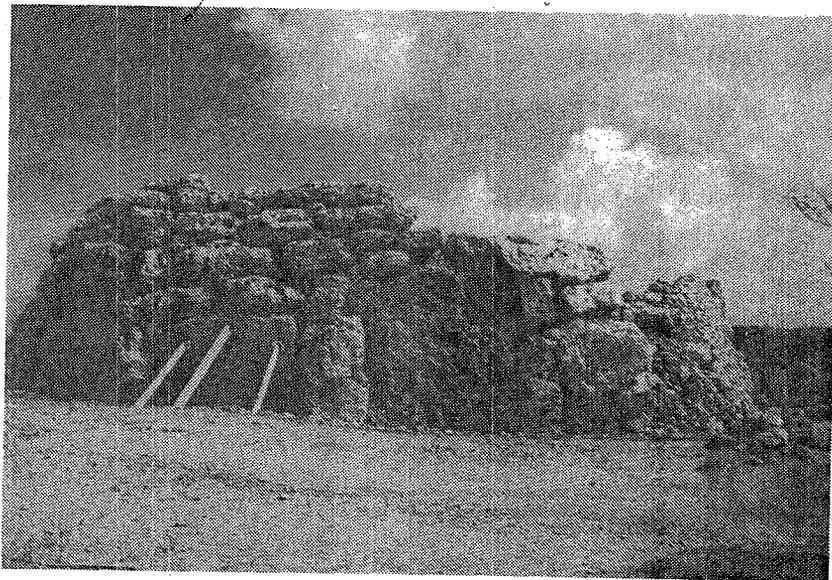
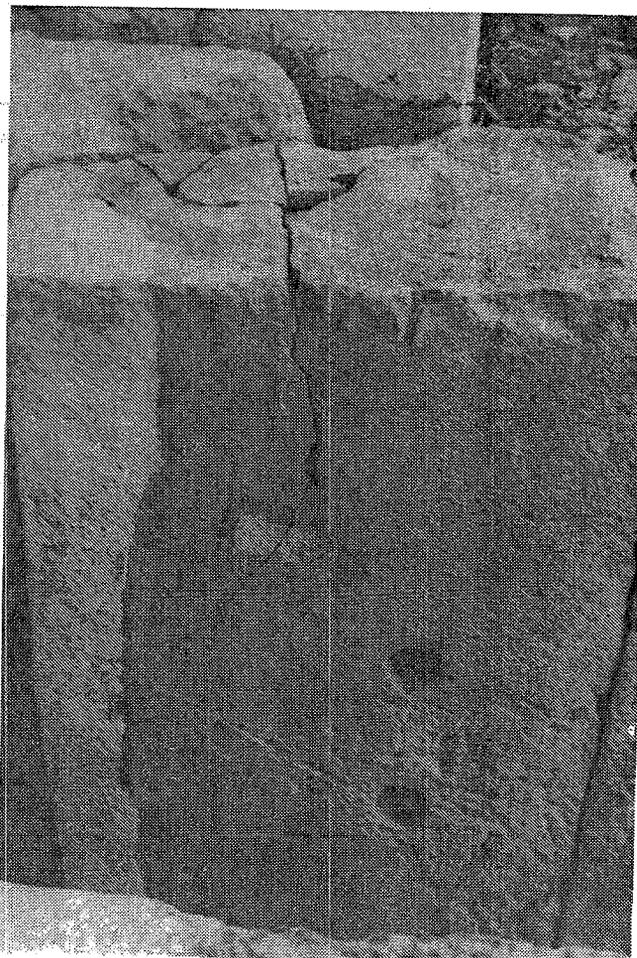
A very few examples of the insertion of swallow-tailed stone elements to connect blocks affected by cracks, which can seem a natural practi-

ce in the restoration of stone monuments, can be observed in the Tarxien temple. No records of them can be found but we may suppose that were done soon after excavation. In one case the device itself has broken owing to further movement and in another the crack later by-passed the device. In both cases, in fact, the cause of the cracks had not been removed.

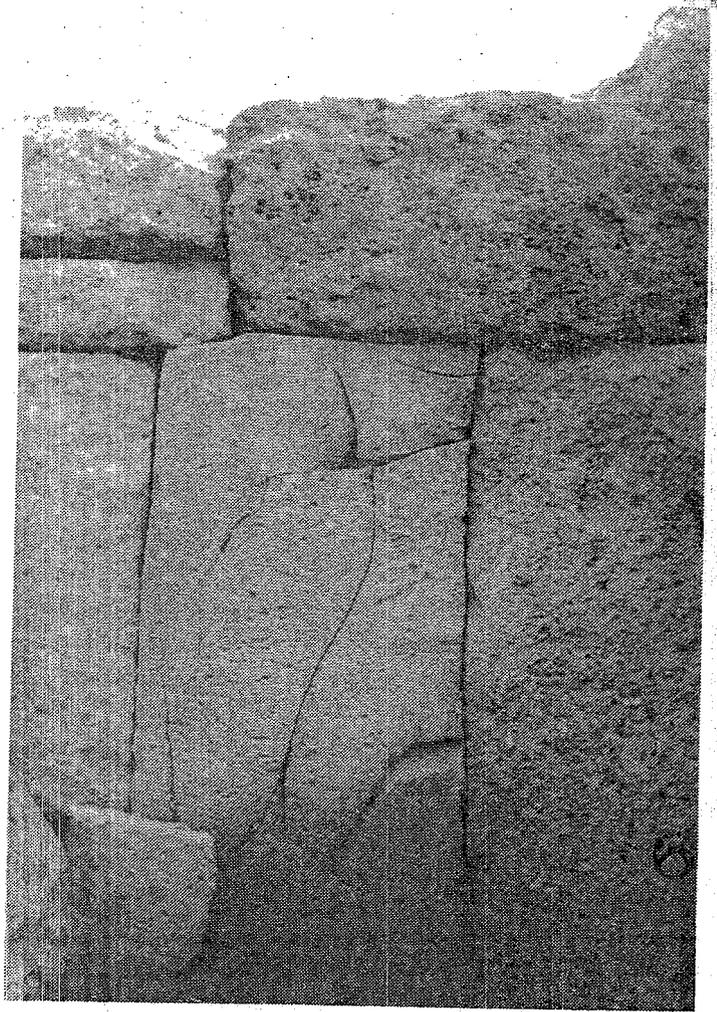
did, in itself, cause some damage in this respect. The surface with the three figures is severely decayed by "corrosion", desaggregation and the flaking off of minute particles.
