Soil Erosion Risk Analysis of a Small Watershed

Galdies Charles, Zammit Amy and Gauci Adam

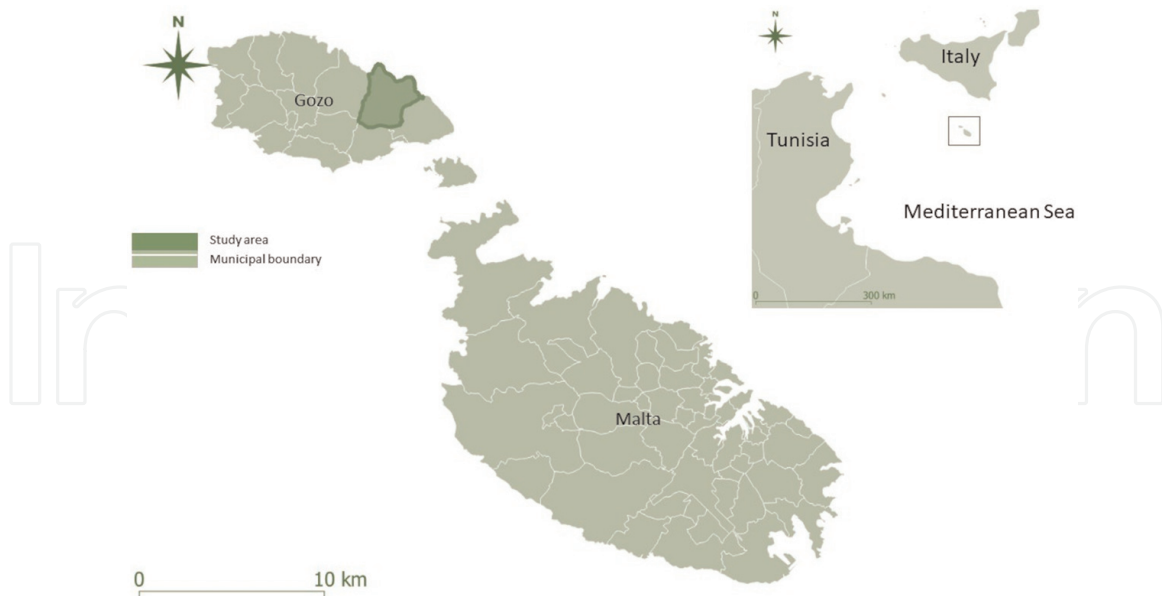
Figure 1.
The Maltese islands show the study area located in Gozo. (Source: OSM & Malta GeoPortal – Planning Authority).

The Maltese islands are located within the central Mediterranean region (**Figure 1**). According to CMIP6 climate models, the projected future climate of the islands is expected to experience a higher frequency of climatic extremes, including prolonged drought conditions and heatwaves, as well as increased frequency of torrential rain that can cause intermittent but significant flooding. The latter may, thus, result in increased mass wasting and related soil erosion, which can negatively affect erosion-vulnerable watersheds that are already significantly impacted by unsustainable and intense anthropogenic influences, including agriculture and associated sediment displacement. Clays and silts from upper parts of watersheds, once suspended in the stream network, can be routed directly to the mouth of the valley, resulting in significant sediment loads in coastal waters, and thus affecting exposed and submerged coastal ecosystems.

The Ramla watershed in Gozo is roughly a 6 km² catchment area extending from its watershed divide down to the Ramla beach (**Figure 1**). The socioeconomic and environmental importance of this sensitive watershed is based on intensive farming activities [4], the presence of perched aquifers along its slopes (MT015 & MT016. [5]), unique biodiversity [6], and the presence of a NATURA 2000 site [4, 7].

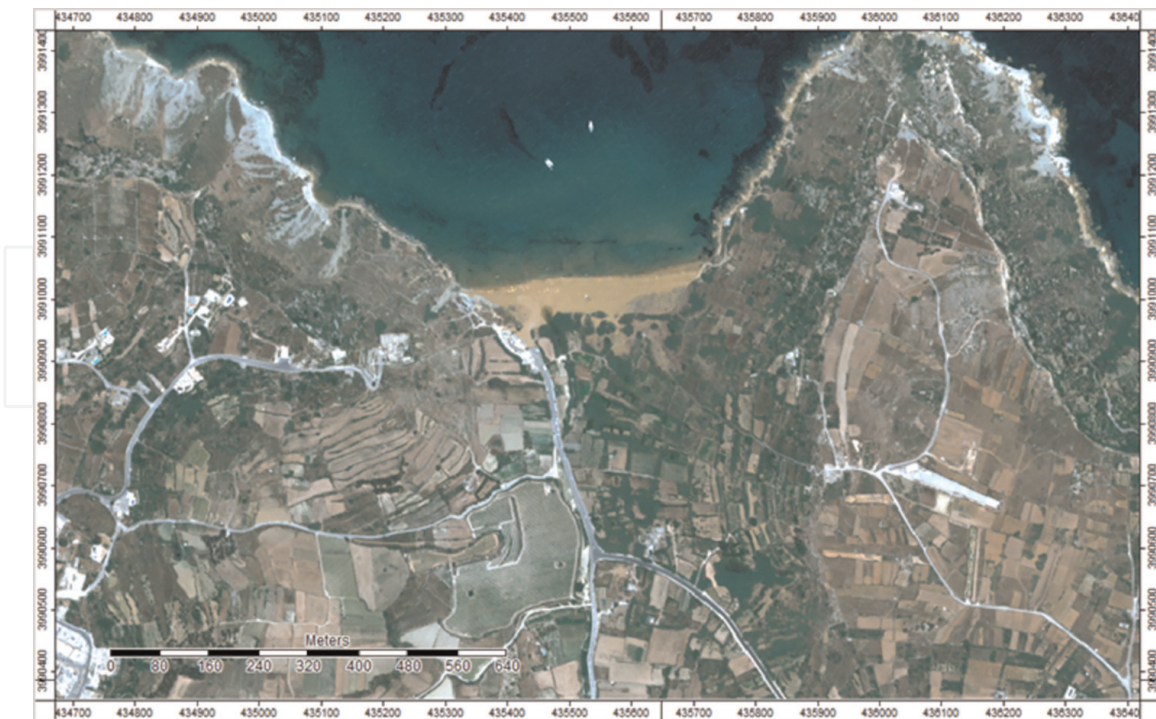
Figure 3. SENTINEL2-A image of the Ramla valley mouth, sandy beach, and adjacent coastal waters (Source: COPERNICUS).

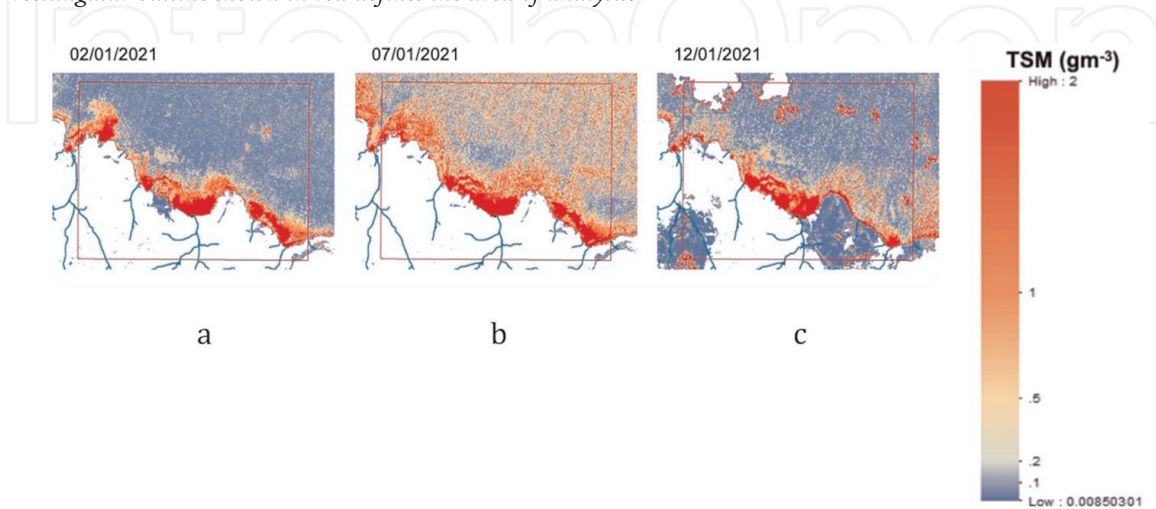
Figure 11. SENTINEL2-A & B derived TSM concentration ($\text{g}\cdot\text{m}^{-3}$) on 07/01/2021 (a); TSM January climatology (b); and merged TSM levels for the period January 02–12, 2021 (c).

The TSM concentration showed a slight increase toward higher levels on the second date (Figure 11). However, the shift was less evident than for CHLA as
