A non-destructive method for fixing placards with masonry structures

Abstract. It is common practice for government agencies to fix signs – and indeed even official temporary notices – onto masonry structures using steel nails. This method of fixing is destructive; it causes irreversible damage to the material fabric, which has a bearing on the overall aesthetic of the building, a scenario which is more acute if the site is of cultural heritage significance. Stones and concrete blocks (locally referred to as concrete bricks), the latter introduced in the 1950s, are the main materials used in masonry construction in Malta. Clay bricks are not utilized, as in Malta there is a blanket prohibition on the extraction of local clay. The main building material used in Malta since time immemorial is Lower Globigerina Limestone. This article puts forward the case for a non-destructive, reversable method to fix notices to building which respects the integrity of the dimension stones. Instead of being hammered into masonry blocks, the proposed removable plugs are installed in the mortar. Their size is relative to the thickness of the mortar bed and the load they are designed to carry, the lat

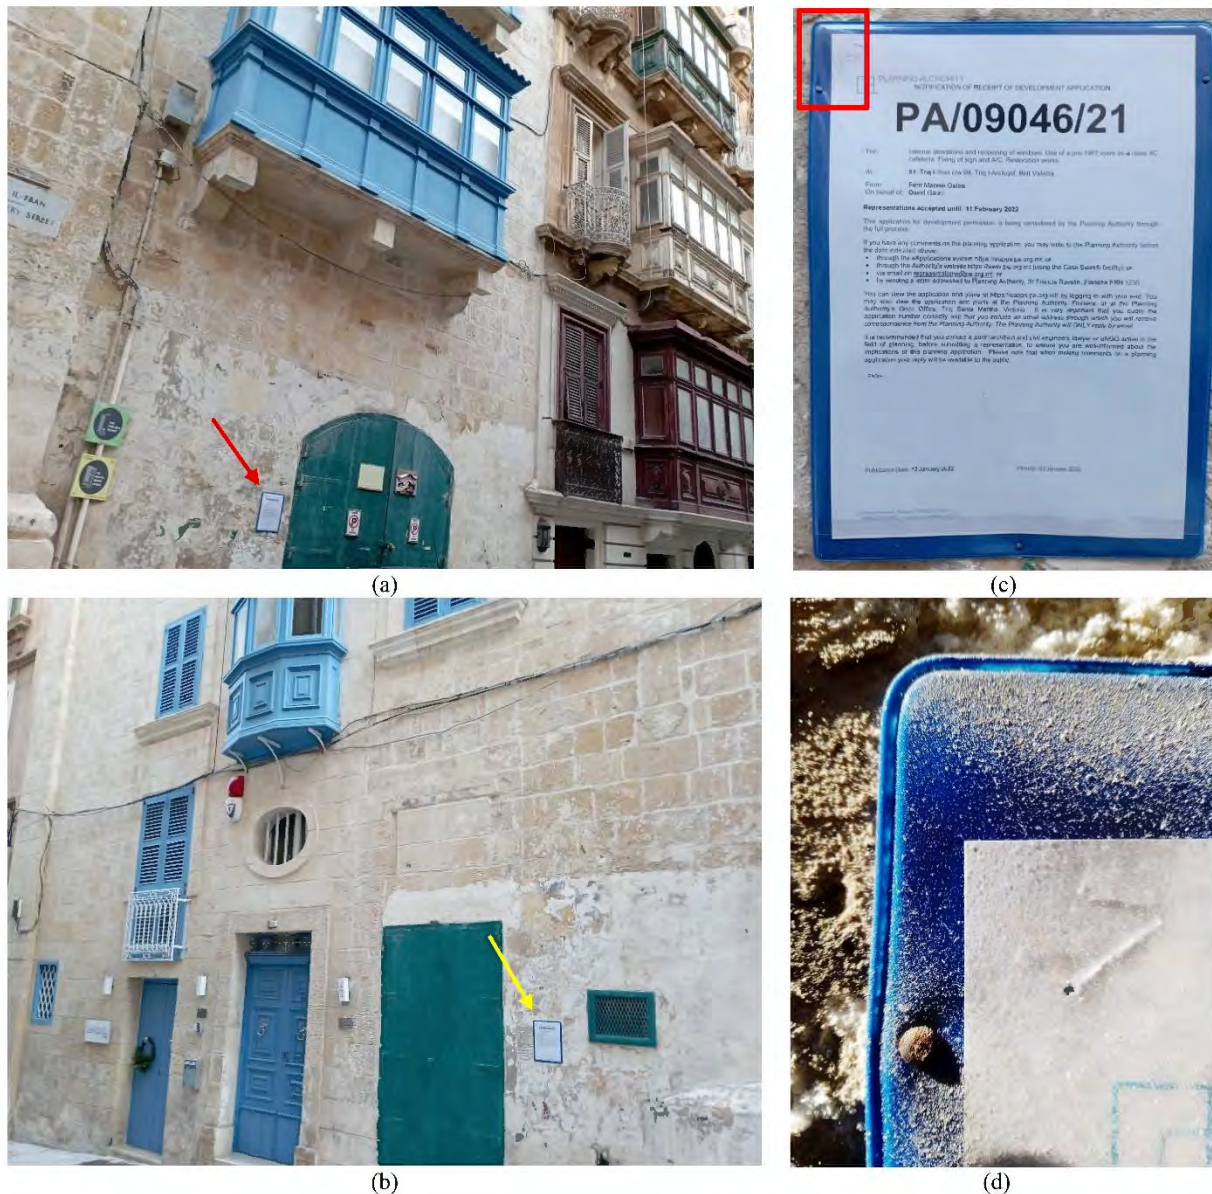
Figure 2. Development planning application at 99 Archbishop's Street on the corner with 81 Bakery Street, Valletta. Streetscape along (a) Archbishop's Street and (b) Bakery Street with site notice indicated by the authors in red and yellow markers respectively [20]; site notice (c) as on 12 January 2022 [20], and (d) detail marked in (c) as on 12 October 2022 – note the rusting steel nail.
