A study on the effect of mortar joint strength and placement on masonry  
blockwork wall capacity.

Dissertation submitted to the  
Faculty for the Built Environment, University of Malta  
In part fulfilment of the requirements  
for the attainment of the degree  
Master of Engineering (Structural Engineering)

June 2025

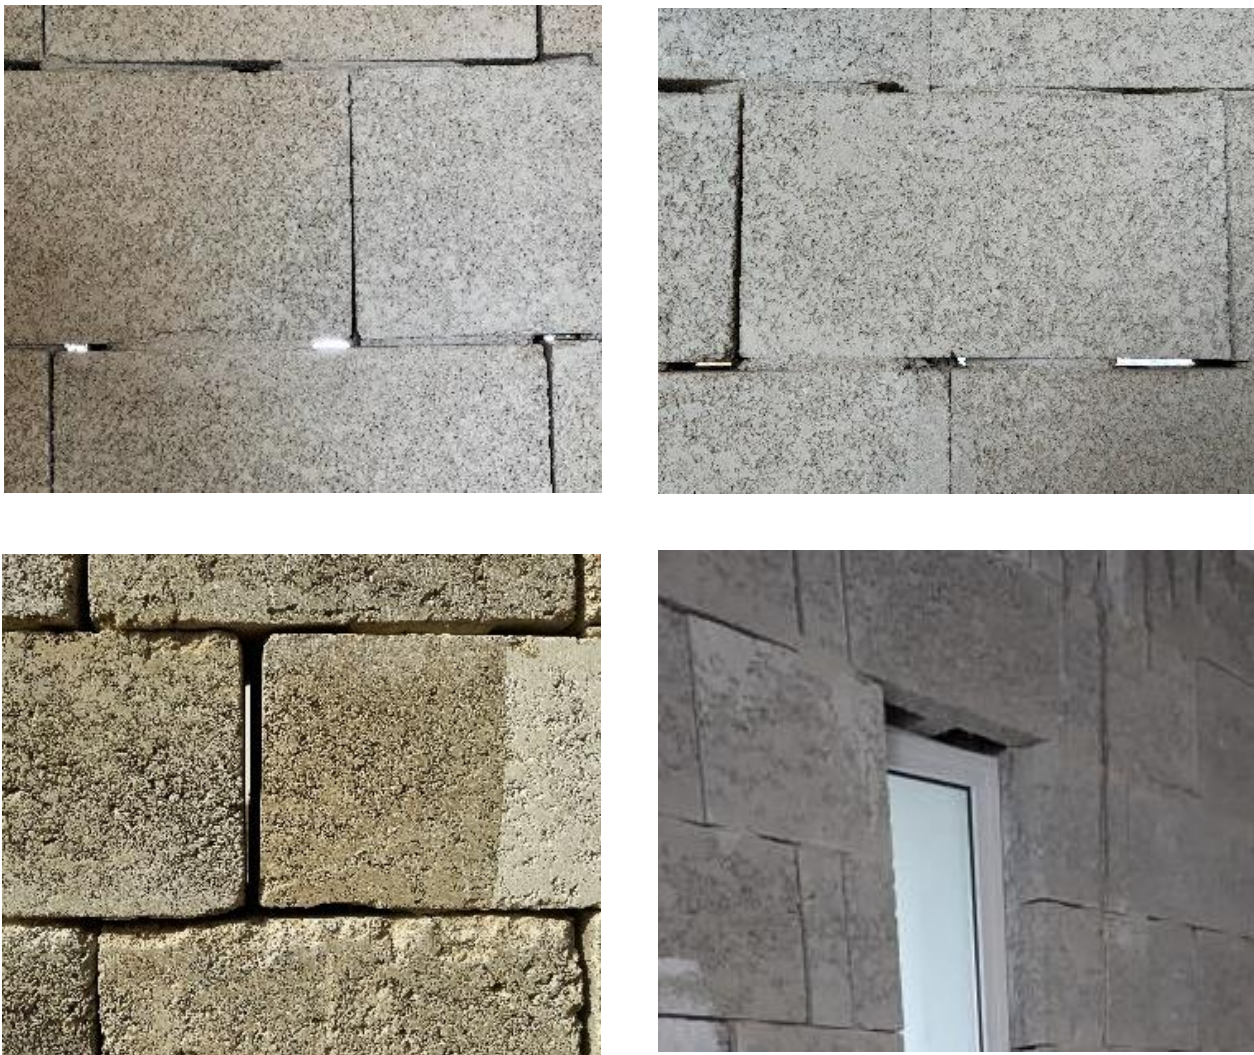
Over the past few decades, there has been a boom in construction on the Maltese Islands (NSO, 2021). This has resulted in multiple instances of subpar workmanship, as seen in **Figure 1.1**. Masonry walls are key components in construction; however, an aspect that is often overlooked is the mortar joint, which relies more on the brick for structural strength. The effects of mortar placement have not been studied extensively within the local context, with only brief mentions in Eurocode 6 discussing shell bedding. Hence, the identification of the effects of mortar placement in masonry construction is of interest. In order to further understand the effects of poor workmanship on load bearing walls and the structural behaviour of mortar and masonry.

*Figure 1.1: Examples of poor workmanship, Marsaskala, Malta*

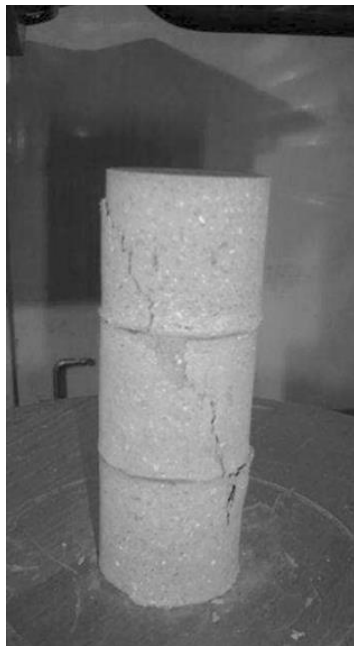
Hence in testing brick cores as seen in **Figures 2.11** and **2.12** were used to find the young's modulus and characteristic compressive strength as well as stack bond configuration for comparison. An advantage to coring was being more aware of the influence of local imperfections and for them to be measured or avoided. As for the tensile strength, 3-point bending was used. Two types of mortars were used that being ALM – Aerial Lime Mortar and HLM – Hydraulic Lime Mortar, both using a 1:3 lime to sand ratio, tested using EN 1015-11 with samples being cube prisms, tested both for flexure and compressive characteristics. (Drougkas et al, 2015)

Figure 2.11: Vertical Cracks in Core sample (Drougkas et al, 2015)

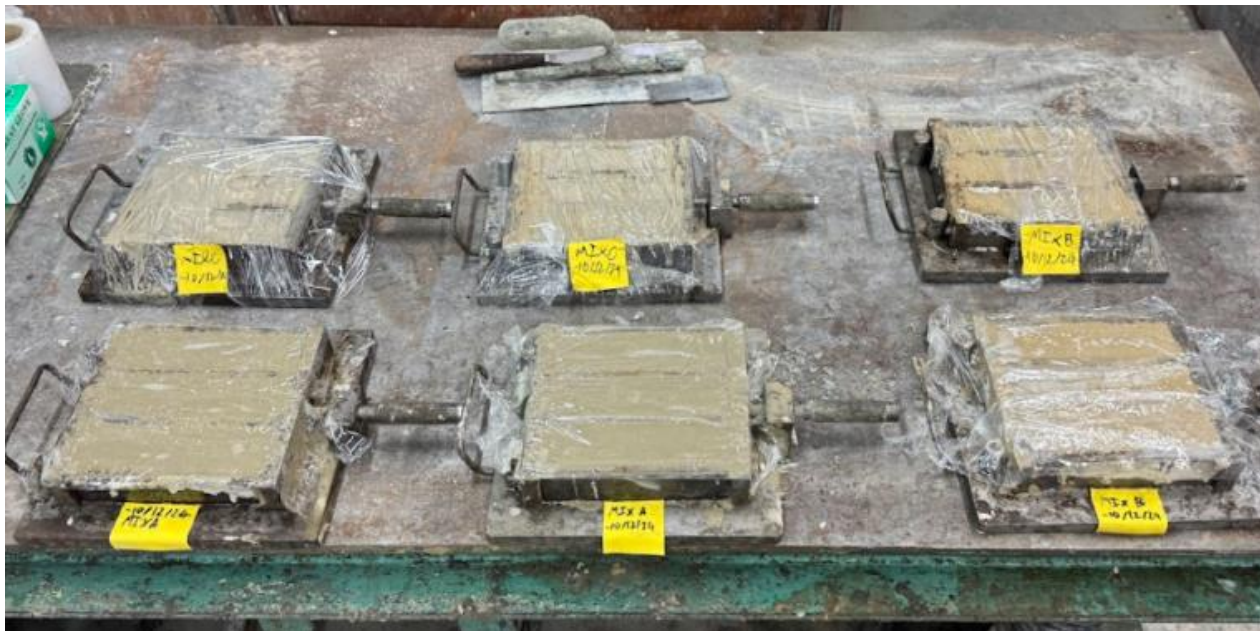
As a general guideline, BS EN 1015:1999 Methods of testing for mortar for masonry and all its parts were used for the testing procedure of mortar samples. In total, eighteen prisms were prepared, six per mix, three tested for the 7-day tests and three for the 28-day tests. The test samples, 160 x 40 x 40 mm ( $\pm 1$  mm), were prepared. Each constituent of the mix was weighed in a container of known mass, and the weights were recorded. The mortar mix constituents were placed in a mixer, and water was added till a visually usable mix consistency was obtained. The mix was then placed in steel moulds, and the moulds were lubricated with oil to prevent adhesion of the mortar. Each sample of mortar was properly compacted by hand at least ten times into the moulds, which were then vibrated via a jolting table. This procedure was adopted to create a uniform, consistent mortar test sample with no air entrapment and segregation of the mix. The samples were then sealed in transparent polyethylene laboratory film and left to cure, as seen in Figure 3.1.

*Figure 3.1 Mortar Moulds*

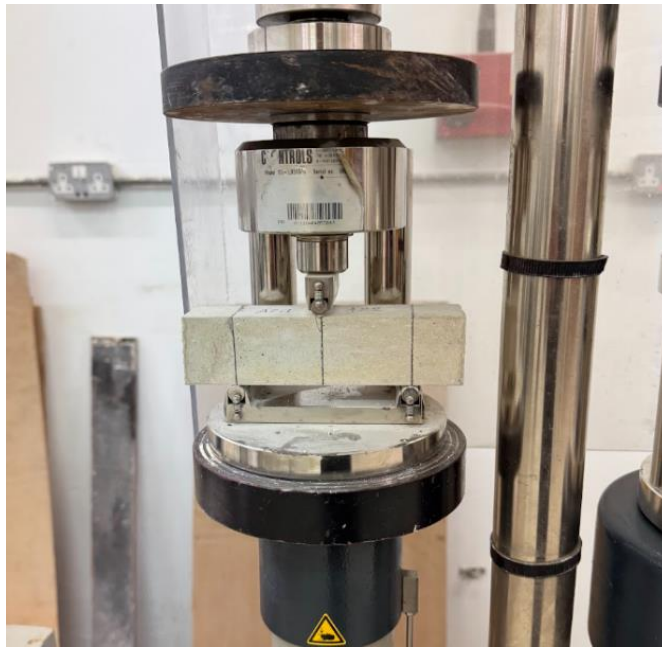
The load is applied uniformly over the width of the prism, such that through its length it is acting as a point load at the centre point of the specimen. The maximum load to cause flexural failure was recorded and the broken specimen kept for the compressive strength test. The test apparatus seen in **Figure 3.3** consisted of steel supporting rollers and the test specimen prism, with the third roller on top apply the flexural load. The rollers remained equidistant and can tilt slightly to avoid torsion and uneven stress distribution. The tilt accommodates for any minor misalignments or unevenness in the samples.

*Figure 3.3: Three Point Flexure Test*

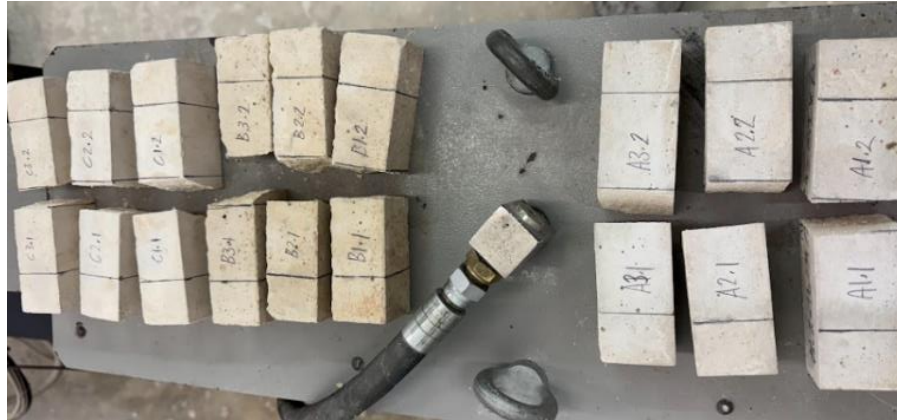
From the 18 flexural test specimens, 36 compression test samples were obtained, as seen in **Figure 3.4**. These halved samples were then tested in the compressive test machine shown in **Figure 3.5**. The compression contact area was 40 x 40 mm, for both the 7- and 28-day tests. A loading rate of 2400 N/s was applied to the specimens up to failure. The maximum load obtained was recorded.

*Figure 3.4 : Mortar compressive test samples obtained after flexural tests*

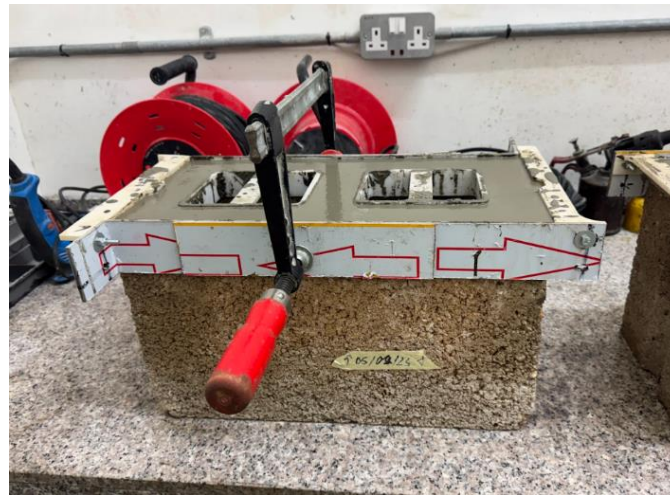
One should note that fibreboard is no longer accepted as a capping medium for block testing for standard compressive tests as it alters the measurements for displacement due to not having a high enough stiffness in comparison to the brick. Whilst when capping with a non-shrink grout it does not affect the measurements of displacement.

*Figure 3.7: Capping Moulds and Set-Up*

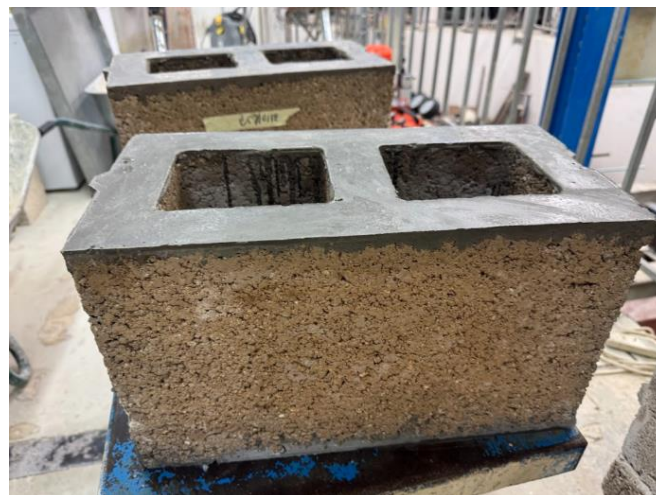
As a guideline the capping procedure BS EN 772–1:2011; Section 7.2.5 was used, changes being made to account for tolerances. For example, using g-camps as well as putty to prevent leaking during the casting. In accordance with EN 1015-11:1999, the capping mortar had to have a minimum compressive strength of 30 N/mm<sup>2</sup>, a non-shrink grout Sika 312 was used as it has a compressive strength of 40 N/mm<sup>2</sup> after 1 day of curing. The spec sheet recommends using 3.3 - 3.4l of water per 25kg, one cap is approximately 1 kg of sika hence the water ratio proportionally changed for scale. Through trial and error, it was found that the ideal water content was 175~185ml, for workability, flow and self-levelling. The grout needed to be self-levelling so that a near perfectly flat finish could be obtained, as seen in **Figure 3.8**. The blocks were placed on a smooth level surface, prior to pouring the grout, the faces were pre moistened to as to ensure proper adhesion between the surface and the capping grout.

*Figure 3.8 : Capped Hollow Concrete Block*

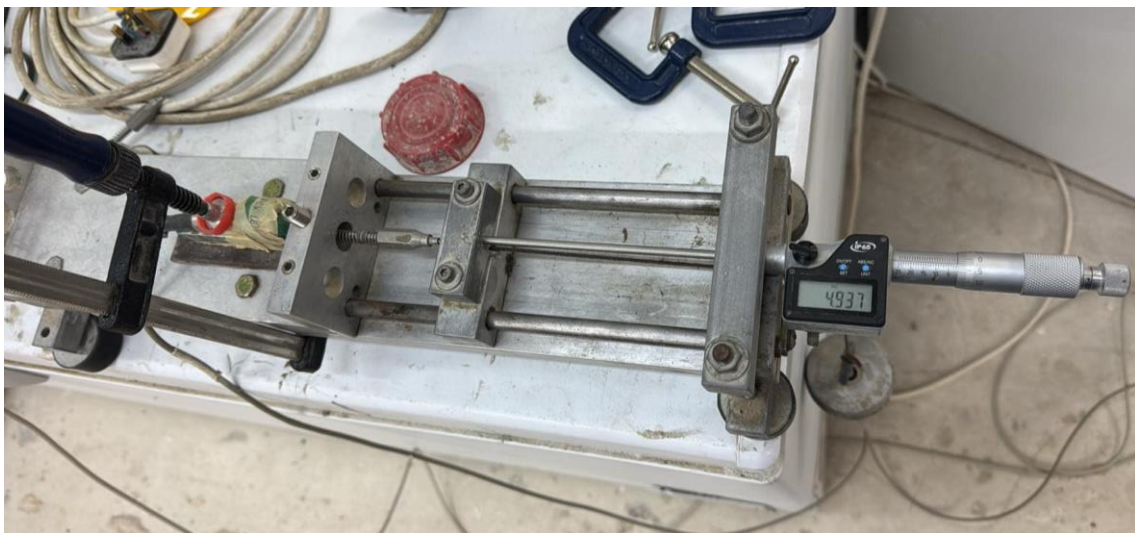
*Figure 3.11 : LVDT Calibration*

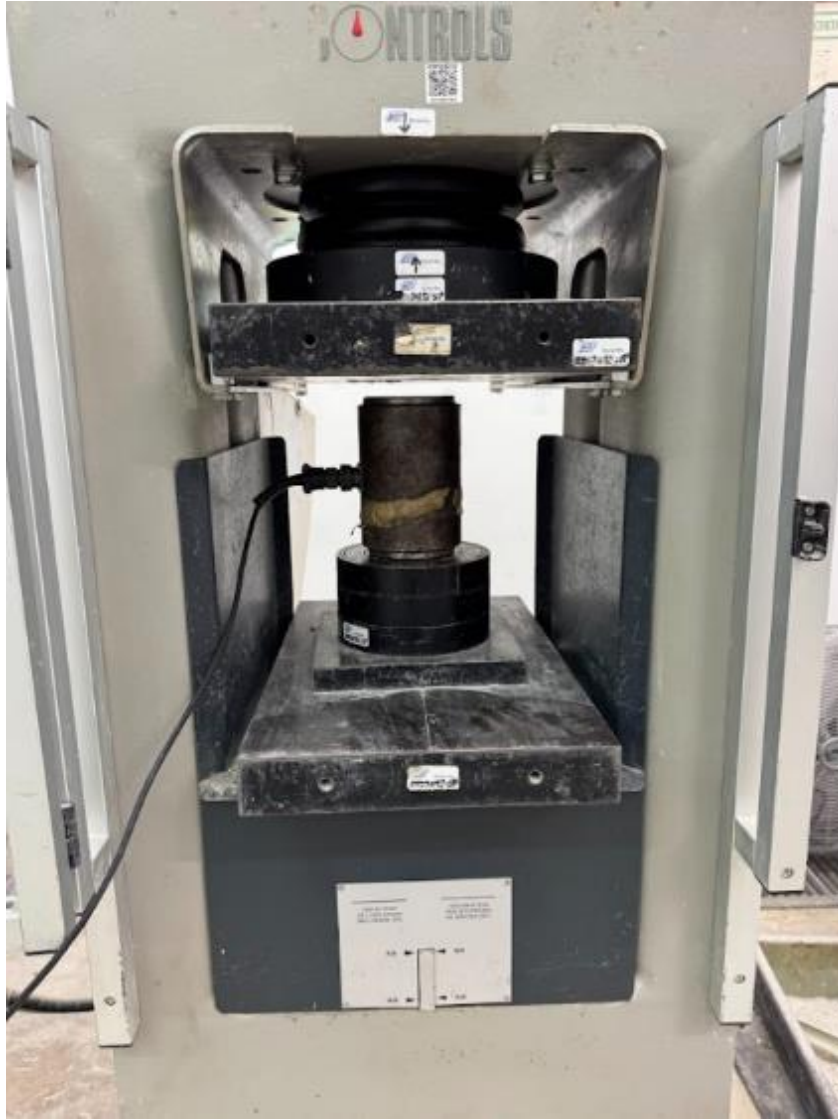
The 1000 KN load cell was calibrated up to 950 KN, at a sensitivity allowing for intervals of 50 KN. This was done by placing the load cell in a compression machine, as seen in **Figure 3.12**. The load cell was positioned centrally on the loading platens to ensure axial alignment. A load was applied at intervals and compared to the values obtained from the load cell when the values match it is well calibrated.

*Figure 3.12 : Load Cell Calibration*

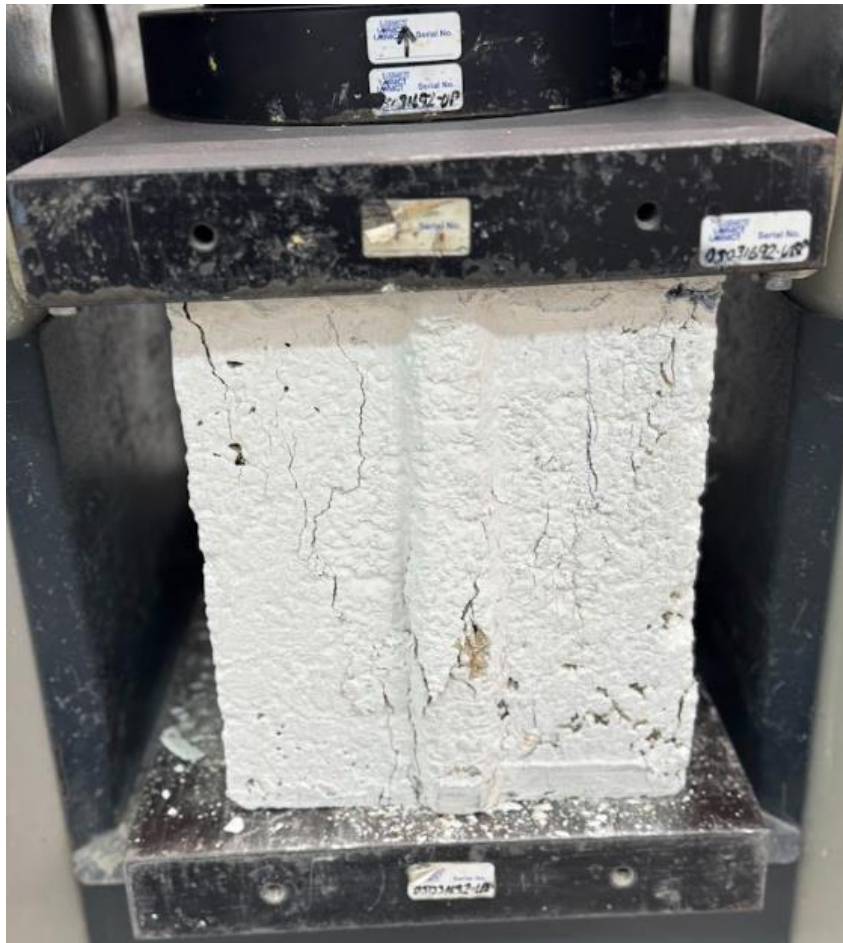
*Figure 4.1: Specimen G Crushed Block in Compressive Rig, Failure @5.34 MPa*

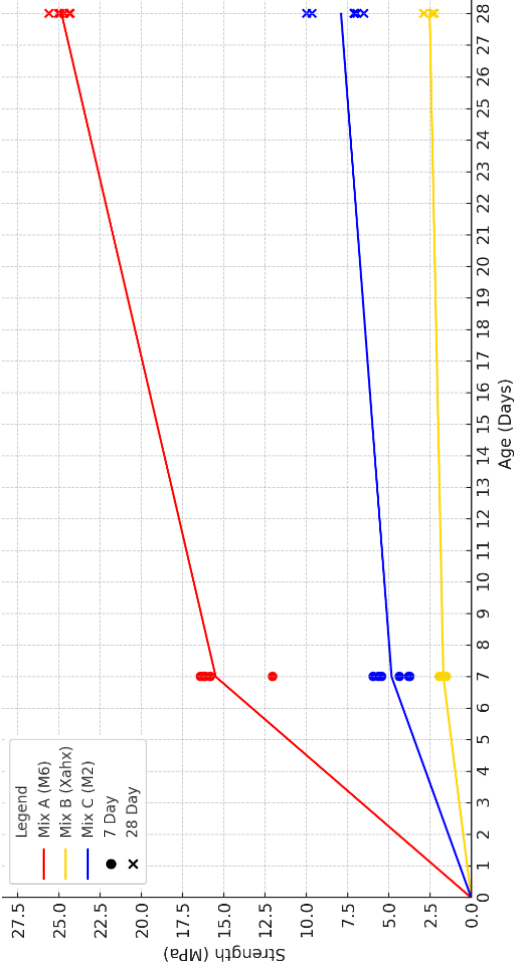
Figure 4.2: Compressive Half Prism Tests Values of Mixes A, B and C

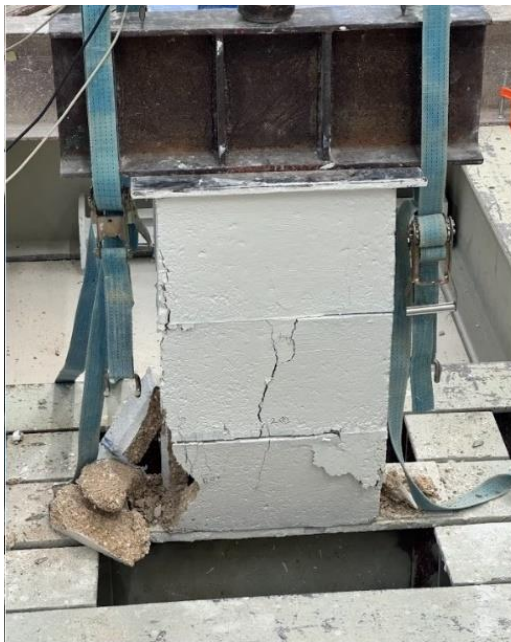
In contrast to the dry joint case, in which the whole wall split in half from the sides, such that all the blocks were crushed but did not explode, as the wall was not acting monolithically, as seen in **Figure 4.16**. Additionally, the steel bedding test were overly stiff when compared to the mortar cases, causing brittle failure due to local stresses that led to crushing and edge spalling at the interface, with no adhesion to the interface and non-monolithic behaviour. In the mortar bedding test, at failure the mortar joint sheared off with it sticking to one brick face and being ripped off the other, this indicates that the voids were filled in and were absorbed into the pores. The initial cracks were primarily at the sides; this is dangerous in practice, as a wall could appear uncracked on the outside but internally have a considerable amount of degradation. The exception was the M2 mix, which also showed cracks on the front.

Dry Joint @2.56 Mpa

*Figure 4.16: Failure of Fully Embedded Mortar (fully capped) and Dry Joint Wallettes*

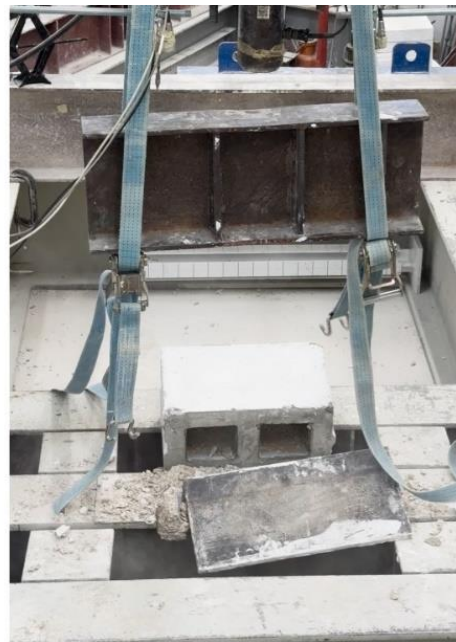
M6 Mortar (double cap)  
@5.3Mpa

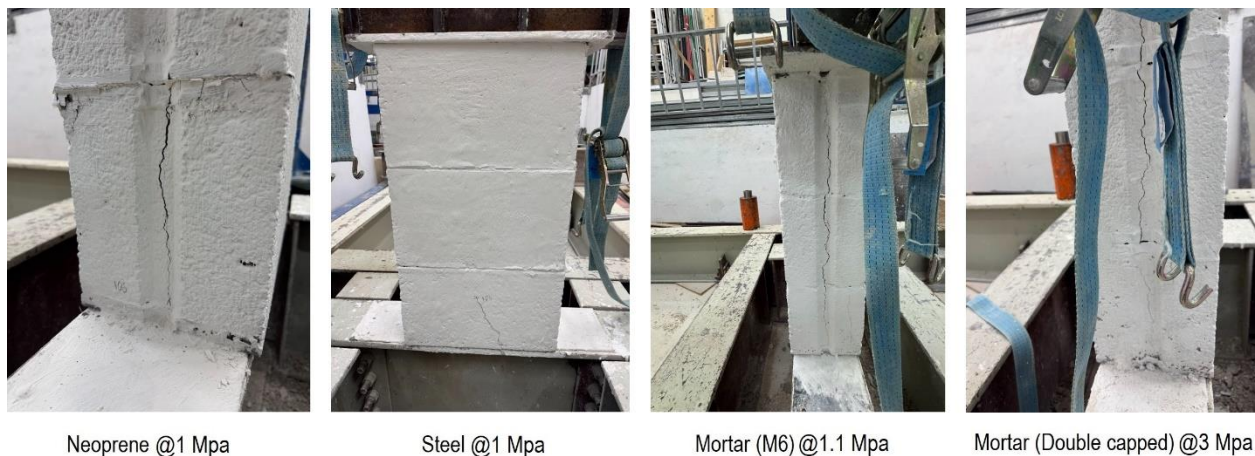
*Figure 4.18: Images of Initial Cracking of Shell Bedded Wallettes.*

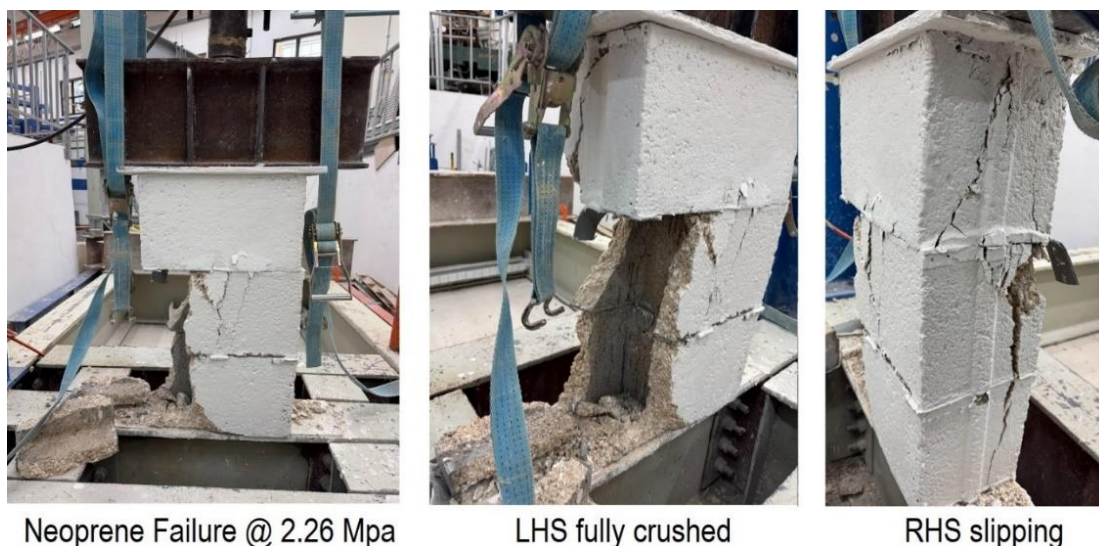
*Figure 4.26: Images of Neoprene Full Wallette Failure*

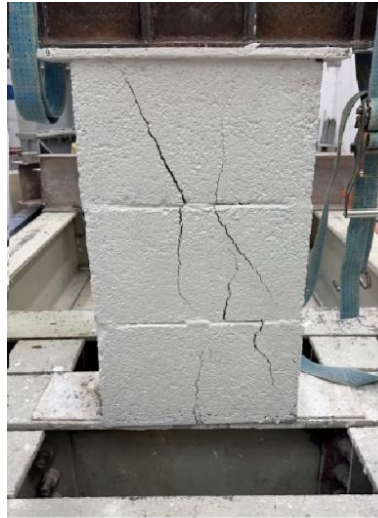
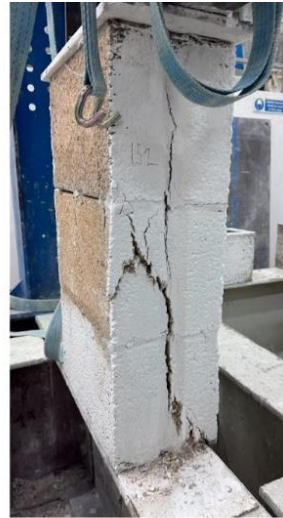
LHS

M6 Failure @ 2.32 Mpa

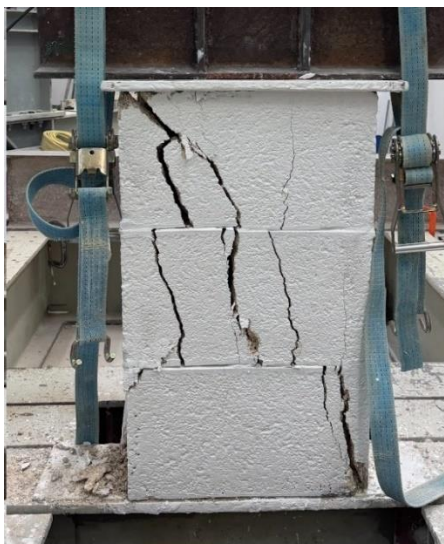
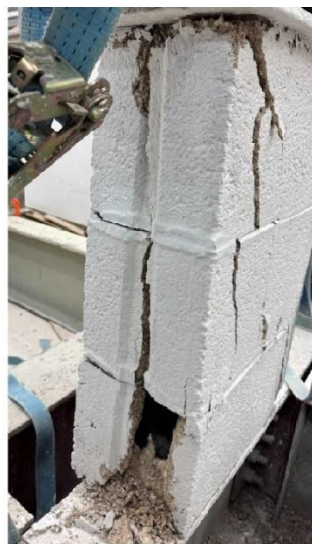
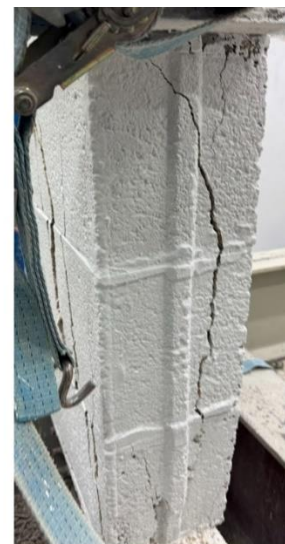
M6 (double cap) Failure

@ 3.28 Mpa LHS
