Continuity and Change: The Curation, Modification and Reuse of the 15th-century Choir Stalls in St Paul's Cathedral, Mdina, Malta (1625 – 1725)

Dissertation submitted to the Faculty for the Built Environment, University of Malta in part fulfilment of the requirements for the attainment of the degree of Master of Arts in Cultural Heritage Management.

January, 2025

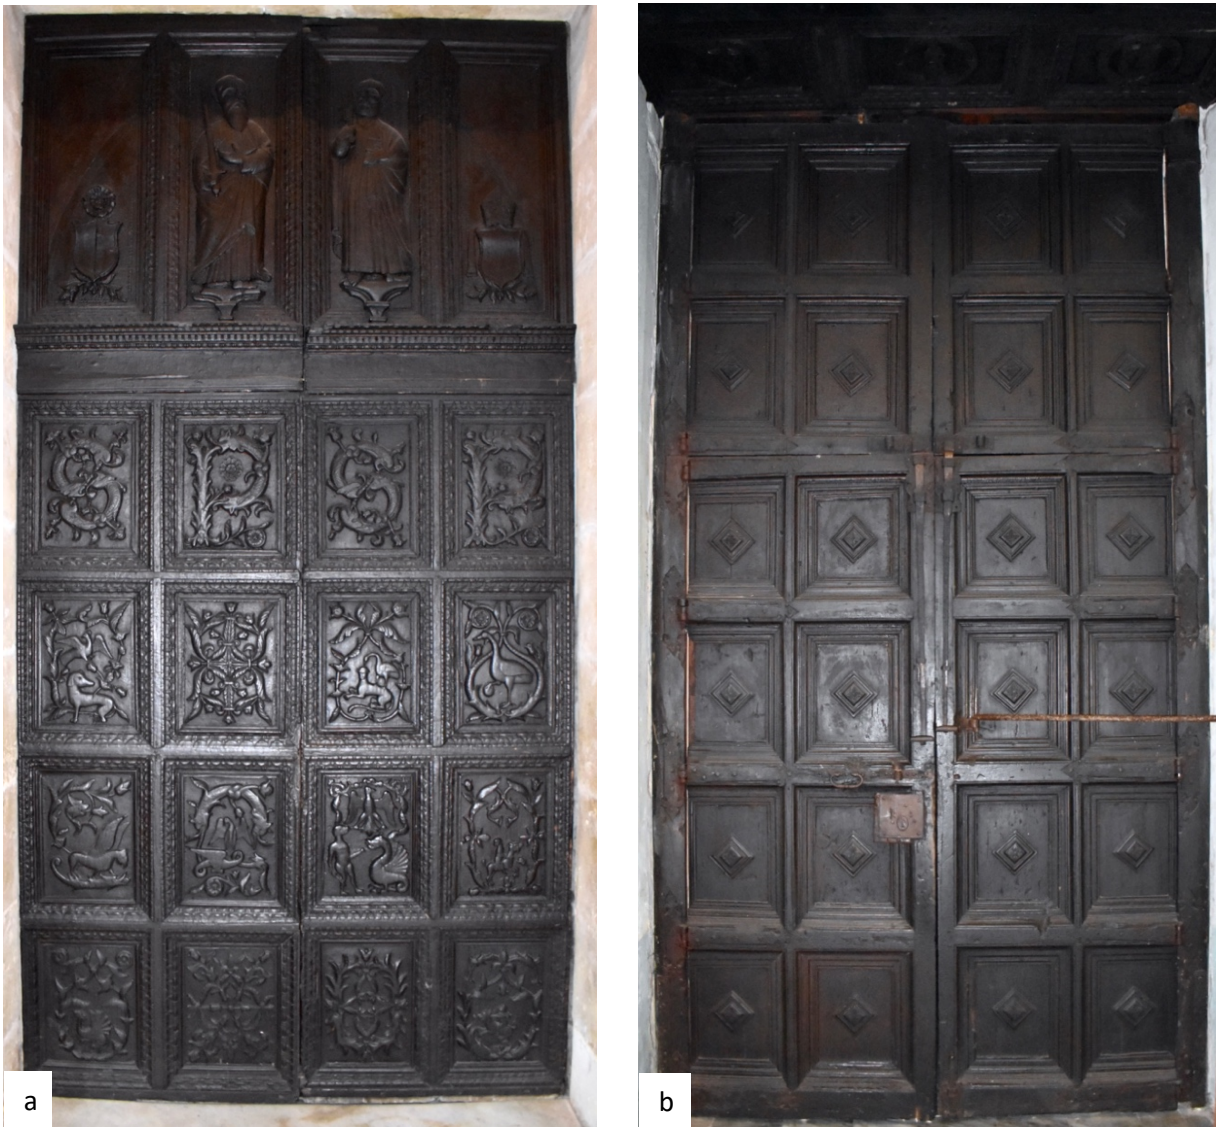
Fig. 3. The west door carved in chestnut by Cola Curmi and Johanni Calleja and installed as the main portal in 1535, later repurposed and currently serving as the door leading to the sacristy.

(a) External side (b) Internal side

Further modifications were made to the Cathedral in the early 16th century. The Mandati documents, which record payment authorisations issued between 1473 and 1539, show extensive activity in the Cathedral between 1515 and 1535 (Fiorini, 1992). The alterations included both structural and decorative changes. The ceiling of the nave was raised to allow for a clerestory, with windows added to brighten the interior (Abela, 1647, p.332). By 8 June 1520, work had begun on a wooden ceiling, elaborately carved, gilded and decorated with scenes from the life of St Paul and episodes from Church history, painted by Syracusan artist Alessandro Patavino (Abela,1647, p.332). A hanging crucifix was installed at the front of the nave, supported by a painted and gilded beam, crafted by Mastro Cola La Puzella and Mastro Cola di Fiderico between 1537 and 1538. In 1535, Cola Curmi was sent to Sicily to purchase an unspecified amount of chestnut wood for the *sancto sanctorum* of the Cathedral, indicating the continued influence of the Greek rite (Buhagiar & Fiorini, 1996, p.153) (see 7.3.1 *Before 1625: Original Configuration and Placement of the Choir Stalls*). During this period of redecoration, a new west door, carved in chestnut by Cola Curmi and Johanni Calleja (Fig. 3), was also installed in 1535 (Buhagiar & Fiorini, 1996, pp.184-190).

Some of the fitted timber artefacts from Mdina Cathedral's late-Medieval and early-Modern periods still survive, reflecting their enduring value. The west door (Fig.3), installed in the early 16th century, remains in situ but was repurposed and enlarged to fit the entrance of a new

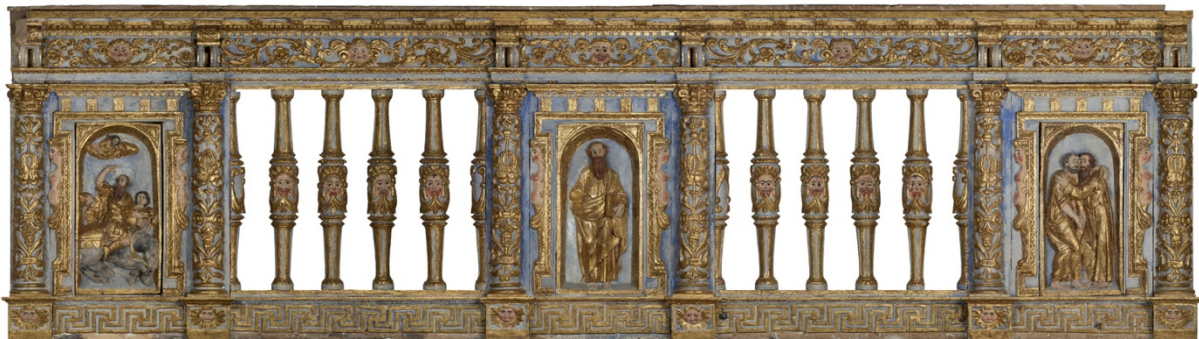
Fig. 4. Mannerist organ balcony, installed in 1601, currently exhibited in the Baroque Hall at the Mdina Metropolitan Cathedral Museum.

sacristy (Buhagiar & Fiorini, 1996, p.190). Meanwhile, the early 15th-century polyptych of St Paul, which served as altarpiece until it was replaced by Mattia Preti's titular painting in the late 1680s, and the mannerist organ balcony (Fig.4) are now displayed at the Mdina Metropolitan Cathedral Museum. The museum also houses a possible fragment of the decorated timber beams, installed in the early 16th century (Buhagiar & Fiorini, 1996, p.179).

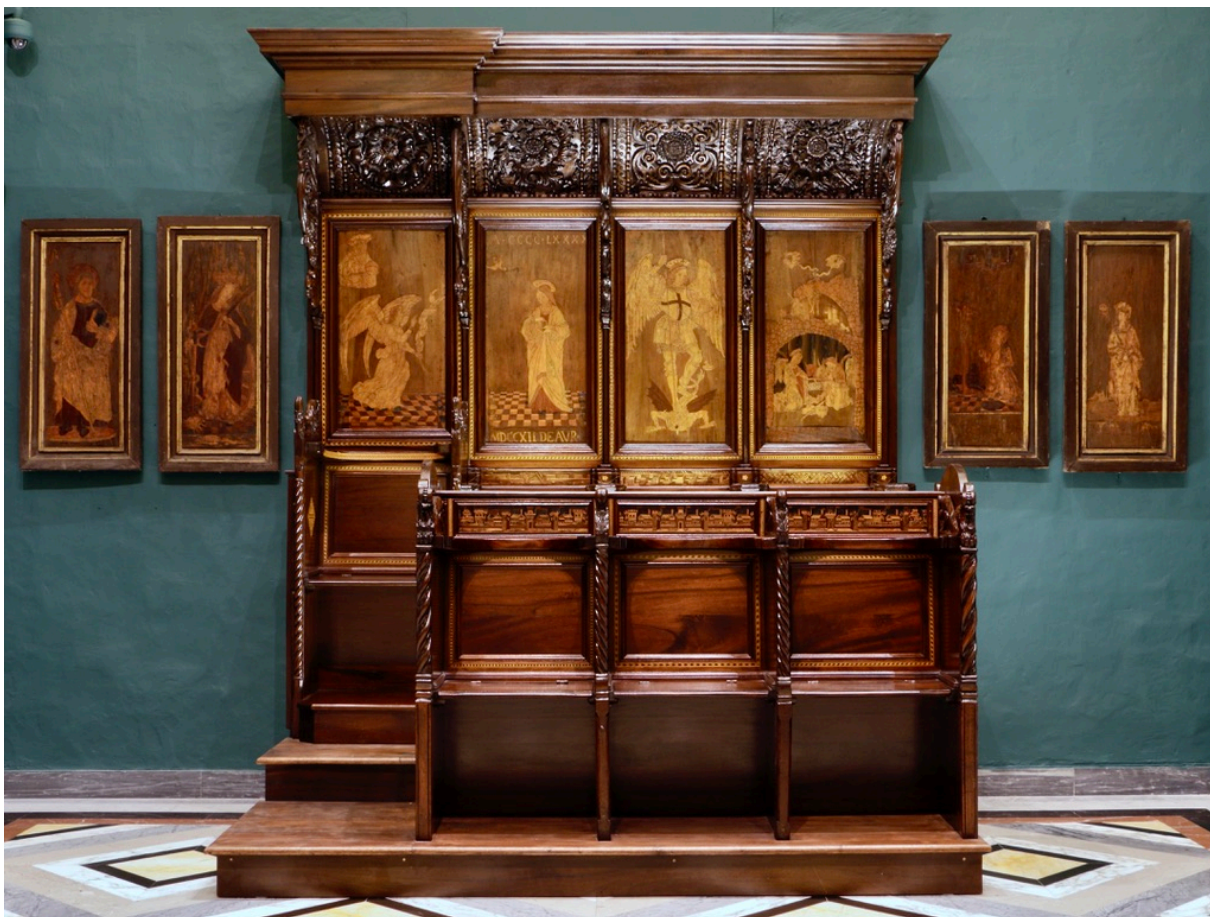
Fig. 5. Fragments of the 15th-century choir stalls displayed along the 2018 segmental reconstruction at the Mdina Metropolitan Cathedral Museum. (James Saliba 2021)

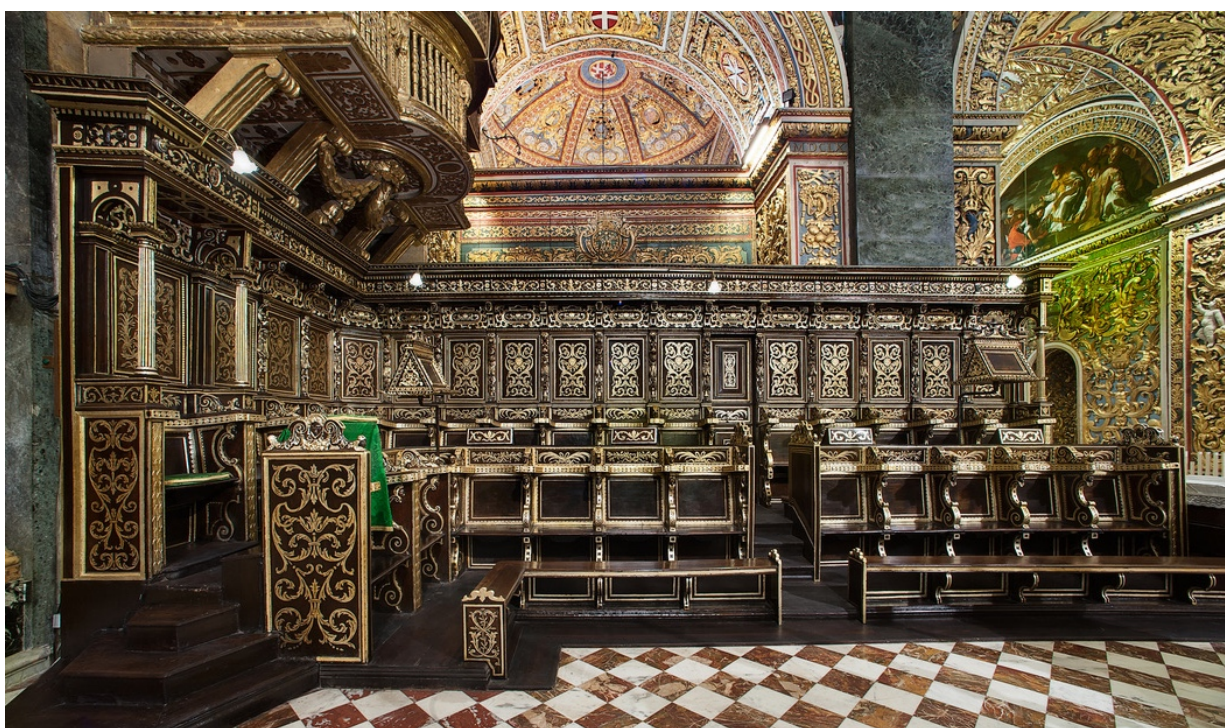
Fig. 6. The 16th-century choir stalls at St John's Co-Cathedral, Valletta (Epistle side). (Joseph Borg, 2014)

Although the surviving evidence remains fragmentary, preliminary indications suggest that the relocation or reconfiguration of choir stalls in Malta may not have been confined to the context of Mdina alone. During conservation works on the sixteenth-century choir stalls at St John's Co-Cathedral (Fig. 6.), several material observations—such as position marks visible on the underlying flagstones and the presence of a blocked window fitted with a metal grille suggestive of an earlier external elevation (Fig. 7)—collectively implied that the stalls might

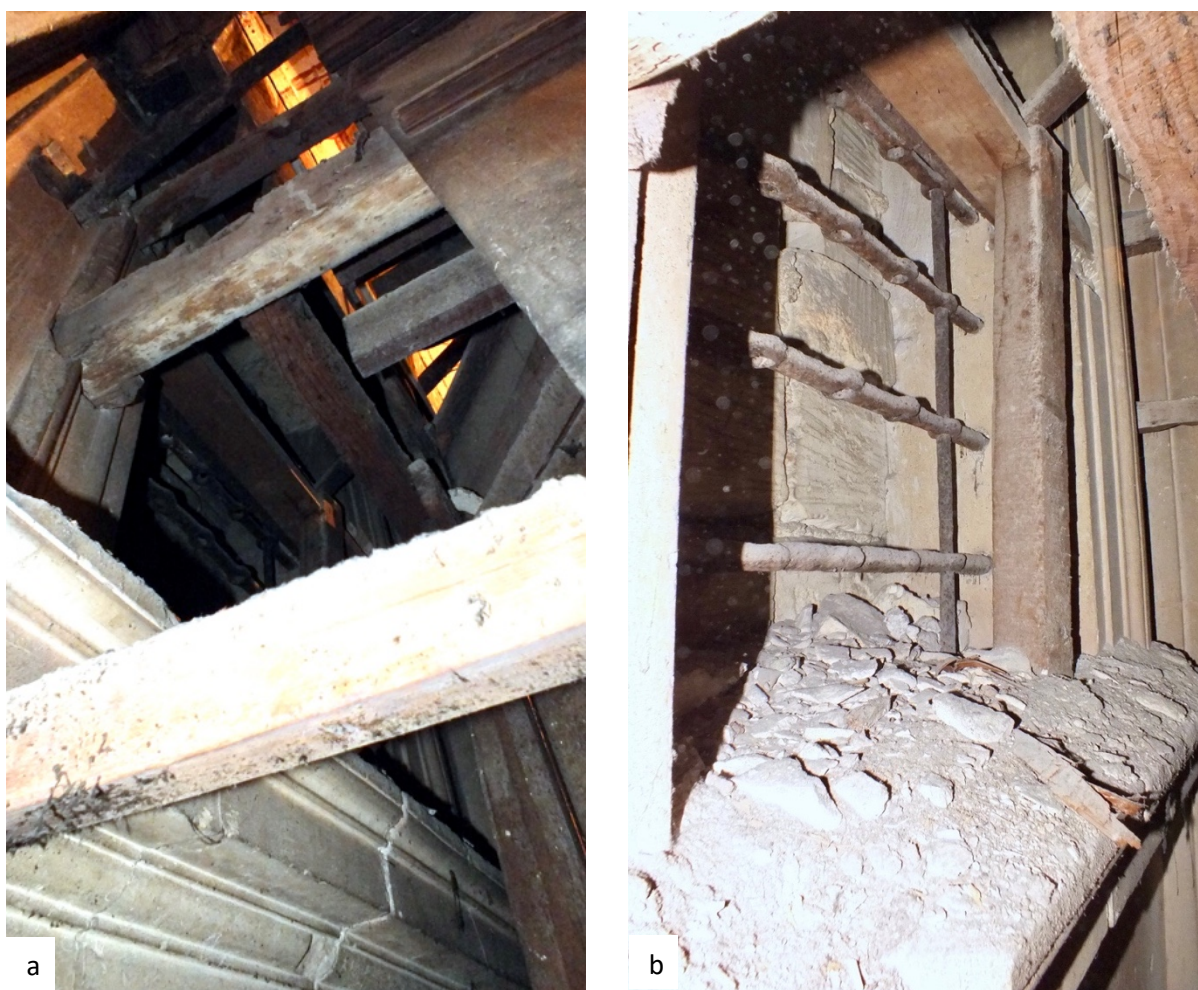
Fig. 7. Architectural features concealed beneath the choir stalls at St John's Co-Cathedral, Valletta. (James Saliba, 2013)

(a) View showing the moulded stonework and timber framing forming part of the concealed window recess beneath the choir substructure.

(b) Detail of the blocked window fitted with an iron grille, indicating a possible earlier external elevation later enclosed during the reconfiguration of the choir area. These elements together suggest that the current choir stalls were installed over a pre-existing architectural boundary.

not have been conceived for their present location when the church was first constructed¹. These observations, recorded during conservation treatment, point to the potential mobility and spatial reassignment of choir furnishings in Malta beyond the medieval period. While this evidence has yet to be examined systematically within an art-historical framework, it may indicate that the adaptation and reorganisation of choir stalls formed part of a broader, though yet underexplored, pattern within Maltese ecclesiastical practice rather than an isolated phenomenon confined to Mdina.

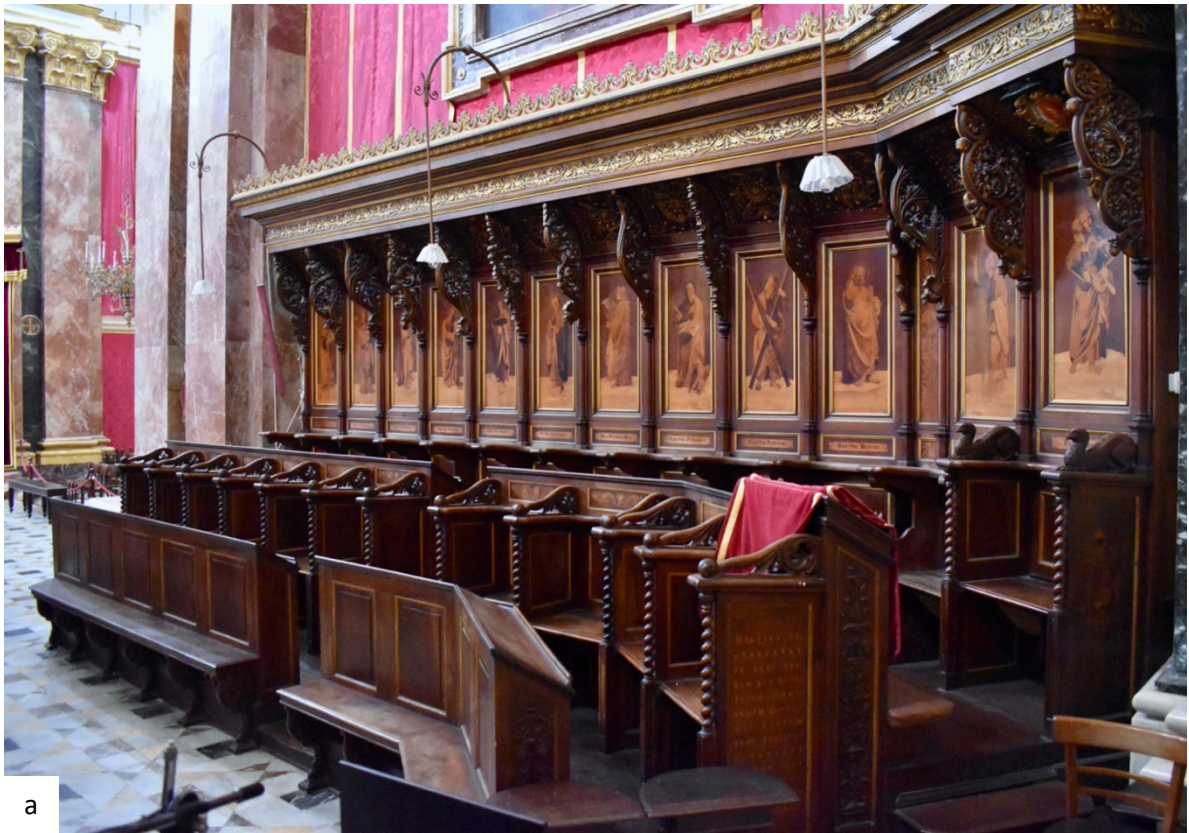
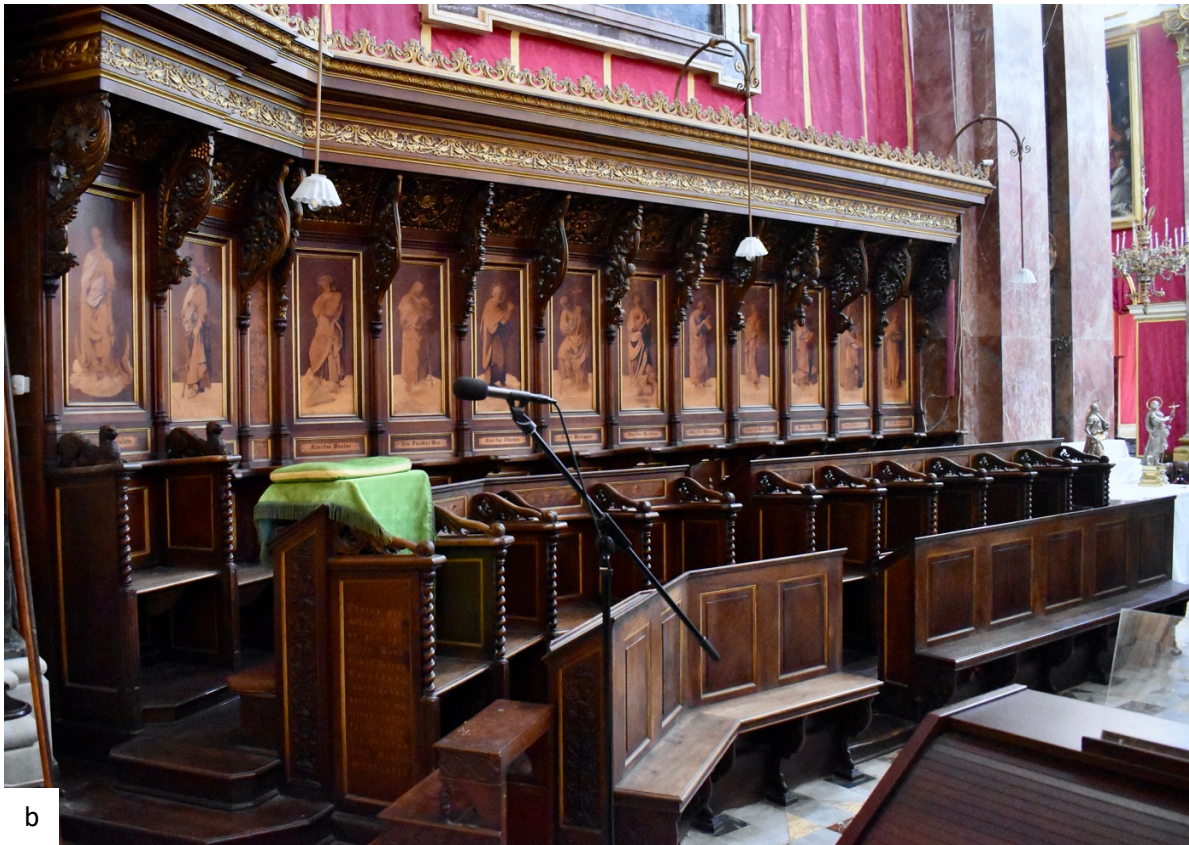
Fig. 8. The late 19th-century choir stalls at St Paul's Cathedral, Mdina. (James Saliba, 2024)

condition of the 15th-century choir stalls in 1876, at the moment they were being dismantled and replaced by the present set, which remains in-situ today (Fig. 8.).

The late 19th-century choir stalls, currently installed in the Cathedral (Fig.17), provide very limited insight into the design of the 15th-century stalls. Pullicino (1877, p.20) notes that the newer stalls did not follow a completely new design but rather maintained the general proportions and ornamental style of the older stalls. However, modifications were made to 'correct' certain elements considered as having been altered by previous interventions. The influence of 19th-century cultural trends, such as the Neo-Gothic movement and the Arts and Crafts movement, as well as stylistic restoration practices (Jokilehto, 1999), evidently influenced the intervention. For instance, the architectural frieze was replaced with inlays modelled after those on the choir stalls of San Pietro in Perugia, attributed to Raffaello d'Urbino, as they were considered a better match for the 15th-century style (Pullicino, 1877, p.26). Similarly, the 'disproportionate' cornice was 'corrected' to better align with the Medieval proportions. Similarly, the 'rough and deformed' columns on the front-tier were 'improved' and a small capital, matching to the style of the choir, was introduced. Various other minor elements were meticulously 'studied' and 'improved' to enhance the overall 'perfection' of the stalls (Pullicino, 1877, pp.30-31). Any interpretation of the previous 15th-century choir stalls based on the currently installed 19th-century version must therefore be approached with great caution.

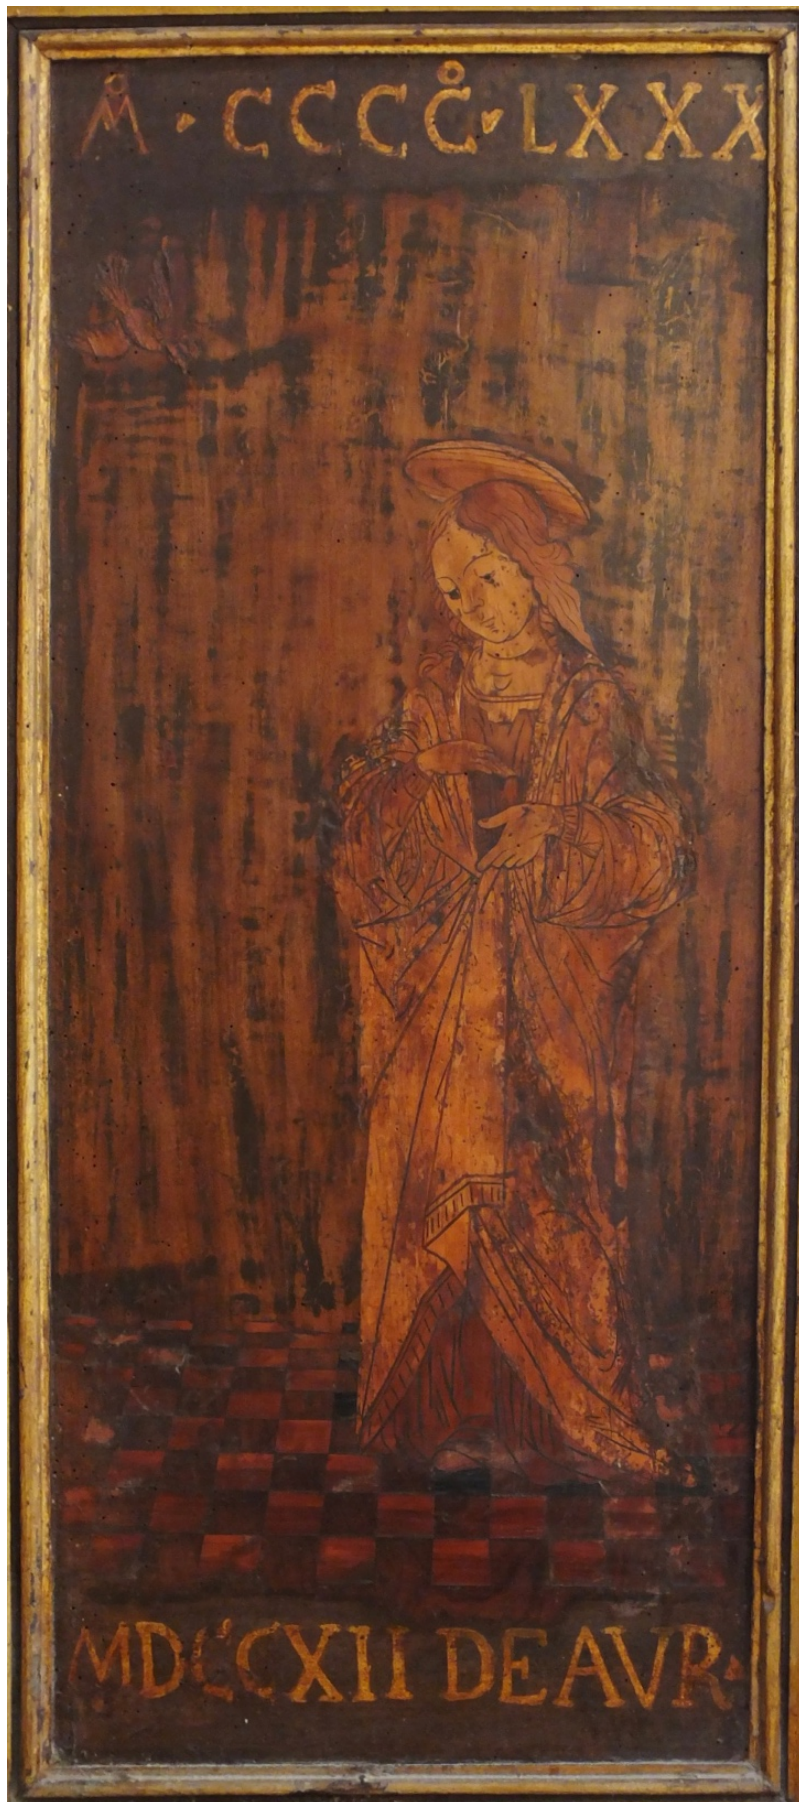
Fig. 9. Virgin and Holy Ghost panel before the 2018 intervention, presenting gilding inscriptions M.CCCC.LXXX (1480) top, and MDCXCII (1712) bottom. (James Saliba, 2014)

There are conflicting accounts of the contractual date of the choir stalls. This discrepancy is likely due to the potential use of different calendar systems, although the misinterpretation might have also been exacerbated by potential previous alterations to the stalls (see 5.3 *Alterations*). Pullicino (1877, p.3) cites the contractual date as 2 January 1481, a date supported by De Piro (2000, p.17), who references a 17th-century manuscript explicitly stating 1481 as the year of manufacture. Abela (1647, p.334) also gives this date, and other authors, including Larinà (2008), Galea-Naudi and Micallef (1996), follow this view. In contrast, Ferres (1866, p.81) claims the choir stalls were made in 1480, likely basing his conclusion on the inscription at the top of the **Virgin and Holy Ghost** panel (Fig.9.), as visible in the late 19th century.

Gilding: Several authors interpret the 1712 inscription on the **Virgin and Holy Ghost** panel (Fig.6) as evidence of a significant restoration, possibly following damage sustained during the 1693 earthquake (Pullicino, 1877, p.15; Galea-Naudi & Micallef, 1996, p.37). Other scholars dispute this connection, with some stating that the choir stalls sustained only minor damage on this event (Buhagiar & Fiorini, 1996, p.169). Despite these differing views, there is consensus that the 1712 inscription marks a major restoration, widely recognized to have included the gilding of the choir stalls (Larinà, 2008, p.45) (see *Timeline 3.*). This interpretation is further supported by the inscription's use of the term 'De Aur', which denotes the application of gold, consistent with the gilding observed on the stalls remnant parts.

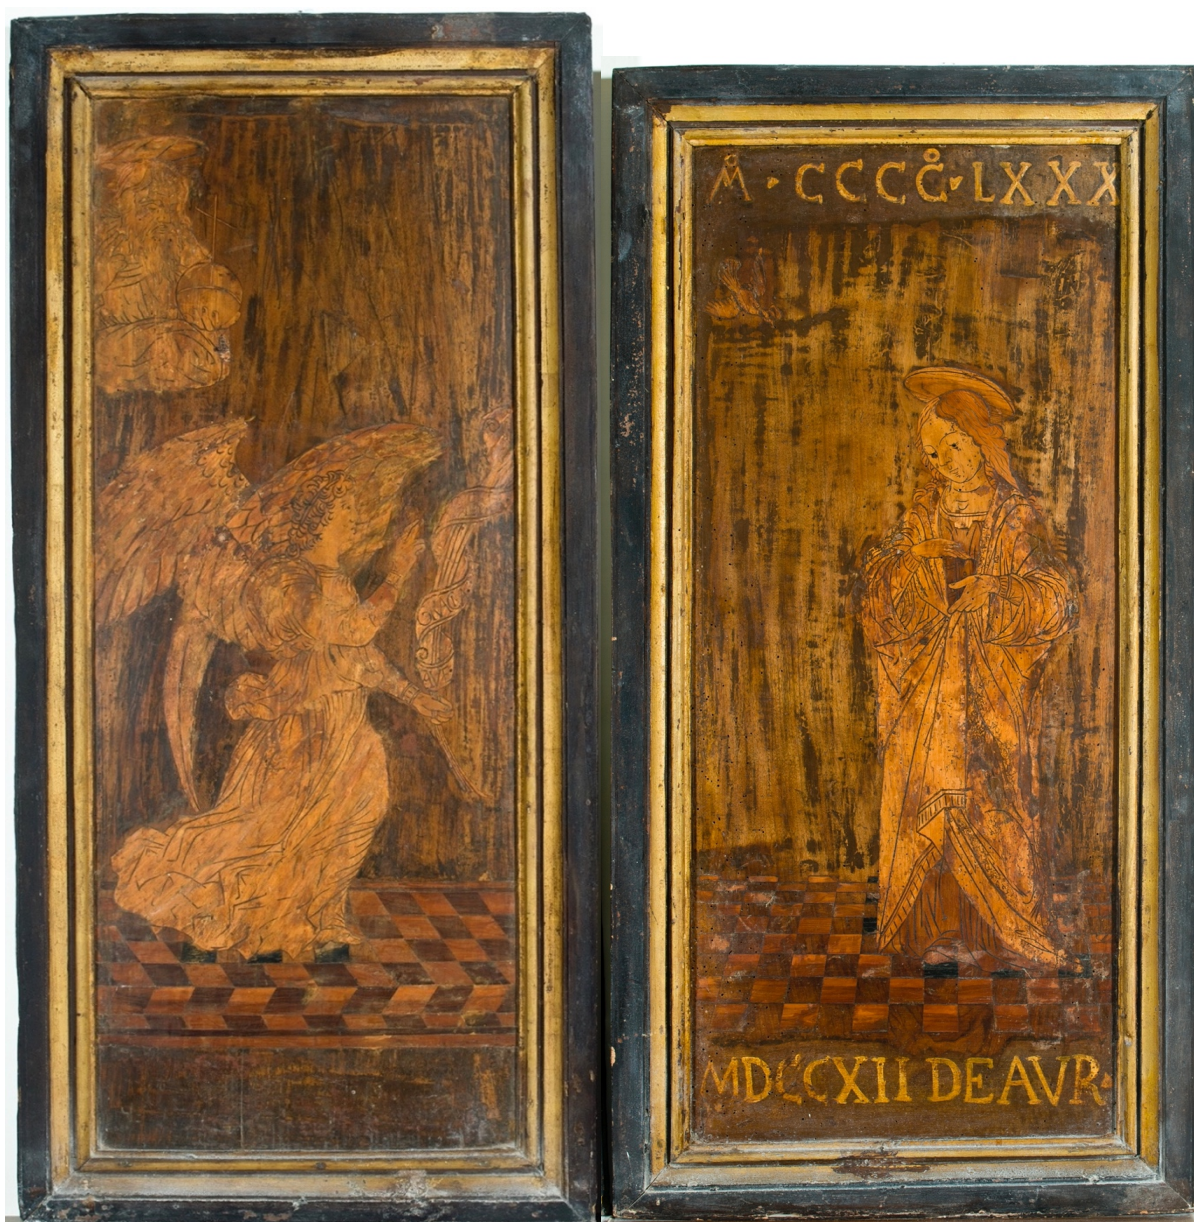
Fig. 11. **Annunciation** scene - **God the Father and Archangel Gabriel** panel (left) and **Virgin and Holy Ghost** panel (right), forming the Annunciation scene, before their latest restoration, completed in 2018. (James Saliba, 2014)

Through an analysis of the stylistic approach to the inlaid panels and canopy carvings, Larinà (2008) identifies striking similarities between the Ortigia stalls and the Mdina choir. She notes that the in the **Nativity** panel and **Annunciation** scene (composed of 2 panels - **God the Father and Archangel Gabriel panel** & **Virgin and Holy Ghost** panel, Fig. 11.) share closely corresponding compositional lines across both choirs, suggesting the possibility that the same *cartoni* were used for both sets of stalls. Given that the contract produced by Capodieci explicitly assigns Mirtello responsibility for half of the choir stalls, Larinà considers the potential involvement of the Calachura brothers in the production of the Ortigia stalls a plausible scenario (Larinà, 2008, p.48).

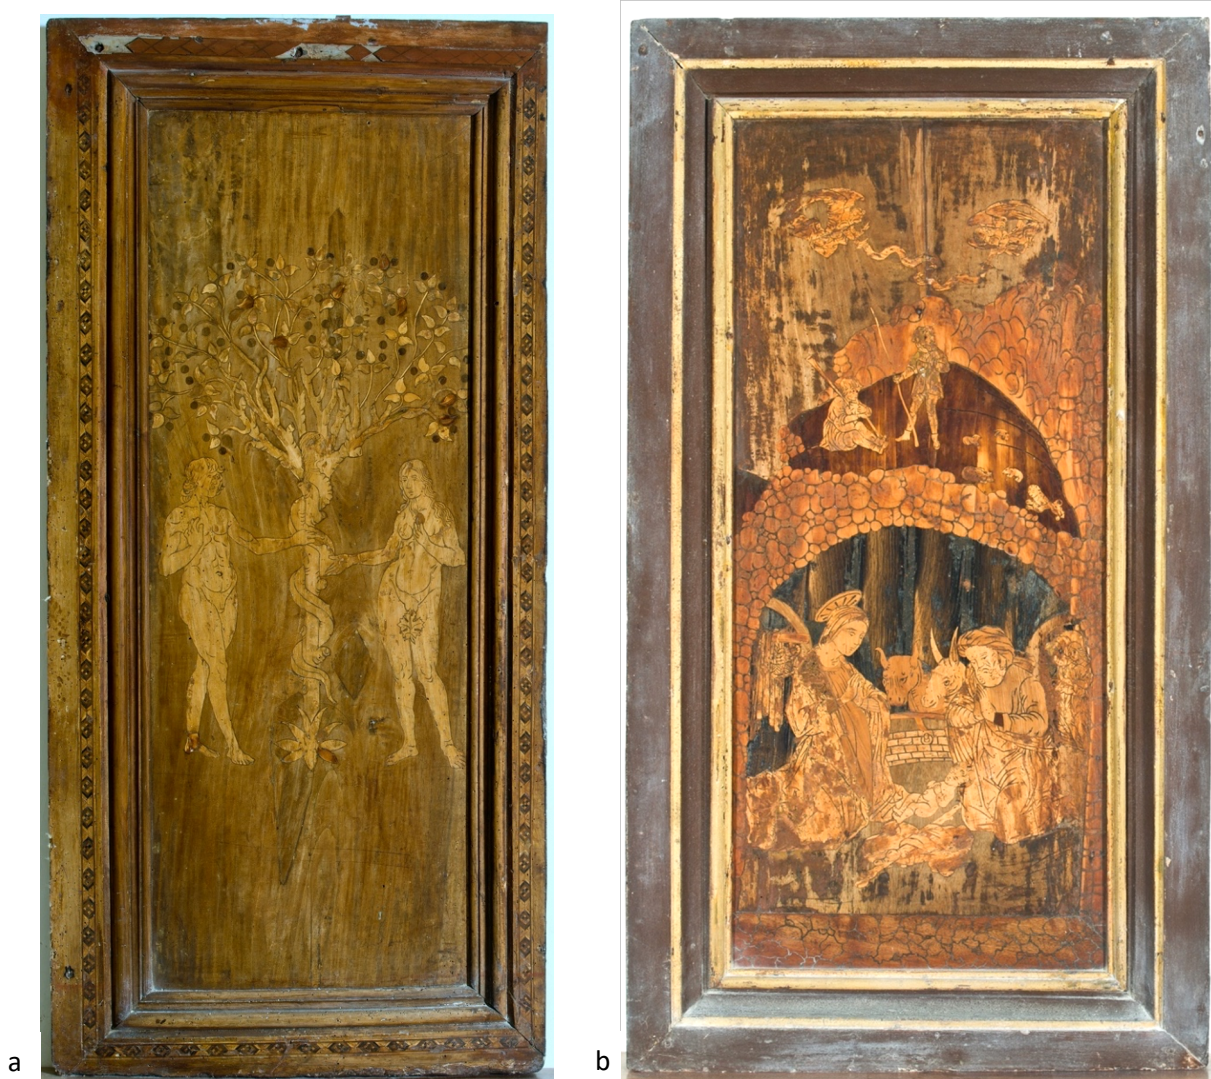
Fig. 13. Two panels presenting distinct frames

Frames: Galea-Naudi and Micallef note that the inlaid panel representing **'the original sin'** or **Adam and Eve** (Fig. 13.a.) still retains its original frame (Galea-Naudi Micallef, 1996, p.37), suggesting that the frames of other panels (Fig. 13.b.) may have been replaced during a previous intervention. However, the authors do not explore further the circumstances or timing of these potential alterations.

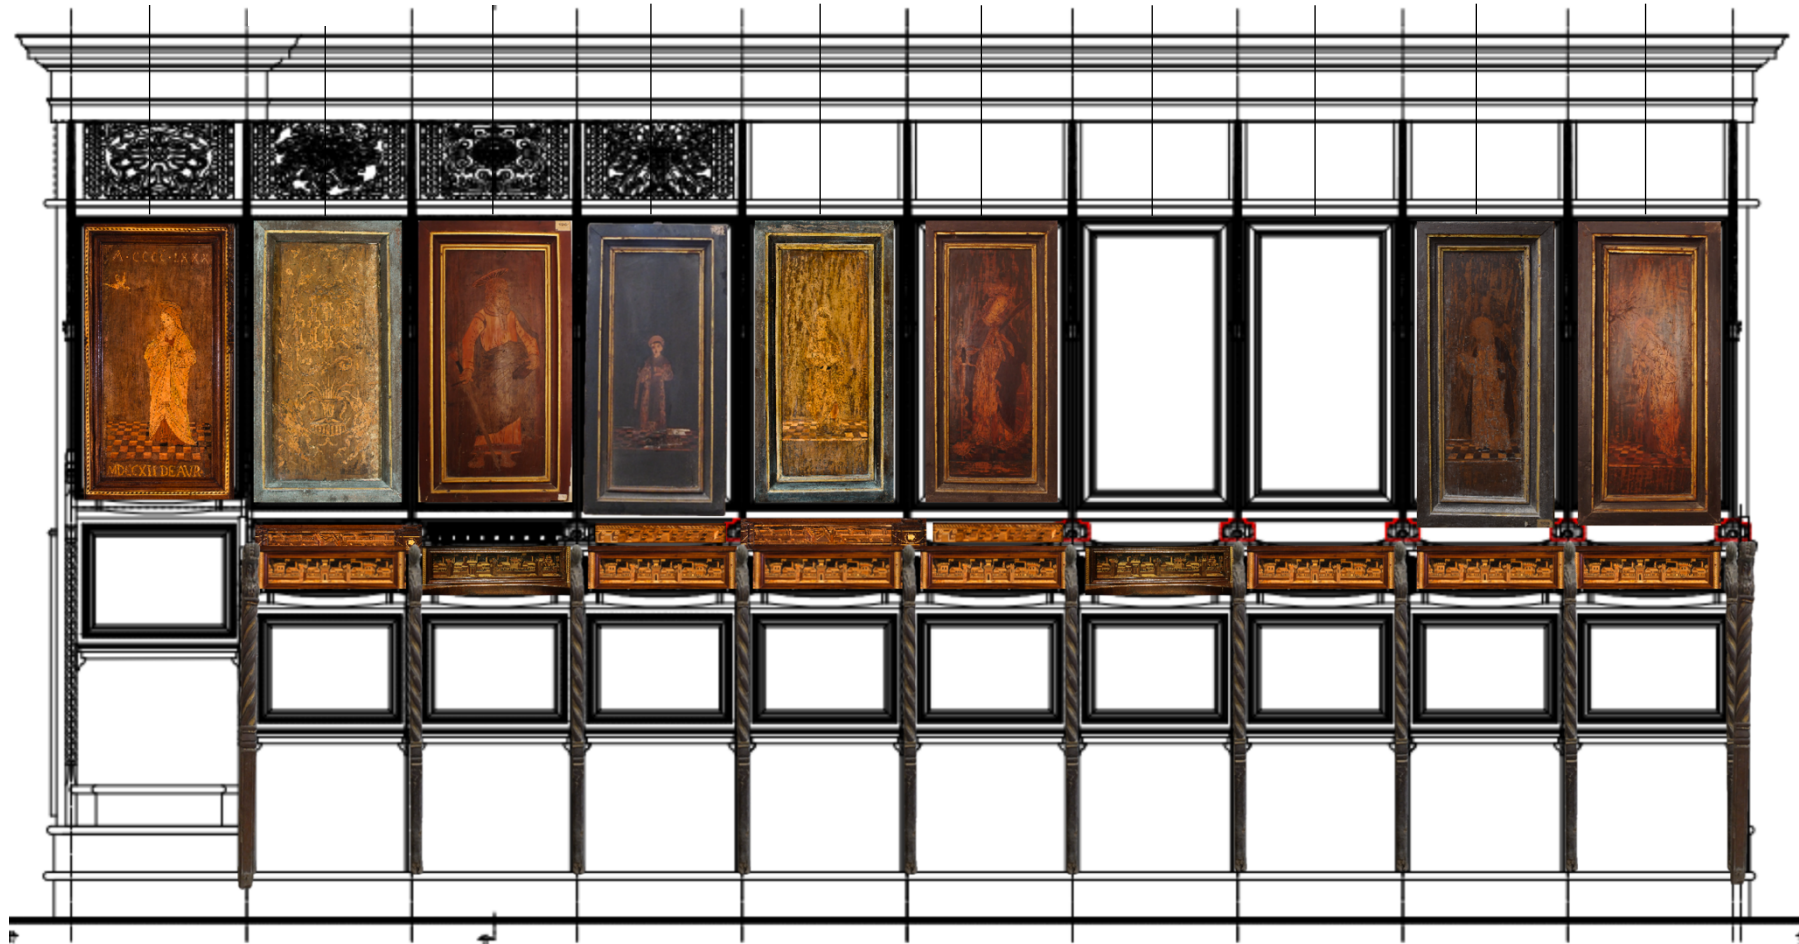
Fig. 16. Hypothetical reconstruction of the placing of inlaid panels in the upper tier with a 10-stall setting - the placing of the inlaid panels is based on Pullicino's 1877 account on the state of the stalls in the late 19th-century (12-stall setting). Epistle side (right when facing altar).

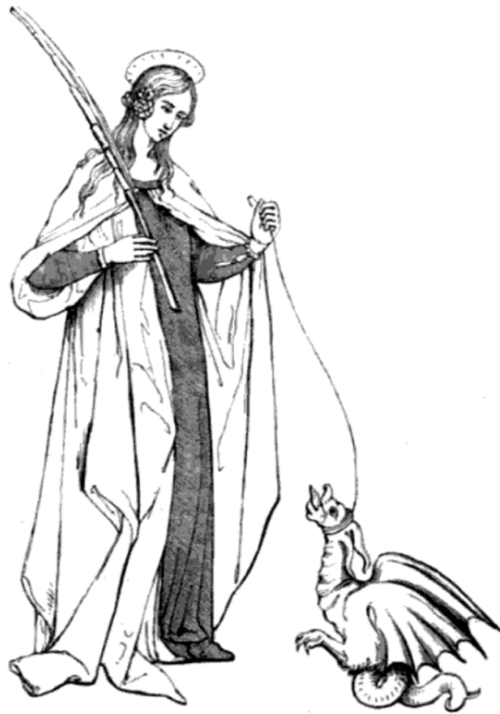
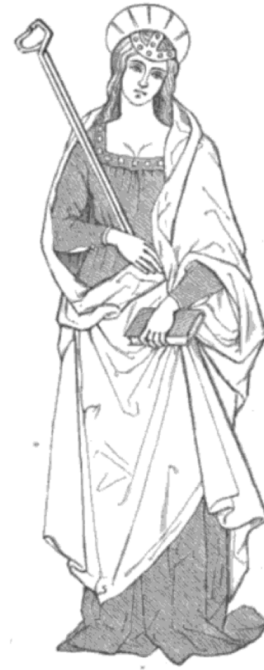
a St. Margaret. (Intarsia, San Giovanni, Malta. Fifteenth century.)

b 154 St. Agatha. (Intarsiatura, Malta. Fifteenth century.)

Fig. 18. Images of Vincenzo Hyzler's drawings of St Margaret (a) and St Agatha (b), from Mrs Jameson's Sacred and Legendary Art Vol.2 (1895, pp. 520 & 611, respectively). Note - in her book Jameson erroneously misplaces the panels as belonging to the choir stalls at St John's Co-Cathedral.

Pullicino also reports that some of the inlaid back panels were in such a poor condition, and had been so poorly restored, that it was impossible to decipher what they portrayed. Despite their deteriorated state, the panels continued to attract attention. Giuseppe Hyzler admired them, and his younger brother Vincenzo (1813-1849) even traced drawings of some of these panels, which were eventually published by Anna Brownell. Jameson (1794-1860) in the second volume of *Sacred and Legendary Art* (1848) (Pullicino, 1877, p.9) (Figs. 18.–19).

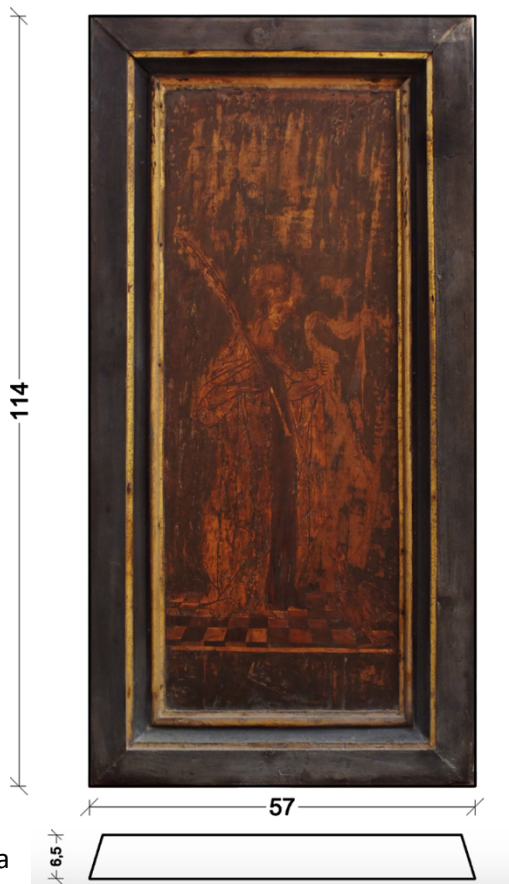
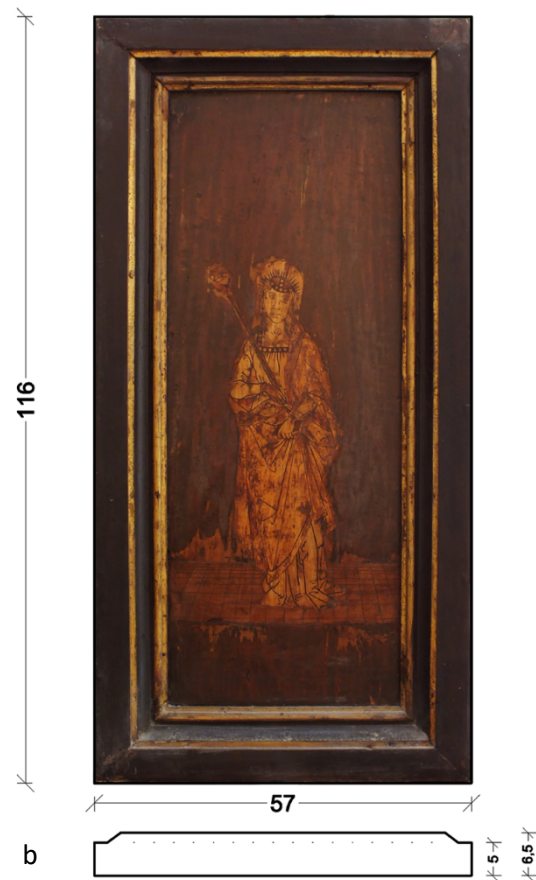
Fig. 19. The panels of St Margaret (a) and St Agatha (b). (James Saliba, 2014)

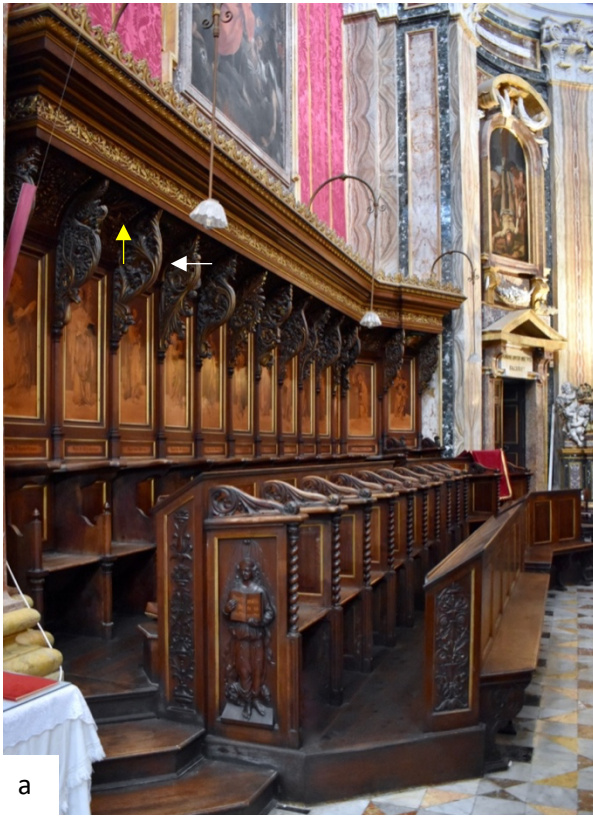
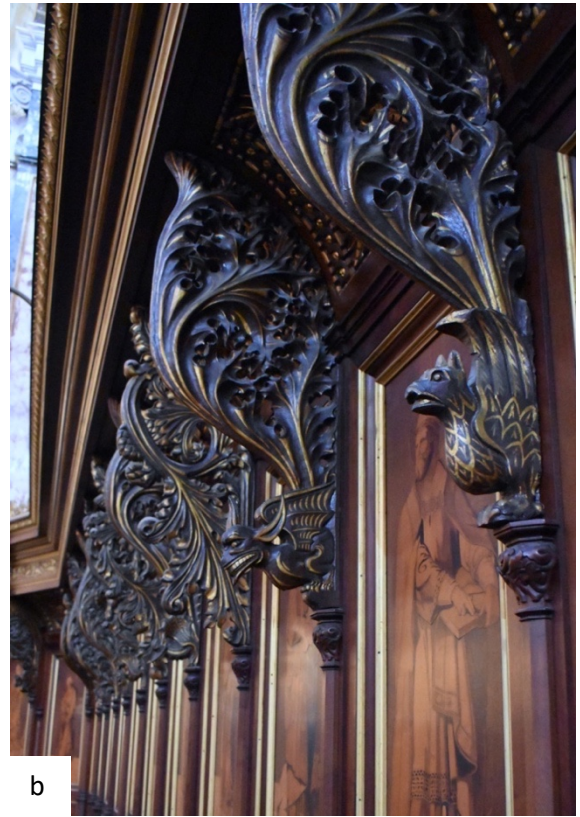
Fig. 20. Carved elements from the 15th-century choir stalls incorporated in the current set of stalls at St Paul's Cathedral, Mdina, crafted and installed by Emmanuele Decelis in 1876. (James Saliba, 2024)

- (a) The position of the carved *guarda polvere* elements, indicated by the white and yellow arrows..
- (b) White arrow – carved stall dividers, each presenting a unique fantasy of vegetal and zoomorphic elements
- (c) Yellow arrow – concave carved rosettes with floral motifs.

By the time of the choir stalls' replacement, in 1876, each wing featured twelve stalls on the upper tier, and ten seats on the lower tier, totalling twenty-two seats per wing. The upper-tier seats were reserved for the Bishop and Canons, while the lower-tier seats were used by priests (Pullicino, 1877, p.13). The twenty-four inlaid dorsal panels, framed and alternated with small columns, adorned the upper-tier stalls (Pullicino, 1877, p.14). Two additional inlaid panels were positioned on the outer face of the dignitary stalls. One of these, referred to as the '**Orpheus**' panel was later re-used, along with the carved elements constituting the 'guarda polvere', in the new choir stalls, manufactured by Emmanuele Decelis, which remain in the Cathedral today (Pullicino, 1877, pp.11,16,25; Larinà, 2008, pp.43-44; Aquilina, 2023) (Figs. 20.–21.).

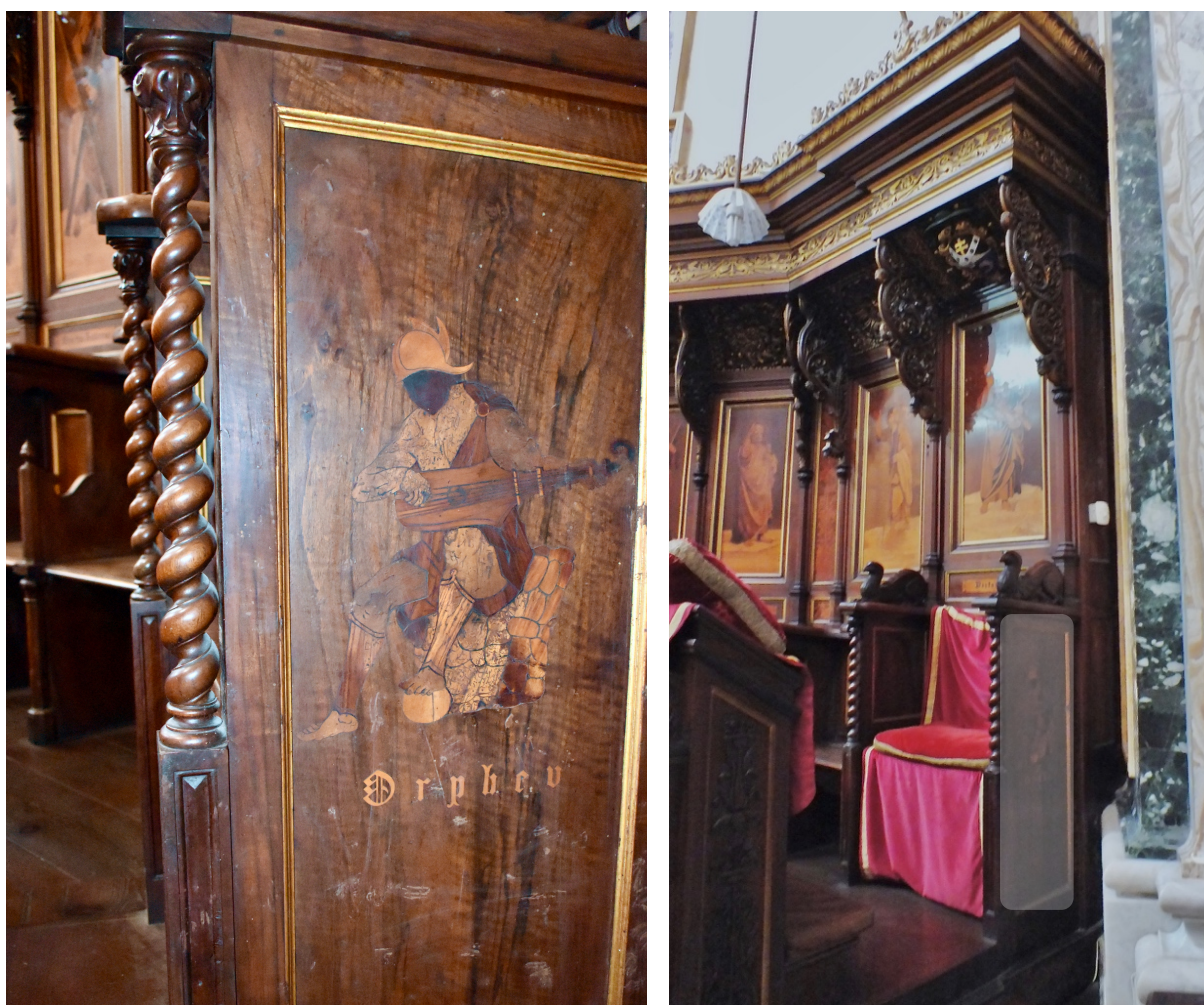
Fig. 21. The 15th-century Orpheus inlay incorporated in the late-19th-century choir stalls. (James Saliba, 2024)

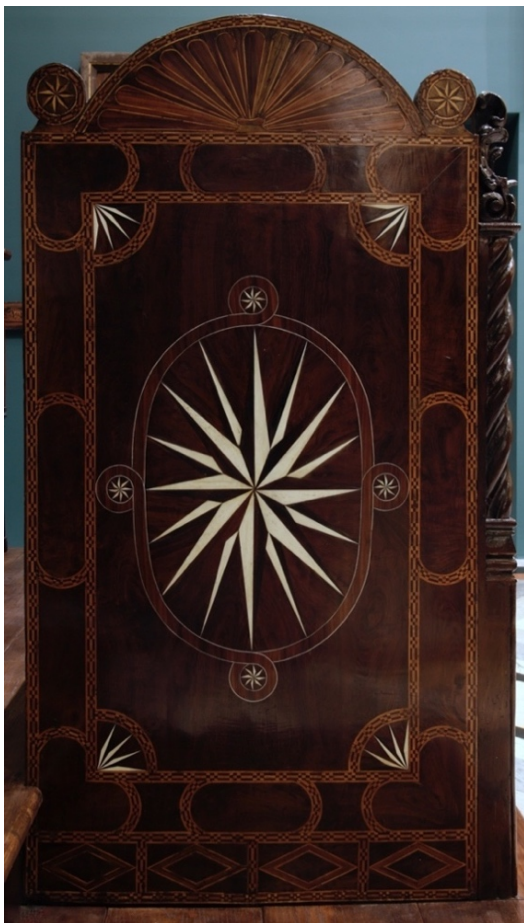
Fig. 23. 15th-century inlaid side panel incorporated in 2018 reconstruction. Criticised by Pullicino (1877) for breaking the aesthetic flow of the stalls and presenting unsuitable decoration. (photos: James Saliba, 2024; drawings: Bruno Ambrosio, 2016)

Another four inlaid panels were located on the outer sides of the kneelers, marking the ends of each wing's lower tier (Fig. 23.). Pullicino (1877, p.28) criticizes these panels for disrupting the aesthetic flow of the stalls, as they interfered with the visual lines formed by the profiles of the seats and kneelers. These panels are further described as being covered with ornaments which were ill-suited for the ecclesiastical setting. He further criticised the columns (Fig. 24.) between the lower-tier seats for being rough and deformed, while carved zoomorphic figures (Fig. 25.), which stood on the dignitary stalls, were described as crudely carved, '*vulgar and Baroque*'.

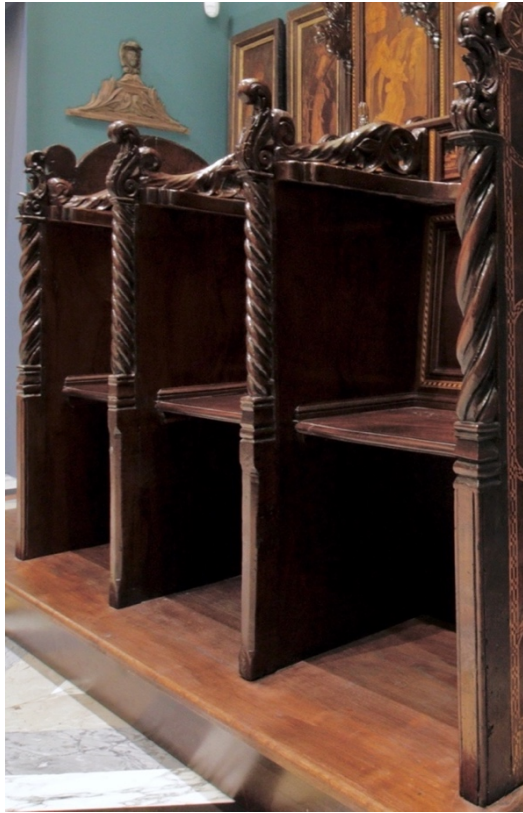
Fig. 24. 15th-century carved Solomonic columns and acanthus leaves, currently incorporated in the 2018 reconstruction. Described by Pullicino (1877) as being rough and deformed. (photos: James Saliba, 2024; drawings: Bruno Ambrosio, 2016)

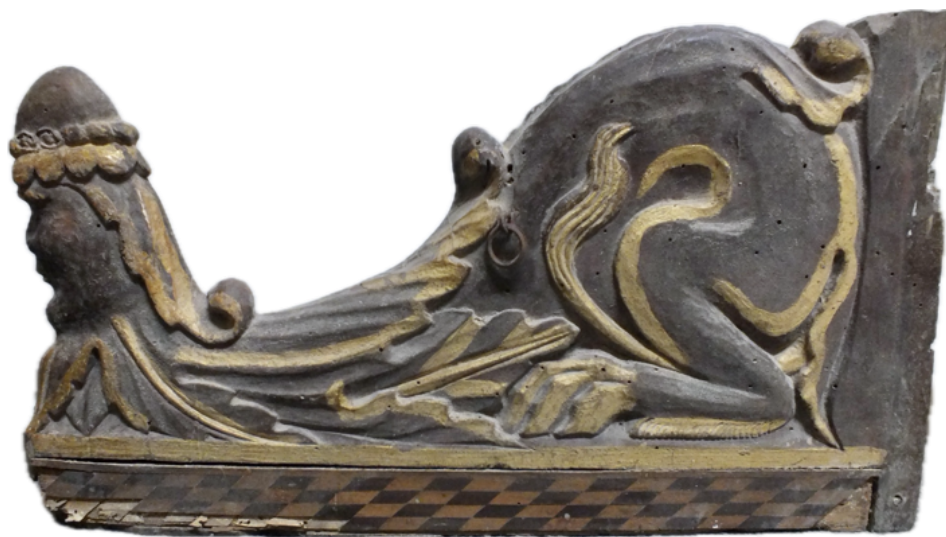
Fig. 25. 15th-century carved zoomorphic figure from bishop's stall. Considered by Pullicino (1877) to be crudely carved 'vulgar and Baroque'. Museum's Reserve collection. (James Saliba, 2014)
