Continuity and Change: The Curation, Modification and Reuse of the 15th-century Choir Stalls in St Paul's Cathedral, Mdina, Malta (1625 – 1725)

Dissertation submitted to the Faculty for the Built Environment, University of Malta in part fulfilment of the requirements for the attainment of the degree of Master of Arts in Cultural Heritage Management.

January, 2025

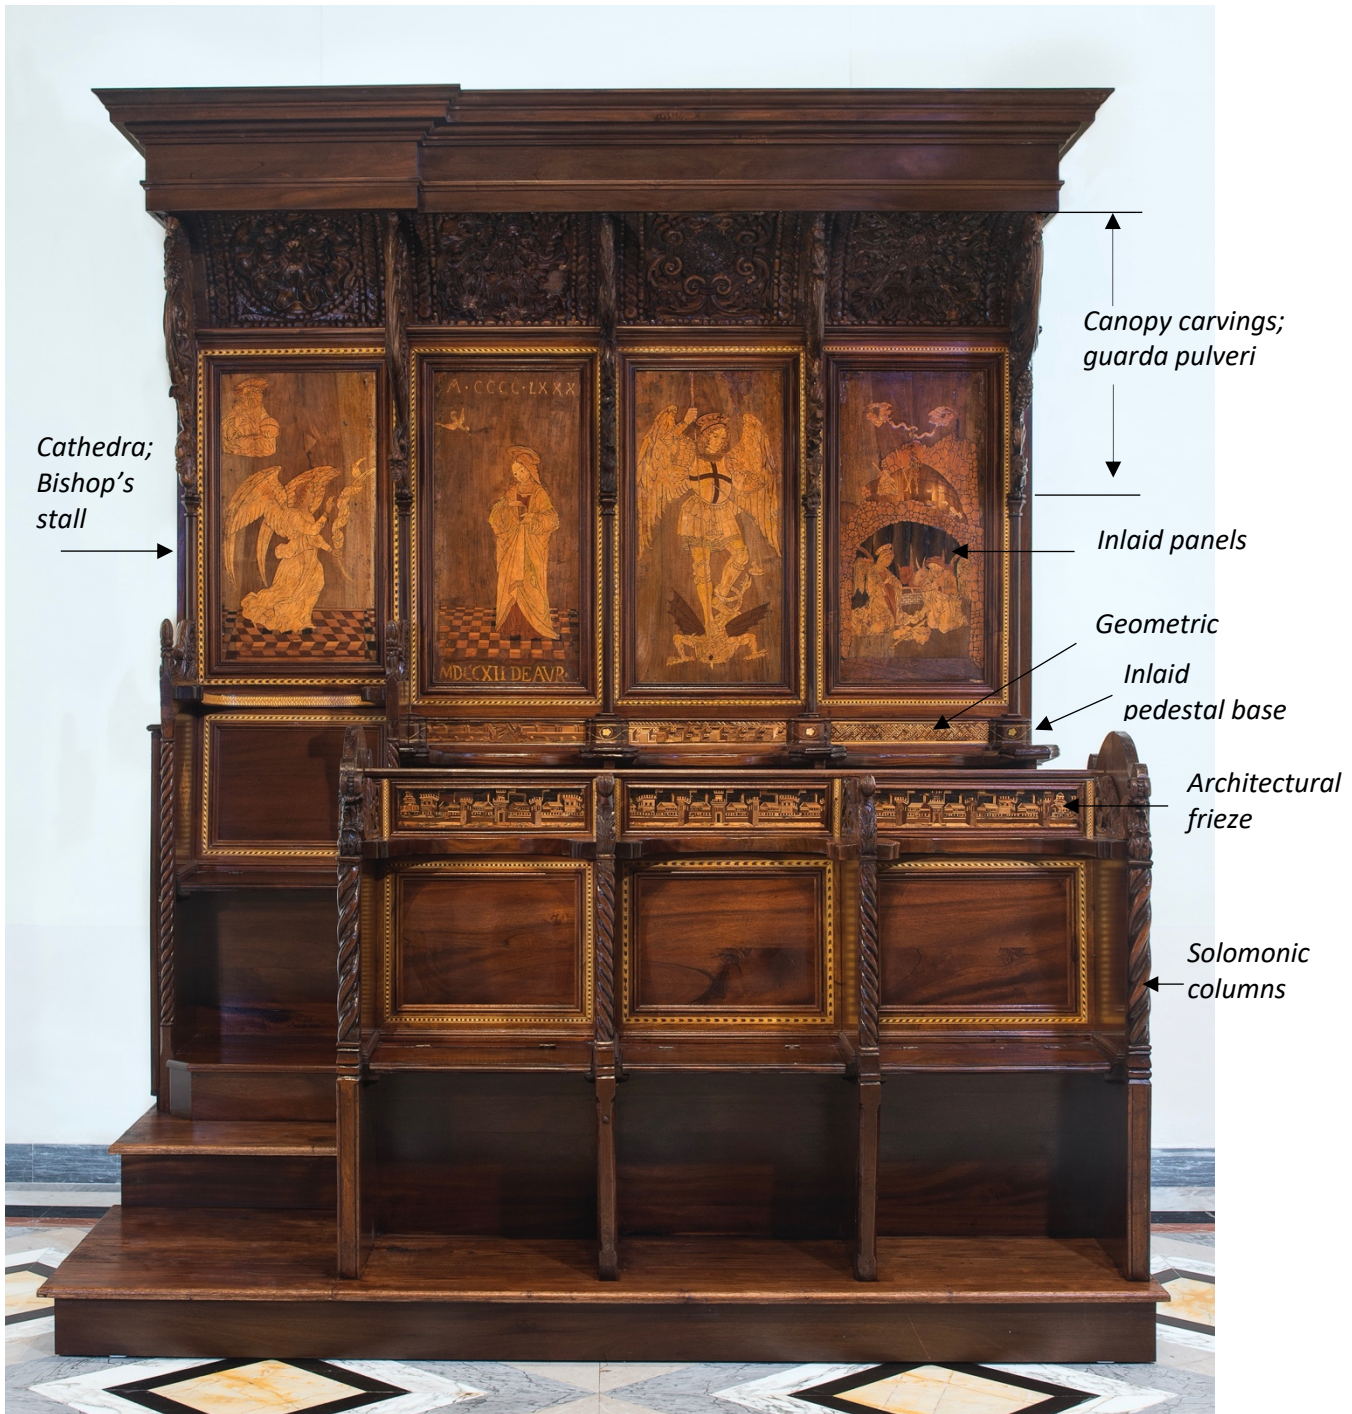
Fig. 26. Annotated image of the 2018 segmental reconstruction of the 15th-century choir stalls. (Joseph Borg, 2018)

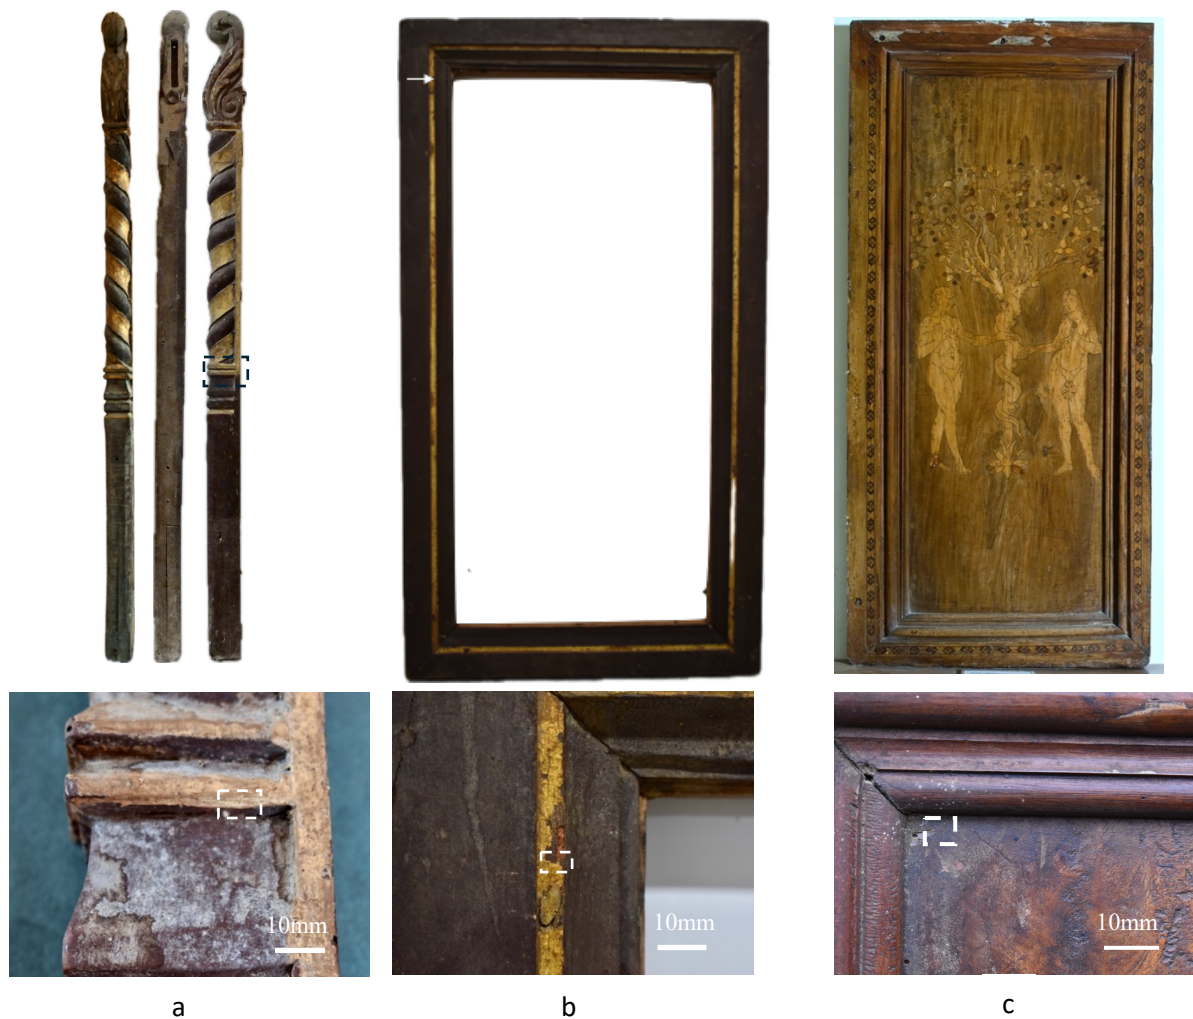
*Fig. 28. Sampling locations for stratigraphic analysis. The locations correspond to the samples listed in Table 1. (a) **CSM02_SC** (Solomonic column), (b) **CSM03_AF** (added frame), and (c) **CSM04_AEP** (Adam and Eve panel). (James Saliba, 2024)*

On this basis, three samples were extracted (see *Table 1.*), each selected to address a specific research question relating to original manufacture, and subsequent modification (see *6.1. Stratigraphic analysis - introduction*). Collectively, the three samples were selected to represent (i) an original structural/carved element, (ii) an original pictorial/inlaid element, and (iii) a later-added component associated with a known modification phase, thereby enabling a controlled comparison between original manufacture and subsequent interventions (*Table 1; Fig. 28.*). This targeted approach ensured that the number of samples was kept to a minimum while maximising the interpretative value of the results. The samples measured approximately 2mm in width and 4mm in length. The extraction included part of the support to ensure a comprehensive stratigraphic sequence and was undertaken following formal authorisation and ethical approval (see *Section 3.4. Ethical considerations*).

Each sample was first examined under a Nikon SMZ800 stereomicroscope (10-63x) and imaged using a Nikon Digital Sight DS-Vi1 camera operated with a NIS Elements BR software (versions 4.20 and 5.21). Samples were then embedded in Technovit 2000 methacrylate resin and cured under blue light. Cross sections were prepared by initially using wet grinding to remove excess resin from the resin blocks. Samples were then mounted on a MOPAS hand polishing device, ground and polished using Micro-mesh abrasive polishing cloths (2400-8000 mesh). Throughout the grinding and polishing process, the samples were monitored under a Nikon SMZ800 stereomicroscope to ensure proper exposure of the cross-section and to avoid any potential damage during the preparation process.

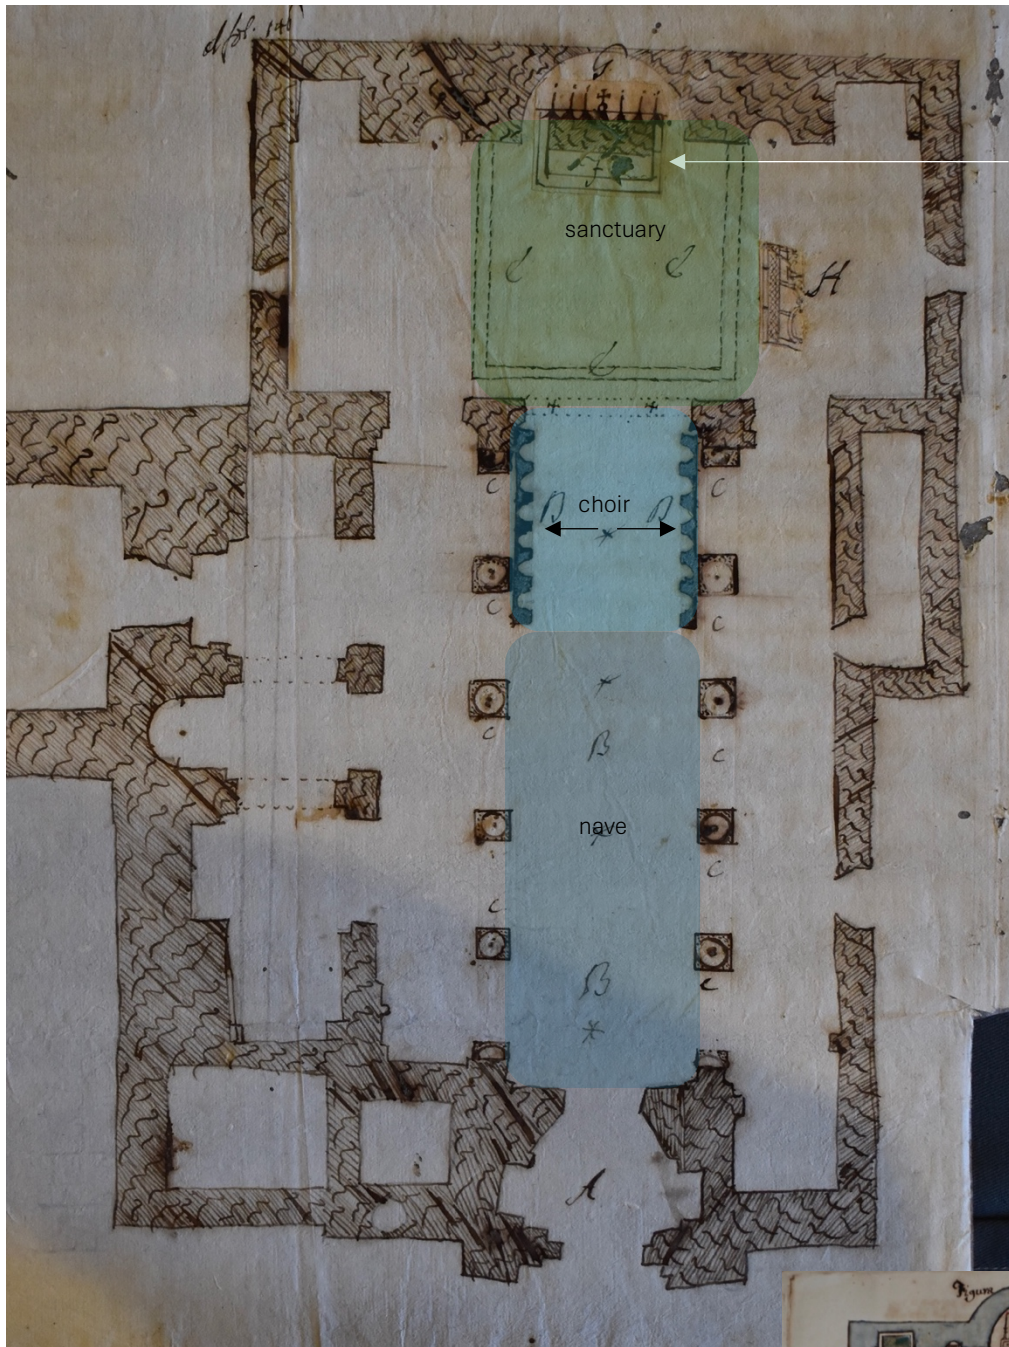
Fig. 29. Plans of the pre-Baroque St Paul's Cathedral (Mdina) showing the choir stalls positioned within the nave (black arrows), a configuration most likely in use between c. 1490 and 1626. The arrangement suggests a tripartite articulation of liturgical space, distinguishing the sanctuary/presbytery from a choir zone inserted within the nave, with the remaining nave reserved for the laity. The titular altar is shown at the east end within the apse. (James Saliba, 2024)

Upon closer examination, it becomes evident that the original position of installation, as noted by Larinà (2008, p.43), was within the nave, specifically occupying the space between the first four pilasters (Fig. 29.). At this time, the main altar, later referred to as titular altar, was positioned against the tribune, as Pullicino (1877, p.5) also correctly states.

This layout is illustrated in MCM. Drawing 636 (Misc. 60 f.146) (Fig.29.a) and corroborated by another plan found in ACM. Misc.47 (f.234, after 1741) (Fig.29.b). This manuscript (Misc.47, f.235) further confirms that the choir stalls remained in the nave till 1626, when they were relocated to the presbytery area, and set against the tribune - '*tirato l coro in sopra et attaccato alla Tribona*' (Fig. 30.).

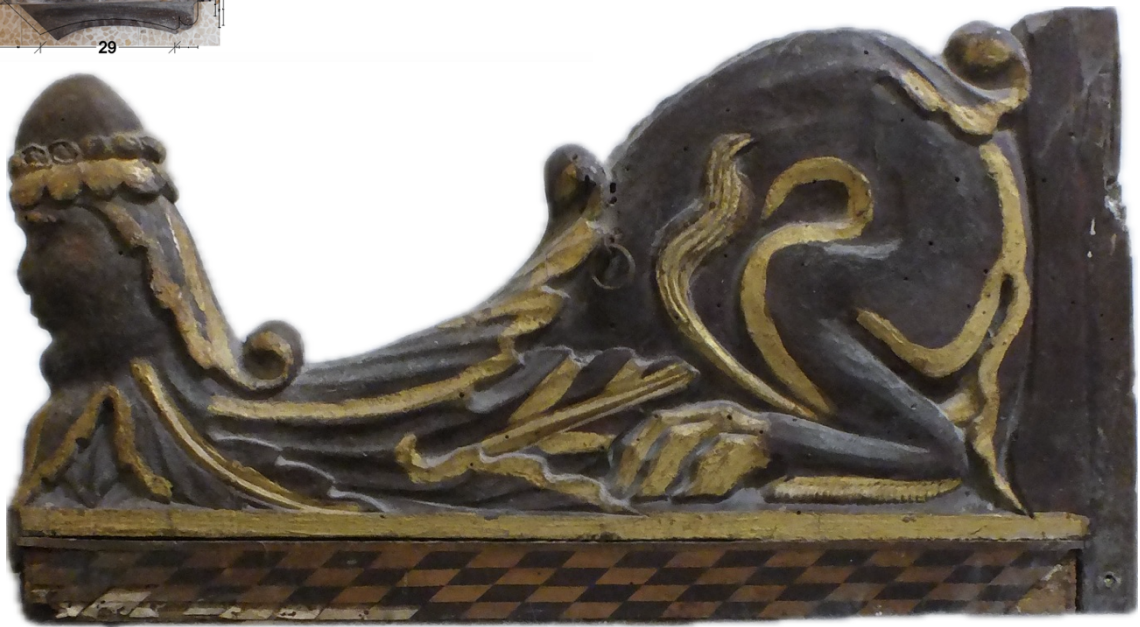
Fig. 45. Bishop stall fragment **D.2.1.** with a checkerboard inlay banding on its external face. The tarsia decoration is assembled on parchment/paper, consistent with the original technique observed on other toppo inlaid fragments (friezes, **Cat. B**). (James Saliba, 2014)

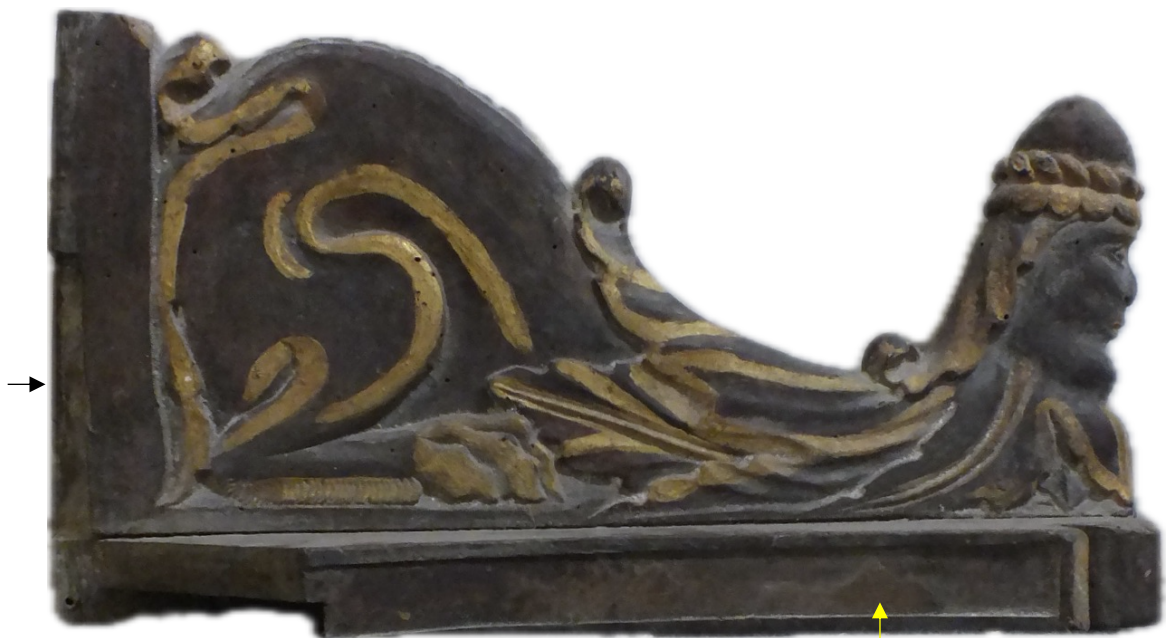
Fig. 46. Bishop stall fragment **D.2.1.** with armrest (external side, internal face). The armrest presents a recessed slot (yellow arrow) likely intended for inlaid banding that probably extended along the missing portion of the armrest. On its back end it presents a mortice joint recess (black arrow), presumably for the attachment of an inlaid frieze below the dorsal panel, as observed for the other stalls. (James Saliba, 2014)

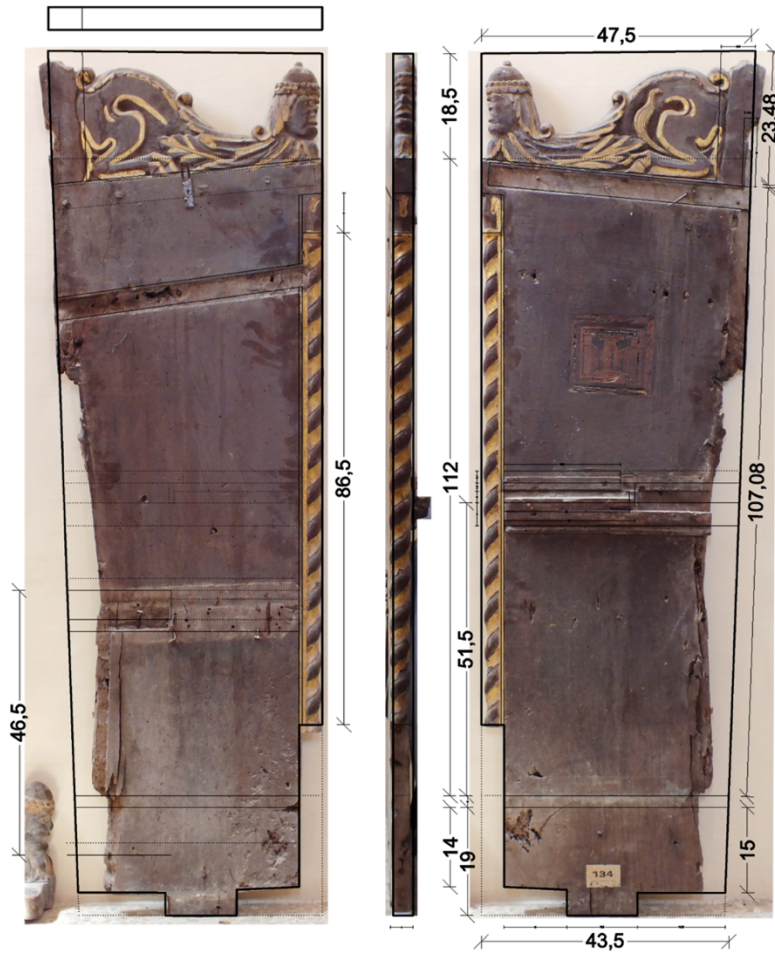
Fig. 48. Internal side of Bishop's stall **D.1.1**. (James Saliba, 2014)

Additional inlaid motifs adorned the internal upper sections of the dignitary stalls' sides. Mortise joint recesses on fragments from the dignitary stalls further suggest the presence of an inlaid frieze running along the back of each stall (Fig. 47.), situated beneath the inlaid dorsal panel, (see 5.2.2 *Framed Decorative Friezes in the Choir Stalls*). A similar recess for frieze positioning on the Cantor's stall was found filled with a composite of glue and sawdust containing a dark-coloured particulate, possibly applied during a subsequent alteration. The front ends of the dignitary stall sides were ornamented with Solomonic columns, like those associated with the lower-tier seating (Figs. 48.–49.). This design element created a deliberate visual continuity while emphasizing the elevated status of these stalls (see 5.2.4. *Rank and Hierarchy*).

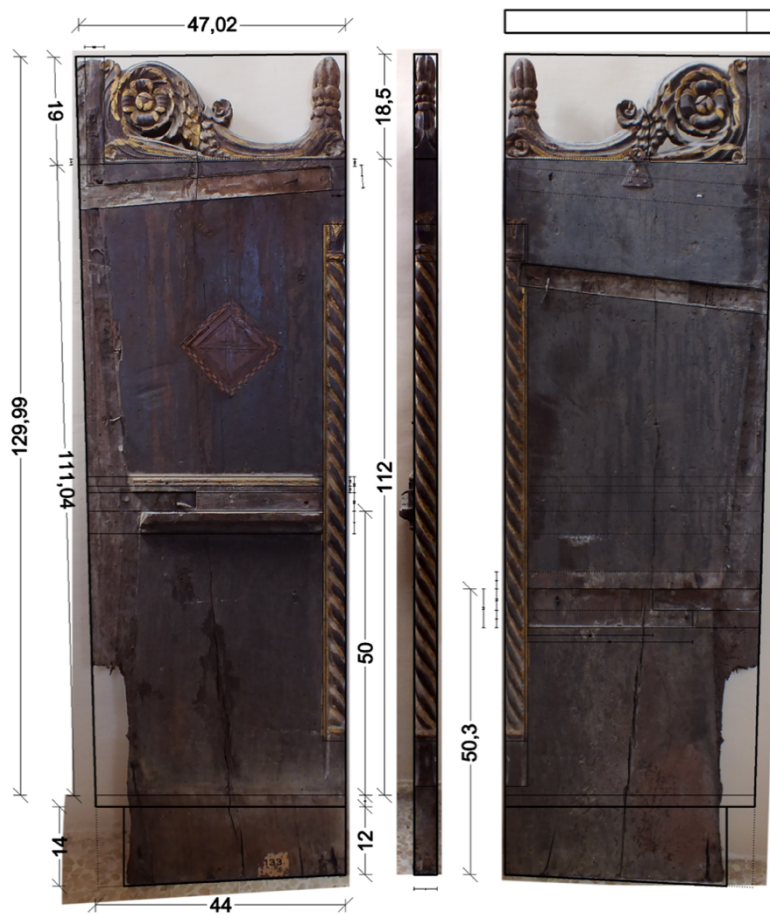
Fig. 49. Internal side of Cantor's stall **D.1.2**. (James Saliba, 2014)

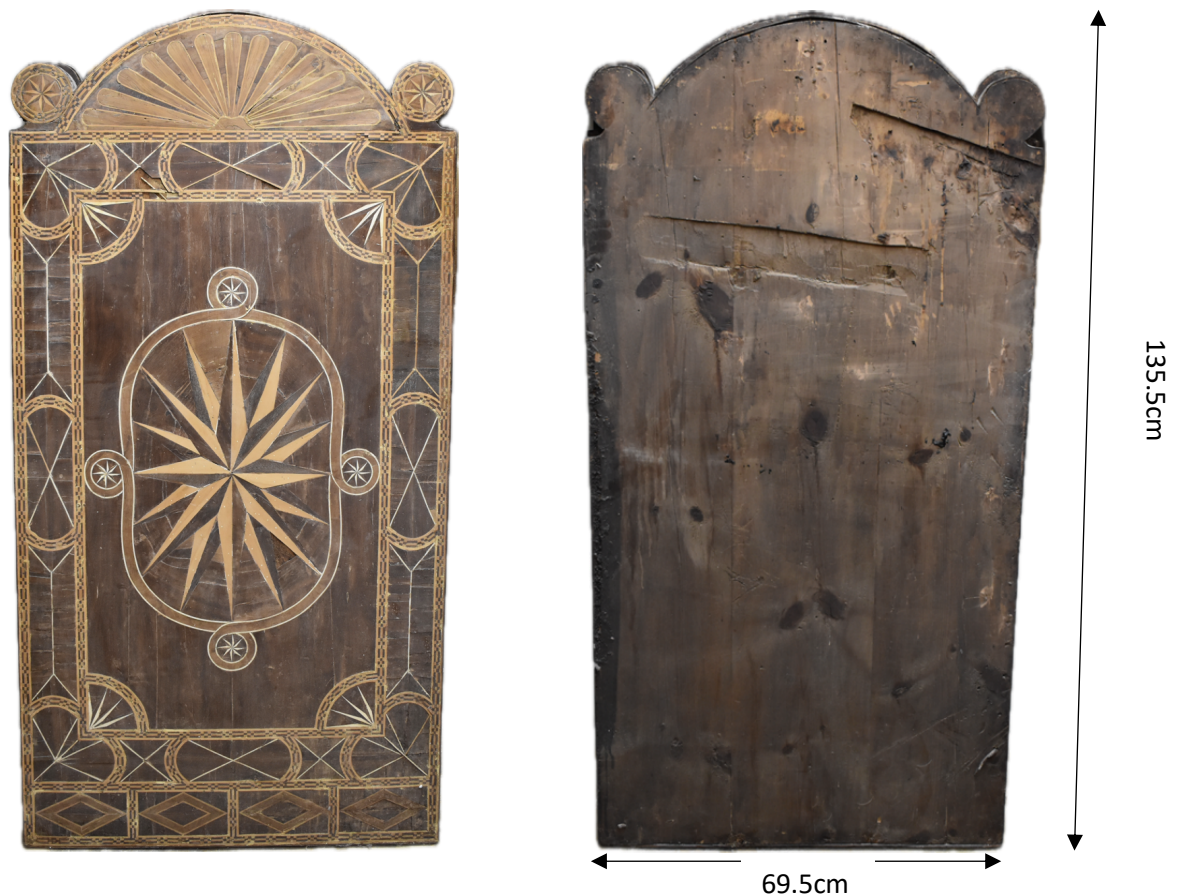
Fig. 56. Certosina panel C.2.1., suggesting the position of these panels on the end sides of the lower tier, the inclination of the lower-tier armrest and the inclination of the upper-tier bookrest (below). (James Saliba, 2014)

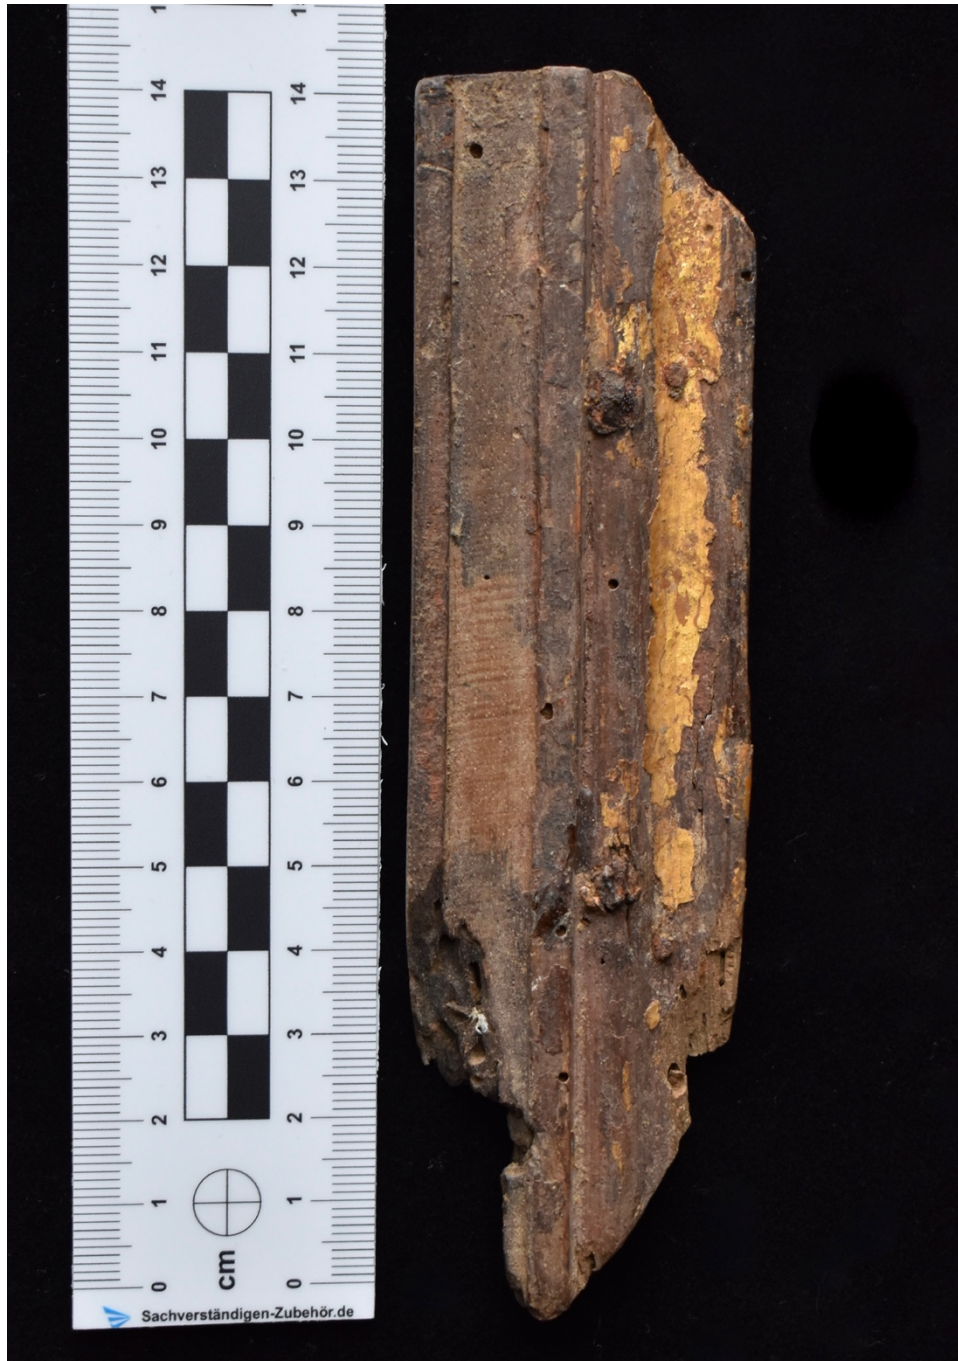
Fig. 60. Original lower-tier frieze frame with slot for toppo technique inlay banding. (James Saliba 2024)

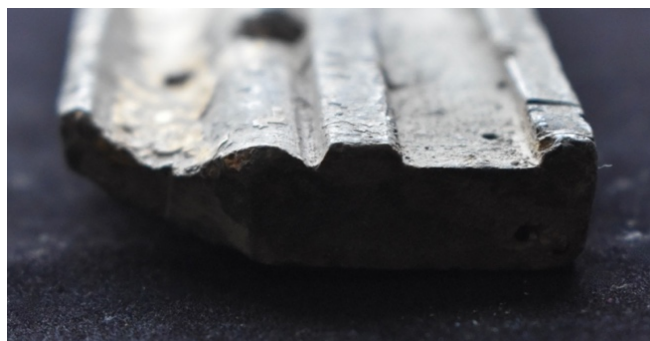
Fig. 61. Profile of original lower-tier frieze frame. (James Saliba, 2024)

The frieze on the lower tier depicted a cityscape (Pullicino, 1877, p.26) (**B.1.1.**, Fig. 58.), probably imbued with theological symbolism, representing the *City of God* as described in St Augustine's writings. The frames for these cityscape inlays on the lower tier (Fig. 59.) were wider than those on the upper tier. Evidence from two surviving fragments reveals that the original frame (Figs. 60.– 61.) included an inlay banding, as indicated by a slot designed for its insertion. This feature aligns with other original frames and *toppo* inlays identified in other parts of the stalls. However, most of these frames were replaced during later interventions. The profile and dimensions of the original frame can be reconstructed from the surviving fragments.

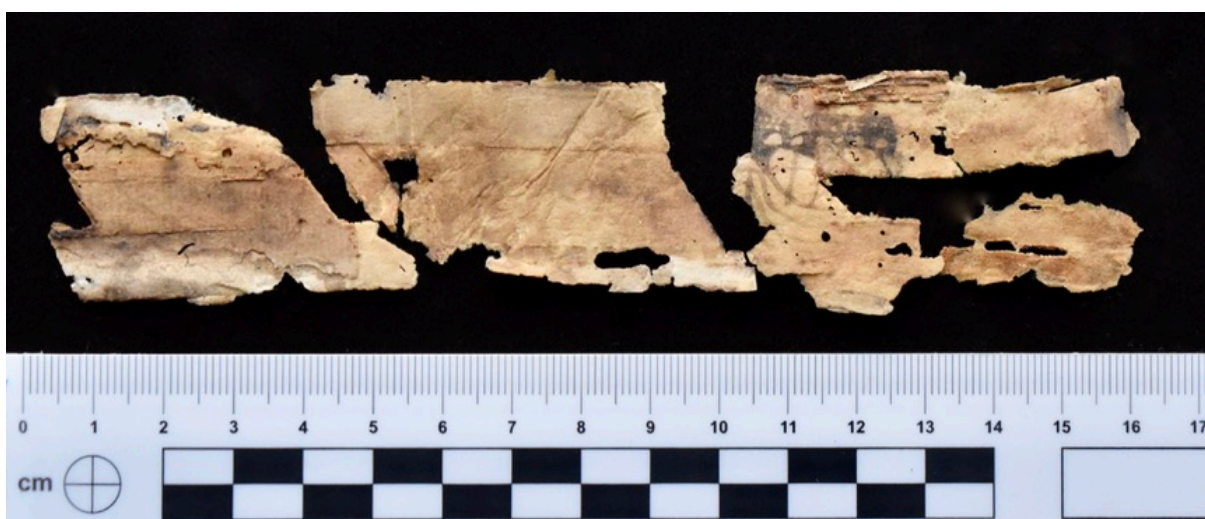
Fig. 63. Parchment used for the transfer of inlay decoration, as part of the 15th-century manufacturing process, recovered from fragment **B.2.1.** architectural and geometric frieze, currently conserved at the Mdina Metropolitan Museum. (James Saliba, 2024)

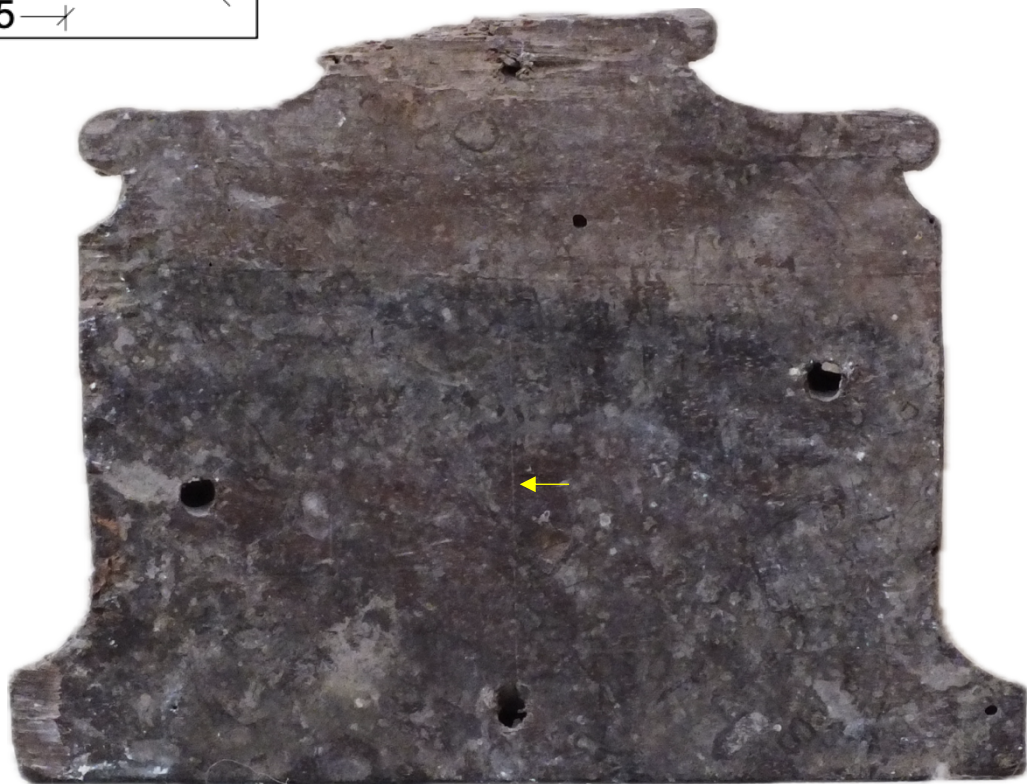
Fig. 65. Rear view of pedestal base fragment (*J.1.*) in previous figure. This fragment presents a central etched marking line (yellow arrow) similar to the ones marked on the geometrical frieze support.

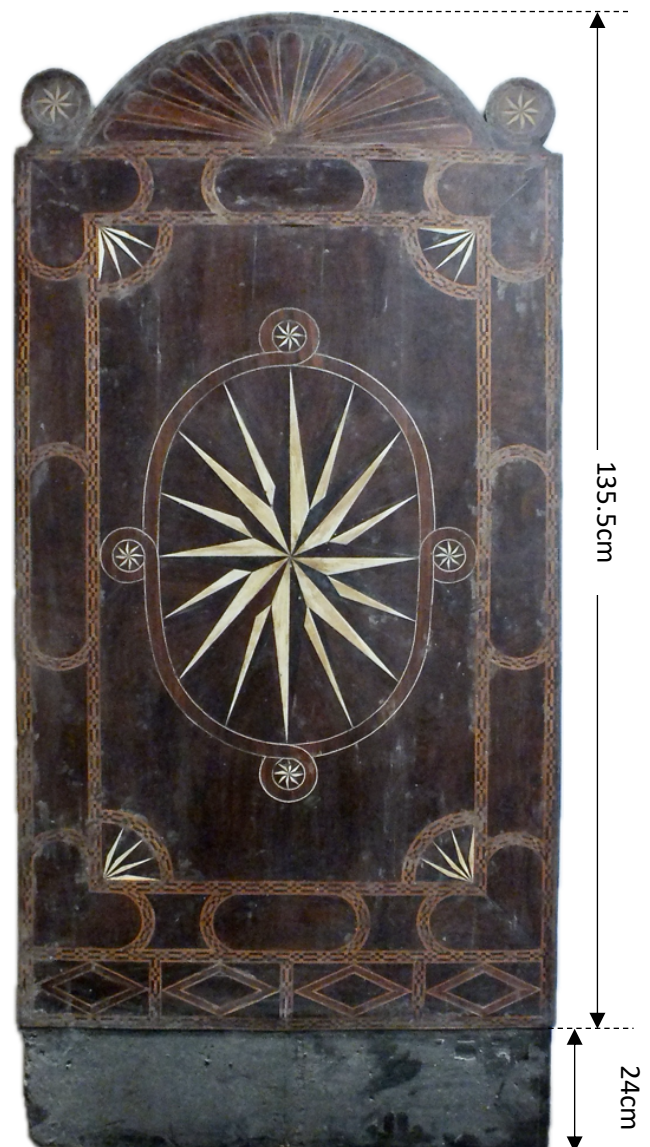
Fig. 67. Fragment C.1.1. lower-tier end panel. The undecorated band at the base is indicative of the height of step leading to the second tier seatings. (James Saliba, 2014)

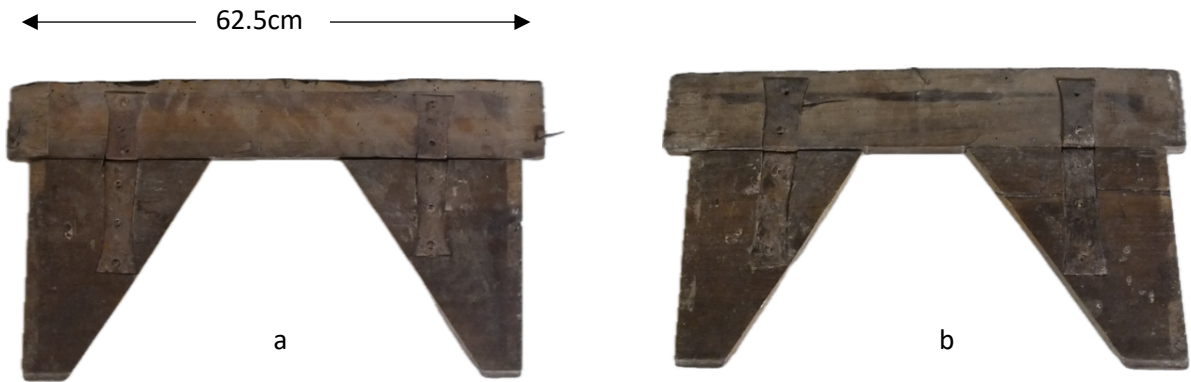
Fig. 69. Removal of misericords after 1876. Seat fragments **G.4.** (a) and **G.7.** (b) are two of the seven seat fragments that display a distinctive V-cut on the seating surface. This V-cut appears to have been a deliberate methodological approach for the removal of the misericords. By employing this technique, the section of the seat to which the misericord was attached could be sawn off while avoiding contact with the metal hinges. (James Saliba, 2014)

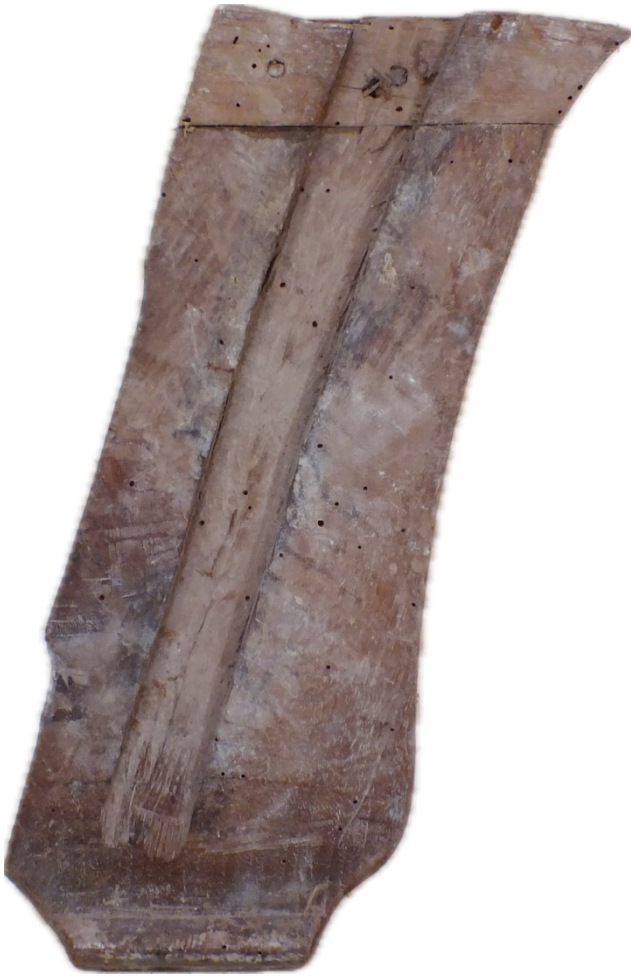
Fig. 77. Bottom side of armrest **F.1.9**, revealing joinery groove for the attachment of stall side originally set at an 18-degree angle to the vertical axis. (conservation records: James Saliba, Bruno Ambrosio, 2016)

Additional support for a non-linear configuration comes from an armrest with an angled slot. This armrest, **F.1.9.** (Fig. 76.), has been attributed to the original construction of the stalls based on its manufacturing details, which align with those of the original fragments. However, it exhibits a carved slot on its underside set at an 18-degree angle—distinct from other armrests, which have slots aligned perpendicularly to the back-rail (Fig. 77.). Notably, the slot on armrest **F.1.9.** shows no signs of later modification.

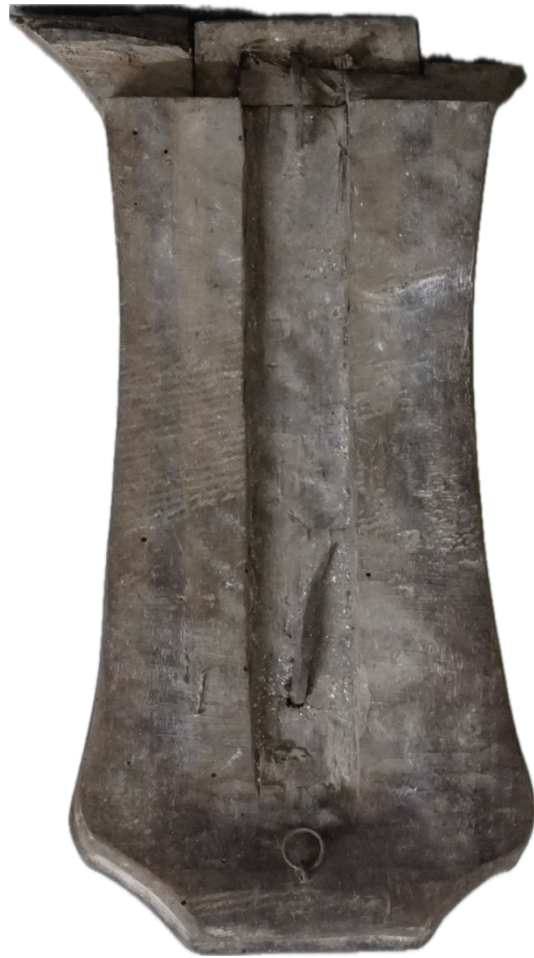
Fig. 76. Bottom side of armrest **F.1.5**, showing joining groove along its central axis, as per the majority of armrests (conservation records: James Saliba, Bruno Ambrosio, 2016)

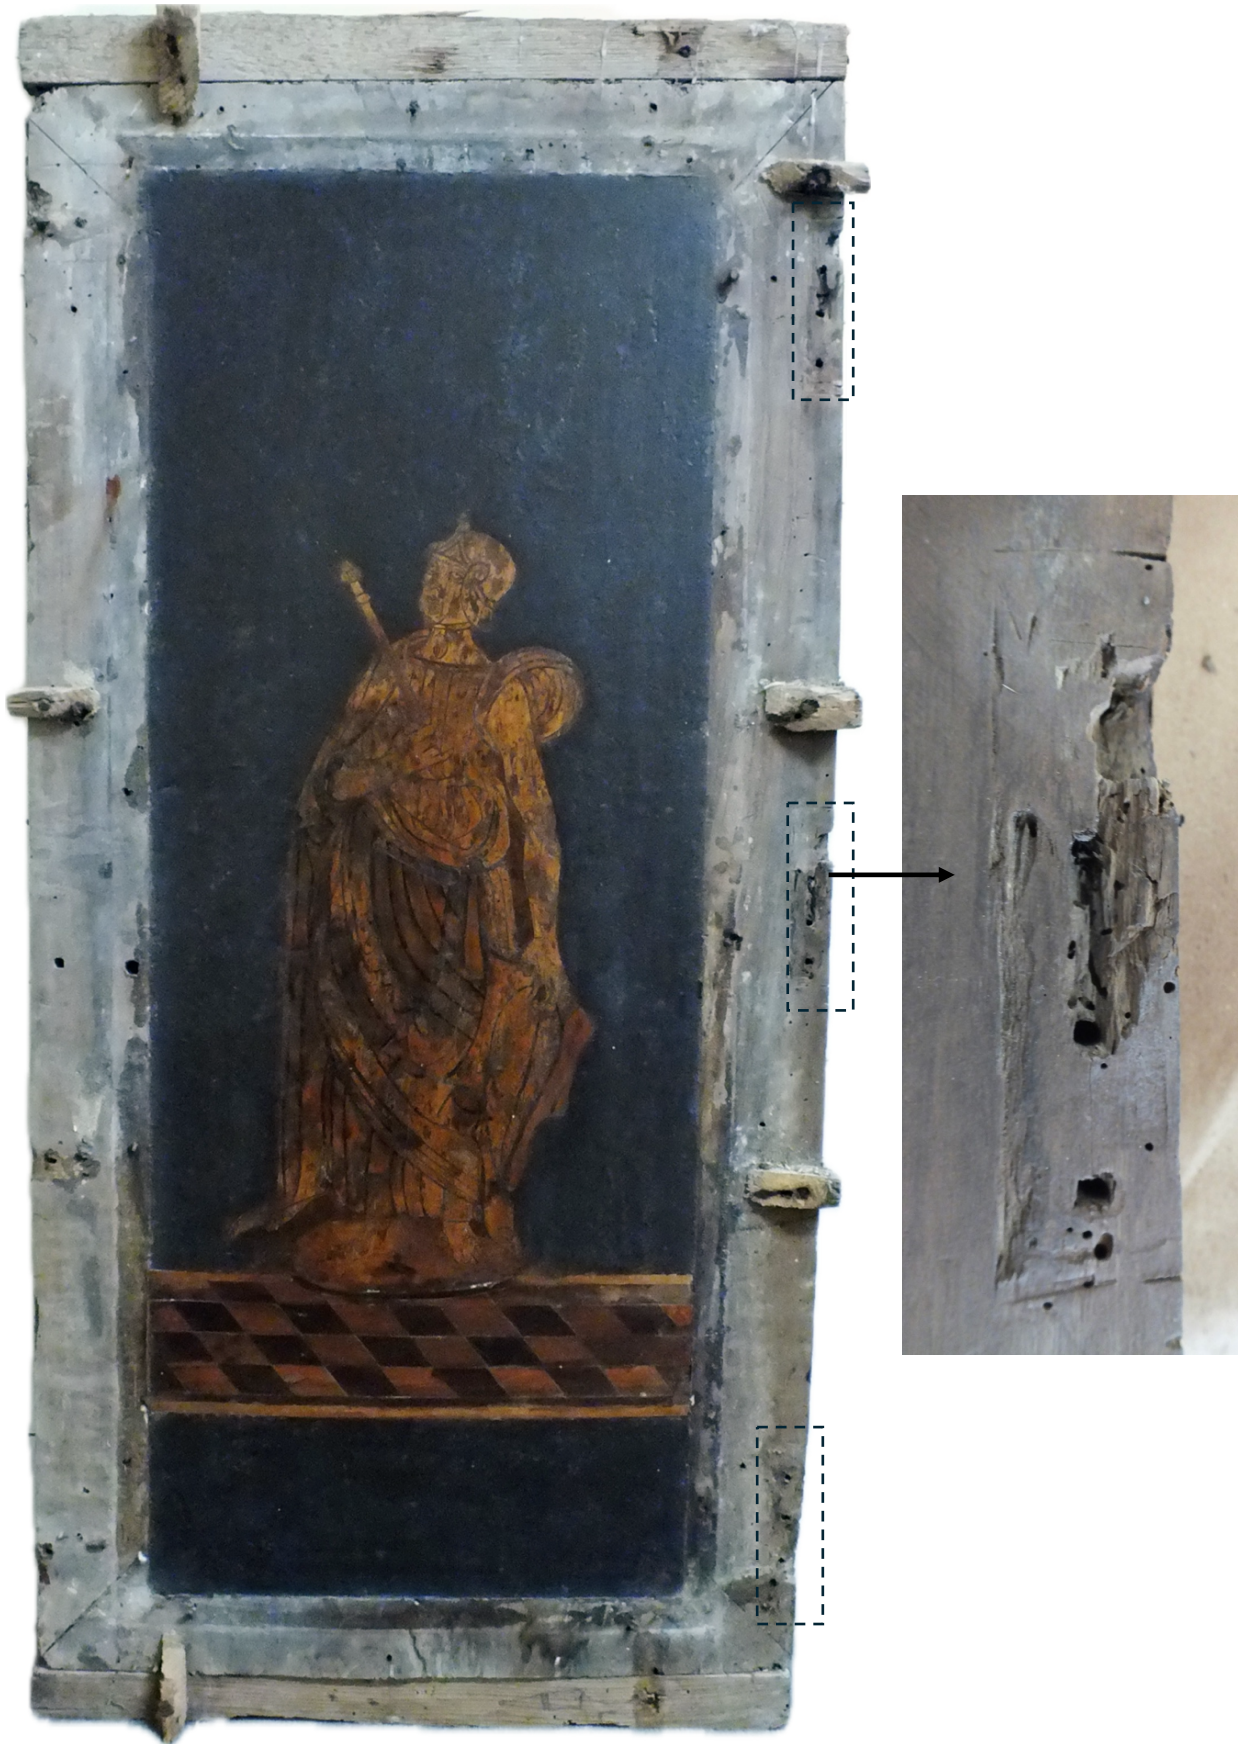
Fig. 78. Residual hinge attachment marks on the *Allegory of Malta* panel. The equidistant marks on the panel indicate the prior attachment of rectangular elements secured with three square shank nails. Intentionally carved out pockets in these areas suggest accommodations for a protruding pivoting system. These features strongly suggest the possibility that hinges were once attached and concealed beneath the original 15th-century panel frame. (James Saliba, 2015)

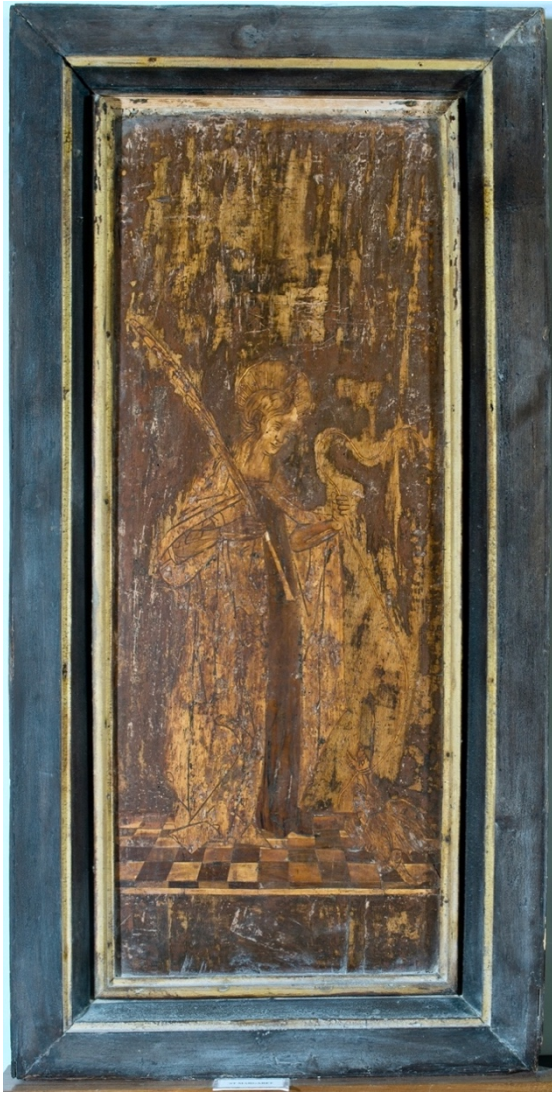
Fig. 80. **St Margareth** panel with its later-added frame replacement. (James Saliba, 2024)

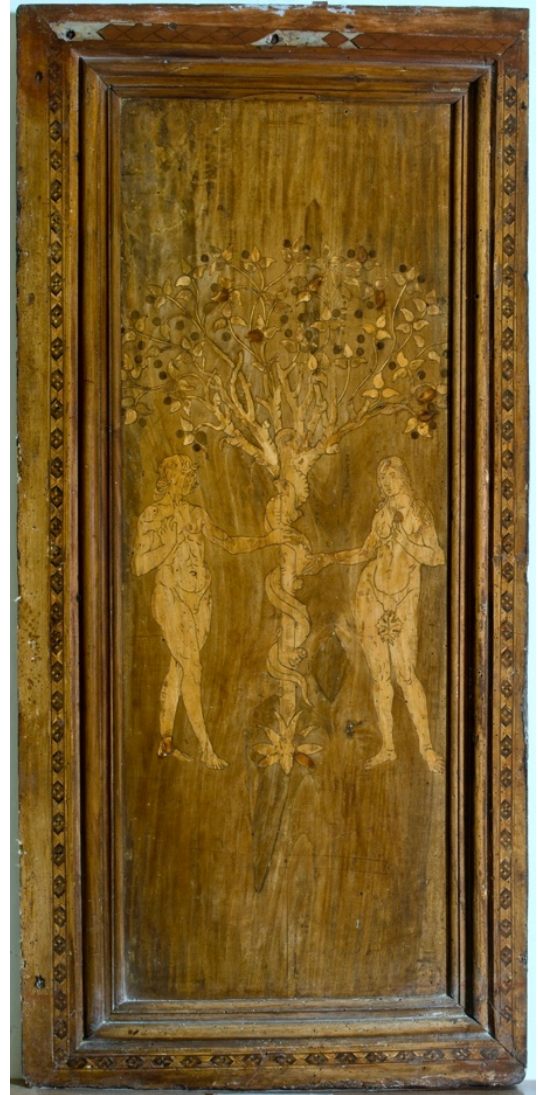
Fig. 79. **Adam and Eve** panel still retaining its original frame. (James Saliba, 2024)

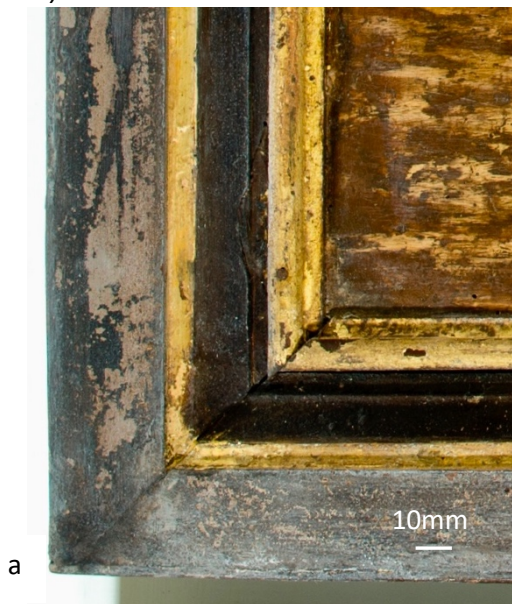
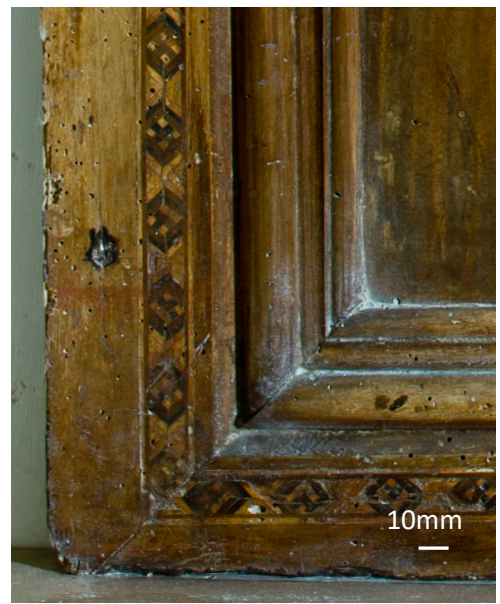
Fig. 81. Detail of added frame on **St Apollonia** panel (a) and inlay banded **Adam and Eve** panel frame (b). (James Saliba, 2024)

A major modification to the choir stalls was the replacement of the original inlaid frames with other less ornate frames. Their presence on all the panels, apart from the Adam and Eve panel, which was found on the back in 1876, suggests that these frames were added during, or after the enlargement of the choir stalls by the addition of three stalls per wing. These later-added frames on the panels (Fig. 79.) represent a significant aspect of their historical modifications, offering valuable insights into their evolving design. According to Galea-Naudi and Micallef (1996, p.38) (see 2.2.3. *Form – original design*), the panel depicting **Adam and Eve** retains its original frame (Fig. 80.), suggesting that the other frames are later additions (Fig. 81.). However, the authors do not delve further into this observation.

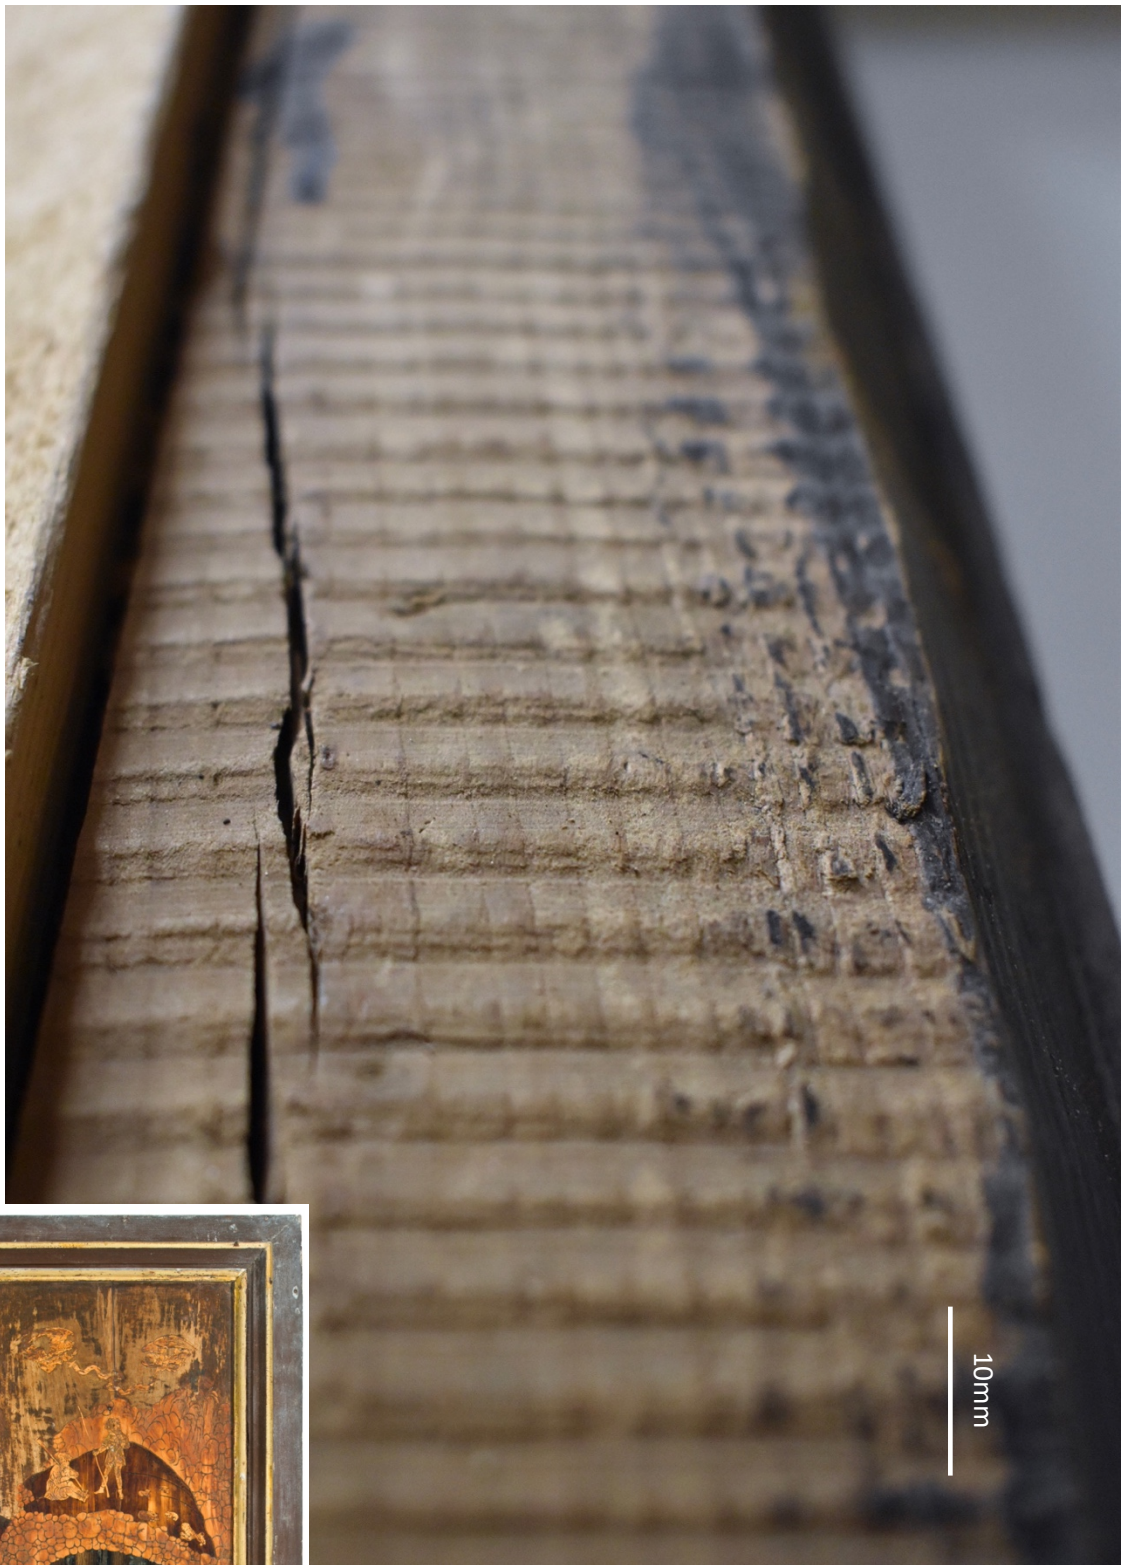
Fig. 83. Detail of the regular saw marks on back side of the Nativity panel's added frame, suggesting the use of reciprocating equipment. (James Saliba, 2024)
