Continuity and Change: The Curation, Modification and Reuse of the 15th-century Choir Stalls in St Paul's Cathedral, Mdina, Malta (1625 – 1725)

Dissertation submitted to the Faculty for the Built Environment, University of Malta in part fulfilment of the requirements for the attainment of the degree of Master of Arts in Cultural Heritage Management.

January, 2025

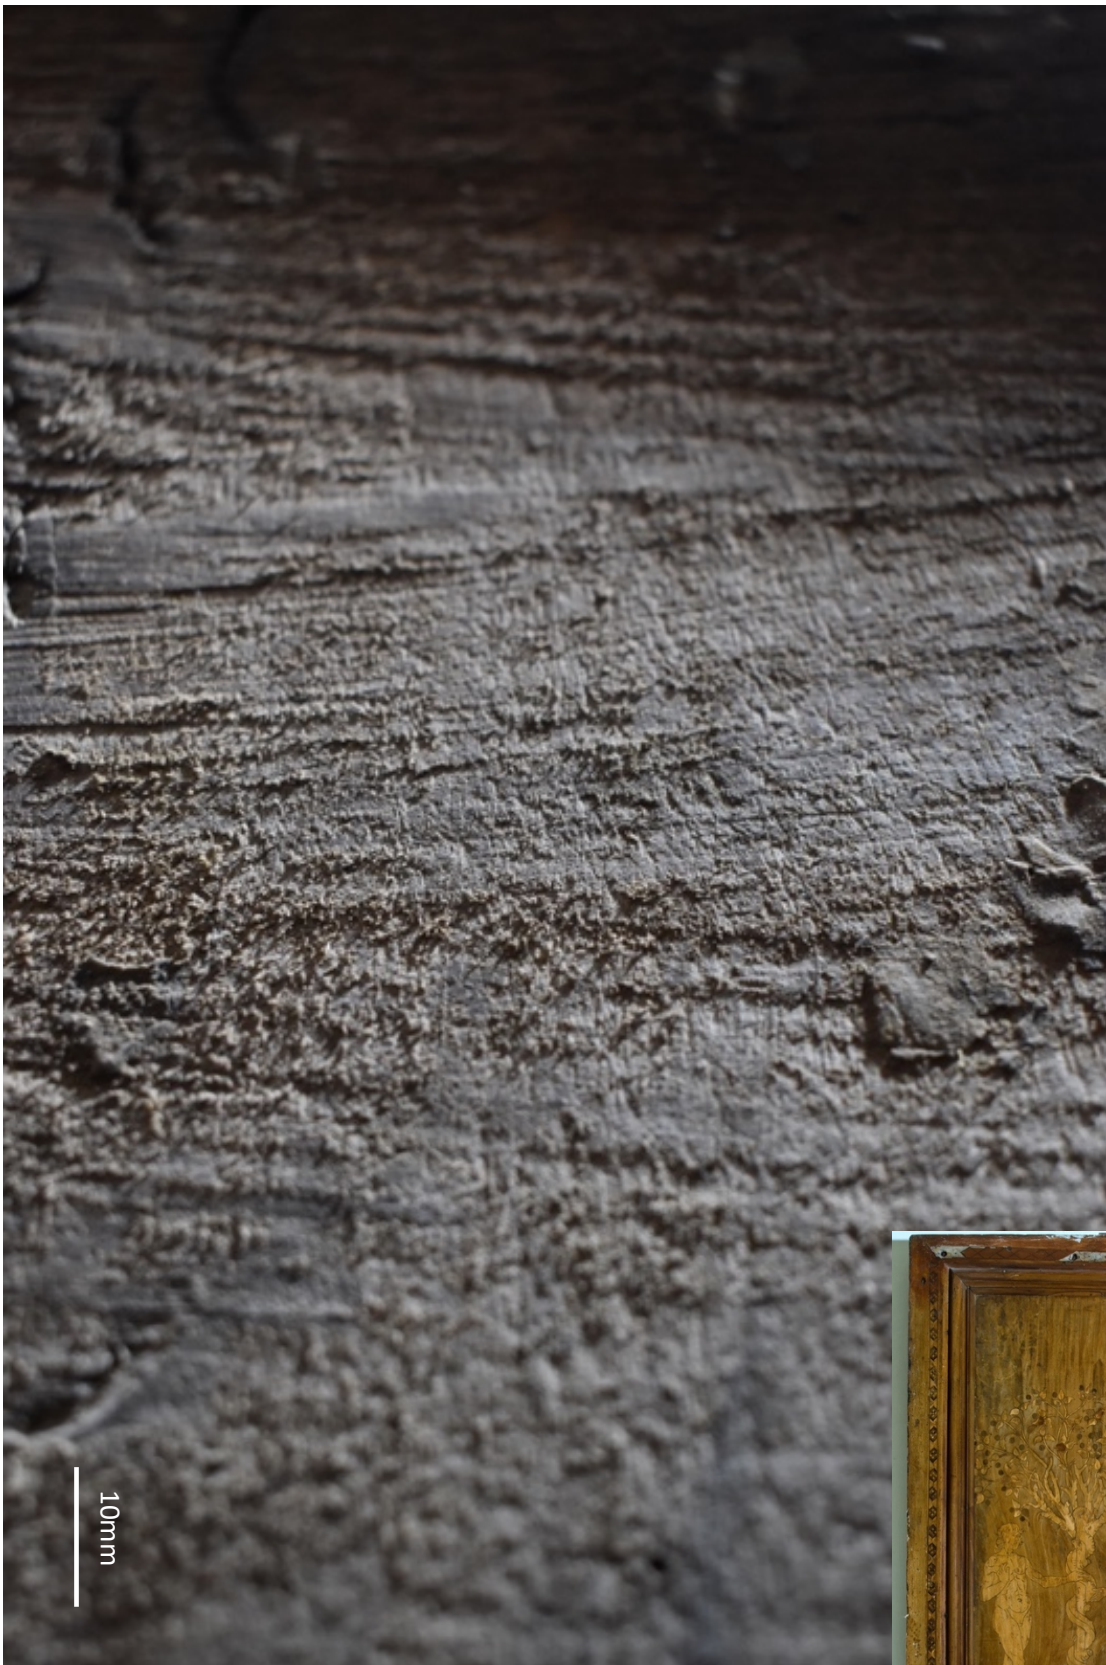
Fig. 84. Detail of the Irregular sawing marks left from original milling, on the back side of the Adam and Eve panel (inset). (James Saliba, 2024)

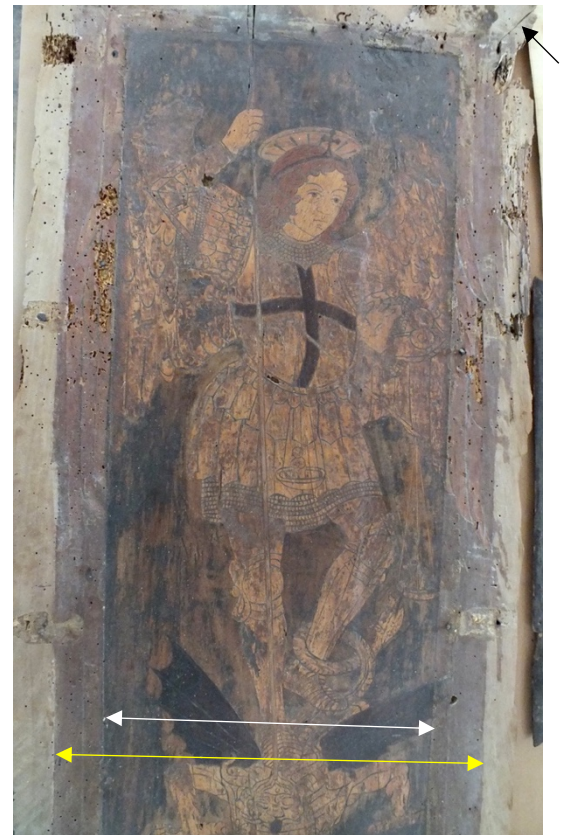
Fig. 85. St Michael dorsal panel after removal of the added frame. The white arrow indicates the panel lumen allowed by the added frames, whilst the yellow arrow indicates the original width of the panel lumen. The mitre cut mark, left during original installation is indicated by the black arrow. (James Saliba, 2016)

The replacement of frames significantly reduced the visible area, or *lumen*, of the panels, a detail that was confirmed during the 2018 conservation project when some of the frames were removed. The underlying panels provided valuable insights into the positioning of earlier frames (Figs. 85.–86.).

Notably, mitre cut marks on the panels indicated that the 45-degree angles of the original frames had been cut directly in place (Fig. 87.). Furthermore, the original distance between the internal edges of the frames was markedly greater than the width afforded by the later additions. This disparity was also evident in the finishing layers, as portions of the original panels, concealed by the added frames, seemed to lack the subsequent layers of finishes applied after their coverage.

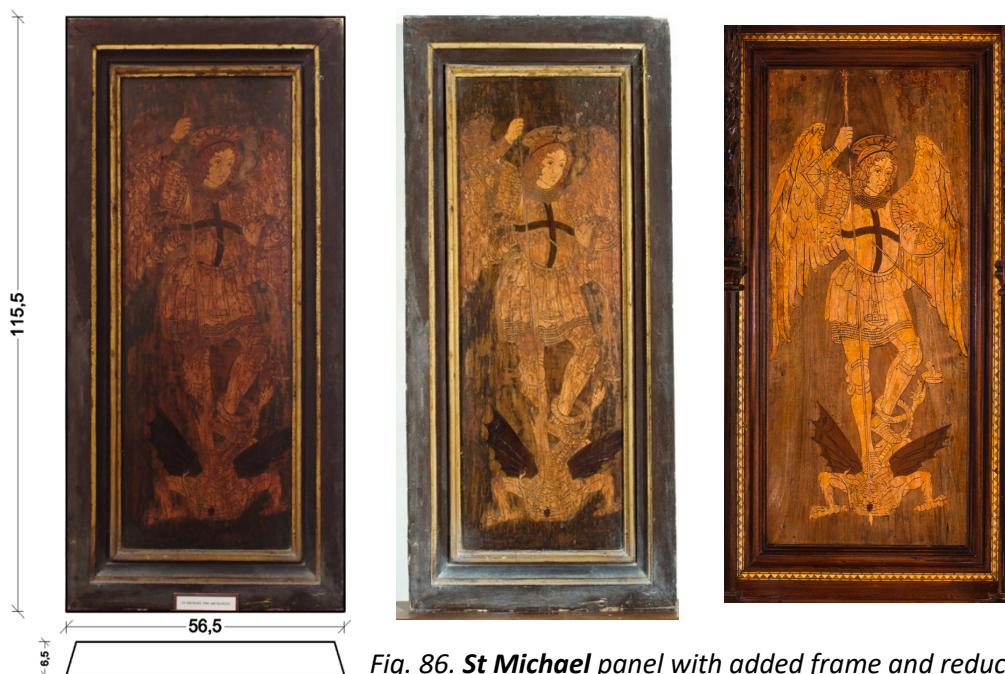
Fig. 86. St Michael panel with added frame and reduced panel lumen (a), and restored original panel lumen after the 2018 intervention (b). (James Saliba, 2014 & 2024 respectively)

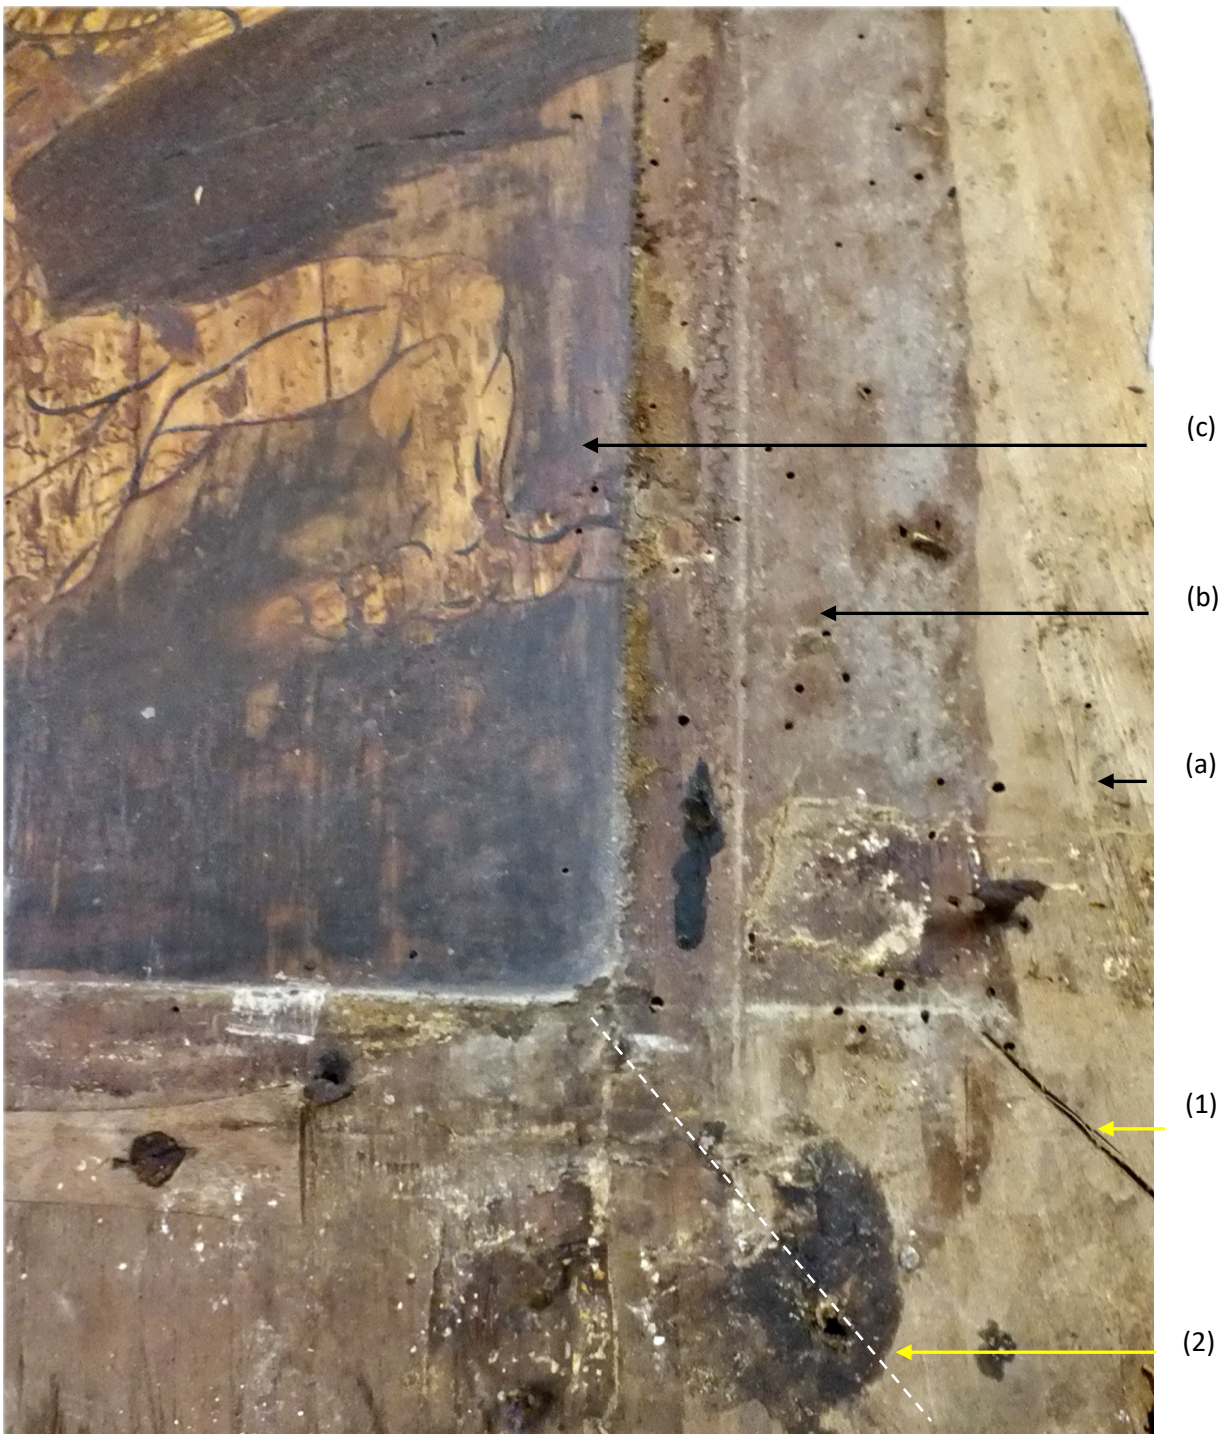
Fig. 87. Evidence of panel lumen reduction on **St Michael** panel. (James Saliba, 2016)

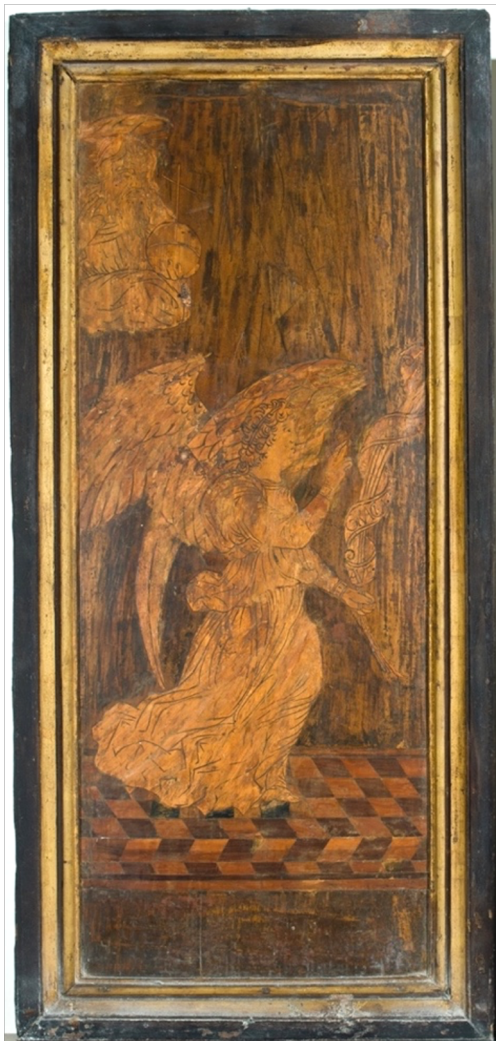
Fig. 88. **God the Father and Archangel Gabriel** panel, with restricted panel lumen as allowed by the later added frames. (James Saliba, 2014)

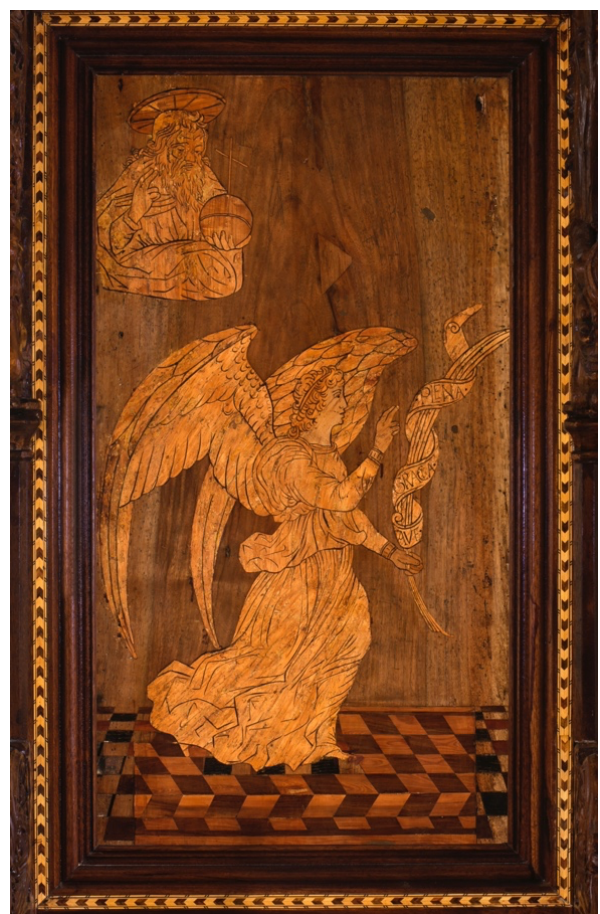
Fig. 89. **God the Father and Archangel Gabriel** panel restored to its original panel lumen width after the 2018 intervention. (James Saliba, 2024)

The reduction of the panel lumen also obscured parts of the inlaid decoration that were originally intended to remain visible. A striking example is the depiction of Archangel Gabriel's wings, which appeared truncated by the added frame, altering the visual integrity of the design.

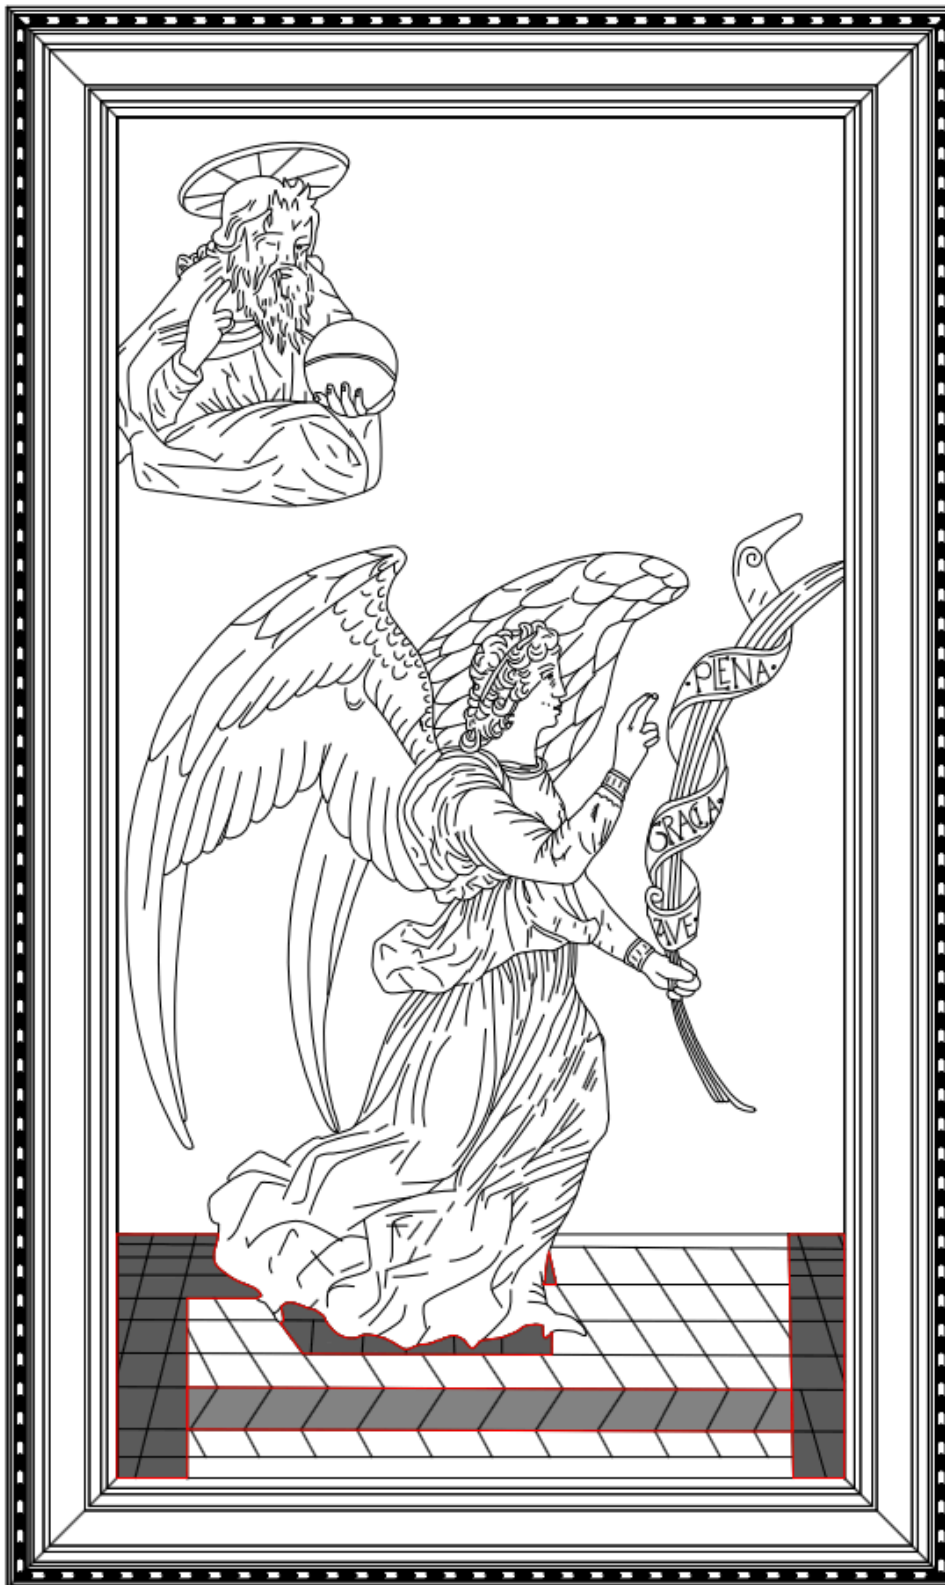
Fig. 90. Graphic representation of **God the Father and Archangel Gabriel** panel indicating interventions on the flooring inlay. (conservation records James Saliba, Bruno Ambrosio, 2016)
 Dark grey: surviving 15th-century inlaid floor – with darker wood tarsia encased in the walnut back panel – retained where protected by the later-added frame (i.e., beneath the reduced panel lumen).
 White: replacement of the floor pattern following the replacement of frames and the reduction of the panel lumen; the repair is executed in parquetry and differs from the original *tarsia* technique.
 Light grey: subsequent intervention to flooring area.

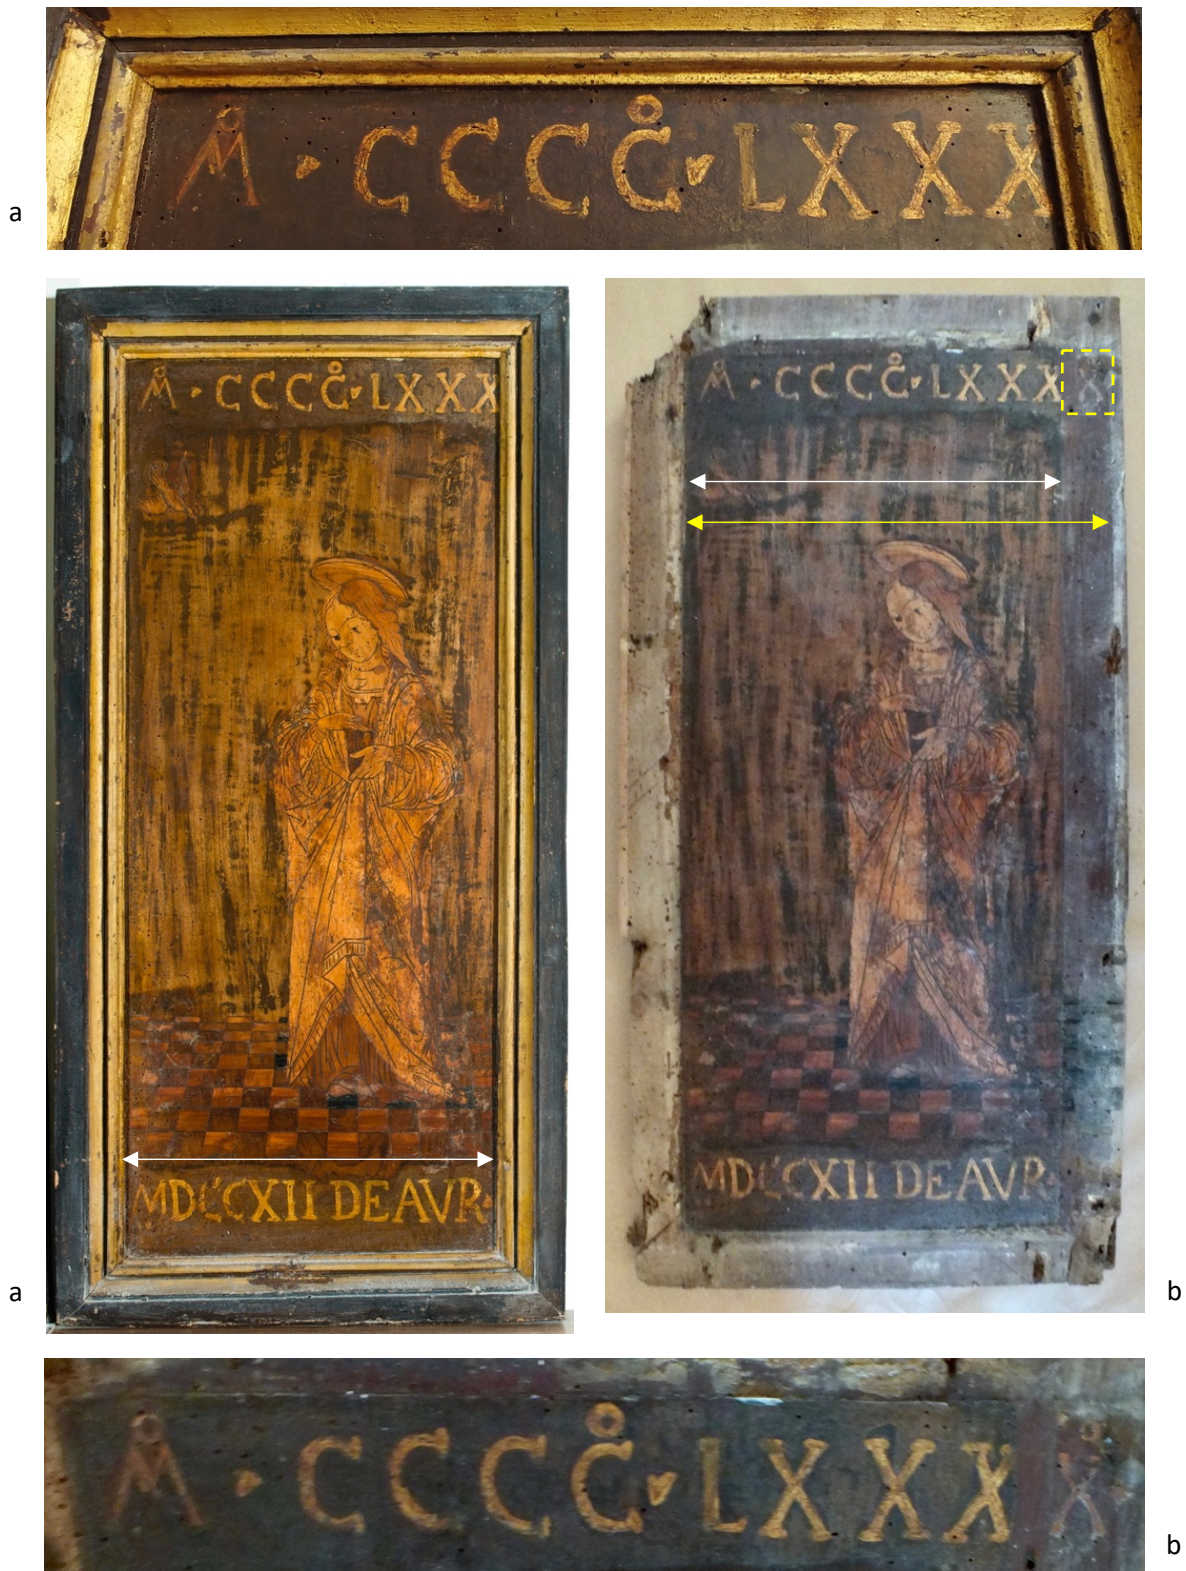
Fig. 91. Uncovering the original date.

- The original inlaid date was created, marking the panel's initial completion.
- Later frames were replaced, reducing the panel lumen and partially obscuring the original date.
- The gilding intervention of 1712 was executed, consistent with the reduced panel lumen.

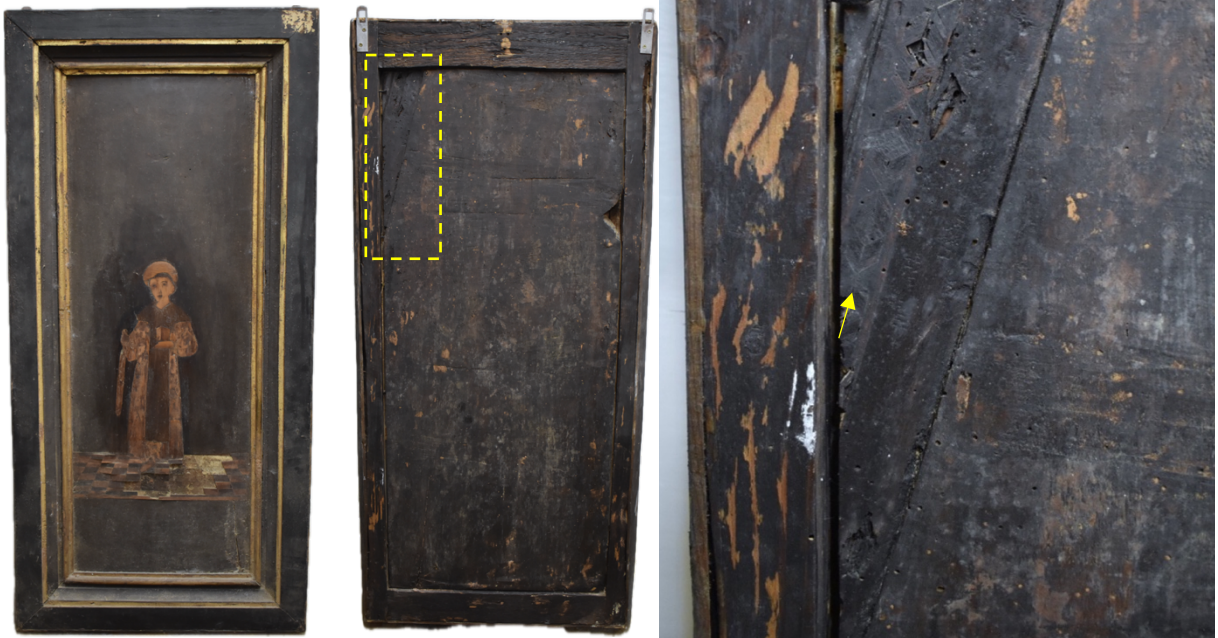
Fig. 92. St Leonard dorsal panel, possibly Pullicino's Anacoreta? Presenting evidence of inlaid frame repurposed as repair material. The inlay banding is indicated by the yellow arrow. (James Saliba, 2024)

Notable evidence of this practice has been observed on the reverse sides of the **St Leonard/Anacoreta** panel and the **Mary Magdalene/St Helen** panel.

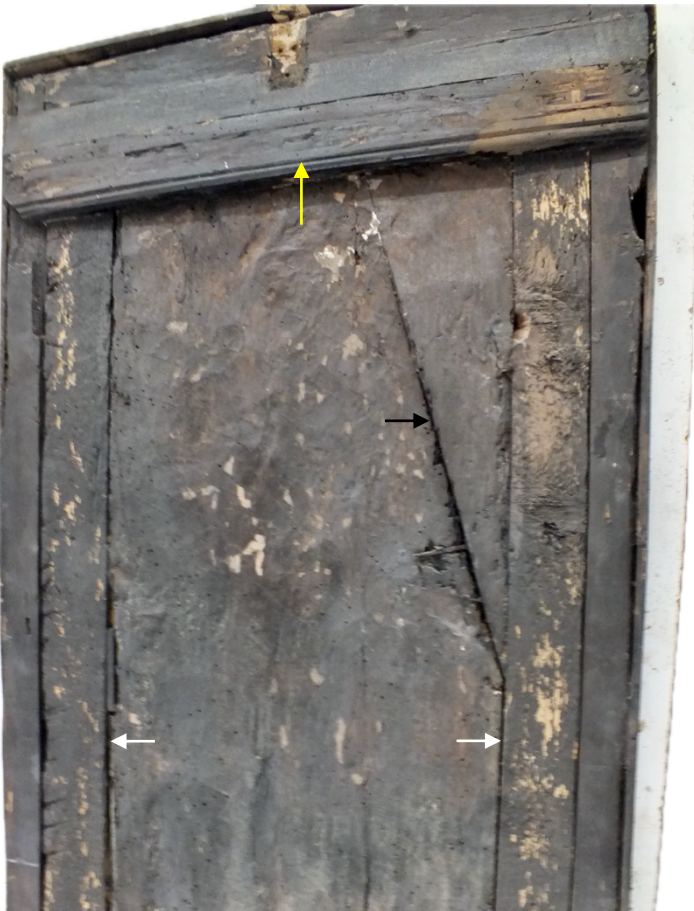
*Fig. 93. Inlaid frame used as repair material to support patchwork and additional strips on **St Mary Magdalen/StHelen** dorsal panel.*

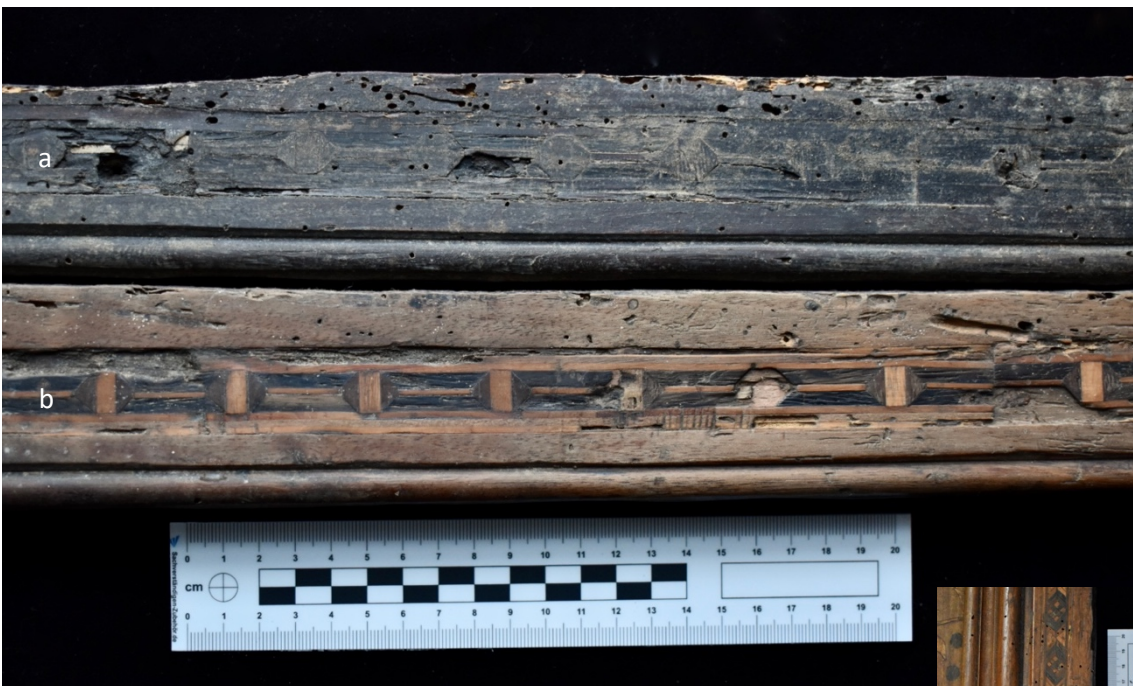
Fig. 94. Recovered 15th century frames that had been reused as repair material. The frames, manufactured out of solid walnut feature a central 'toppo' technique inlay banding.

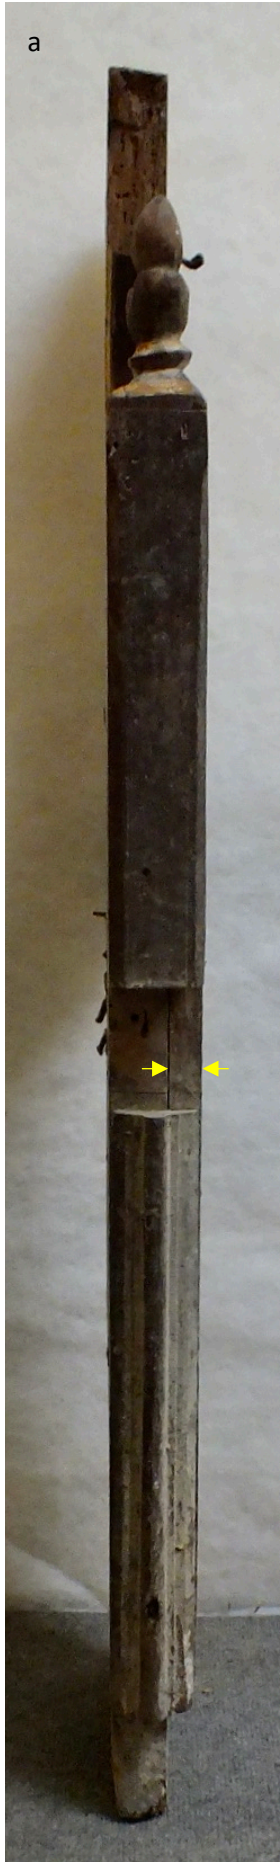
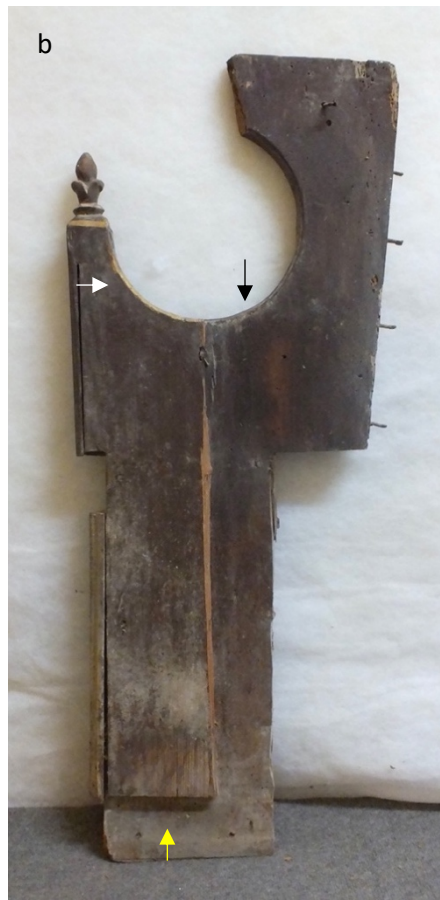
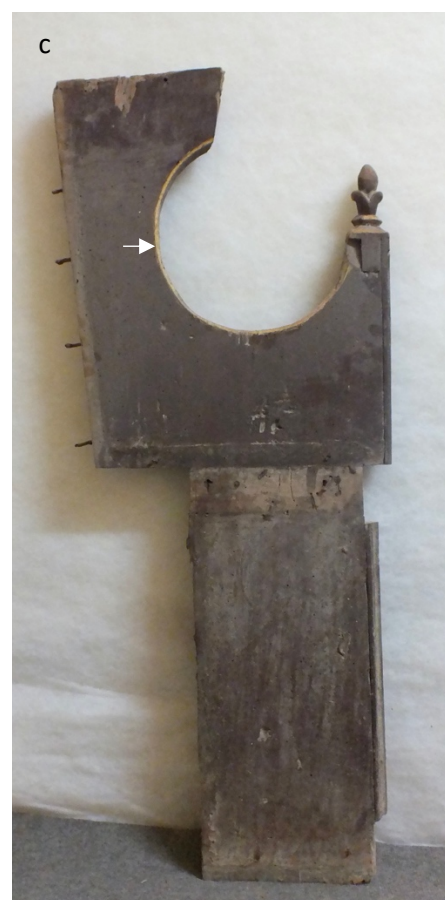
b- altered face of **E.2.**
 yellow arrow – indicates the additional wood plank (coniferous)
 white arrow - indicates gilding detailing on the added wood
 black arrow – indicates the non-gilded but refined concave carved profile of the cutout

c- opposite face of **E.2.** (walnut)
 white arrow - indicates gilding detailing the concave carved profile of the cutout

(a) Frontal view of **E.2.**
 yellow arrows indicate the thickness of the added wood plank

The date of the modification can be deduced from the gilding on the outer surface of the added plank. Both sides of the now-enlarged fragment were adorned with gilded decoration. However, while the gilding extends to the cutout edge of the added plank, the concealed edge of the original element remains ungilded.

These observations suggests that the additional plank was introduced before 1712.

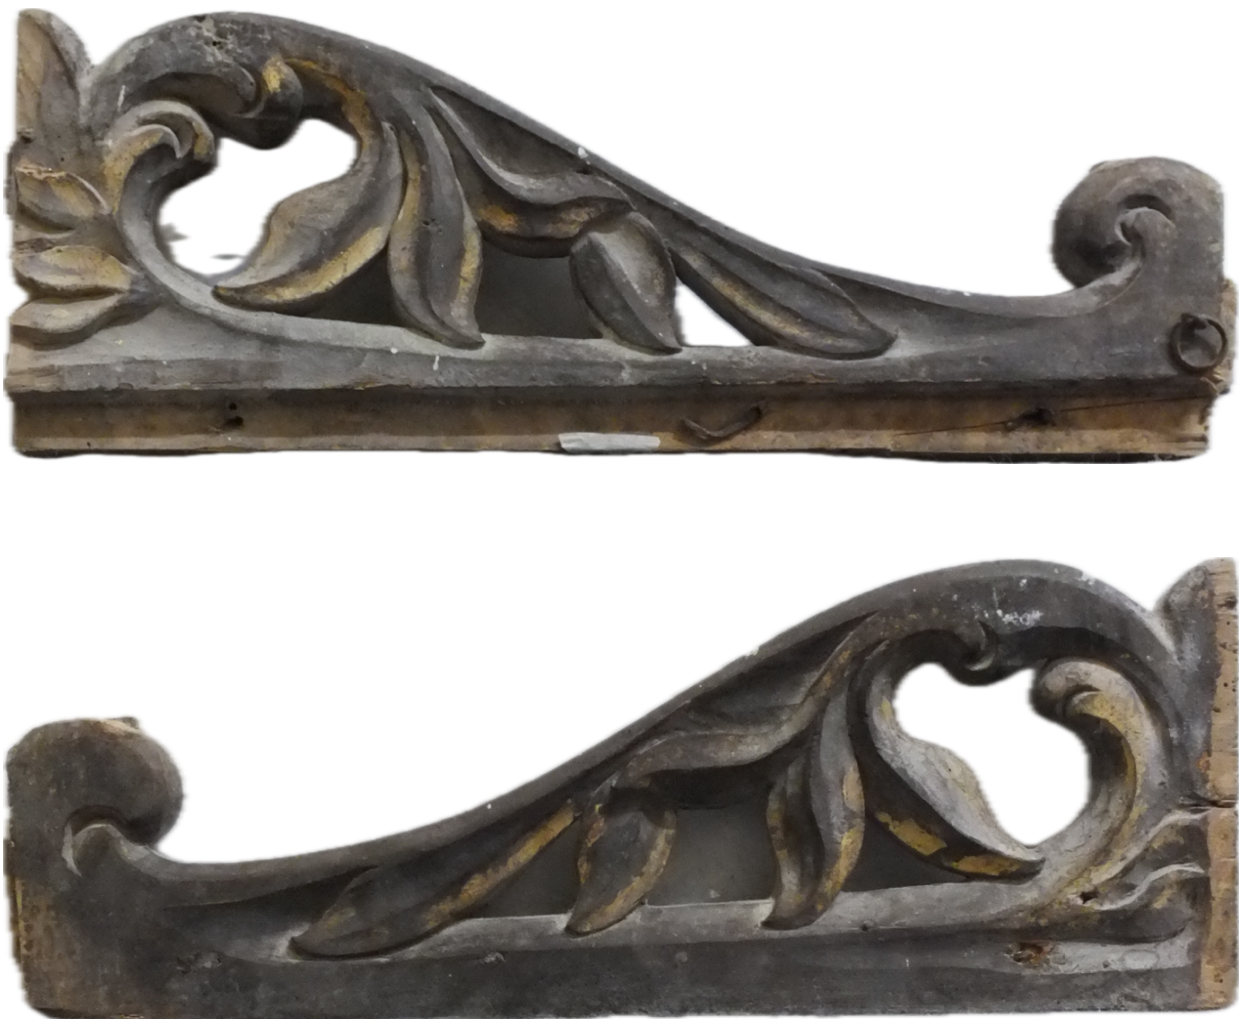
Fig. 97. . Acanthus leaf I.21. presenting a different carving approach . (James Saliba, 2015)

Some fragments present a different carving approach. Fragments **I.21.** (Fig. 97.) and **I.11.** (Fig.98.) from the Acanthus Leaf category (**Cat. I**) are suspected to have been additional elements rather than part of the original set. While they generally align with the overall design of other fragments (Fig. 99.) in this category, their carving style is noticeably different, exhibiting less intricacy and elaboration.

A distinctive feature of fragment **I.21.** is the extension on one side of its lower portion, which further sets it apart from others in the same group. Fragment **I.11.** appears to share the same carving style as **I.21.**, reinforcing the notion that these two elements may have originated from a similar context or purpose distinct from the main set.

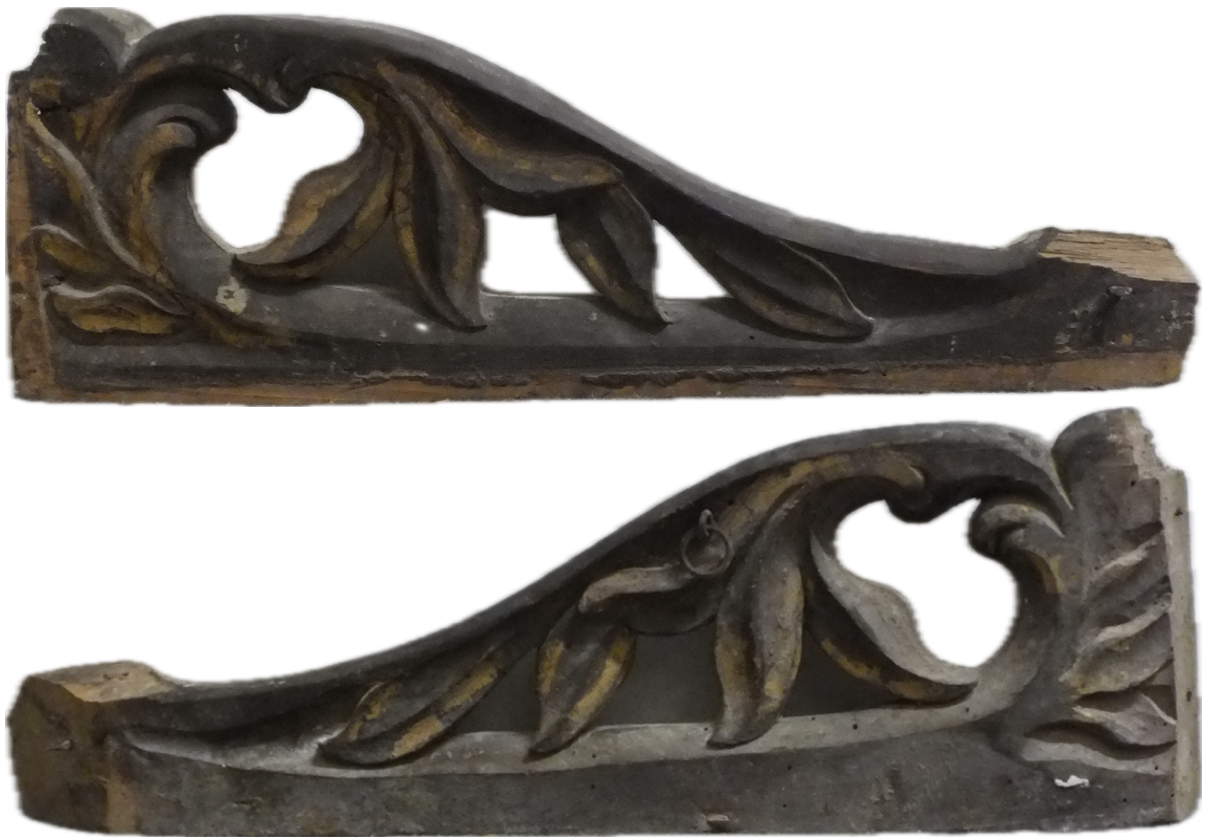
Fig. 99. Acanthus leaf **I.11.** similar carving style to **I.21.**, differing from the original. (James Saliba, 2015)

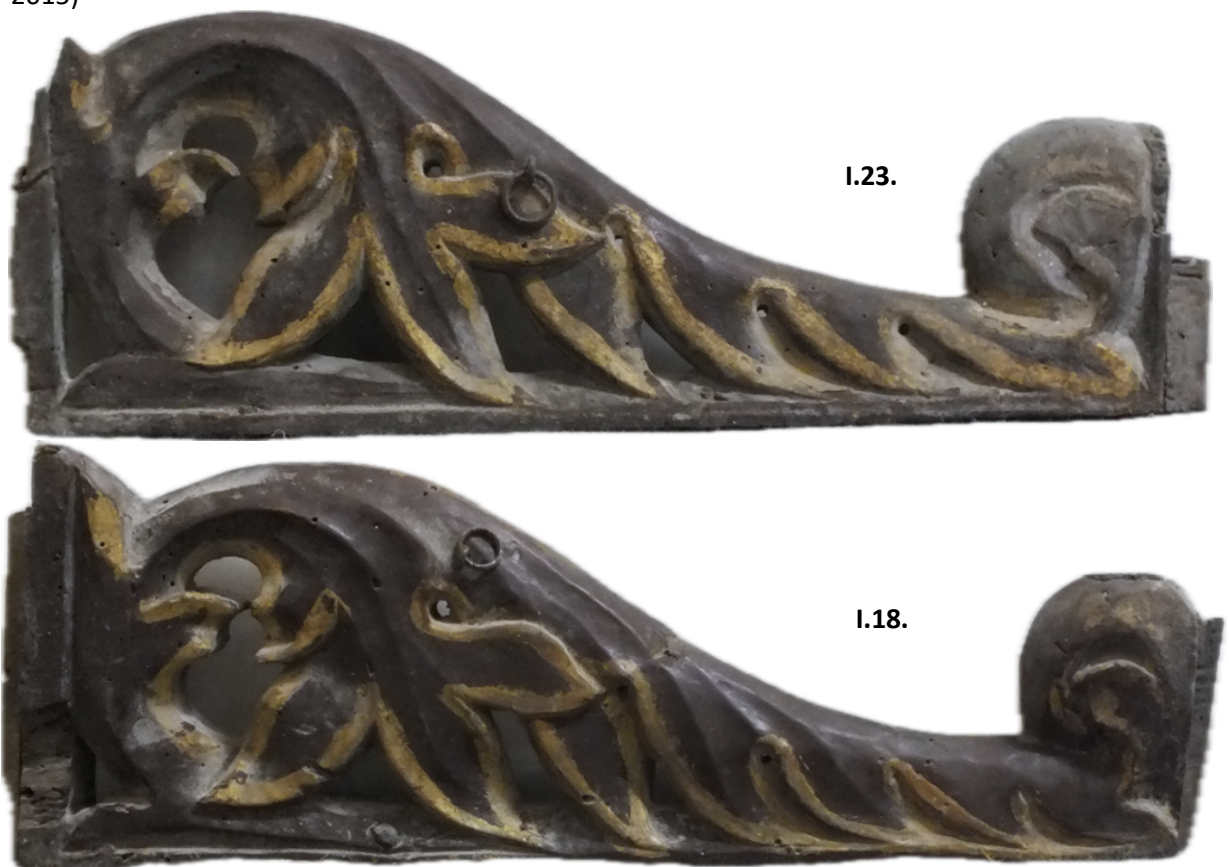
Fig. 98. Acanthus leaves **I.23.** and **I.18.** displaying the original carving style and approach. (James Saliba, 2015)

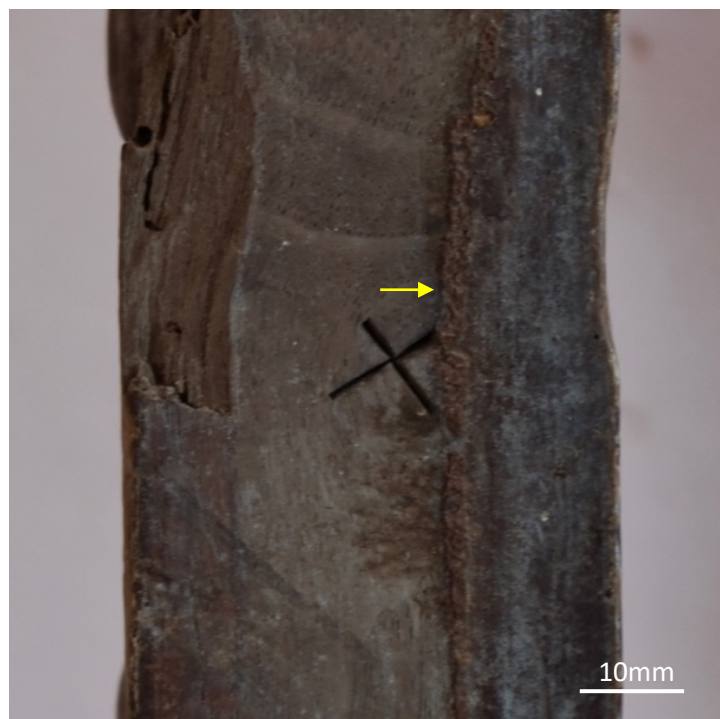
Fig. 100. Reverse side of Solomonic fragment H.1.7., showing a chiseled Roman numeral 'X'. On the right, the natural grain and color characteristic of European walnut are clearly visible. On the left (indicated by the yellow arrow), a thick accumulation of red paint is visible, applied to the exposed surface of the fragment prior to its dismantling. (James Saliba, 2016)

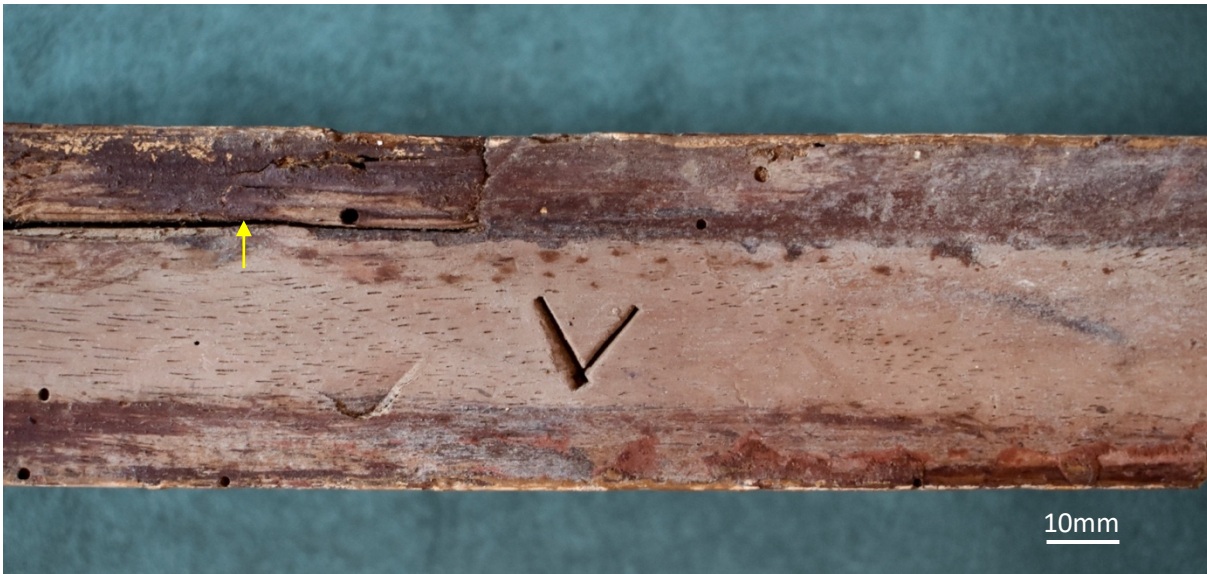
Fig. 101. Reverse side of Solomonian fragment H.1.5., revealing the treatment with red paint on the exposed sides of the back, including repair works carried out with timber of different species, indicated by the yellow arrow. (James Saliba, 2024)

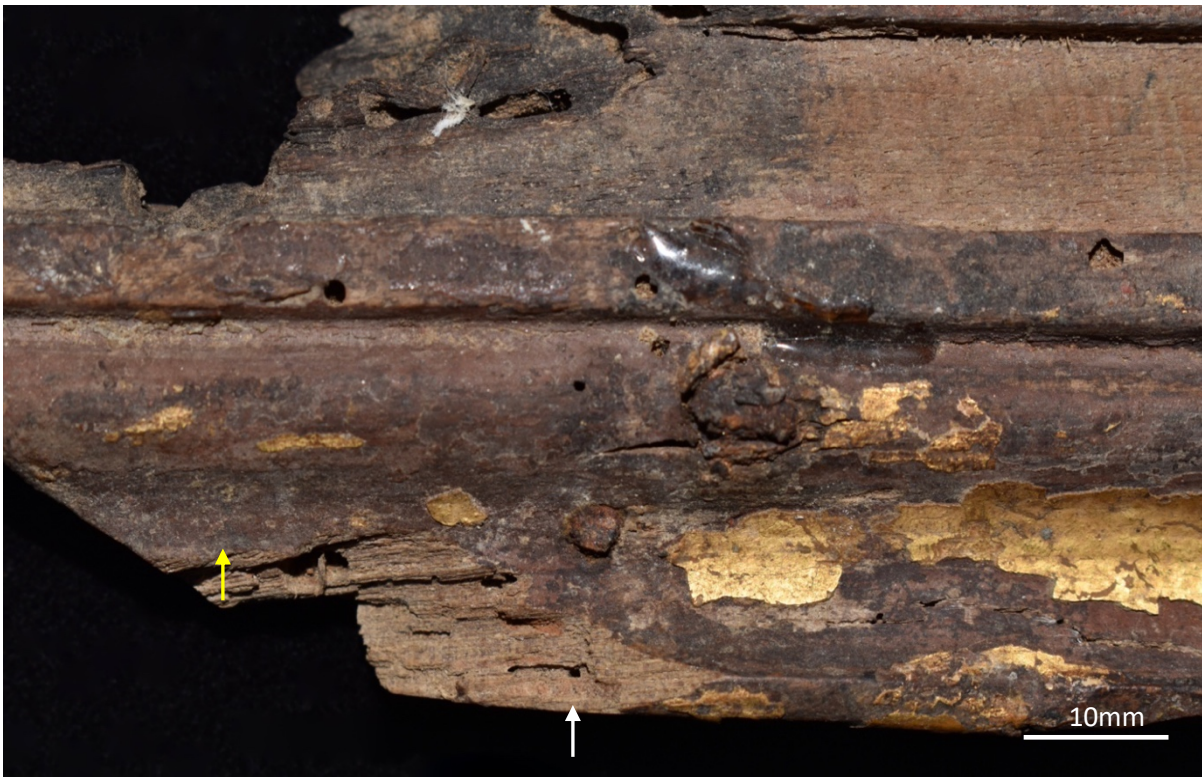
Fig. 102. Detail of an original 15th-century frame from the lower-tier frieze, revealing non-original application of grain obscuring finish. (James Saliba, 2024)

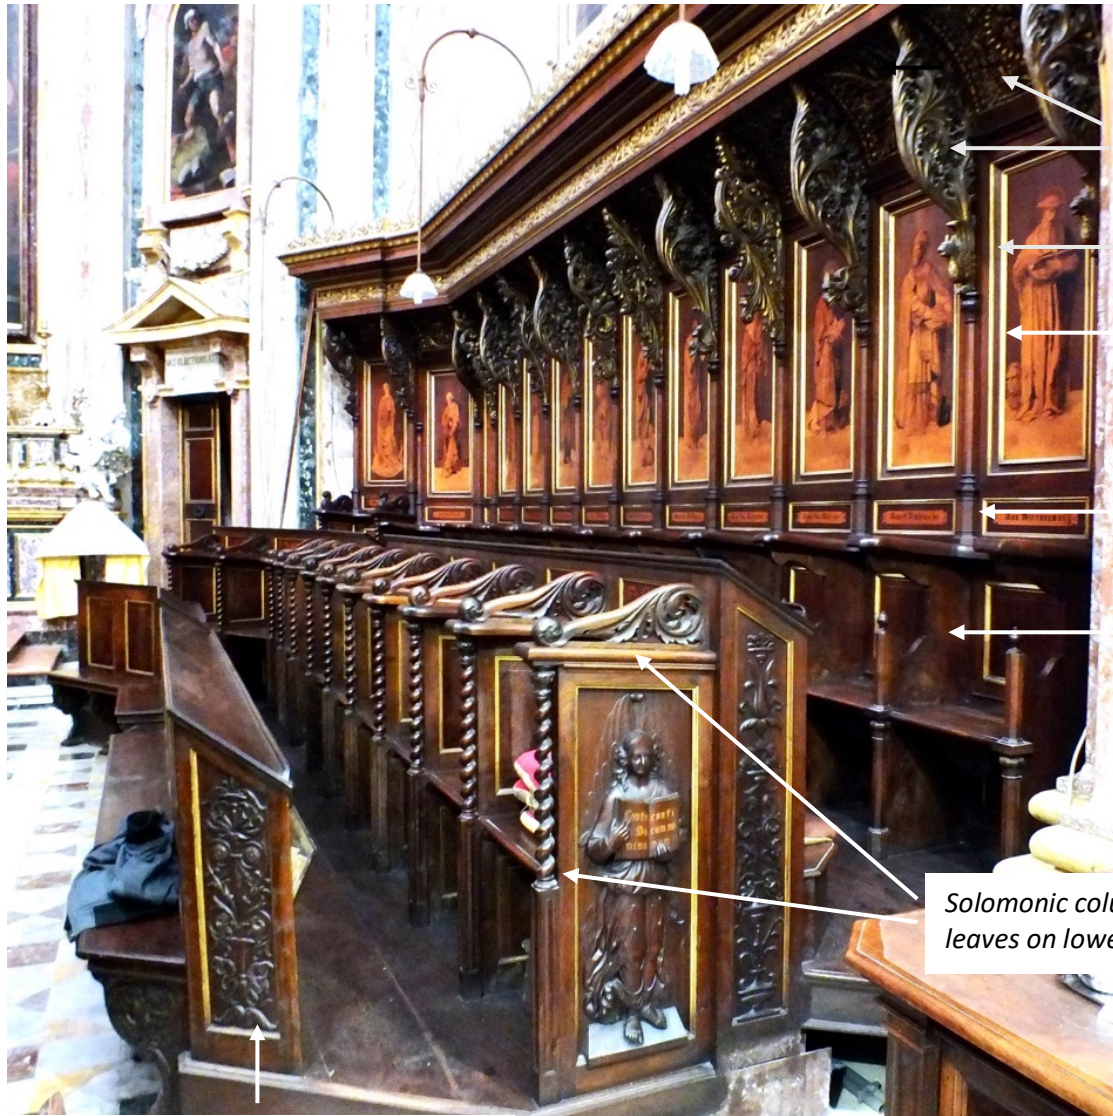
Canopy carvings – 15th-century with 17th-century additions

Frame profile – introduced 17th-century

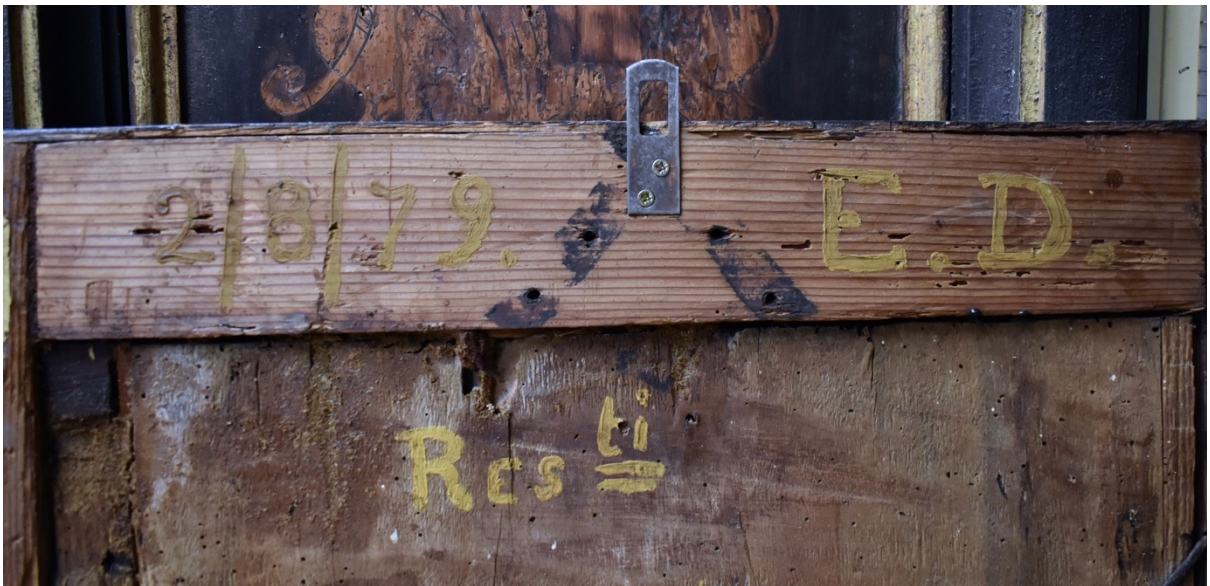
Even after their dismantling, fragments of the choir stalls retained cultural significance and were carefully preserved. One particularly revealing detail is an inscription painted in thick oil paint on the back of the St Apollonia panel, now held in the museum's reserve collection. This inscription reads "2/8/79. E.D. Res^{ti}." While its precise meaning remains uncertain, it may point to a restoration intervention carried out by Emmanuele Decelis in 1879 (Fig.122). Regardless of its exact interpretation, the inscription attests to the continued recognition of the stalls' significance beyond their functional lifespan. It marks the opening of a new chapter in their biography, as fragments that had lost their original function came to be valued, preserved, and recontextualized as historical artefacts – a process that remains ongoing and rich with potential for further study.

Fig. 122. Inscription on the back side of *St Apollonia* panel (James Saliba, 2024)

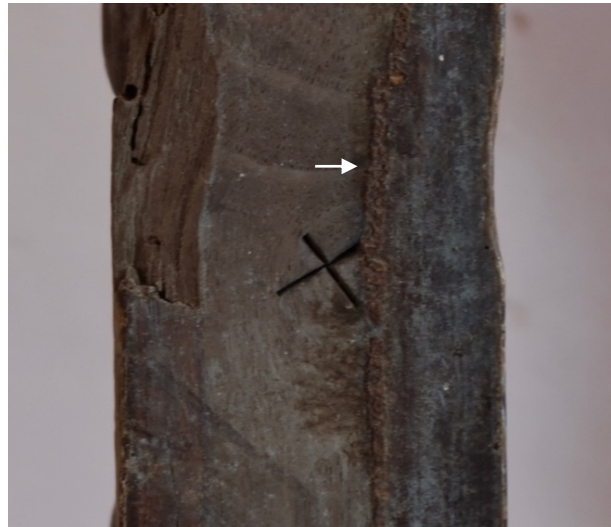
Fig 2. - Reverse side of Solomonomic fragment **H.1.7.**, showing a chiseled Roman numeral 'X'. On the right, the natural grain and color characteristic of walnut are clearly visible. On the left (indicated by the white arrow), a thick accumulation of red pigment is visible, applied to the exposed surface of the fragment prior to its dismantling.

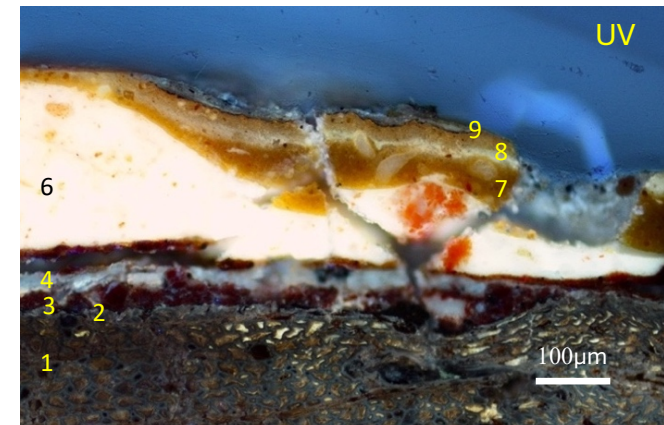
Fig.11. - Micrograph of CSM02_SC at 100x under UV light
Layer 2 was visible only under UV light
Layer 5 is not captured in this micrograph
