Continuity and Change: The Curation, Modification and Reuse of the 15th-century Choir Stalls in St Paul's Cathedral, Mdina, Malta (1625 – 1725)

Dissertation submitted to the Faculty for the Built Environment, University of Malta in part fulfilment of the requirements for the attainment of the degree of Master of Arts in Cultural Heritage Management.

January, 2025

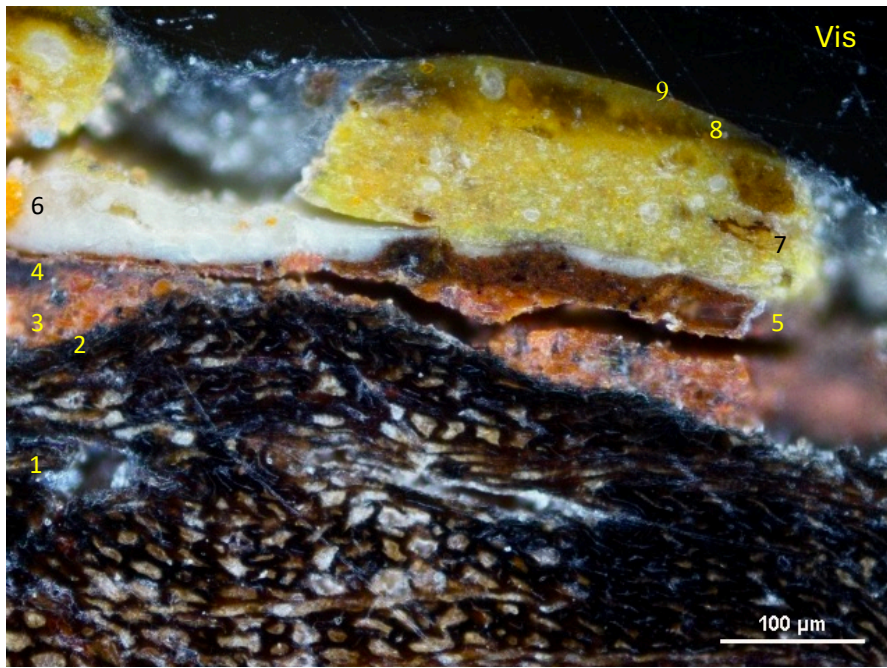
Fig.14. - Micrograph of **CSM02_SC** at 200x under Visible light
Highlighting the presence of Layer 5

Fig.13.-Micrograph of **CSM02_SC** at 50x Yellow square indicates area of focus for Figs. 14. & 15.

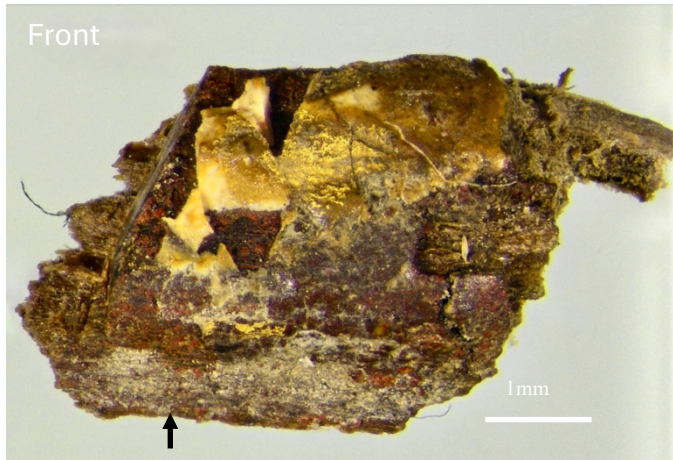
Fig.18. - CSM02_SC – Non-gilded side of collar

Sampling and analysis: Observation of sample under PLM		Microscopy: Cross section
Date: 20/10/24	Location: Solomonian fragment no.10 – column base colar	Sample: CSM02_SC

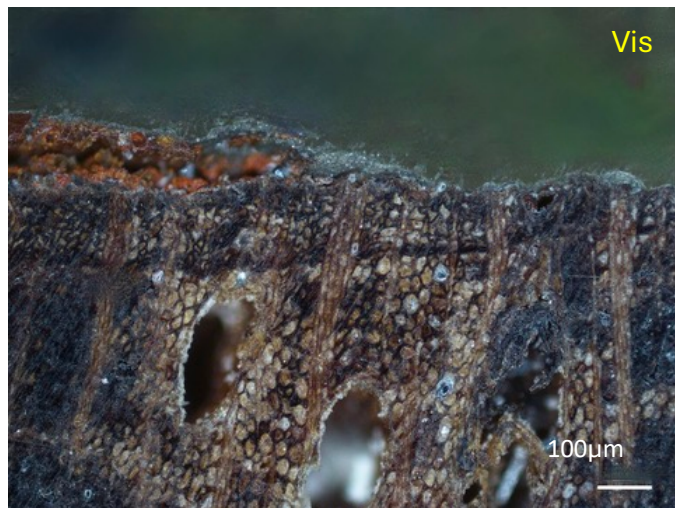
Fig.19. - CSM02_SC at 100x magnification under visible light

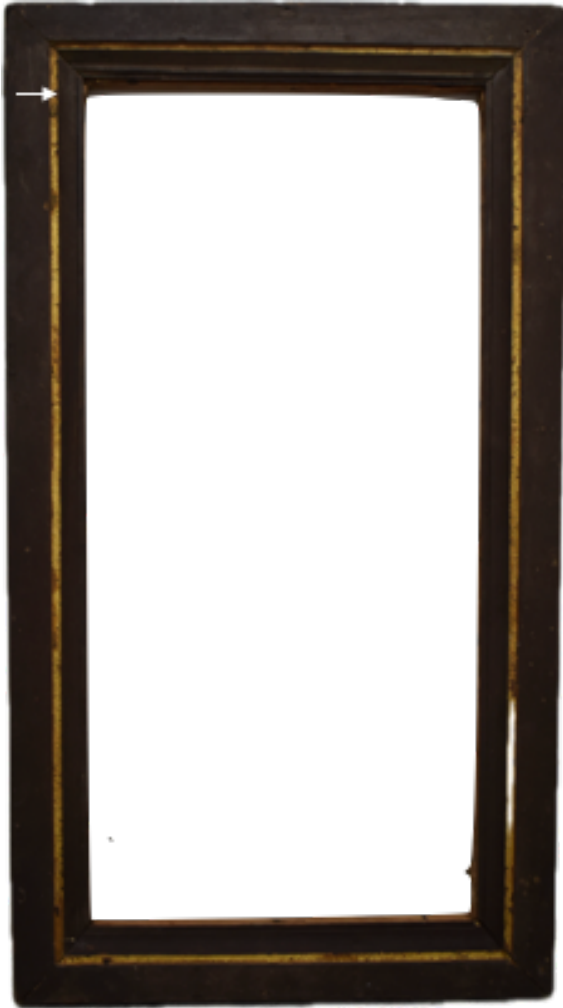
Fig. 21. – Added frame. The white arrow indicates the area of sample extraction

Sampling and analysis: 15th century choir stalls, Mdina Metropolitan Cathedral Museum, stored fragments – Nativity panel, added frame		Sample location
Date: 20/10/24	Location: Gilded section of moulding on later added frame recovered from the nativity panel	Sample: CSM03_AF (a&b)

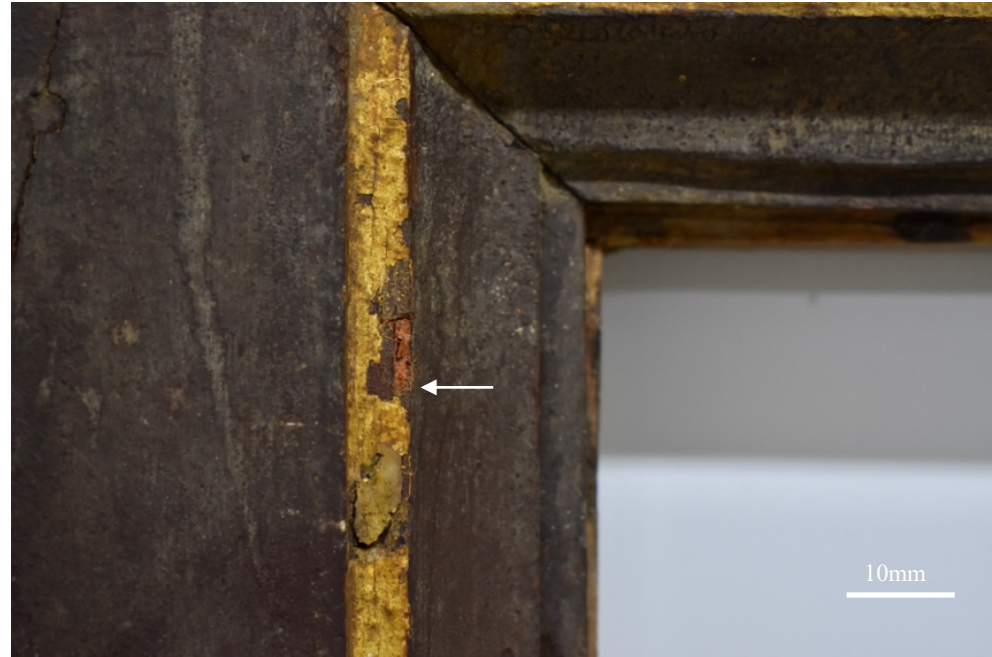
Fig. 22. - Area of sample extraction on the gilded part of the added frame

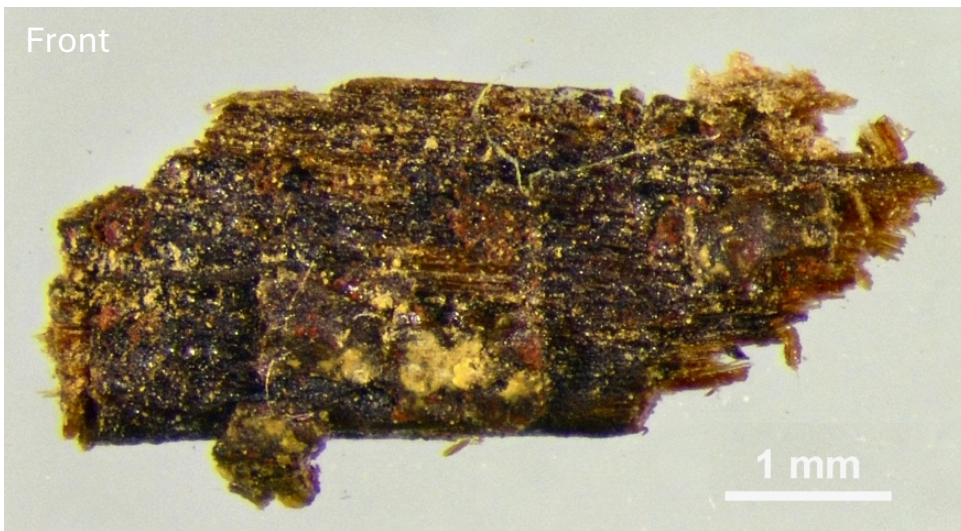
In the lacunose areas revealed after separation, the wood substrate was exposed. A dark brown coating was observed covering the surface and filling the wood pores. A super imposed brittle, varnish-like layer was also observed.

The back side of the sample presents anatomical features consistent with coniferous species.

Fig.24. - **CSM03_AF_a**: Front

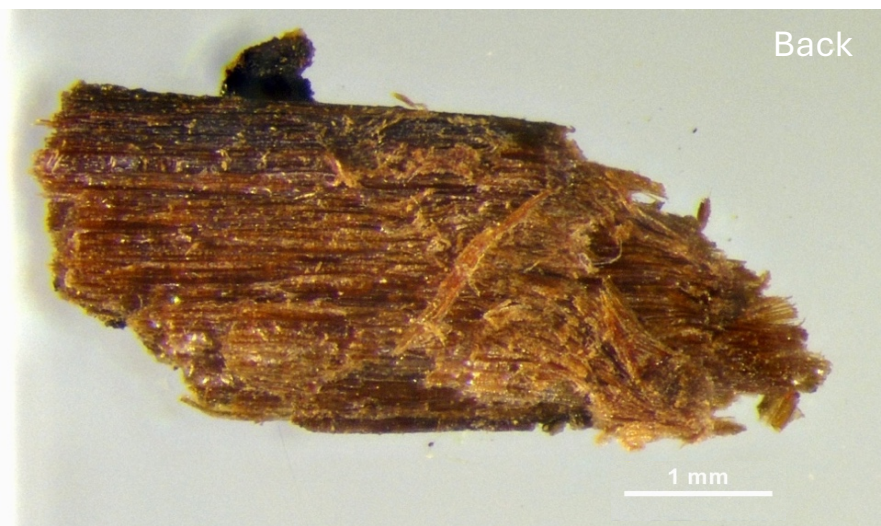
Fig.25. - **CSM03_AF_a**: Back

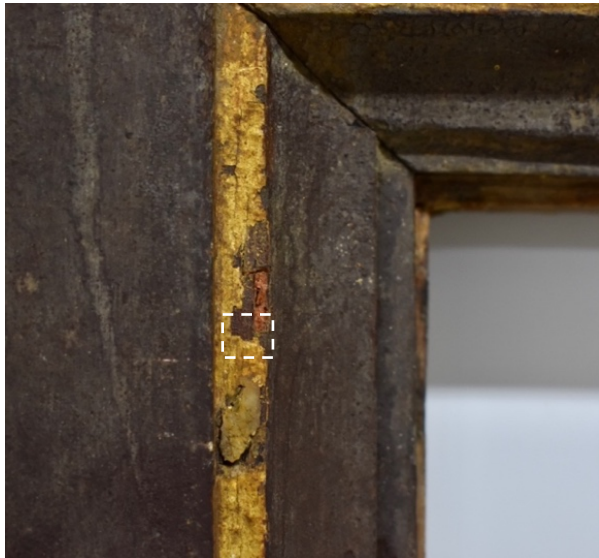
Fig. 32. - Area of sample lifting

Sampling and analysis: Observation of sample under stereo microscope		Microscopy: Unmounted Sample
Date: 20/10/24	Location: Gilded section of moulding on later added frame recovered from the Nativity panel	Sample: CSM03_AF_b

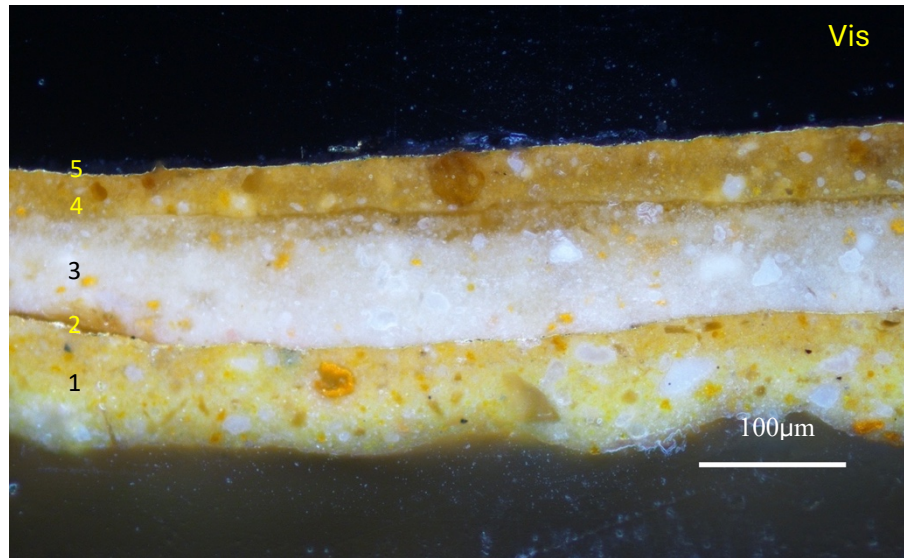
Fig.35. - CSM03_AF_b: 200x magnification under Visible light

Sampling and analysis: Observation of sample under PLM		Microscopy: Cross section
Date: 23/10/2024	Location: Gilded section of moulding on later added frame recovered from the nativity panel	Sample: CSM03_AF_b

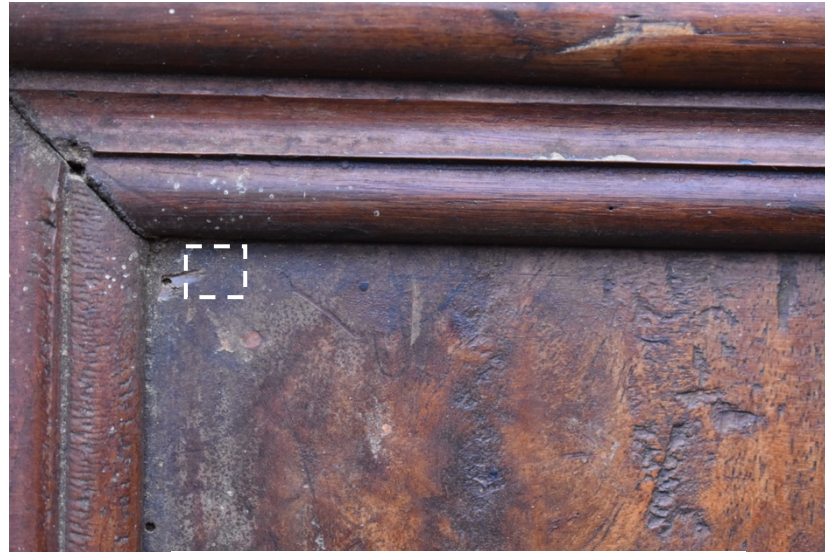
Fig. 40. - Area of sample lifting

Sampling and analysis: 15th century choir stalls, Mdina Metropolitan Cathedral Museum, stored fragments – Nativity panel, added frame		Sample location
Date: 20/10/24	Location: Adam and Eve panel	Sample: CSM04_AEP

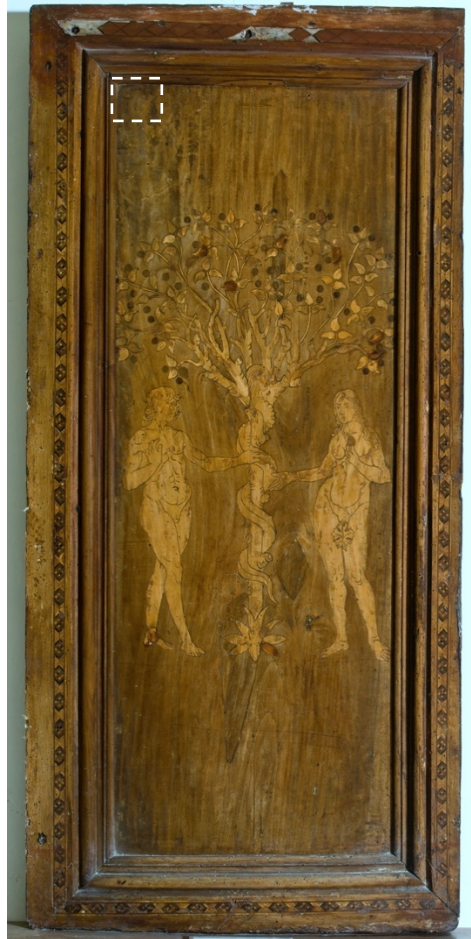
Fig.41. - Adam and Eve panel with original frame and area of sample lifting

Sampling and analysis: Observation of sample under stereo microscope		Microscopy: Unmounted Sample
Date: 20/10/24	Location: Adam and Eve panel	Sample: CSM04_AEP
