# Change and continuity: Significance and physical history in the conservation of the 16th-century *Great Siege* wall paintings in Valletta, Malta

**Figure 1.** *Great Siege* wall painting cycle, Grand Council Chamber, Grand Master's Palace, Valletta, Malta. © DCBH, 2022

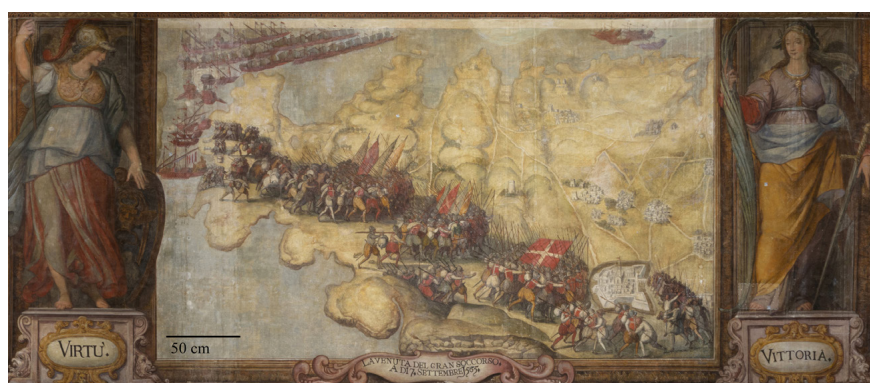
**Figure 2.** Detail of one narrative scene and two Allegories. © DCBH, 2019

The vast cycle (ca. 250 m<sup>2</sup>) depicts the four-month siege in a narrative sequence, from the arrival of the Ottoman fleet to its defeat and departure, and is composed of twelve episodes interspaced by allegorical figures (Figure 2). The story dominates the four walls of the Grand Council Chamber, which was used by the Knights for large state gatherings and ambassadorial deputations (Vella 2015, 167), and maintains its importance in the government and public life of Malta today.

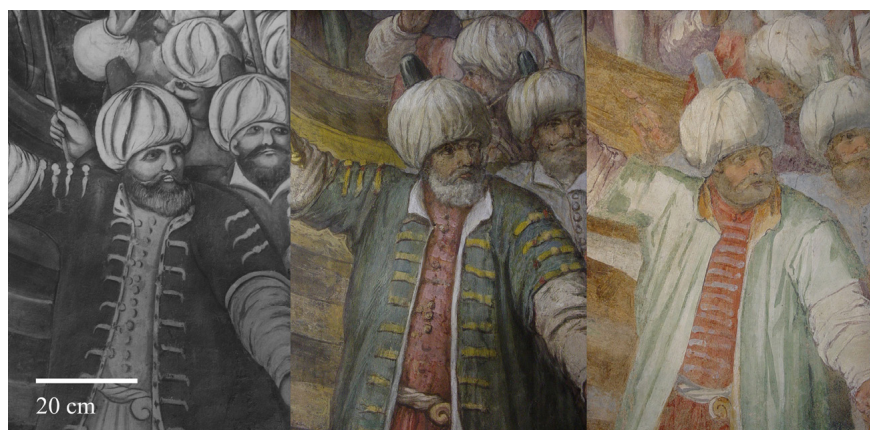
**Figure 7.** Single area of painting after the 1909 restoration (left) (© NMA, Heritage Malta, 1909), after post-war restorations (middle), and after the HfBK intervention (right) (© HfBK, 2003)

The third, most recent (and, one hopes, final) wave of conservation interventions began in 2000, initiated by the Valletta Rehabilitation Project (Leitner 2001), and later continued by UM, and is characterized by a modern scientific approach to treatment. These interventions aim at the removal of all past restoration overpaints and coatings, many of which show signs of deterioration (discoloration, flaking, weeping, acidification), and the recovery of the surviving d'Aleccio painting, as well as stabilization of materials at risk of loss. The first of these projects was carried out in 2000–2005 by the Dresden University of Fine Arts (HfBK) (Leitner 2001). The HfBK only completed the treatment of two-thirds of the cycle, but it clearly demonstrated how much of the original d'Aleccio painting had survived through years of damage and intervention. The project also left exciting visual records of their finds, from before, during, and after treatment, which provided critical insight into what the current project would face during treatment (Figure 7).

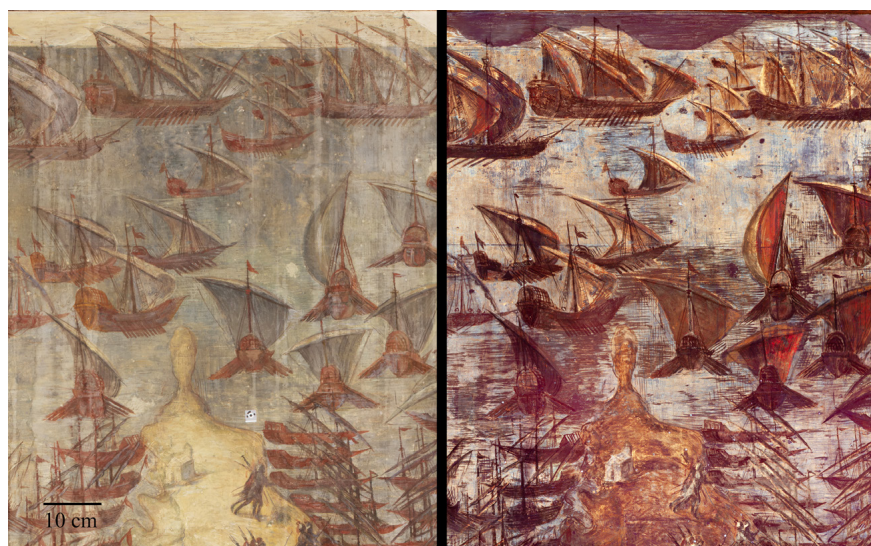
**Figure 8.** Visible light (left) and ultraviolet luminescence (right) images showing multiple layers of restoration overpaint and coatings © DCBH, 2020

Full-scale MSI of the paintings during the current project proved indispensable in distinguishing between the various layers of restoration paint and original materials; it thus also informed cleaning decisions and supported the evaluation of the cleaning results (Figure 8). On top of the remains of the 1909 overpainting, at least three further overpainting layers were identified, along with various coating layers. A tin of shoe polish was found during the cornice excavation, suggesting that this material may have been used to coat or varnish the paintings, though this has not yet been confirmed through analysis by portable Fourier transform infrared (pFTIR) spectroscopy (it may have simply been used as a storage tin). Interestingly, the excavation also provided some very tangible glimpses into the daily life and working habits of the post-war restorers. For example, an old packet of cigarettes, produced in Malta, and a religious medal were found amongst the accumulated debris of years of restoration materials.
