# THE ŻEJTUN ROMAN VILLA: CONSERVATION ISSUES

JoAnn Cassar<sup>1)</sup> and Roberta De Angelis<sup>2)</sup>

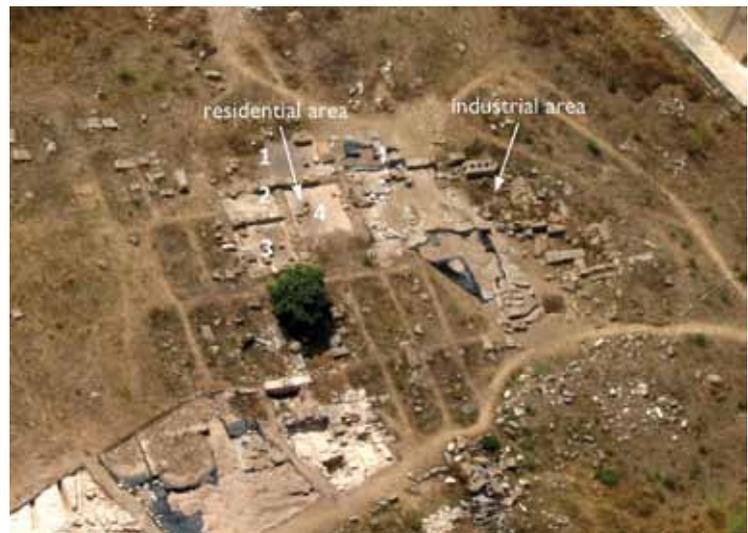
Figure 1. Aerial photograph of the villa remains in the grounds of the Girls' Secondary school, Zejtun. The individual rooms are numbered. Photograph by courtesy of the Armed Forces of Malta.

The Żejtun Roman Villa complex was discovered in 1961 and excavated during a series of archaeological campaigns in the 1970s (see Bonanno and Vella, this volume) and continued in recent years. The western part of the complex, defined by the archaeologists as the residential zone of the Villa (Fig. 1) includes four rooms paved with terracotta tiles, and enclosed by walls still bearing remains of plaster with traces of paint. This paper concerns a multidisciplinary research project, still at an initial stage, being carried out by the University of Malta to study and preserve these parts of the complex. The Department of the Built Heritage is leading the conservation project and the Department of Classics and Archaeology is leading the archaeological studies. The whole programme is being supported by Din l-Art Helwa and the HSBC Malta Foundation.<sup>1</sup>

Restoration works, which presumably took place in the 1970s, concerned primarily the tiled floor of the long room (room 1 in Fig. 1). Here a large (probable) cement repair was applied where the preparatory layers for the tiles had been lost. Where these layers were still extant, edging repairs in (probable) cement were instead applied along the tiles, presumably to prevent them from being dislodged. A number of tiles were also relaid in some small areas, probably again using cement, especially but not only along the perimeter of the floor of the long room.

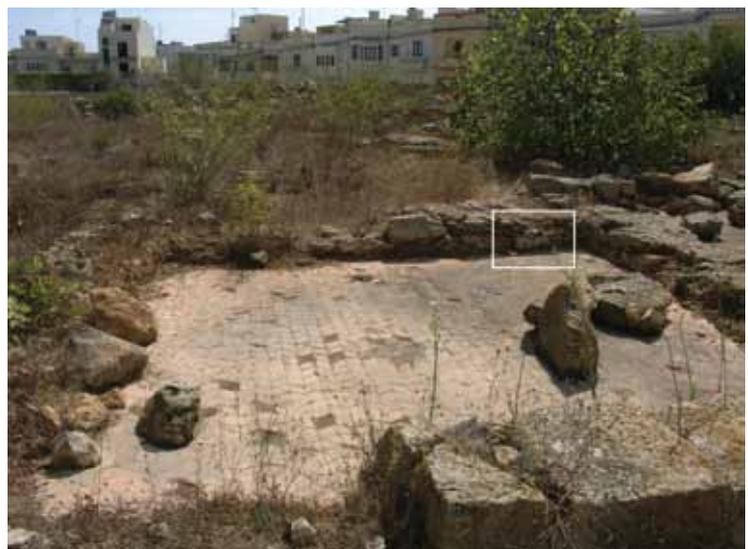
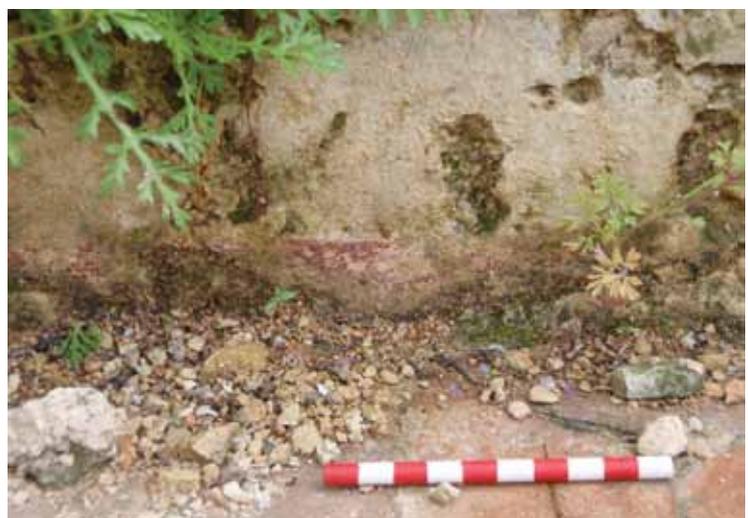
Figure 2. Detail of a plaster bearing traces of red paint (bottom image) in room 4 (top image). Photograph by the students in Conservation and Restoration Studies, University of Malta.

are a few traces of red or yellow paint, showing no distinct decorative pattern. An exception is the eastern room, where a sort of dado, painted in red over a white background, can still be distinguished, although with difficulty (Fig. 2). During the condition assessment (see below), also scant microscopic traces of green-blue paint were noticed in a few locations.

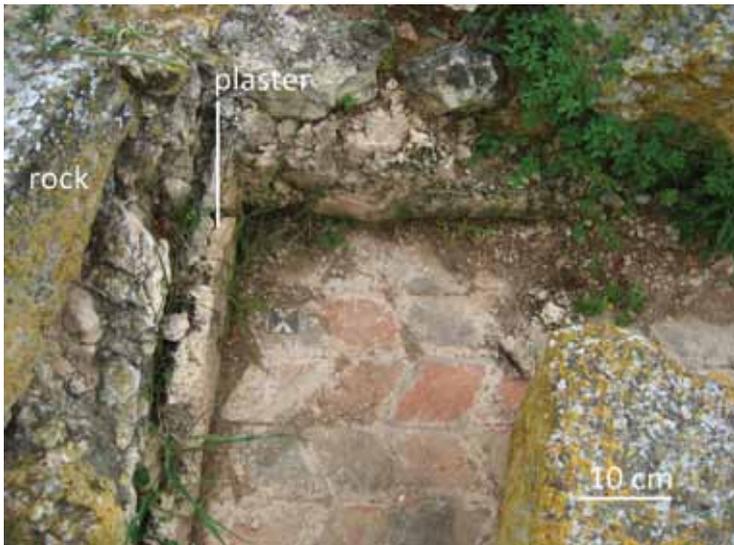
Figure 3. Detail of room 4 showing plaster applied to bedrock. Photograph by the students in Conservation and Restoration Studies, University of Malta.

The walls of the Villa have a heterogeneous structure and are partly hewn from the bedrock, and partly built using rubble and ashlar (Fig. 3). Even the plaster remains show a diverse typology with a texture ranging from fine to very coarse. All this is in line with the strong indications, already put forward by archaeologists, that the site was used or re-used over a fairly long period of time (Bonanno and Vella, this volume).

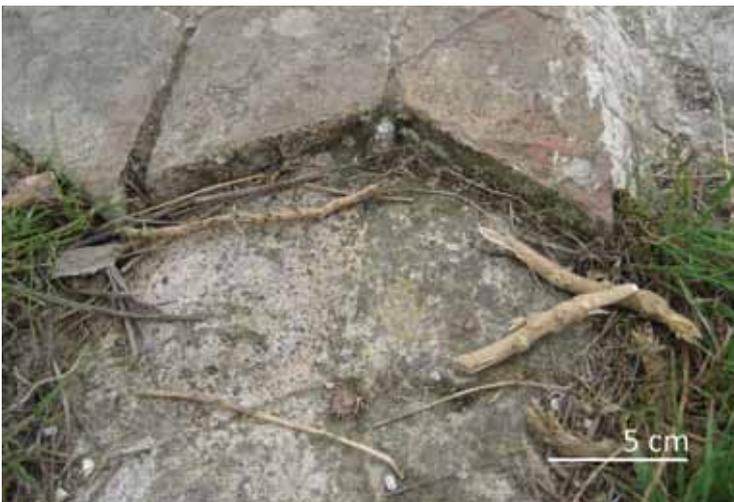
The lozenge-shaped terracotta tiles appear to be largely homogeneous in their size and composition. Their arrangement follows a herring-bone pattern, aligned on an East-West axis in three rooms and on a North-South axis in the other. Only in one small area were slightly smaller and misaligned tiles noted. Evidence of preparatory layers can also be seen where the tiles have been lost (Fig. 4).

Figure 4. Detail of the tiled floor of room 1 showing the preparatory layer where some tiles have been lost. Photograph by the students in Conservation and Restoration Studies, University of Malta.

There is now unfortunately widespread deterioration in the tiled floors and especially in the plaster remains, many of which appear detached (Figs. 4 and 5). The current state of conservation of all of these areas was documented by students following the Bachelor degree in Conservation and Restoration Studies (Department of the Built Heritage), supervised by conservators from Heritage Malta Conservation Division. The main deterioration forms affecting the floors, walls and plaster remains were described in a detailed visual glossary, and their distribution mapped on large-scale photographs. The hand drawings prepared on site are currently being converted to ACAD drawings by a professional conservator.

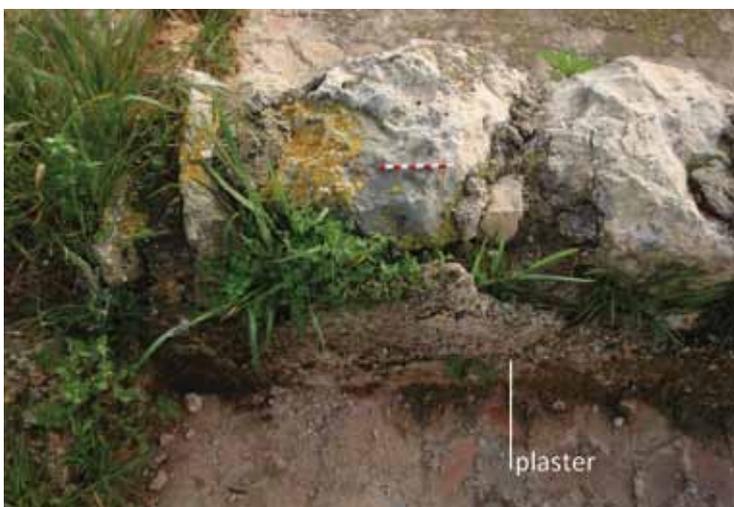
Figure 5. Detail of room 2 showing the effect of the growth of vegetation on plaster remains. Photograph by the students in Conservation and Restoration Studies, University of Malta.

The annual growth of intrusive plants and trees is a major cause for concern since it damages both materials and structures, as well as archaeological deposits, leading to cracks and fissures within the building and decorative materials. Roots growing within the structures' interstices slowly dislodge fragile tiles and fragments of stone, mortar and plaster (Figs. 5 and 6). Rainfall causes the collapse of plaster fragments, and of the fragile parts of the stone walls, whilst recurrent ponding has been observed to take place in several areas within the tiled rooms (Fig. 7). Soluble salts, originating from the air, transported by rain and/or emanating from the soil, sometimes also coming for the use of unsuitable restoration materials, enter the porous materials and crystallise cyclically with every wetting/drying cycle, leading to disaggregation of the original materials, which can be stone, mortar, bedding layers or decorative tiles.

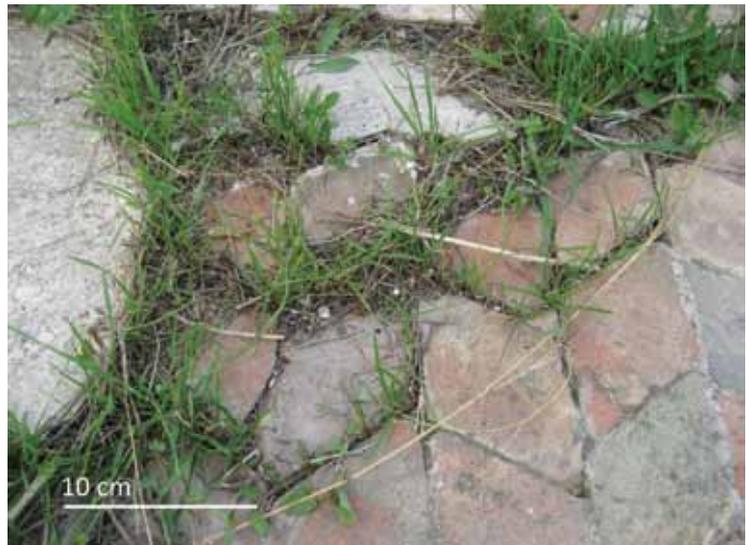
Figure 6. Detail of room 2 showing the effect of the growth of vegetation on the tiled floors. Photograph by the students in Conservation and Restoration Studies, University of Malta.

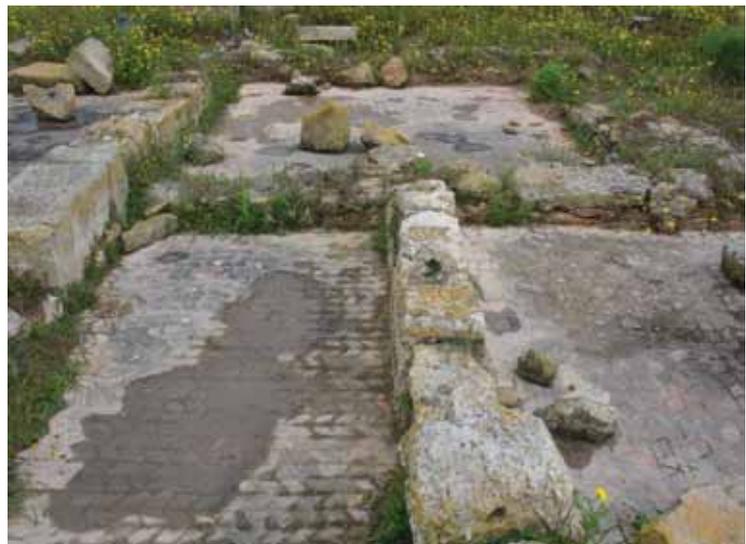
Figure 7. The residential area of the Roman Villa after rainfall. Photograph by the students in Conservation and Restoration Studies, University of Malta.
