The Frightening Tremors of January 1693

GODWIN VELLA

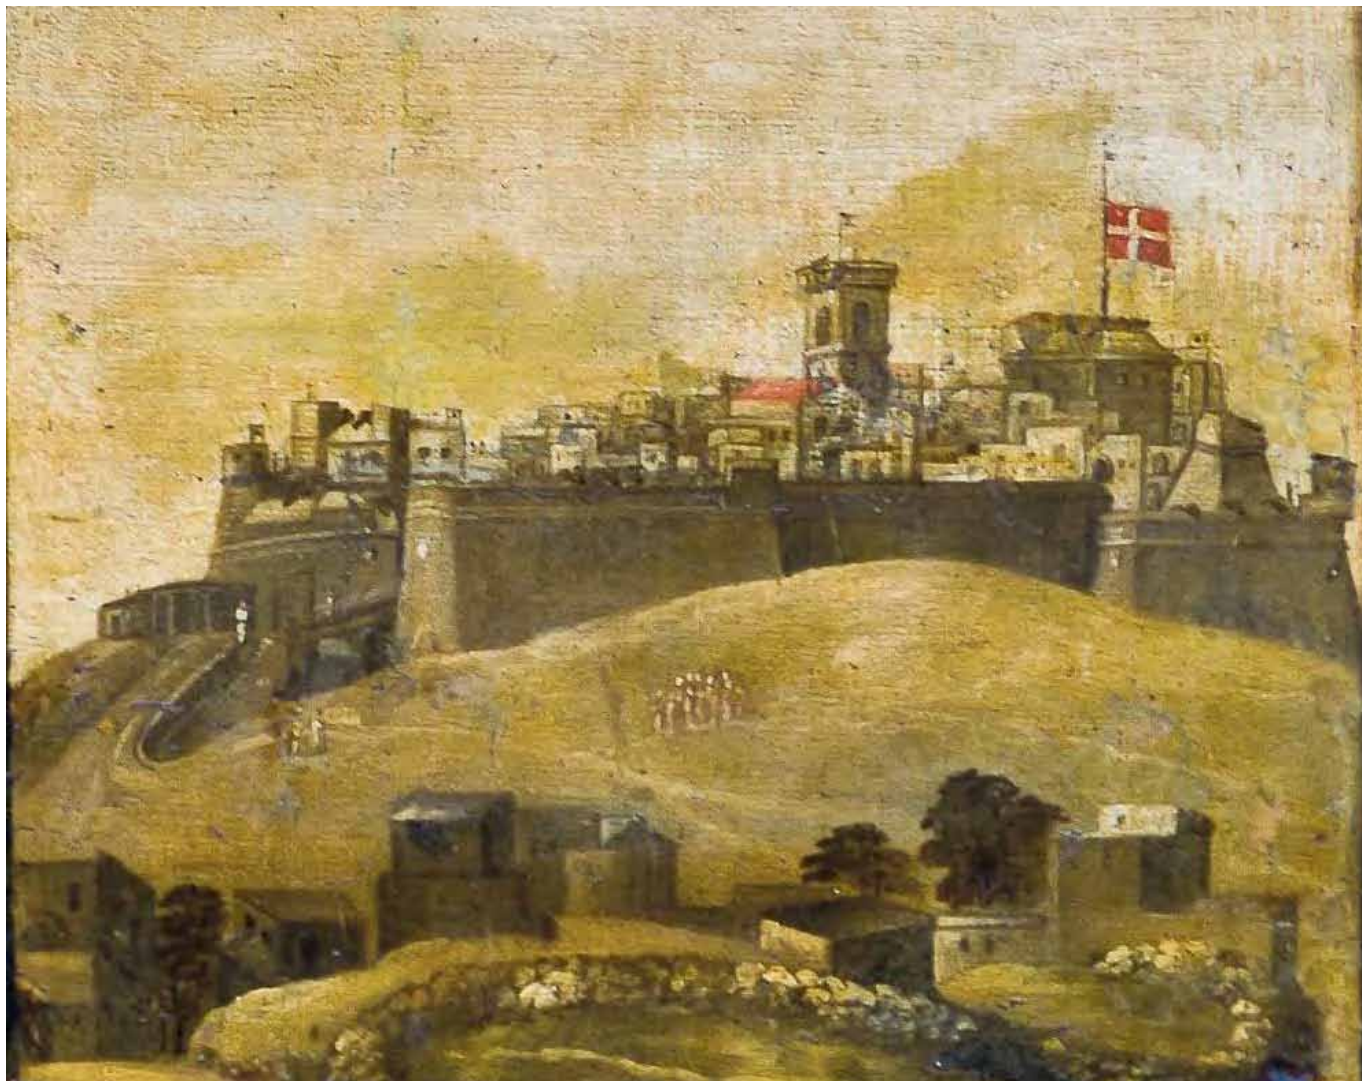
1620's view of the Castello (extract Ta' Savina Church Altarpiece). The bell tower of the Matrice stands at the centre.

One cannot but emphasize the earthquake's detrimental effect on the only belfry of the Collegiate Church of the Castello, which is several centuries old and is believed to have been founded by Count Roger. Its fabric is characterized by good quality and large building blocks of foreign extraction that are so craftily dressed that the joints are hardly visible. Notwithstanding, it did not succeed in resisting the earthquake's terrible shakes. Ironically, the finer buildings seem to have suffered most. The upper section of the bell tower, which abuts onto the choir and rises above the roof of the nave, has to be dismantled and reinstated.

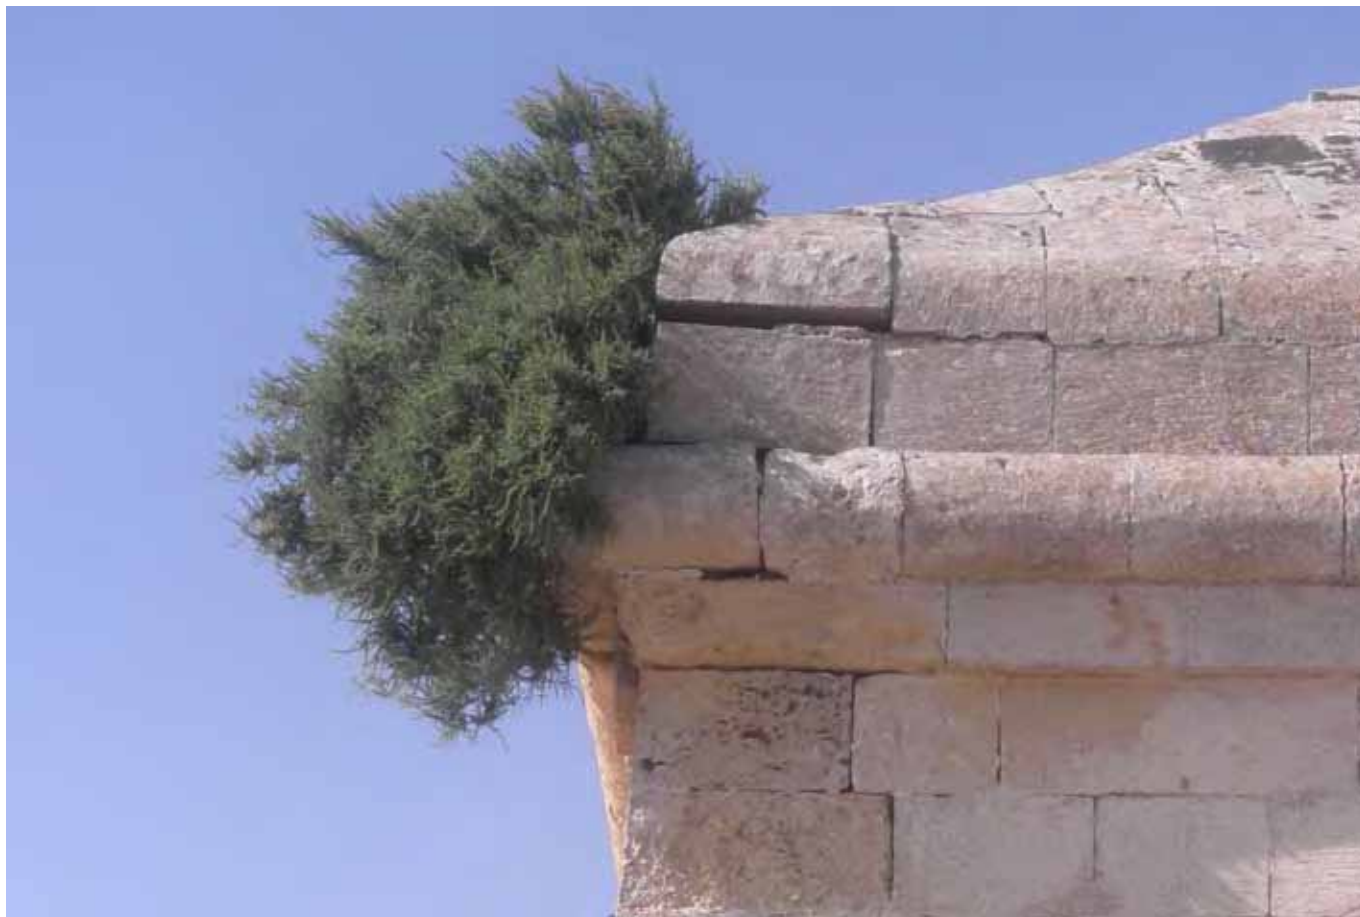
A salt tree shrub atop the parapet wall of St John's Cavalier. Note the dislodged masonry.

Castello and of the Ravelin situated outside its main gate. Its big roots reach deep into the walls' thickness, dislodge the masonry and jeopardize the overall solidity of the ramparts. Even though I had raised this issue on past occasions and stressed the urgent need of their uprooting, same shrubs were allowed to grow into small trees, thereby implying that my directions were ignored altogether repeatedly. To this effect, I am hereby invoking the mediation of Your Eminence to instruct explicitly the Sergeant of Gozo⁹ through the Governor to enact such mitigation measures, since the damage being inflicted is much more serious than commonly believed.

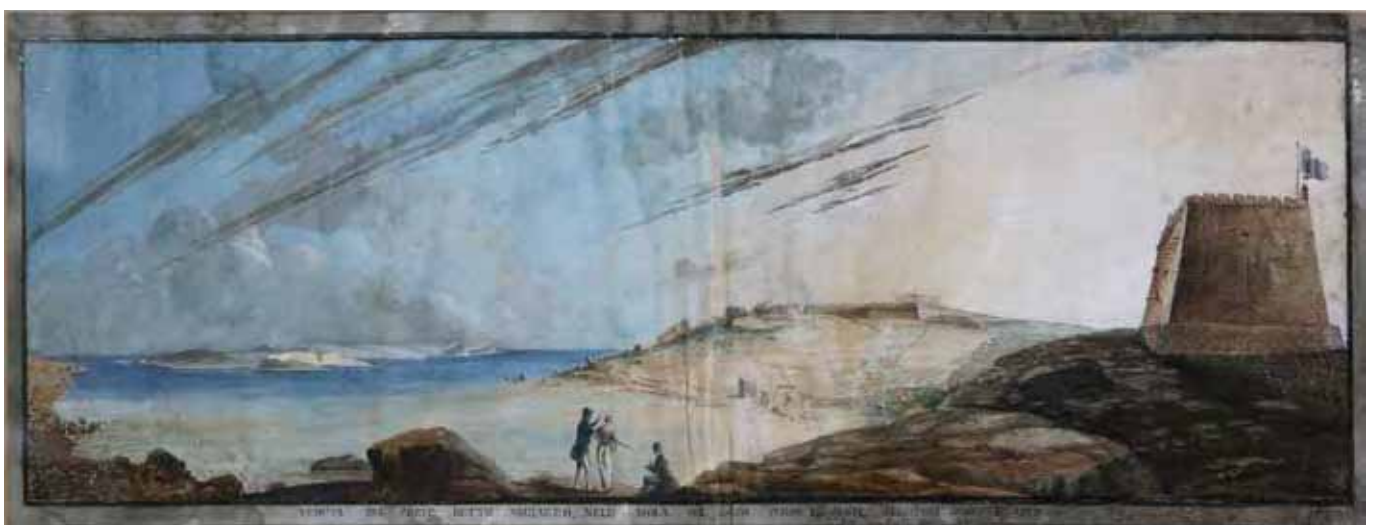
Early nineteenth century view of Garzes Tower by Salvatore Busuttill (1798-1854). Note the plinth supporting the tower structure.

8) The repair and pointing of the uppermost stone course of the plinth along the facade overlooking Mgarr Harbour.
