Institute for Sustainable Energy, University of Malta

**SUSTAINABLE ENERGY 2016:
THE ISE ANNUAL CONFERENCE**

**INVESTIGATING CRYSTALLINE SILICON CELL-BASED SOLAR PHOTOVOLTAIC MODULE
DEGRADATION IN THE MALTESE CLIMATE**

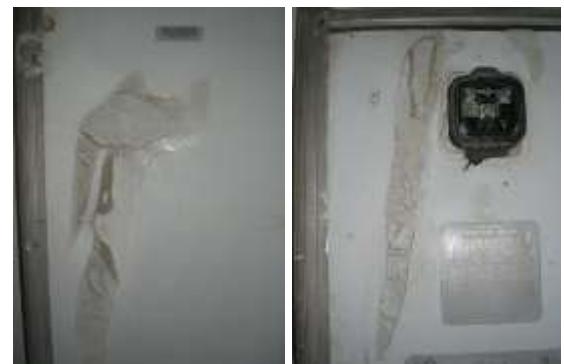
Figure 5: Backsheet tearing

The backsheet of a number of PV modules experienced tearing as shown in Figure 5.

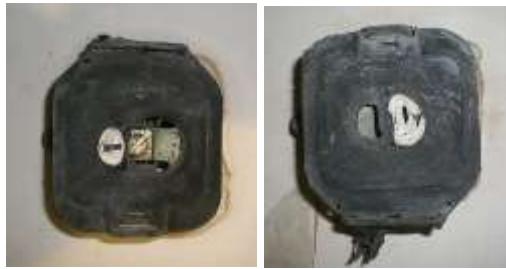
Figure 6: Junction boxes

As shown in Figure 6 the junction box's cover experienced substantial damage due to weathering. Humidity ingress and corrosion of the metal contacts are also evident. The bypass diodes inside the junction boxes were all functional.
