Huqoq – 2015

Jodi Magness, Shua Kisilevitz, Matthew Grey, Dennis Mizzi and
Karen Britt

07/09/2016
Preliminary Report

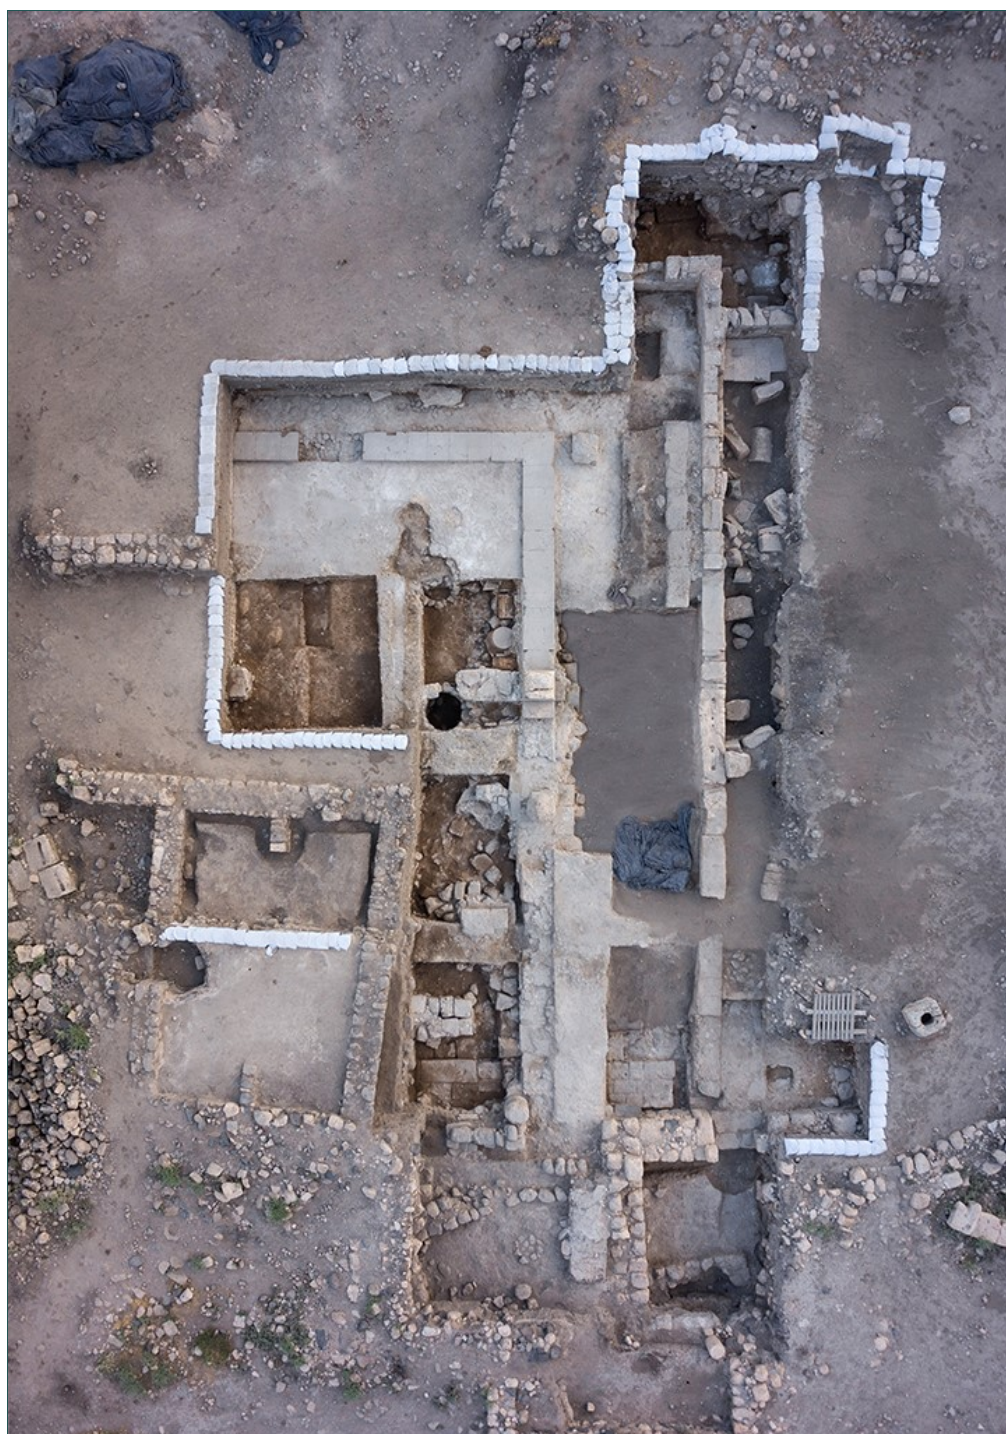
1. Aerial view of Area 3000 at the end of the 2015 season: the Late Roman synagogue and medieval building, north at the top.

The Late Roman level in the synagogue (Fig. 1) was reached in a square containing a small section of the west aisle and part of the nave; in three squares along a north–south axis in the nave; and in places where balks were dismantled in the east aisle. The removal of the balks, which surrounded mosaics that were exposed in previous seasons, revealed more of the foundations of the synagogue's south wall and the large paving stones in its courtyard. Additional mosaics in the east aisle, in a small part of the west aisle and in part of the nave were also exposed.

In the Middle Ages (twelfth–thirteenth centuries CE), a monumental public building was erected on the same spot as the Late Roman synagogue, reusing some of the earlier structure's architectural elements but apparently expanding it in size to the south and west (see Fig. 1). The medieval building reused the synagogue's east wall, which it extended farther to the south; the north wall, which was extended farther to the west; and the stylobates and pedestals, which were raised to the level of the medieval floor. The following discussion proceeds roughly from north to south.

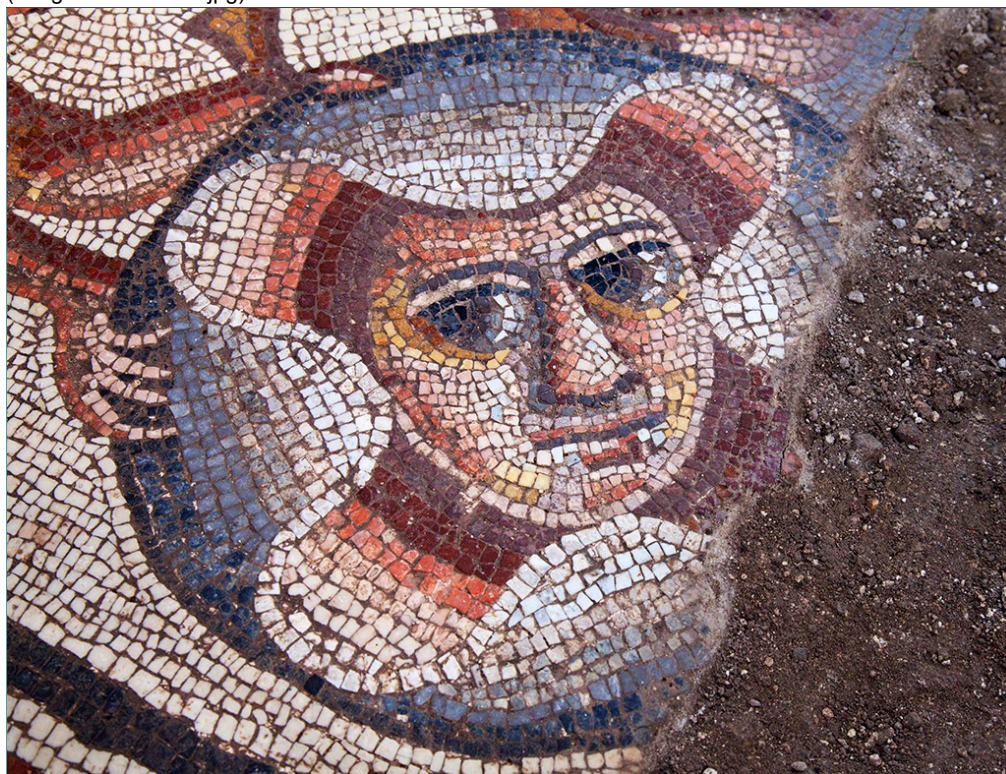
2. Mask in the mosaic floor of the synagogue, east aisle, looking southeast.

The removal of the balks also revealed the Hebrew/Aramaic inscription to the south of the 'elephant mosaic'. It lies in the center of a symmetrical composition, forming a separate, square panel (c. 4.5 sq m). Although the southeast corner of this panel is missing, its composition can be reconstructed based on its symmetrical design. The inscription is encircled by a wreath that contains roundels with female heads on either side of the medallion; these heads, uncovered in 2012, turn toward the inscription. A third head, likely of a male, located in a roundel above and west of the medallion was uncovered this season; the eyes of this figure look down at the inscription. It is almost certain that an additional roundel, now missing, was set below the inscription. The wreath is held aloft by four male figures placed in each corner of the panel. They wear tight-fitting trousers belted at the waist and soft boots. Their upper bodies are bare and display enlarged pectoral muscles, with their arms raised overhead to support the wreath. The men are connected by a continuous garland that passes over the left shoulder of each figure and behind them. The figures' feet are positioned on spheres placed in each corner of the mosaic panel. The spheres are inscribed with quatrefoils containing masks; only the northwest mask is completely preserved (Fig. 2). Each sphere is held in the outstretched hands and arms of two winged putti placed parallel to the sides of the square panel. The arrangement of the visual elements in the panel is intended to direct the viewer's attention to the inscription at the center.

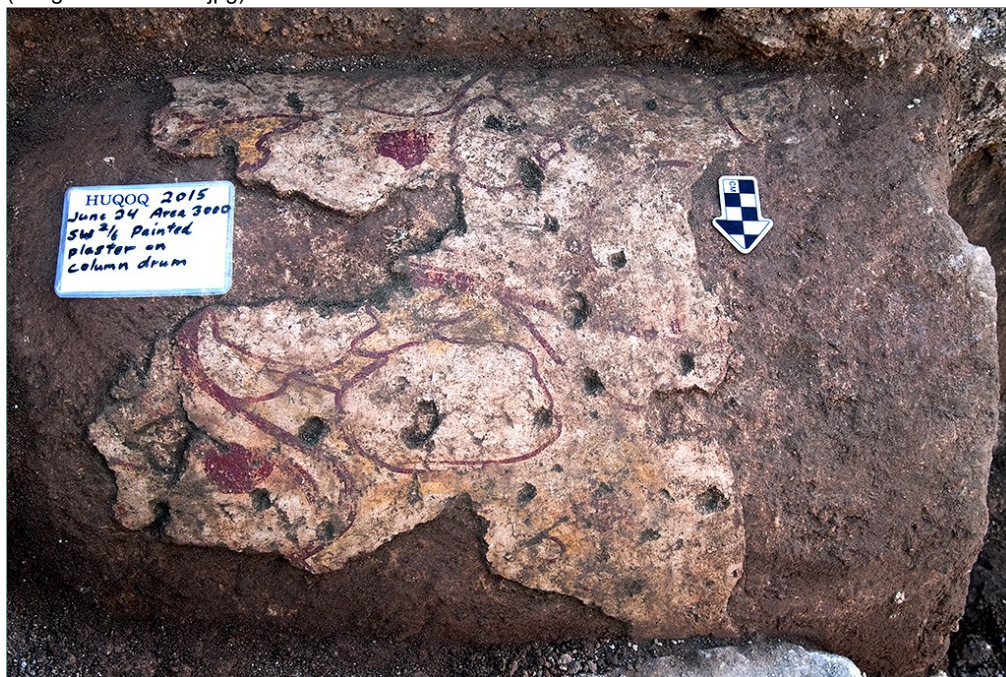
3. Painted column drum from the synagogue in secondary use, east aisle, looking south.

Reused architectural pieces, including plastered column drums still preserving their original painted decoration of red and yellow vine or ivy leaves, were placed underneath the east stylobate (Fig. 3), to support it and the weight of the pedestals. In 2014, one pedestal was discovered still sitting atop the stylobate ([Magness et al. 2016 \(http://www.hadashot-esi.org.il/Report_Detail_Eng.aspx?id=25057&mag_id=124&previewit=TrUe\)](http://www.hadashot-esi.org.il/Report_Detail_Eng.aspx?id=25057&mag_id=124&previewit=TrUe): Fig. 9), while another one, found in 2015 toppled on the medieval floor next to its original location, was restored to its original position. Additional support for the pedestals was provided by short, east–west

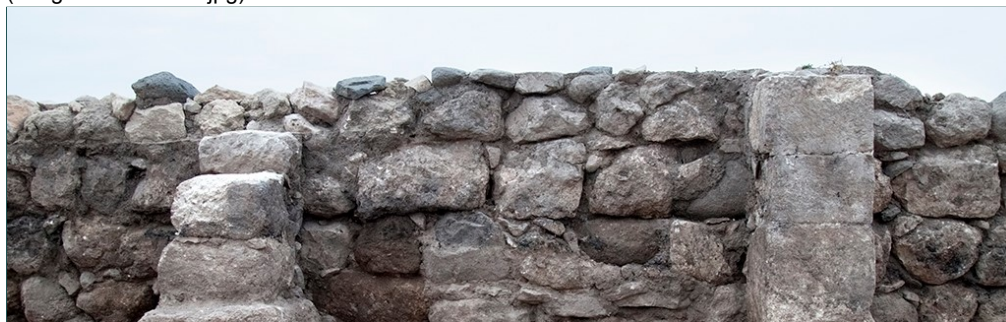
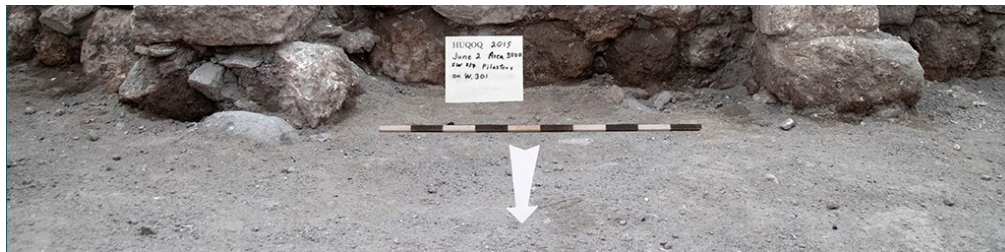
4. Pilasters supporting arches in a nineteenth–twentieth century house in Yaquq, looking south.
(Images//34-2015-4.jpg)

Remains associated with the outdoor cooking area of Phase 2 were reached only in the northeast part of Area 3000 in 2015, and consisted of a single poorly-preserved *ṭabun* surrounded by a thick layer of ash. Remains associated with Phase 3 were encountered in the northeast and southwest parts of Area 3000. These consisted of structures equipped with installations, with sub-phases represented by the addition and cancellation of partition walls and the elevation of floors. The structures in the southwest contained one or two sets of supporting arches for the roof, which were carried on pairs of pilasters built of hewn rectangular stones set upon a rectangular block with a foundation of packed stones (Fig. 4). The structures all seem to be residential and were filled with a massive layer of collapsed stones and ash from a conflagration, apparently from the village's destruction by fire in 1948. This destruction layer yielded finds such as metal wires and tools and glass bottles.
