**Monitoring of Underwater Archaeological Sites with
the use of 3D Photogrammetry and Legacy Data**

Case study: *HMS Maori (Malta)*

Thesis submitted in partial fulfillment of the requirements for the degree of
Master of Arts in Global Maritime Archaeology

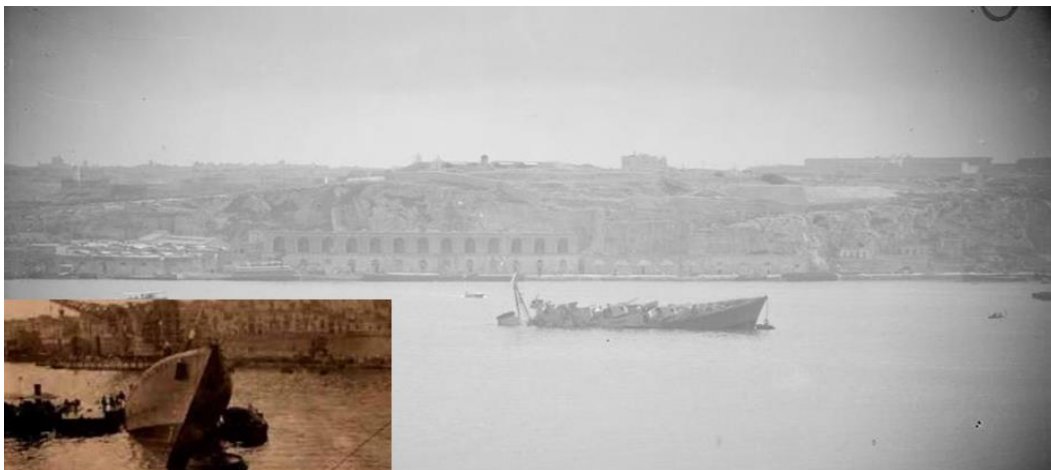
Figure 6. *HMS Maori* after she was bombarded in Grand Harbour, Malta; Mast pole alongside one section of the fore hull can be seen protruding from the water. (Source: <https://bit.ly/2x5J7y2>)

On the night of February 12, 1942, the destroyer was moored at one of the buoys in the centre of the Valletta port (Dockyard Creek) when, around 02.00 AM, a German air raid had begun (Whitley, 2000, p.117). Most likely, it was a solitary Junker Ju 88 that managed to land its bomb in the centre aft area of the vessel. The explosion caused the burning of some fuel deposits, which in turn, besides destroying the stern engine, triggered the explosion of the reserves for the anti-aircraft ammunition of the stern guns (Mason, 2001). The fire was out of control, and about to reach the aft ammunition depot, the crew had to be sent away from the vessel. At 02.10 AM the explosion completely ripped open the ship, and she immediately started to sink to the bottom, with only the forepart still visible above the surface and slightly leaning towards the starboard side (**Fig.6**). The burnt gasoline spread all around, threatening other vessels that were nearby until the fire was extinguished (Caruana, 1995, p.8). Later that day, the water slowly penetrated the bow section until it also went down. The only visible part of *Maori* that was not submerged was the top of the mast alongside its fore hull, which in this case marked the tomb of the ship and one of its crew members.

A decision was made to scuttle the wreck because she was interfering with the traffic inside the harbour. The recovery work started at the beginning of 1945 by the South African rescue ship *Gamtoos* who cut the hull of the destroyer in two sections (Caruana, 1995, p.8). The forward one (bow) was raised on July 15, 1945, with the help of push cylinders and then towed to the entrance of Marsamxett Harbour, where it was sunk in shallow waters and where it still stands today. The aft (stern) section was scuttled in the following September and was towed out of the harbour offshore and sunk in deep waters (Mason, 2001; Heckman, 2017, p.32).

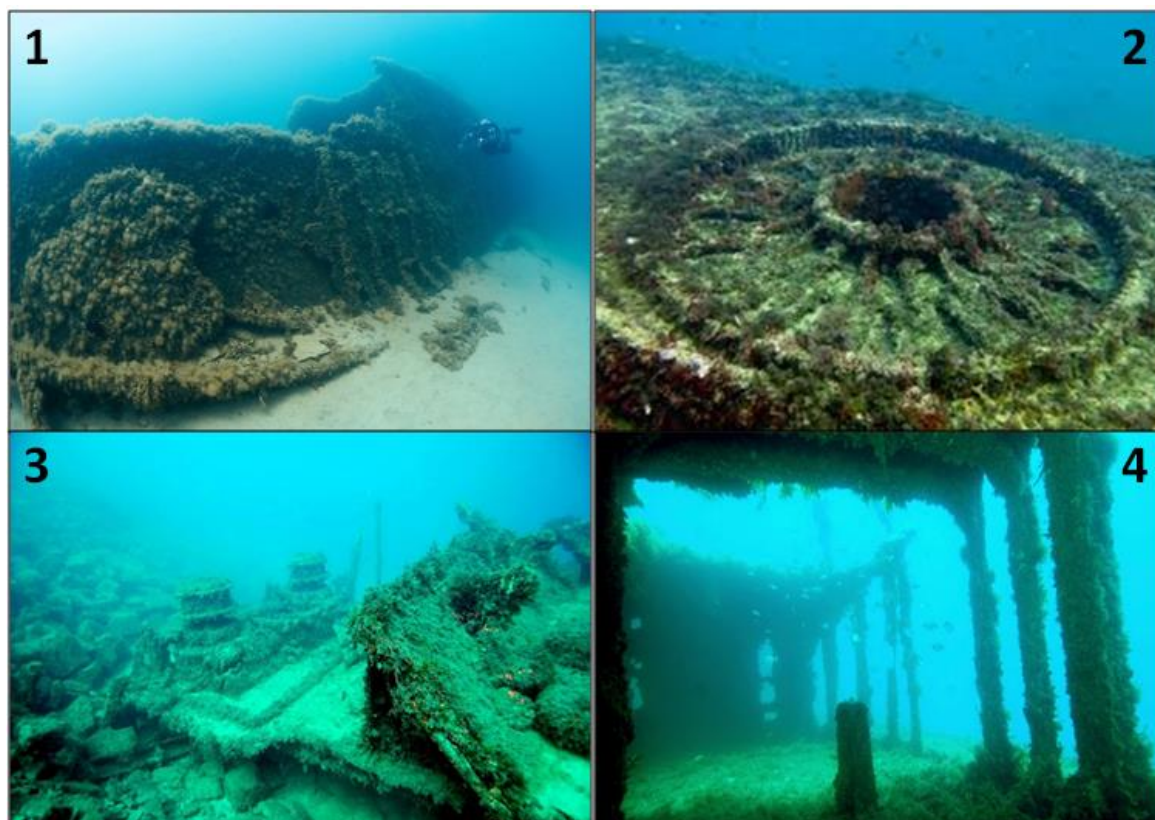
Figure 9. Diver passing along the starboard side (1), mounting base for twin 4.7in gun (turret) (2), forepart (forecastle deck) leaning on the rocky slope - breakwater and anchor windlass can be seen (3), a section of the upper structure before 2019 with shoals of fishes (4) (Source: Google)

Like many wrecks from the Second World War, *HMS Maori* has become an artificial reef where marine life has been thriving for decades (**Fig.9**). Here, one may observe a variety of marine life that resides inside or on the outer part of the wreckage. Depending on the time of year, the metal structure can be covered with green weed, tube worms, shoals of fishes, octopus and with cardinalfish swimming close to the upper structure. A considerable number of hermit crabs and fireworms can be found on *Maori* herself. Also, species such as scorpionfish, moray eels, cuttlefish, or even sea horses can be seen nearby. The information presented on marine life was created by combining the personal experience of the author and discussions with dive club personnel, as well as, general information shared on different dive school websites (Dive Med, 2020; Dive Booker, 2020; Divers Guide, 2020).

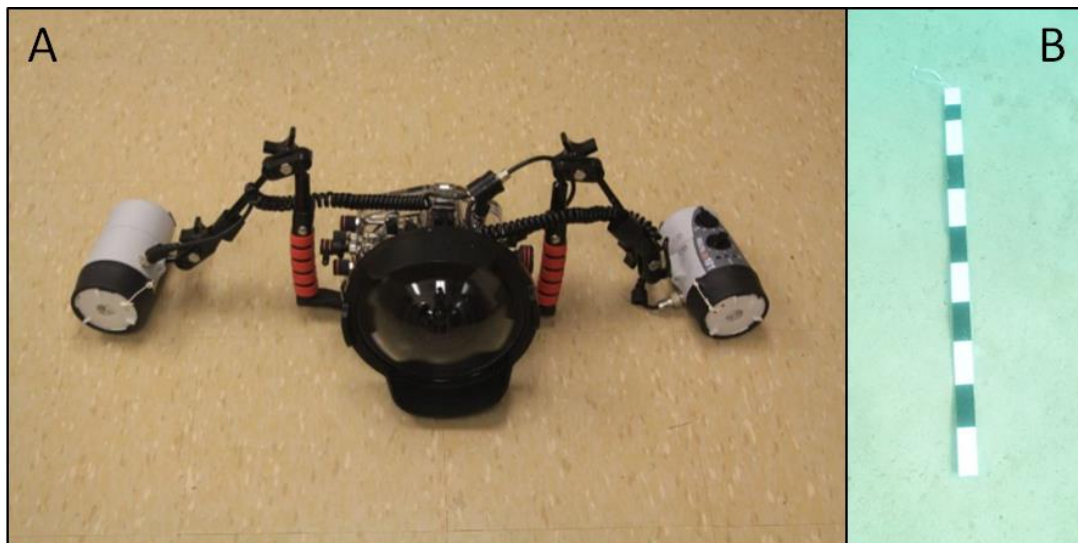
Figure 11. Underwater camera housing (Ikelite) used for 3D survey, with two strobe lights and a hemispherical dome port (A), Scale bar used for the survey (B) (Source: K. Yamafune)

For creating an accurate 3D model using photogrammetry, it is necessary to take good photos. This does not mean that the camera has to be on a higher end of the spectrum. This refers more at choosing the right camera and the accessory equipment used for capturing fine images, alongside knowing the right way of positioning the camera with the area that is being surveyed (Shortis, 2019, p.12). The Sony - Alfa R37 camera was used for the underwater image acquisition. To reduce the optical noise, the wide-angle lens was utilized (FE 12mm – 24mm). A hemispheric dome-shaped underwater housing was used, which, overall, minimizes the refraction caused by the change of density between water and air (Yamafune, 2016, p.8). Two strobe lights served for recapturing the true colours lost by the light absorption, which occurs underwater (**Fig.11**) (before every recording, a white balance had to be adjusted on the camera). That being said, the factors that disrupt the use of photogrammetry underwater are limited visibility, light absorption and light refraction. This will dictate the way how the survey will be planned (Van Damme, 2015, p.17).

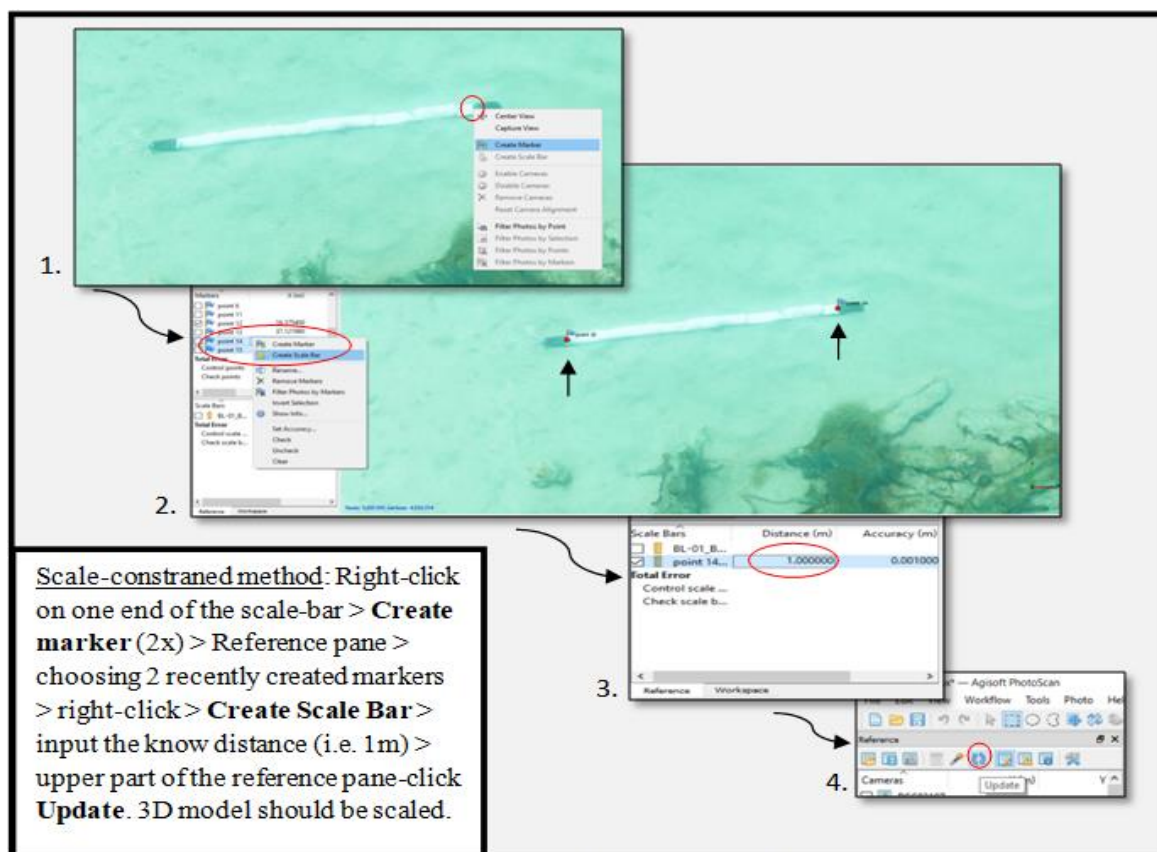
Figure 15. Process of scale-constraining the 3D models in *PhotoScan/Metashape*. (Source: Dj.Cvetkovic)

For creating a 1:1 scale-constrained geo-referenced 3D model, the local coordinate system needs to be established. Direct survey method (trilateration), is a practice commonly used by maritime archaeologists, to create a local coordinate system (Green, 2004, p.87; Costa, 2019, p.70). The disadvantage of this method is the immense number of measurements needed to be taken from the site for geo-referencing, while *PhotoScan/ Metashape* allows the input of measurements differently. Since one of the aims of this dissertation was to properly geo-reference the 3D model of *HMS Maori* in a time and cost-effective way, a decision was made to use the scale-bars method (Yamafune, 2017, p.529). Five, one meter scale-bars were placed around the wreck, and by including scale-bars (known distances) into *PhotoScan/ Metashape* (after the texture has been finished), dimensions and distortions were able to be corrected (**Fig.15**). However, this does not represent a fully geo-referenced 3D model, and the implementation of a complementary method is needed for creating a local coordinate system. This stage of data processing is essential for testing the proposed monitoring hypothesis because for producing and extracting dimensional/ spatial information from the model, it is necessary to create an XYZ coordinate system.

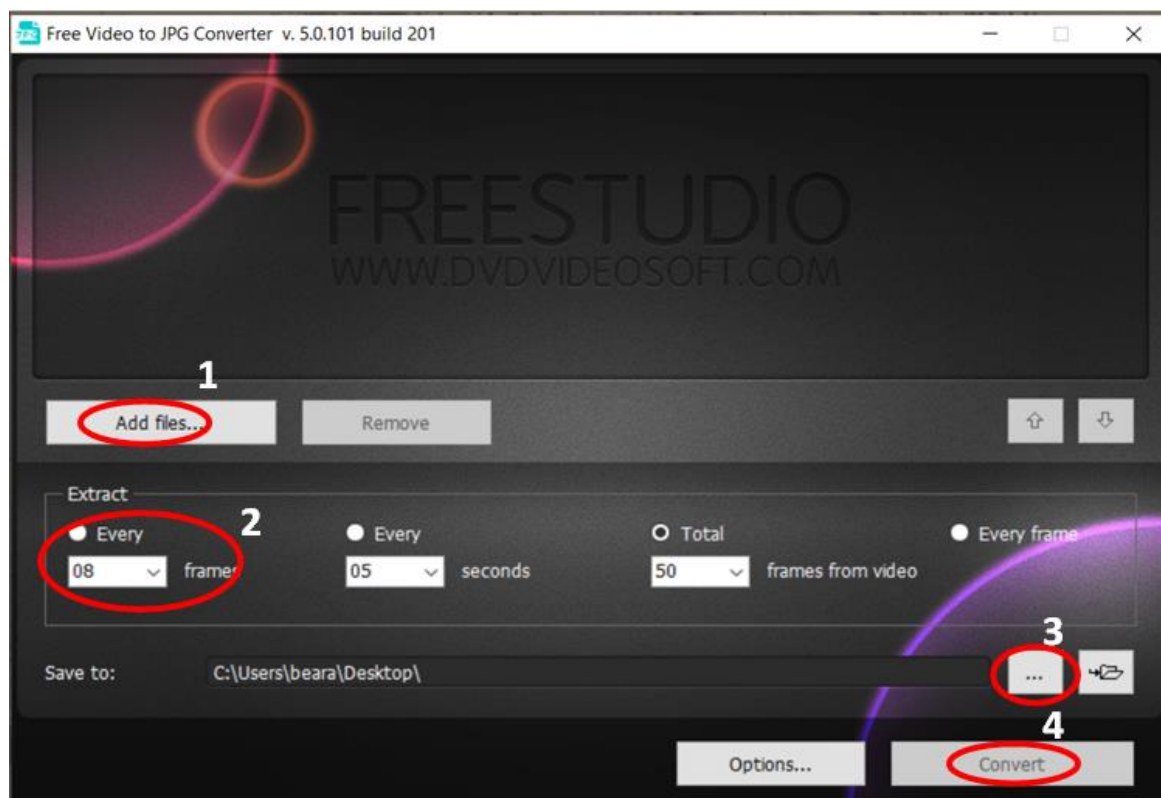
Figure 18. Automated extraction of still frames using *Free Video to JPG Converter*. (Source: DJ. Cvetkovic)

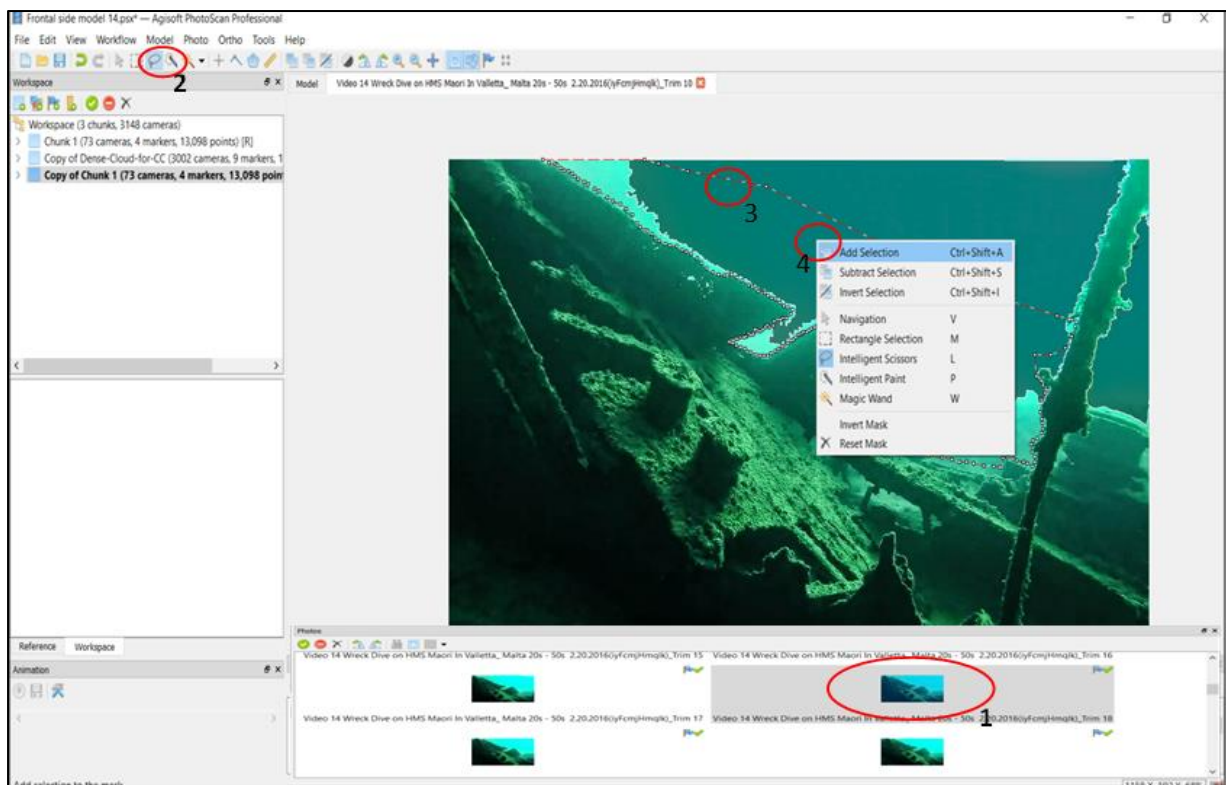
Figure 19. Process of masking photos in 4 steps. (Source: Dj. Cvetkovic)

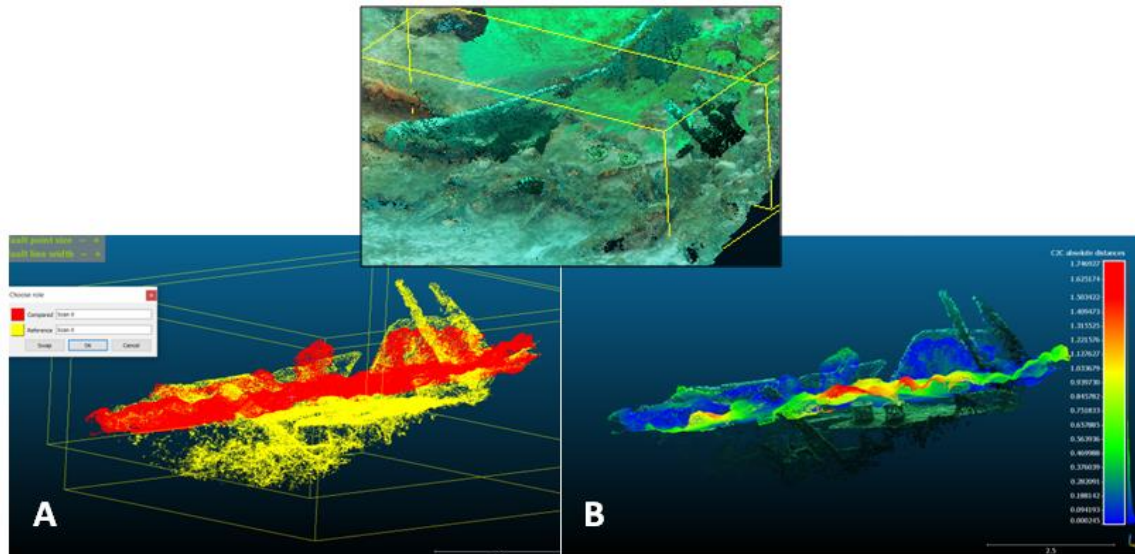
Figure 36. Demonstrating the change in different colours Red (2019) and Yellow (2016) (A), comparing LD and created deviation analysis (B); Clear signs that the forecastle deck did collapsed (Source: Dj.Cvetkovic)
