Ceiling paintings of St Paul's stay on the island restored

REV DR NICHOLAS DOUBLET, VALENTINA LUPO and MARIA GRAZIA ZENZANI

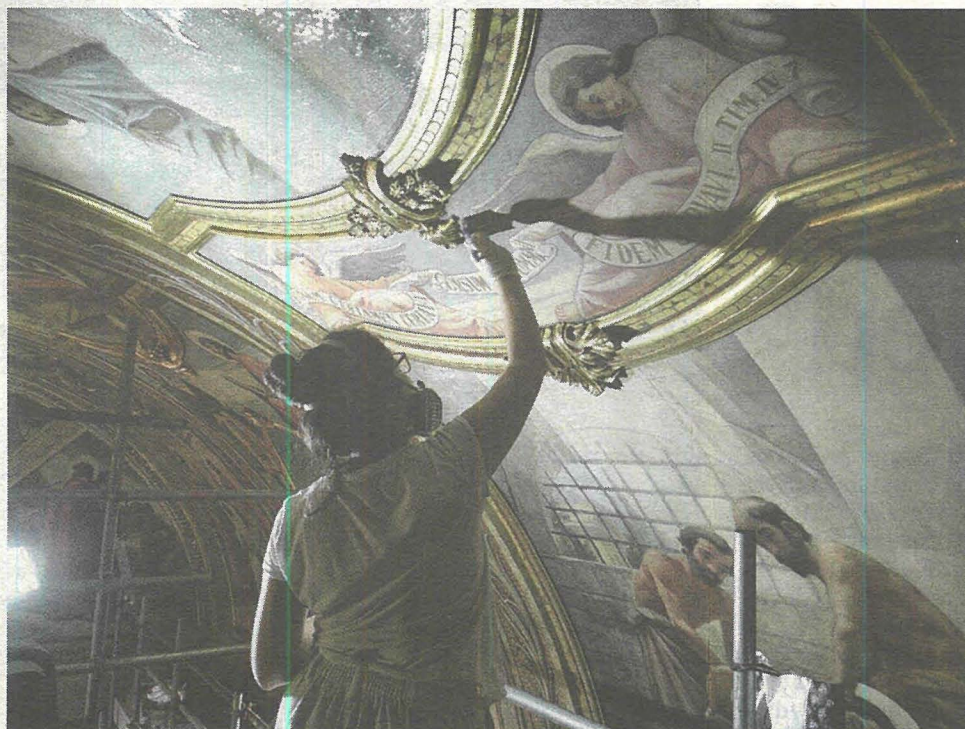
A protective coating was applied on the marouflage painted surface.

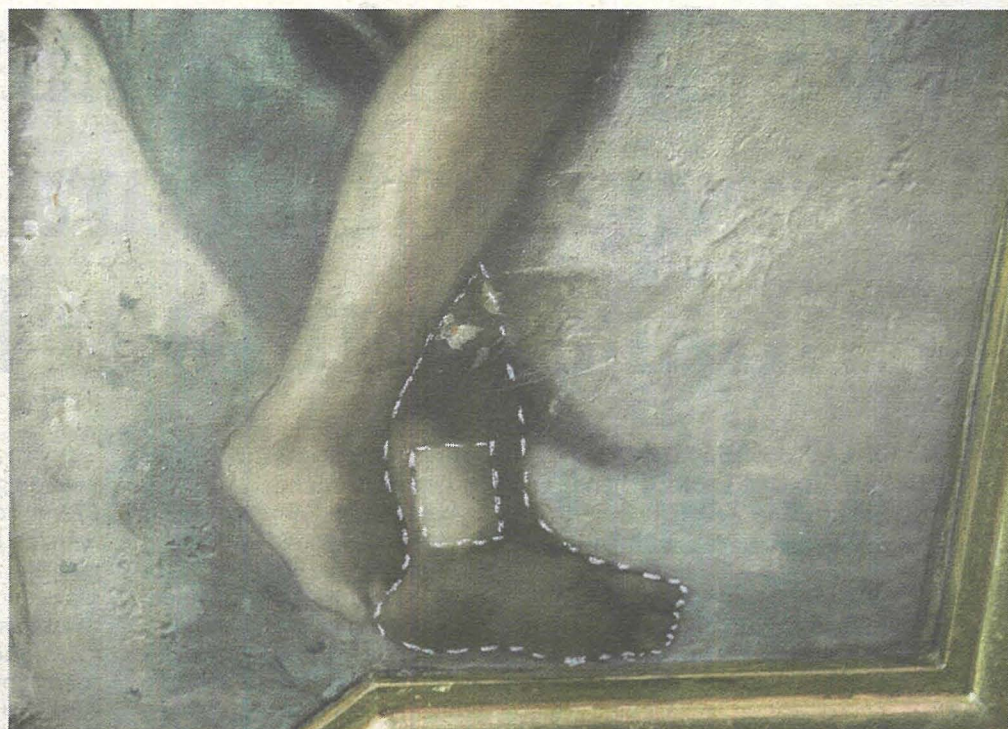
The original skin tone was revealed on removal of the dark deposits of dirt.

The main conservation problem of the paintings was that the surfaces were extremely obscured by an oxidised dark grey layer of particulate matter composed of dust, dirt and soot. Therefore, the ceiling's original colours and gilded surfaces suffered dangers occurring from air pollution, arising from the church being situated in one of the island's busiest roads.

The cleaning revealed a brilliant palette, with an array of colourful details and well-expressed figures for which Briffa was remarked as an artist. The cleaning indeed revived the three-dimensional expression of the paintings and the brilliance of the gilded surfaces and decorations which serve to delineate the scenes represented.

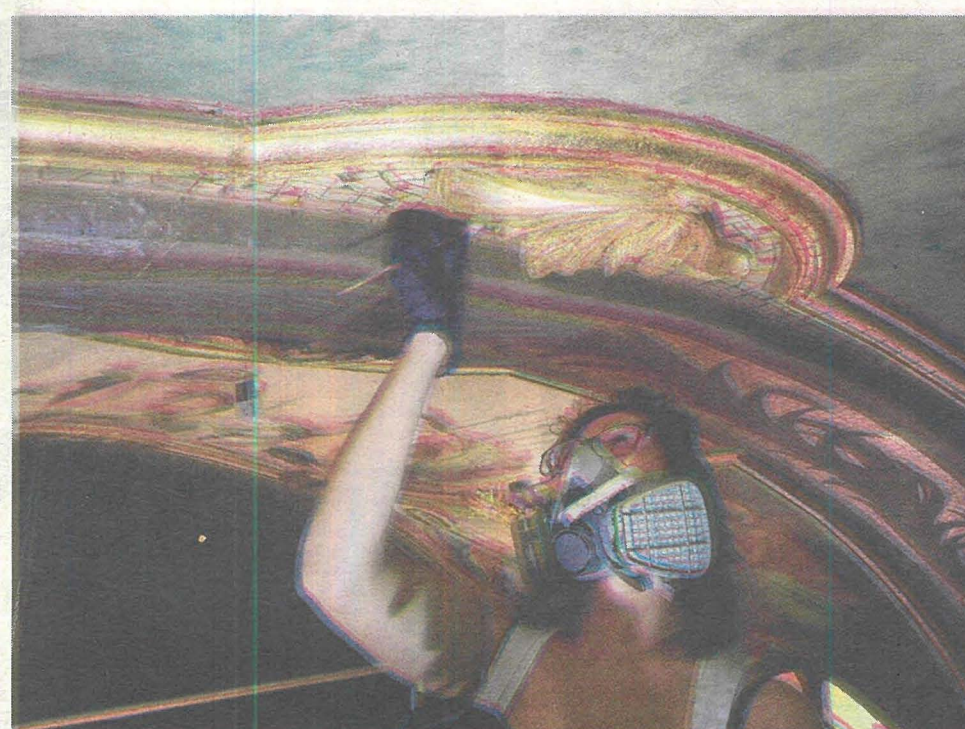
Cleaning of the gilded wooden decorative cornices.

marouflage paintings were carved in wood and were gilded using real gold leaf.
