LIFE AND WELLBEING HISTORY

Construction of the Grand Harbour breakwater

JOSEPH F. GRIMA

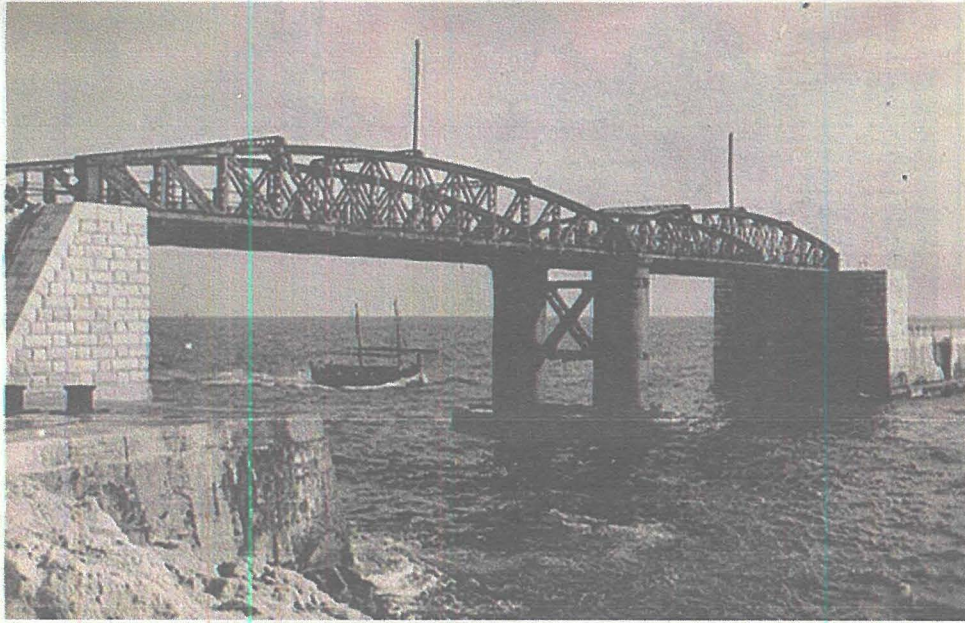
The former footbridge that was completed in 1906 but destroyed through enemy action in 1941.

The foundations of the breakwater lie on solid rock on the seabed. They are made up of concrete blocks each weighing more than 40 tons, together with hard limestone (*zonqor*) quarried from Ras il-Qala in Gozo. The breakwater has two arms. The shorter arm, jutting out from the Fort Ricasoli side, is about 120 metres long and faces the northwest. The longer and main arm faces the northeast from the Fort St Elmo side and is about 371 metres long. This main arm was joined to Fort St Elmo by means of an iron footbridge on two spans, over two columns in the middle, which together measured about 67 metres.

Today, a century and almost two decades later, the breakwater is still there and is still carrying out the work it was primarily designed for. True, for seven decades, people could no longer cross over for a stroll on it in fine weather because the footbridge no longer existed, a legacy of the Italian e-boat attack on Grand Harbour on July 25, 1941, during World War II.

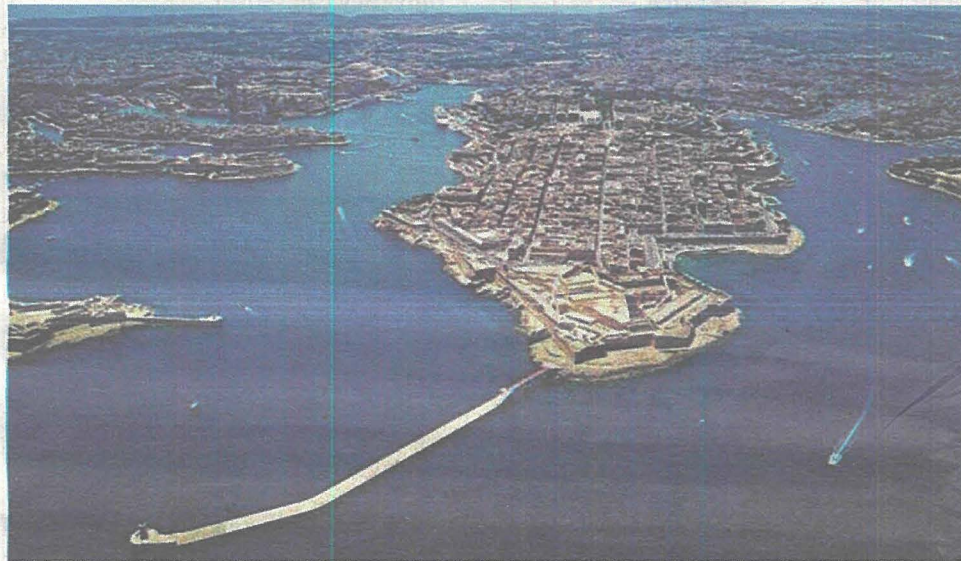
An aerial view of Grand Harbour showing the two arms of the breakwater.

The main arm of the breakwater was not joined directly to the St Elmo side for two main reasons: to prevent the formation of stagnant water within the port and to allow small sea craft to enter harbour (from under the bridge) without having to sail round the long main arm. The edges of both arms are lit by warning lights, with the lighthouse on the St Elmo arm being 14 metres high and completed in 1908.

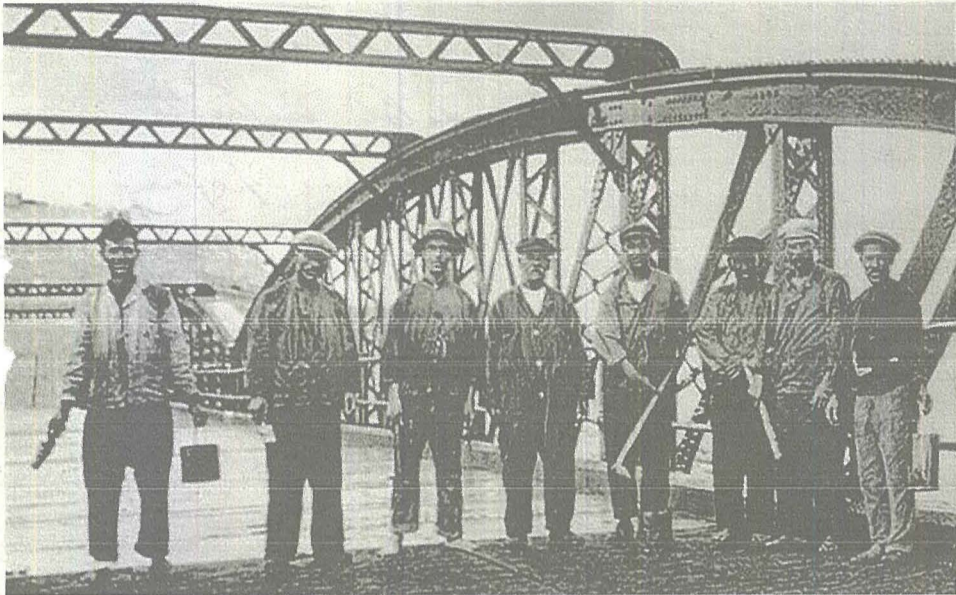
A gang of eight workmen painting the footbridge. A good number of the workmen were foreigners.

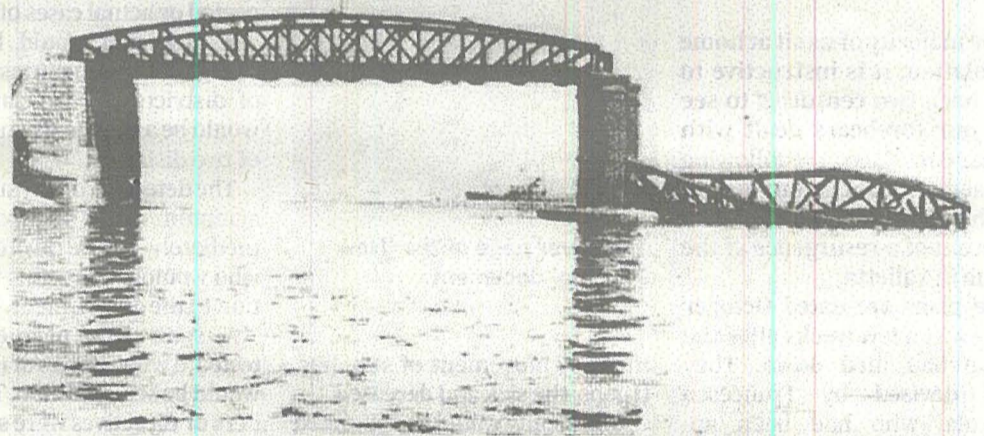
The breakwater bridge after it was destroyed through enemy action during World War II.

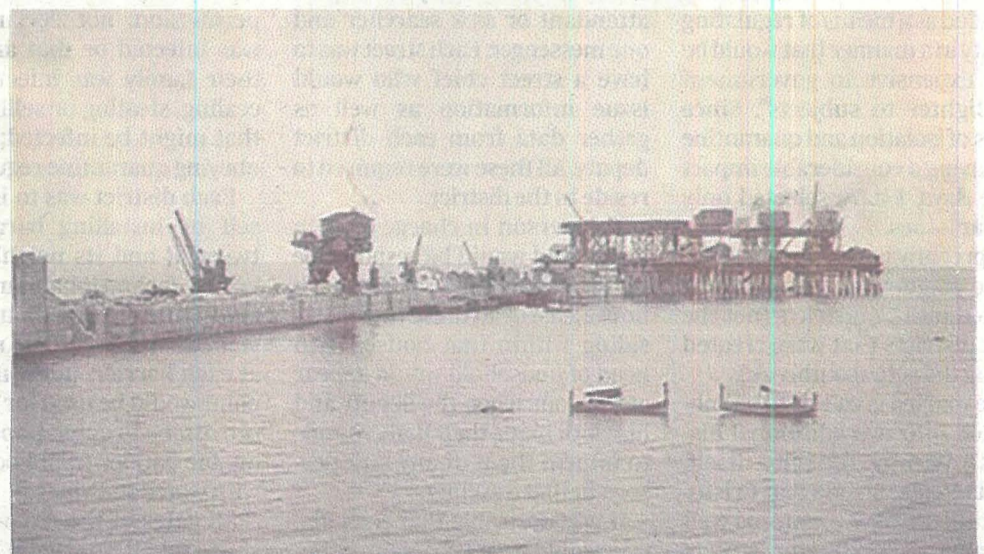
Work proceeding on the main arm of the breakwater.
