# Finding a Treasure Trove of Information

Part 3

## THE 1926 – 1930 GEORGE V DEFINITIVE

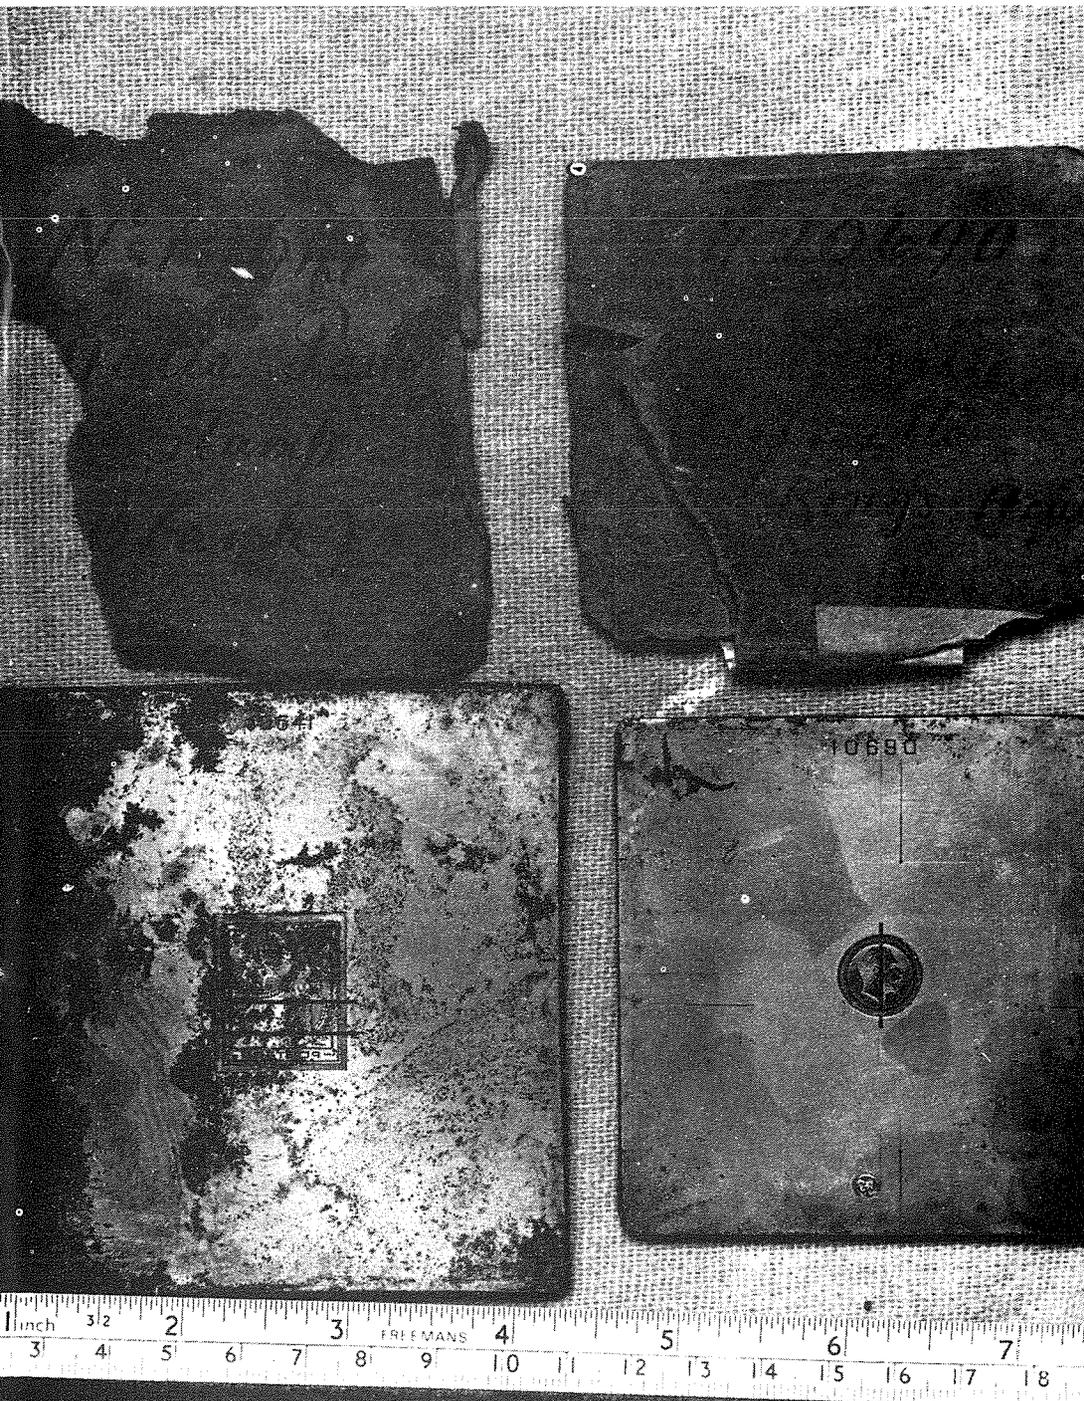
(Photo No 35)

The artist's original engraved steel plate for the 1926 “Postage” issue is present (Photo No 35). The die shows the entire stamp, with the head, but is blank in the value area. It is contained in a wrapper which is labeled: “NO 10641/Malta Postage Stamp/(blank)”. The die is cut into a 5mm thick steel plate. It is 88mm wide and 96mm high. The image of the stamp is reversed, but the number of the die at the top of the plate reads correctly: “10641”. The die appears to be plated with nickel. It has been defaced with two deep horizontal lines scribed across it. The image area is deeply corroded.

The artist's engraving for a relief plate is similar in configuration to the image on the printing plate. The design is reversed left-to-right. Areas which will be dark are raised. Areas, such as the word “POSTAGE” in this design are cut out below the surface level.

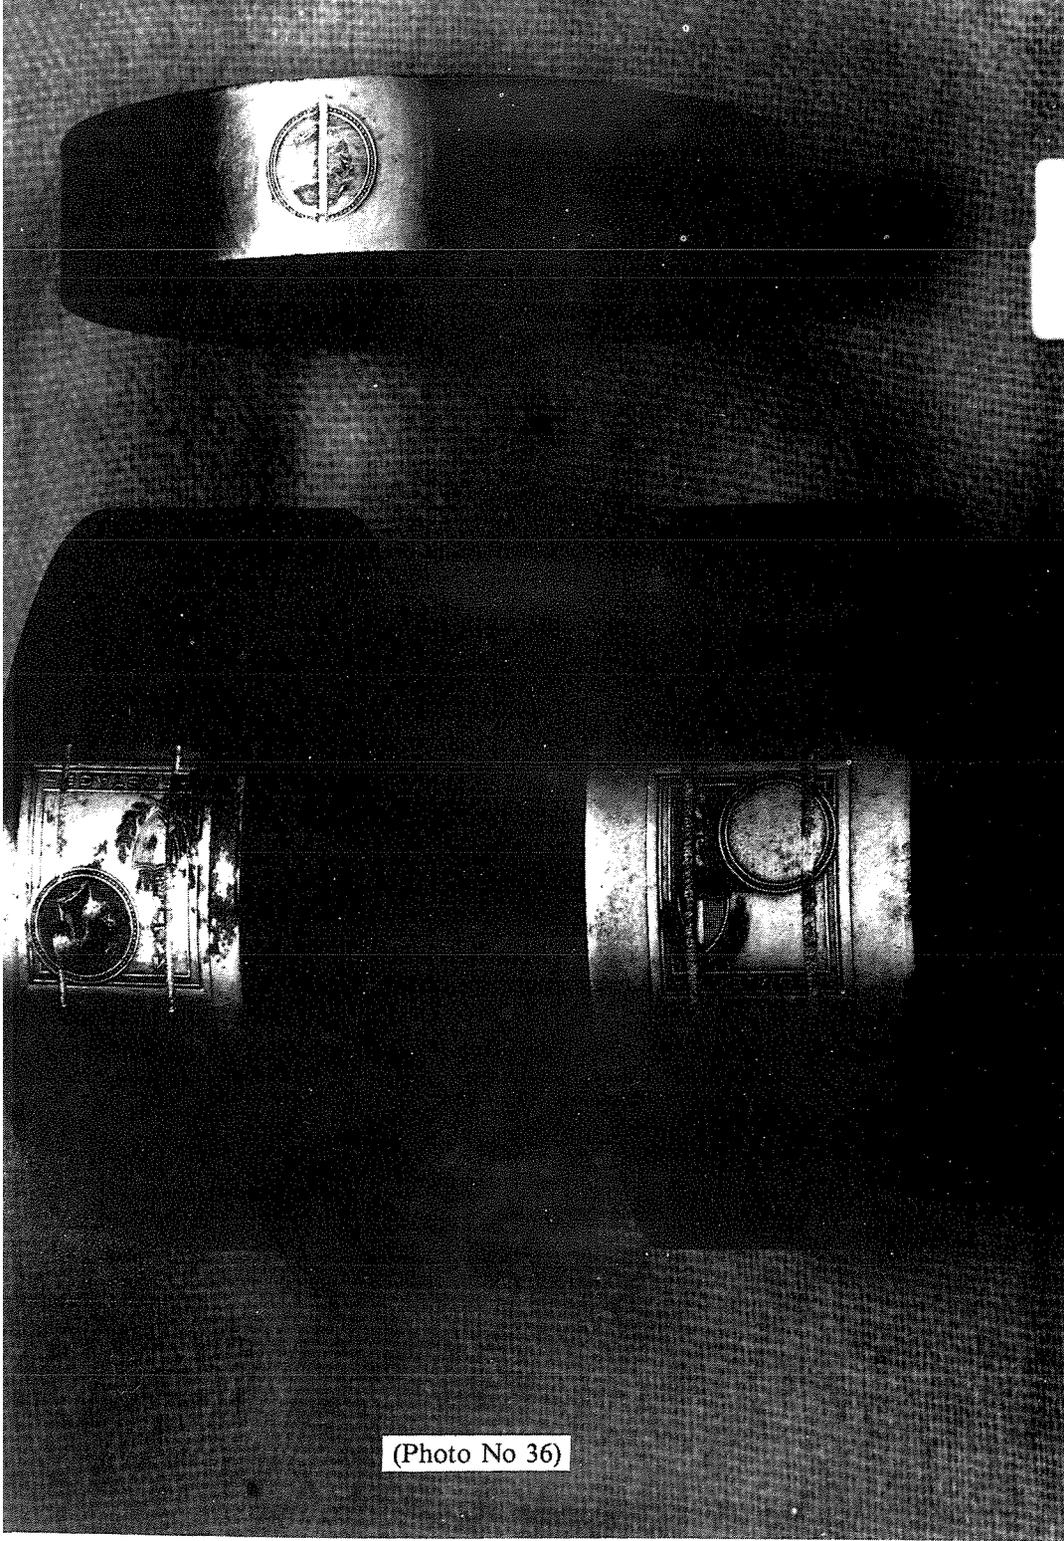
(Photo No 36)

There is a transfer roller of the entire stamp with blank duty and blank portrait area (Photo No 36). On one side the roller contains the punched inscription: “10641”. On the other side it contains the number: “4484”. The roller is 27mm wide. It is 79mm in diameter. The center hole is 27mm in diameter. The roller is made of steel and appears to be nickel plated. The roller was oiled and wrapped in a tissue.

The transfer roller's image is taken from the artist's engraved die. The process involves first hardening the soft steel die through heating in a furnace containing potassium cyanide followed by a plunge into a cooling liquid. A blank soft steel transfer roller is rocked back and forth on the hardened die under great pressure until the image is impressed on the roller. The transfer roller is then hardened. The hardened transfer roller can then be used to rock the image onto other artist's steel dies so that variations such as different denominations can be effected. Ultimately, the final design is rocked from a transfer roller onto a plate from which the molds for the printing plates are made.

The transfer roller in this instance contains a correct reading image of the stamp. It is raised in the areas, such as the word “POSTAGE”, where the stamp will carry no ink. This particular transfer roller is an intermediate step since only a portion of the background horizontal lines are scribed. Presumably from this roller artist's dies would be made on which the values were inscribed for the two-colour stamps of this issue. The portrait would be printed from plates made from the third roller in this group.

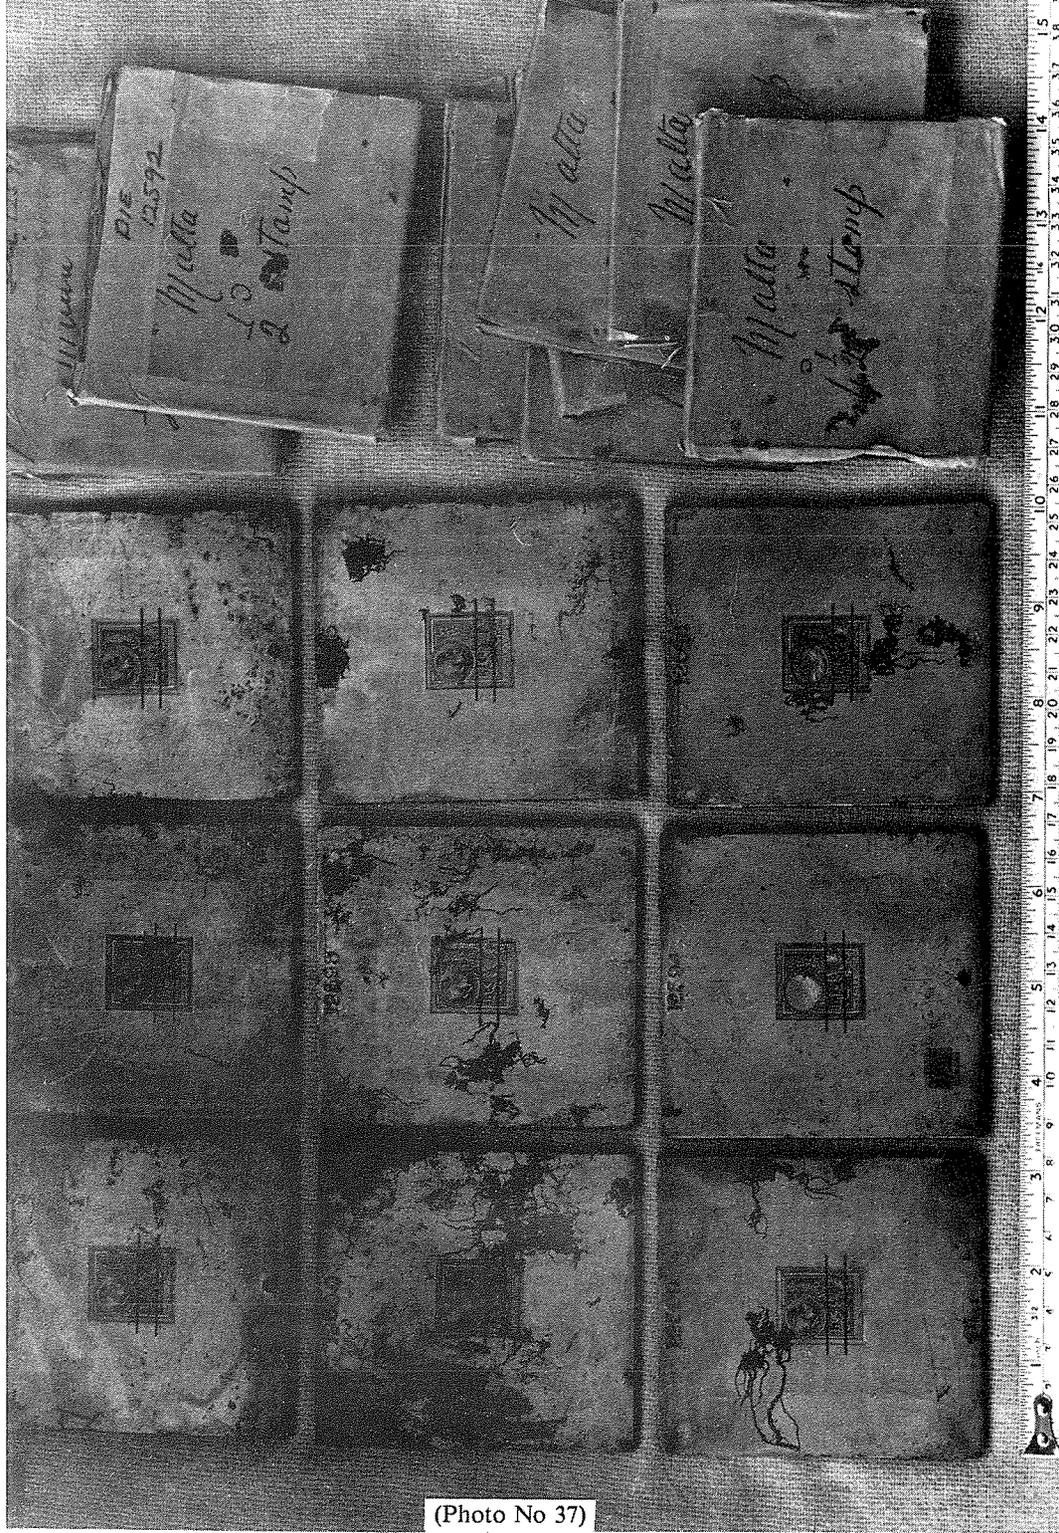
(Photo No 37)

### Artist's Dies (Photo No. 37)

1/4d – The artist's die for this stamp is on a 5mm thick steel plate which has been nickel coated. The plate is 81mm wide and 89mm high. It contains the number: "12591" at the top. The stamp image is reversed left-to-right; the die number reads correctly. There is a 3mm diameter hole bored through the bottom of the die. (Such holes allowed hooked implements to be utilized during hardening and electroplating steps.) This die has been defaced with two lines scribed through it.

1/2d – This die is similar but bears the number: "12592". A hole similar to that on the 1/4d is bored through the top of the die in the area of the stamped die number.

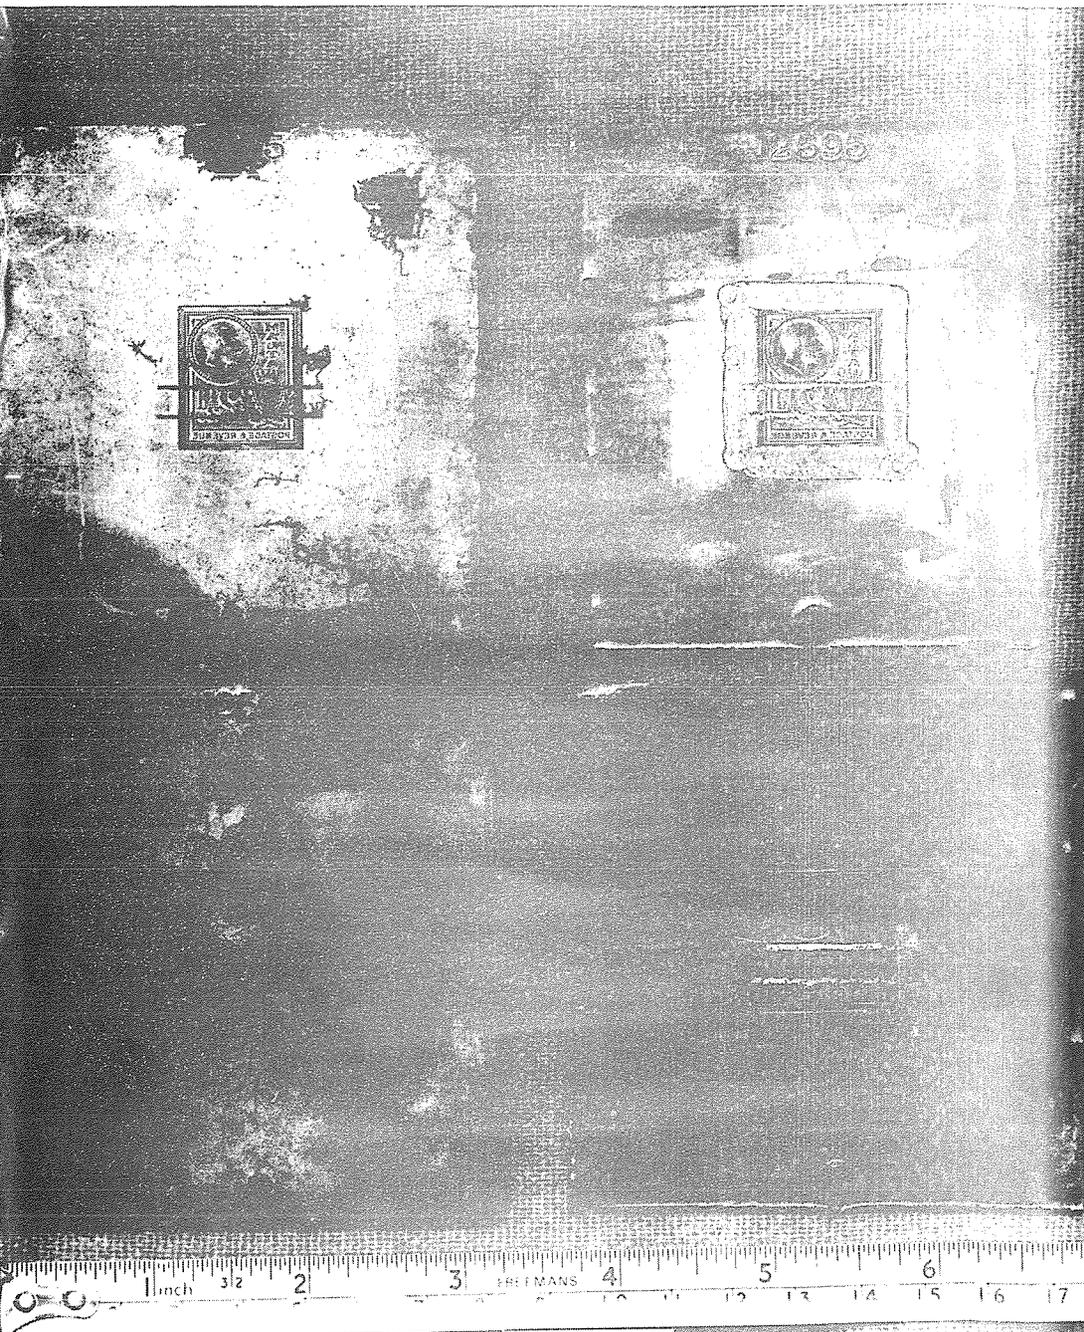
(Photo No 38)

2 – 1/2d (Photo No. 38) – This bears the number: "12695" and has a hole at the bottom.

4d (Photo No. 38) – This bears the number: "12594". It has a hole at the bottom. It has an area on the lower left where cross scribing has been done in a patch approximately 10mm × 10mm. This die contains a blank indentation in the portrait area (since it is a two-colour stamp).

(Photos 38 & 39) – These molds are 1 to 2mm thick. Their edges are curled and rough with a puddling of what had been molten metal showing at the edges and on the backs. The front is shiny and contains the image in reverse. The intended image appears through the back (not in reverse). The face side has been defaced with two scribes through each stamp. Values are present for the 1/2d through the 6d. The die numbers are the same as those given for the artist's dies above. The 6d, for which there was no artist's die, does not contain a die number. On each of these molds a protrusion is round and 4mm in diameter appears at precisely the location of the hold on the artist's dies. One of the molds, that of the 2 – 1/2d value, shows a border around the stamp apparently caused by use of a drill on a prior stage. (See Photo No. 38.)

The retired De La Rue printer contacted through Mr. Robson Lowe described these as "zincos". He indicated that only the 2-1/2d has been prepared for further use. Through use of a router on the relief version (now called an "alto") between the dies and the zincos. The shoulder allows a gutter (for perforation) to be formed. The printer believes the other zincos were spares not yet prepared for further use.

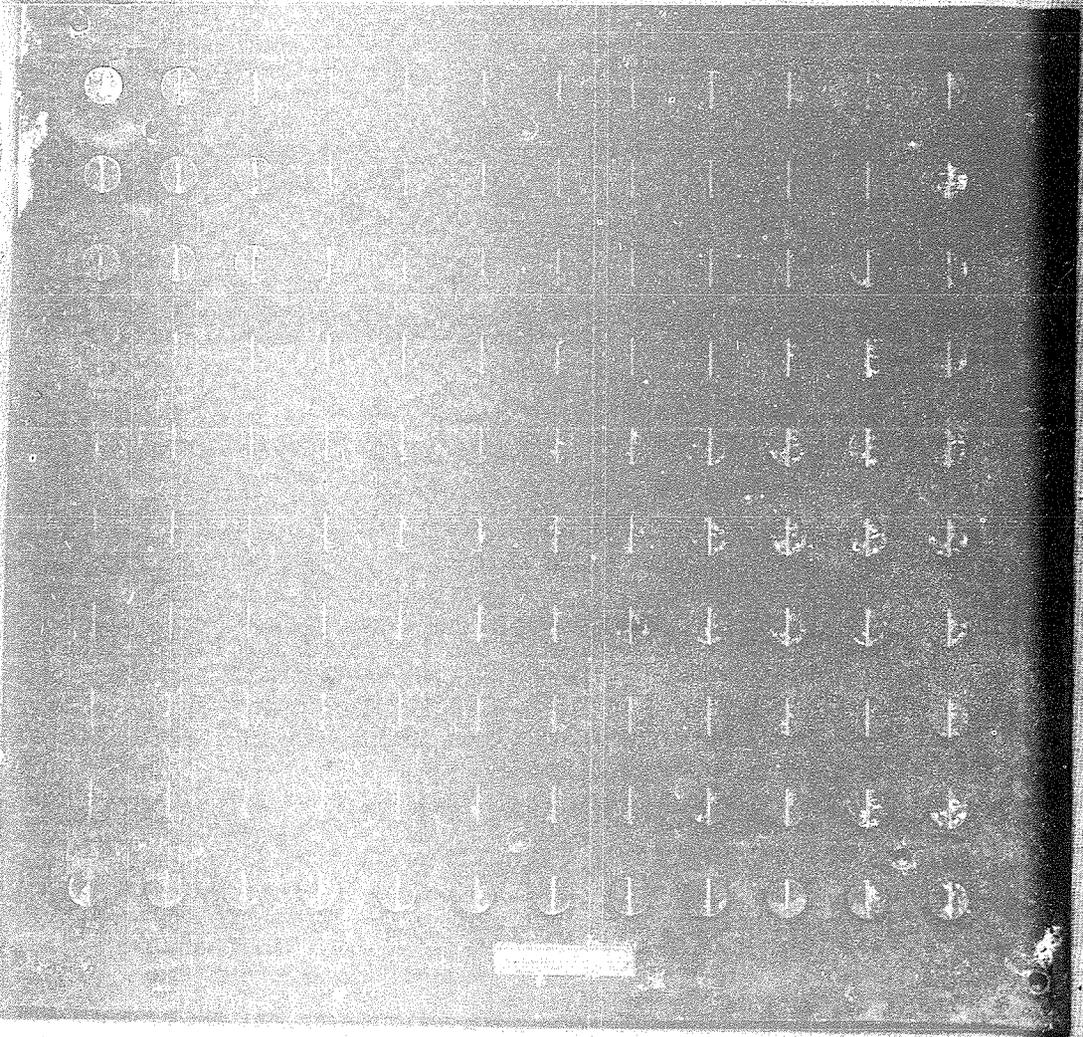
(Photo No 41)

(Photo No. 41) – There is a relief steel plate 4mm thick containing 120 vignettes of the head of King George V. There is a copper coating on the face of the steel plate but an extremely thick layer of corrosion atop this renders the image almost impossible to see. Stamped in the plate is the legend: "Key Plate" with a blank area after the word "Plate" which has been manually scraped from the surface to a depth of 1/2mm obliterating whatever word had been there. At the top of the plate there is punched the numeral "1" in a circle. This appears in a lower area of the surrounded where it would not print. The plate is 279mm wide and 274mm high. The images are in the spacing and format of this issue. A single line defacing the image has been scribed through all 120 vignette heads.

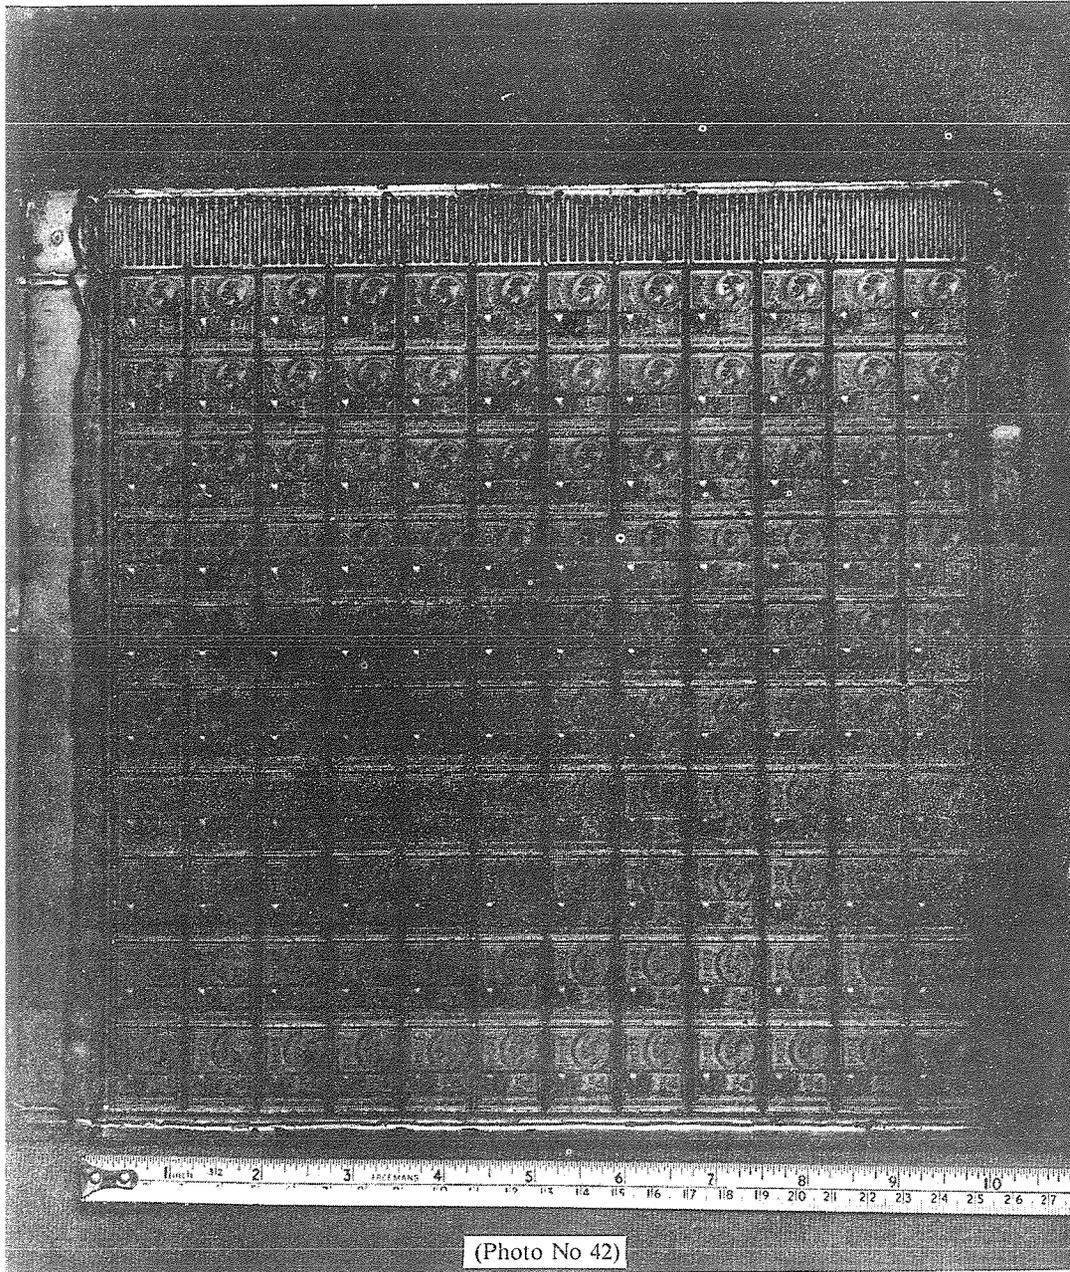
(Photo No 42)

A copper mold coated with a yellowish-silver metal exists for each of the printing plates. The image reads correctly. In all cases two lines have been scribed through each row of stamps defacing the plate. These were the masters (each sometimes called the matrix) used to produce the printing plates.

1/4d (Photo No. 42) – The mold consists of 120 images in the plate layout with the row of vertical pillar lines one stamp high above the top row of stamps. There are no marginal or other notations nor any plate numbers.

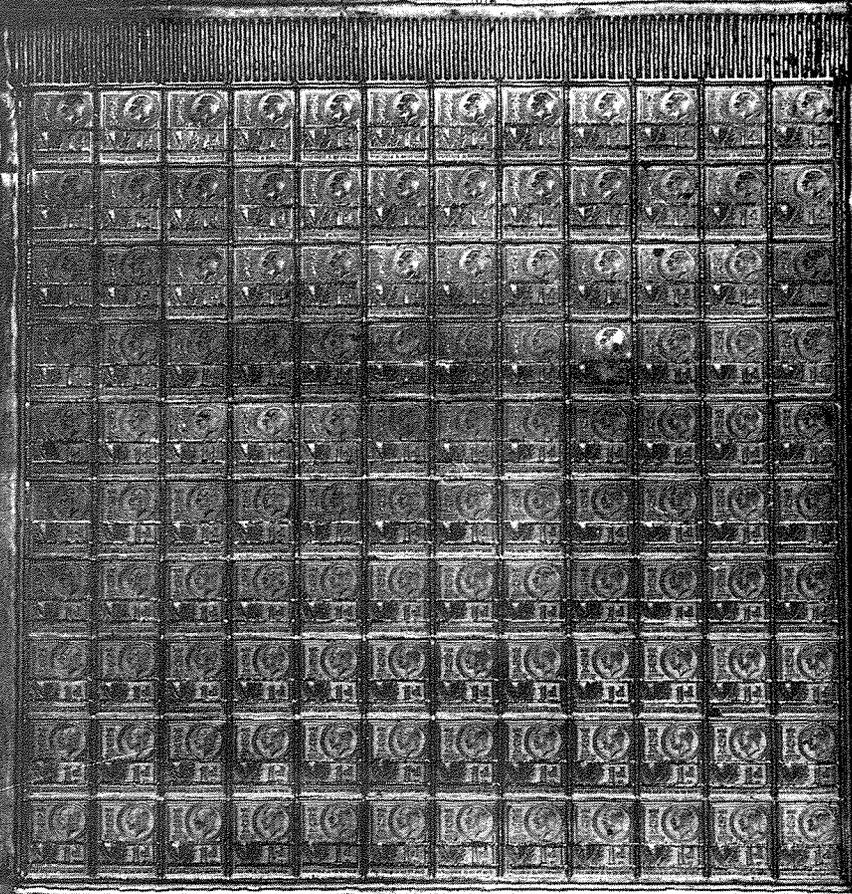
(Photo No 44)

1d (Photo No. 44) – Same as above.

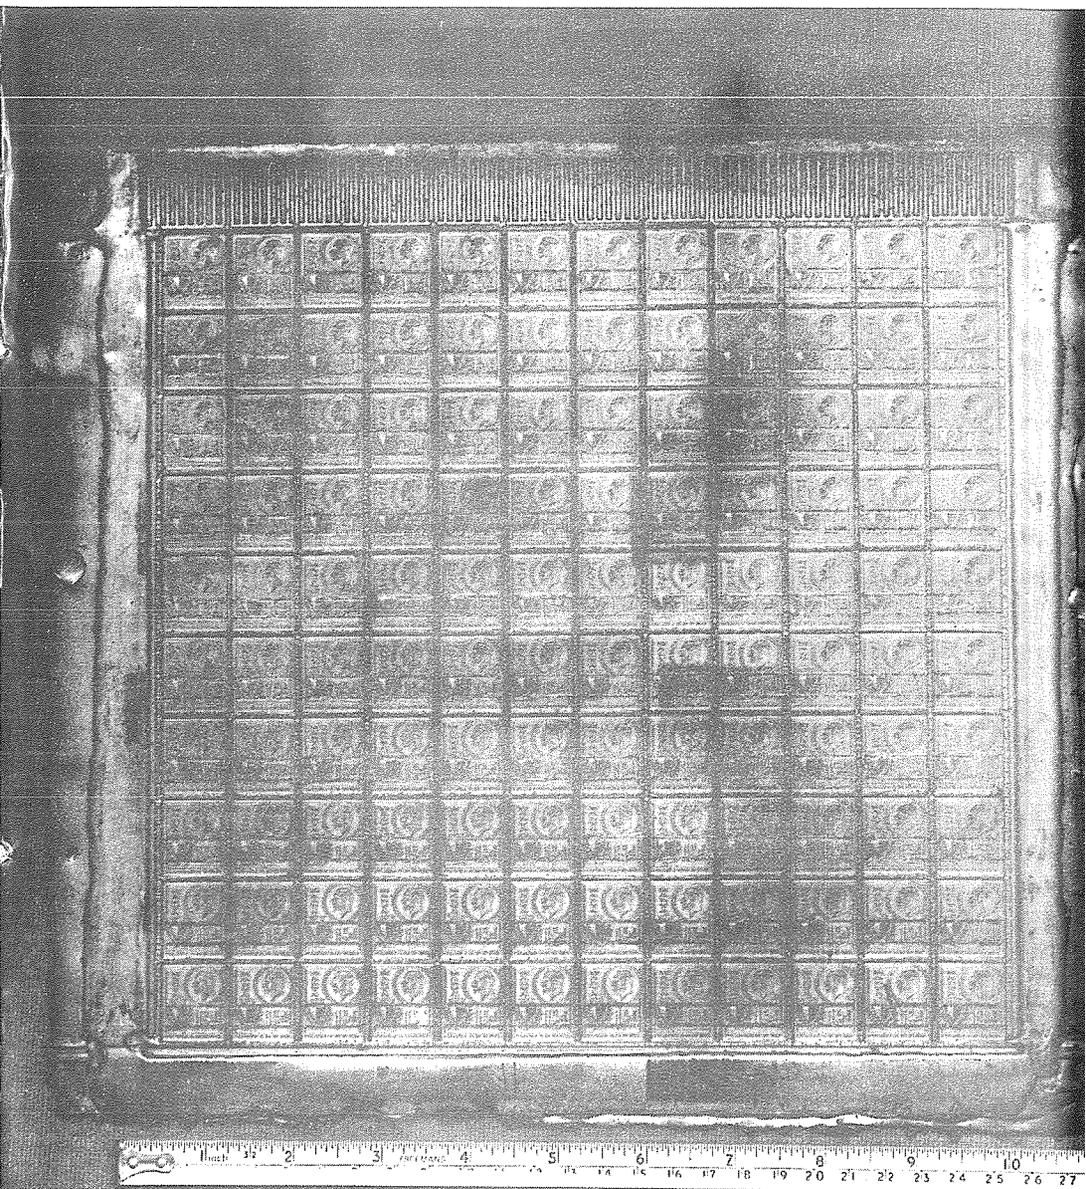
(Photo No 45)

1-1/2d (Photo No. 45) – Same as above.

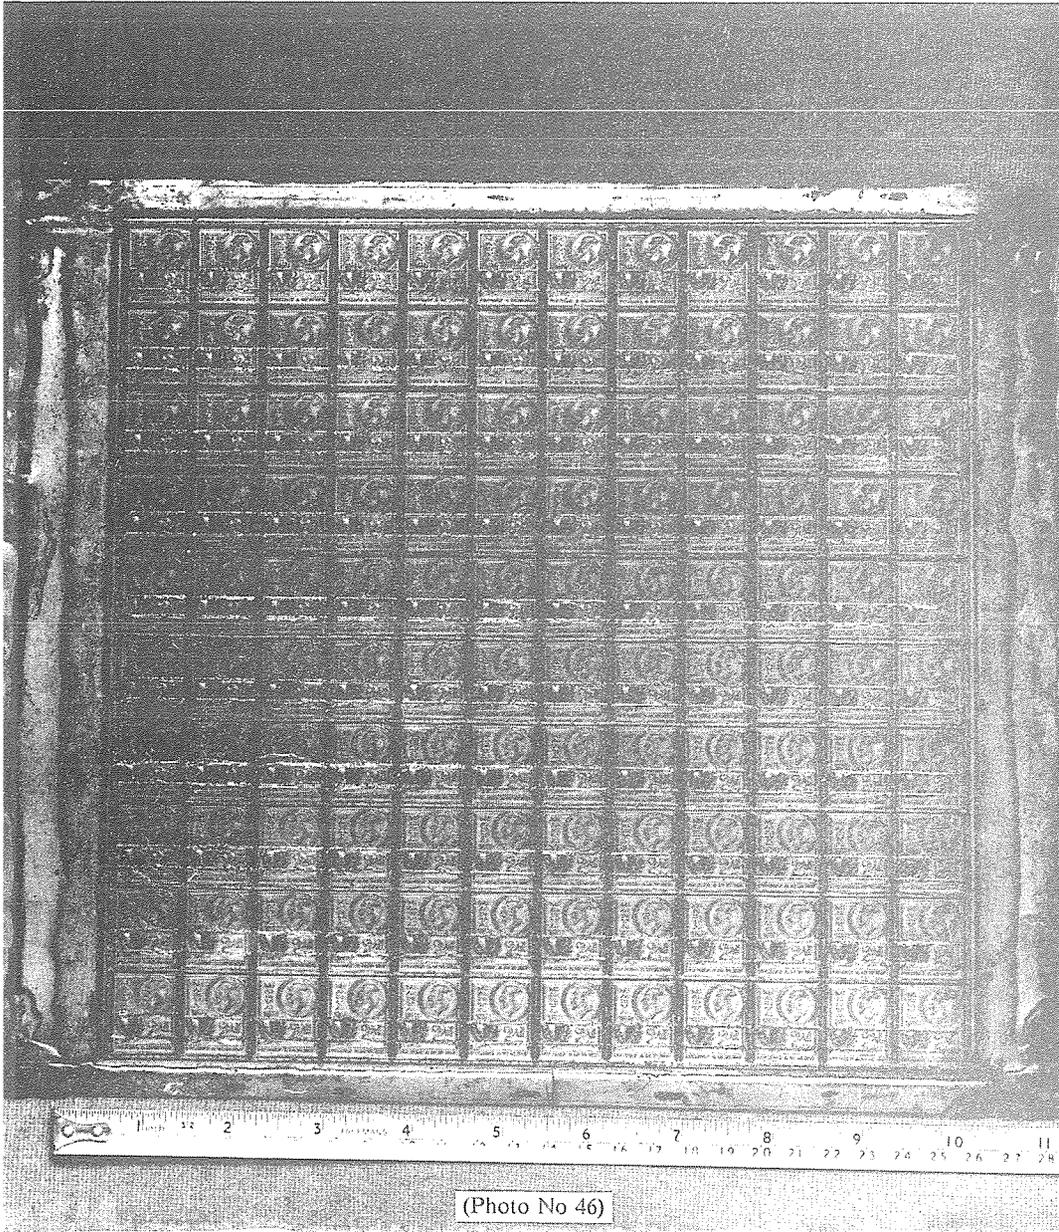
(Photo No 46)

2d (Photo No. 46) – Same as above except that the border is plain above the top row of stamp and no vertical pillar lines are present.

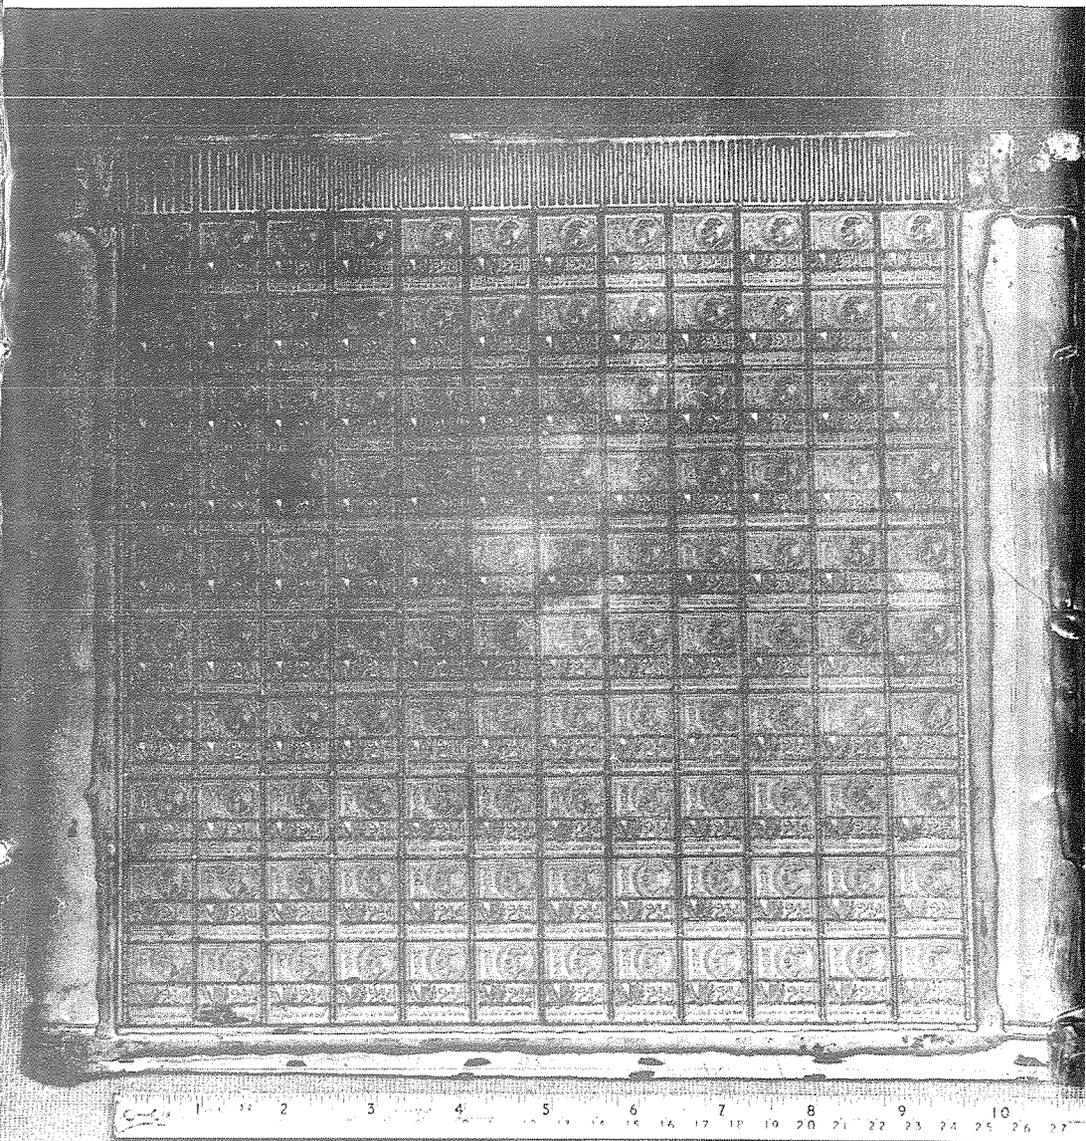
(Photo No 47)

2-1/2d (Photo No. 47) – As 1/2d above.

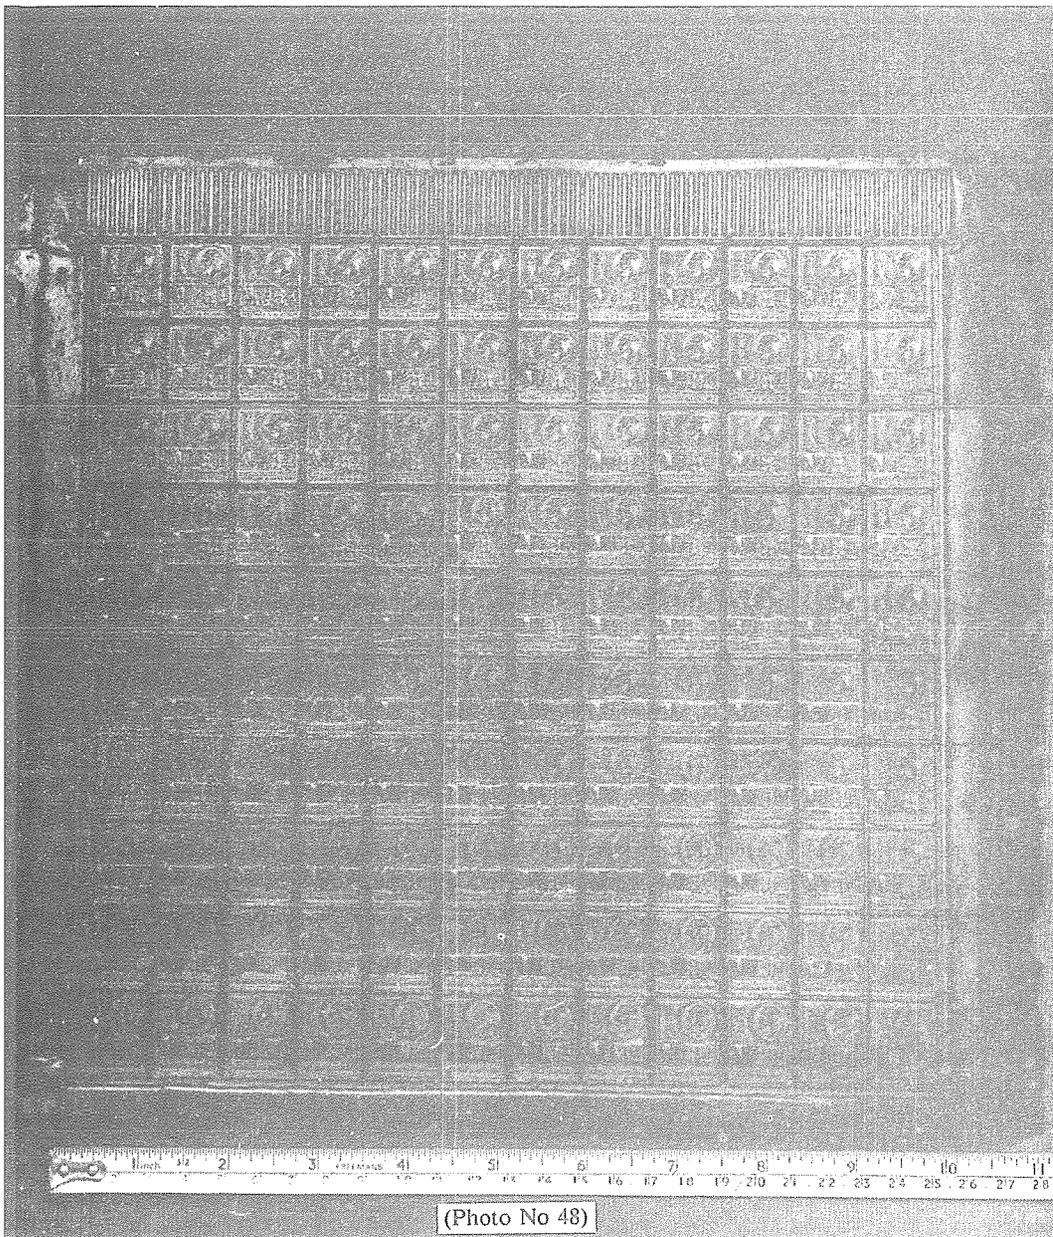
(Photo No 48)

3d (Photo No. 48) – As 1/2d above.

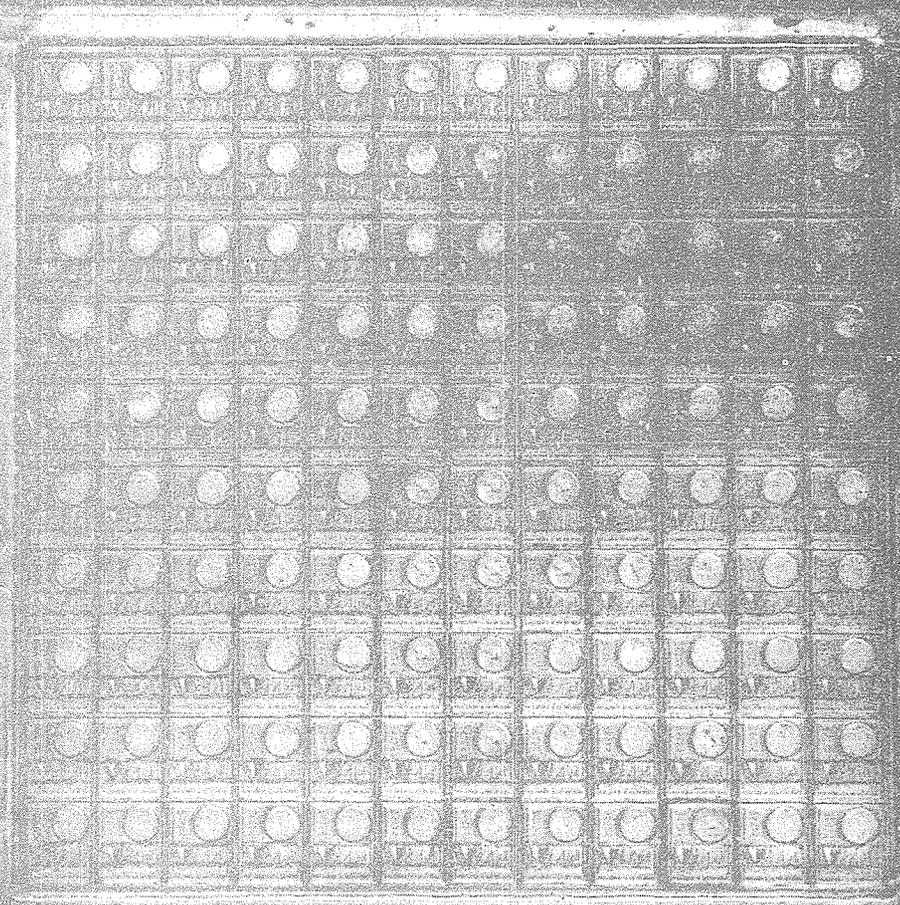
(Photo No 49)

4d (Photo No. 49) – This mold is as above except that the vignette area is raised and blank. There are no pillar lines in the border above the top row of stamps.

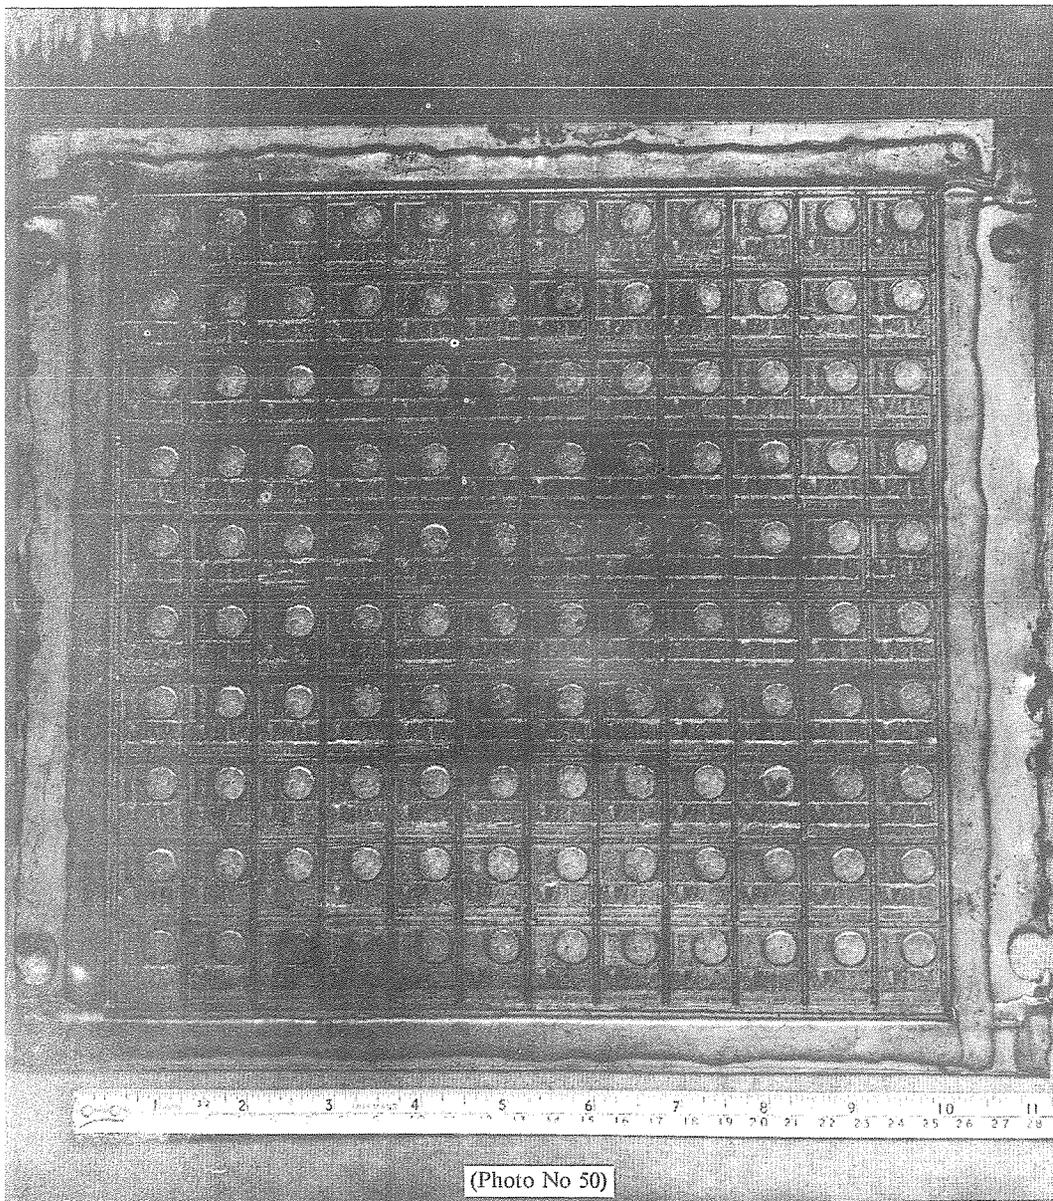
(Photo No 50)

4-1/2d (Photo No. 50) – As 4d above.

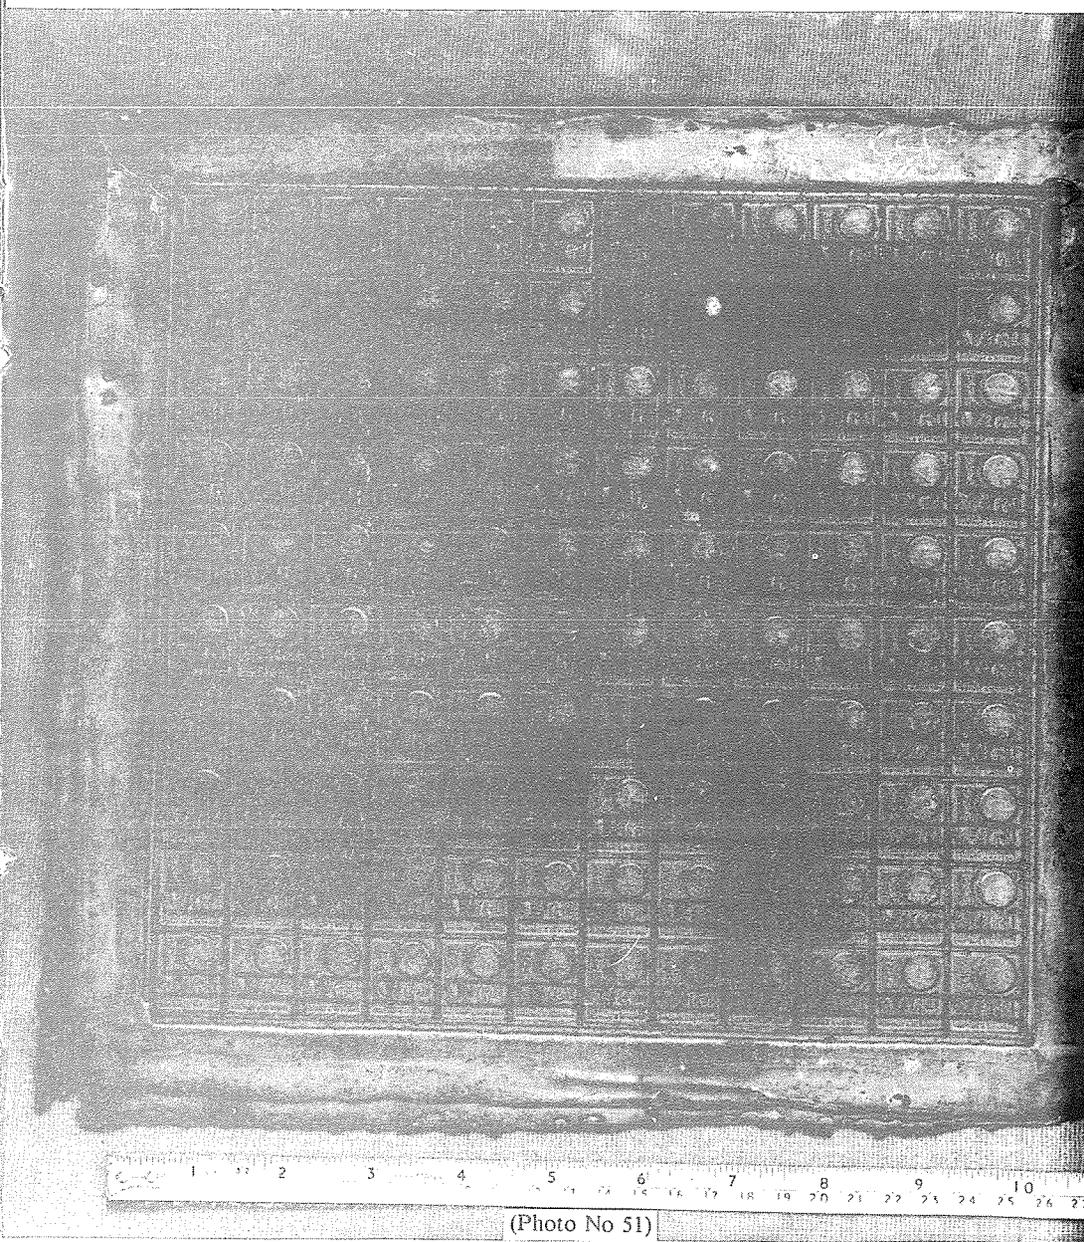
(Photo No 51)

6d (Photo No. 51) – As 4d above.

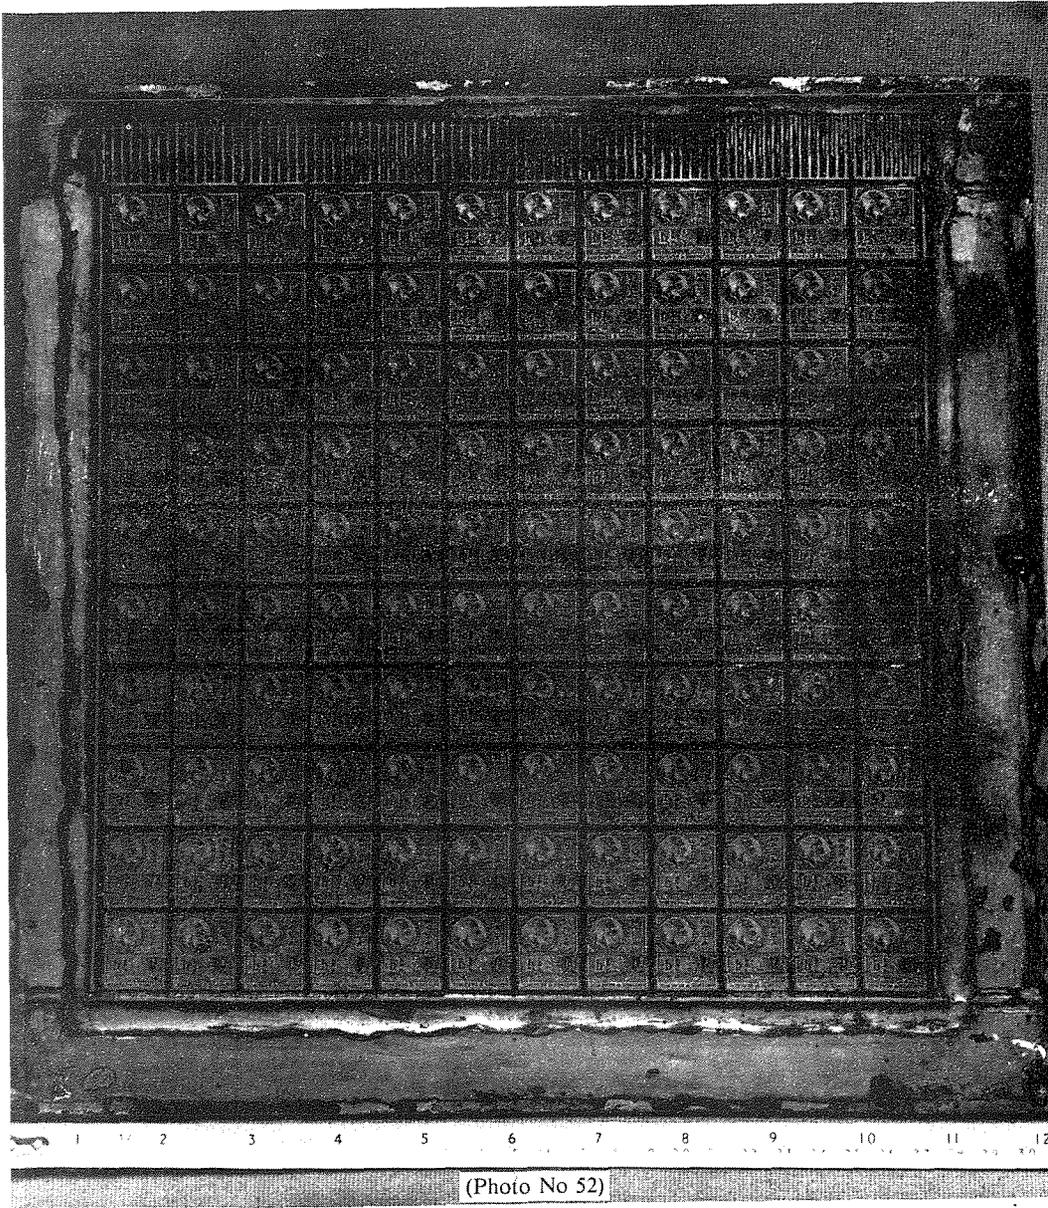
(Photo No 52)

1/4d (Photo No. 52) – This is a steel relief printing plate 4mm thick with a raised copper image on the surface and a yellow/silver metallic coating (nickel?) atop the copper. There are 120 images in a single pane with 10 rows of 12 stamps. The images are reversed left-to-right. Above the top row is a band of vertical stripes one stamp high. There is a single Jubilee Line around the entire sheet. It is broken at each corner and at the top between each stamp. There are no marginal marks of any sort. There is a border of metal approximately 30mm around the image area on both sides and the bottom. A similar sized border at the top contains the vertical stripes. The image has been defaced with a pair of scratches through each stamp.

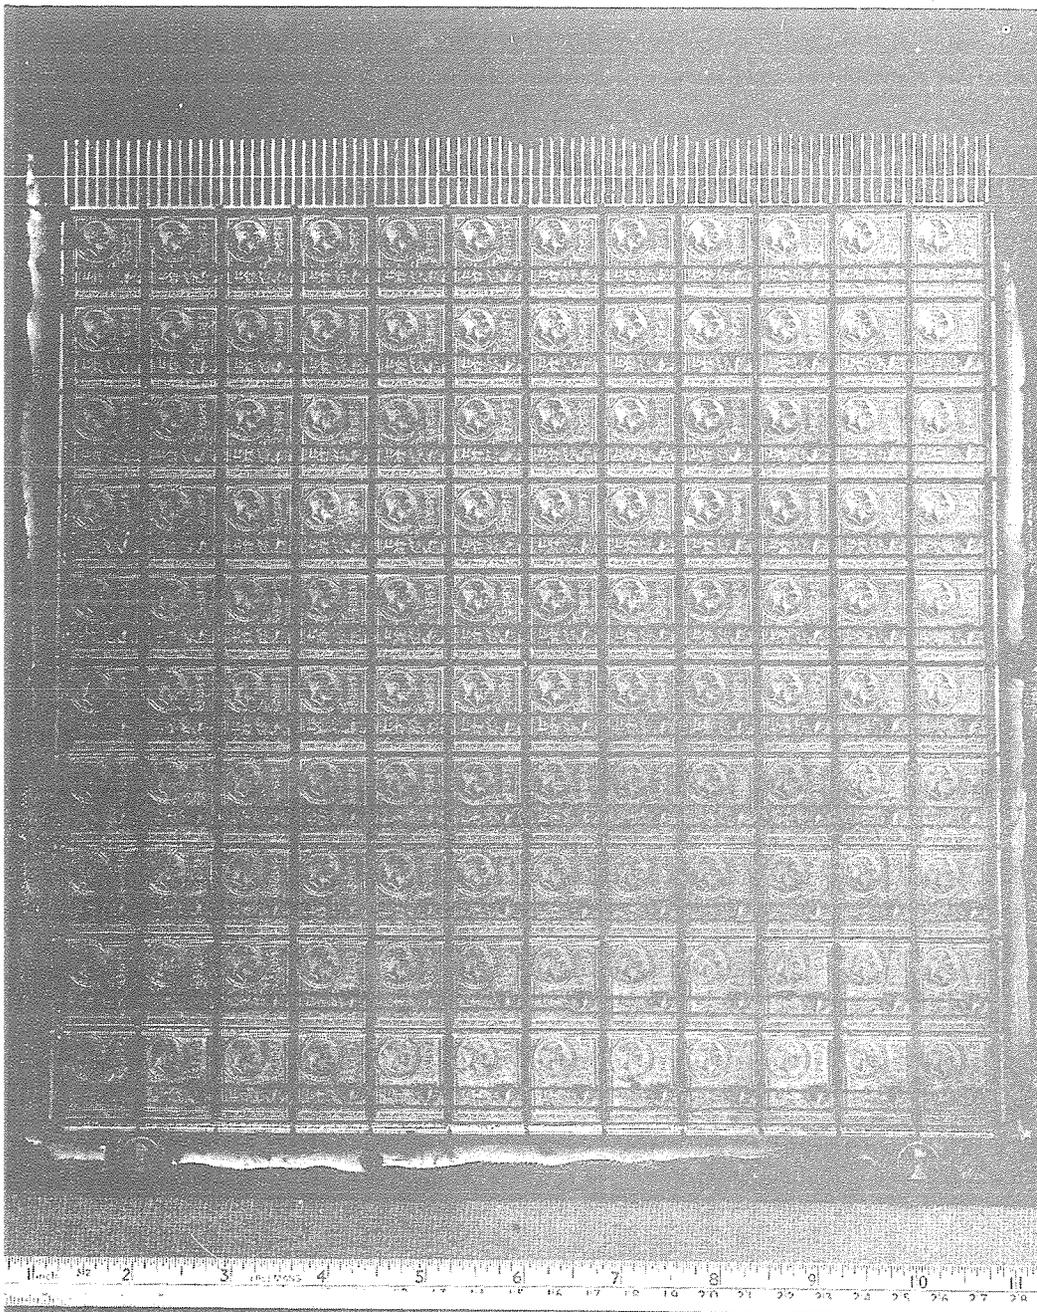
(Photo No 53)

(Photo No. 53) – A second set of printing plates exists. This consists of a bottom pane and a top pane which are separate but appear to have been used together affixed to a common backing which is no longer present. The bottom pane is similar to that described above with the following exceptions:

- A. The border has been cut down so that it is approximately 12mm wide at each side and 15mm wide at the bottom; and,
- B. The plate numbers “1” in a solid colour with a solid ring around them has been braised or soldered into the bottom margin mid-way between first and second stamps at each end of the bottom row; and,
- C. The top margin contains the vertical stripes described earlier. However, the plate has been cut or broken off precisely across the top of the stripes.
