# Finding a Treasure Trove of Information

Part 3

## THE 1926 – 1930 GEORGE V DEFINITIVE

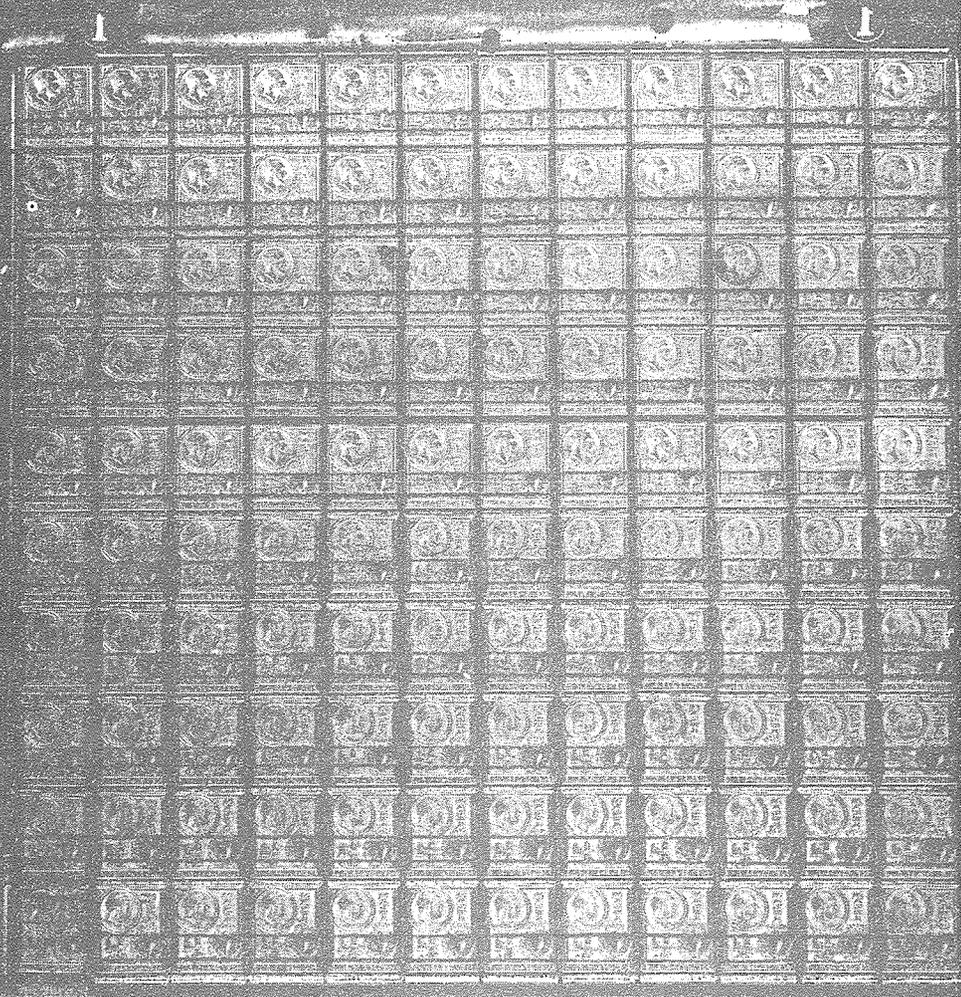
(Photo No 54)

(Photo No. 54) – The top half of this pair of plates is generally as described immediately above. The plate numbers “1” have been soldered into the upper margin between the first and second stamps of each end of the top row. The lower left corner stamp (row 10, No. 12) in the top pane has been cut out and replaced with a new cliché which is soldered or welded into the plate. The entire thickness of the plate is replaced. (See Photo 90 for a view of this type of replacement from the back of a plate.)

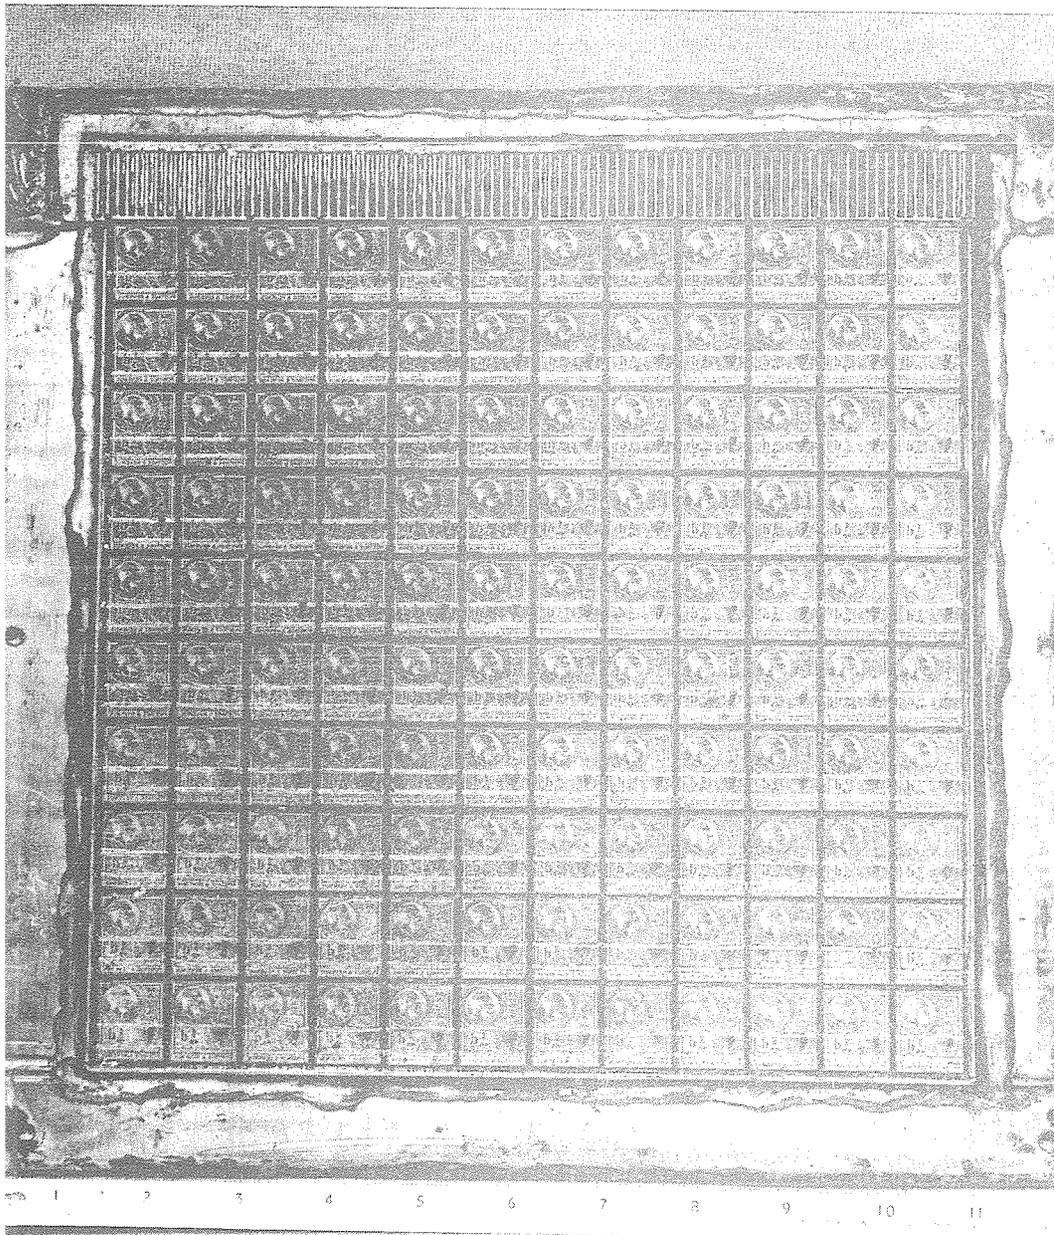
(Photo No 55)

1/2d (Photo No. 55) – There is an unnumbered plate with large margins essentially identical to that described above for the 1/4d.

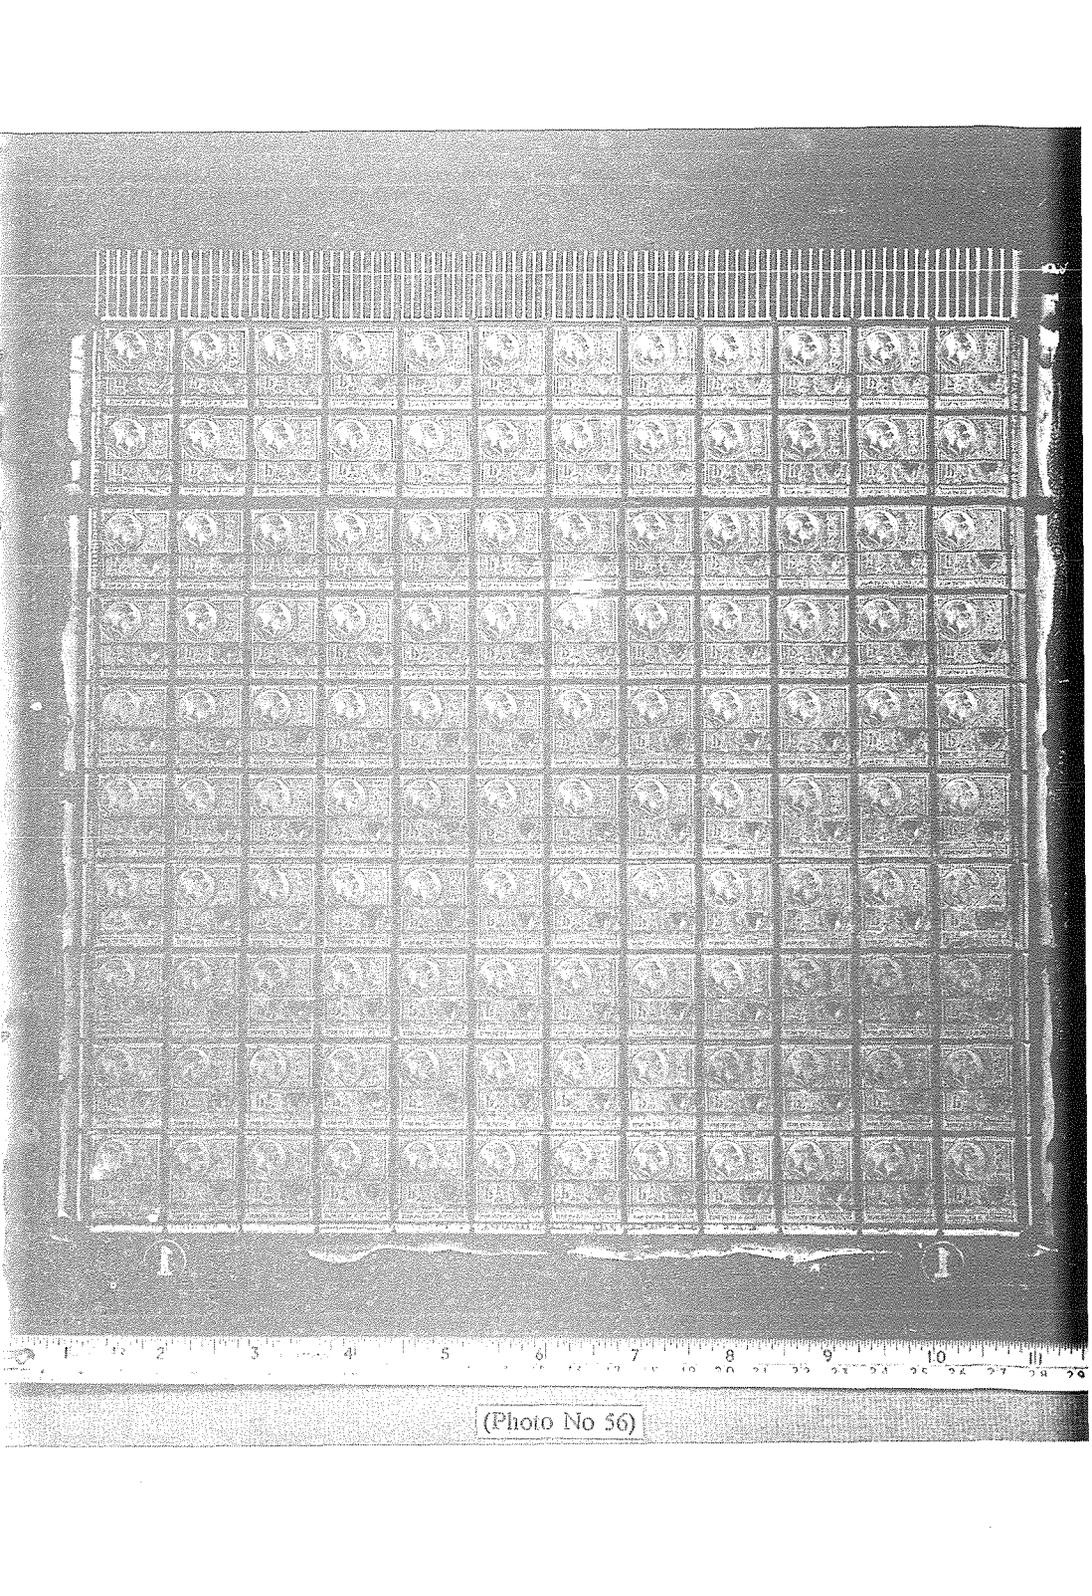
(Photo No 56)

In addition, there are the separate top and bottom panes as described for the 1/4d. Interestingly, however, the bottom pane is mounted on a manufactured backing. This carries the trademark: “Whitfield’s Ironwood Printing Board” (Photo No. 56).

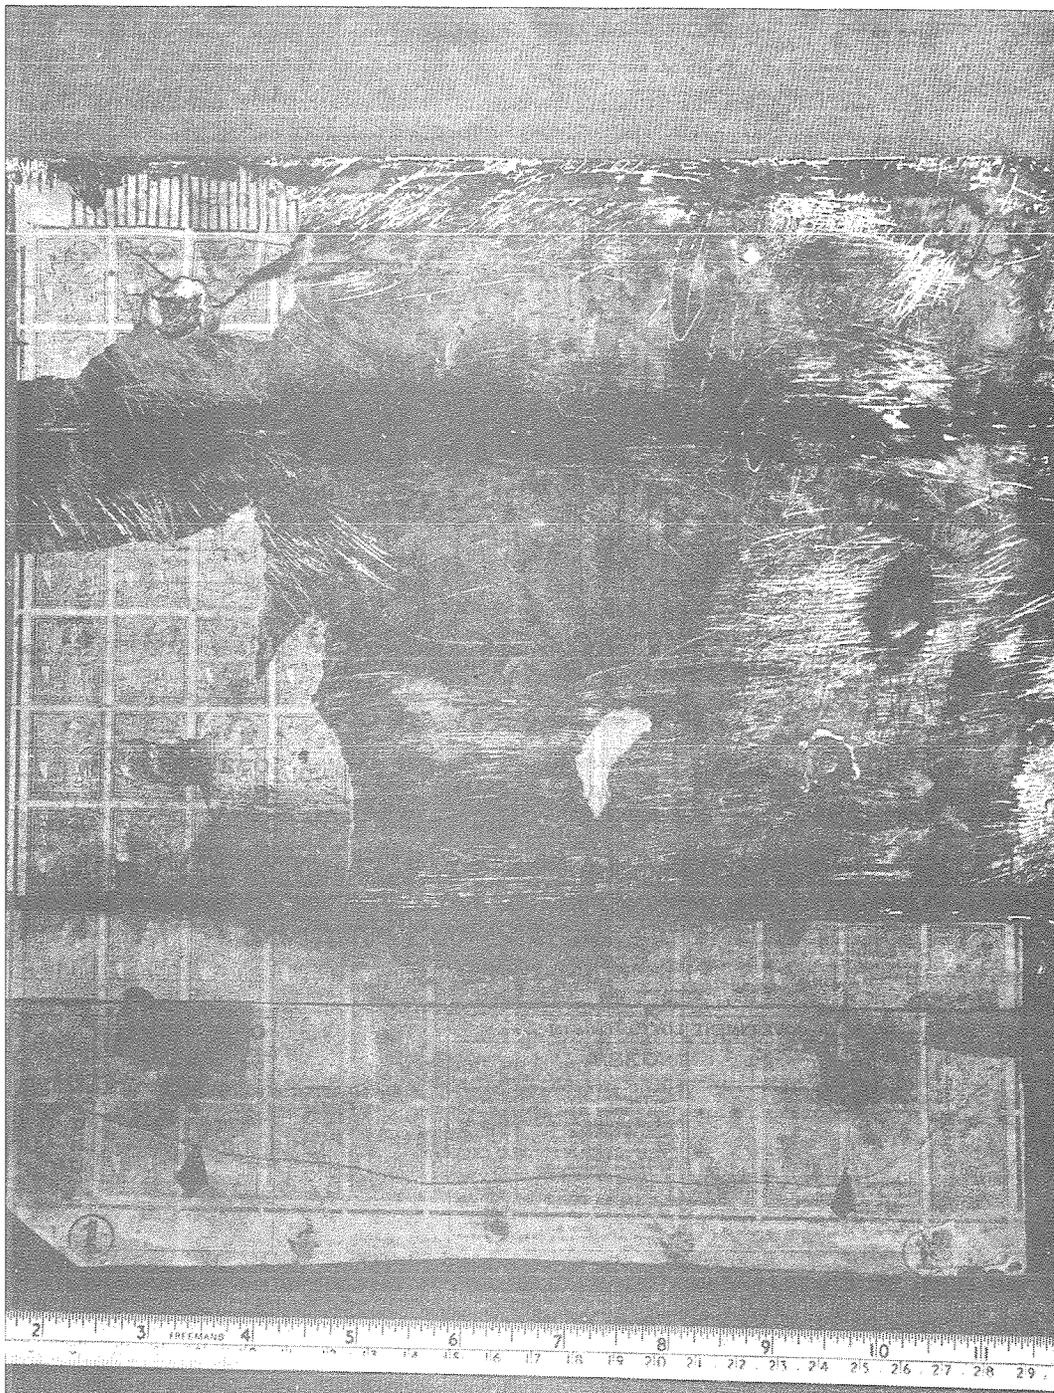
(Photo No 57)

The bottom pane plate attached to this board has broken off into three pieces. Glued to the back of the metal pieces is a pane printed from this plate on a thin paper. The colour of the printing is in the green of the issue stamp. There are remnants of the same green colour ink on the plate (Photo No. 57).

The 1930 1/2d George V Postage and Revenue Plate which was attached to a prefabricated printing board was broken in three places. The attachment was effected by tacks driven into the backing through holes in the plate. When the segments were lifted from the board a neatly printed pane of the 1/2d value in the issued yellow/green colour was found attached to the back of the plate. This printing was on paper which was aged and broken due to brittleness. Most of it

The more than one hundred plates found in the storage attic were scrupulously cleaned of ink with three notable exceptions. These were plates for the 1930 1/2d value described above, which along with 1 - 1/2d and 6d plates of the same issue, were heavily coated with ink in the respective issued colours.

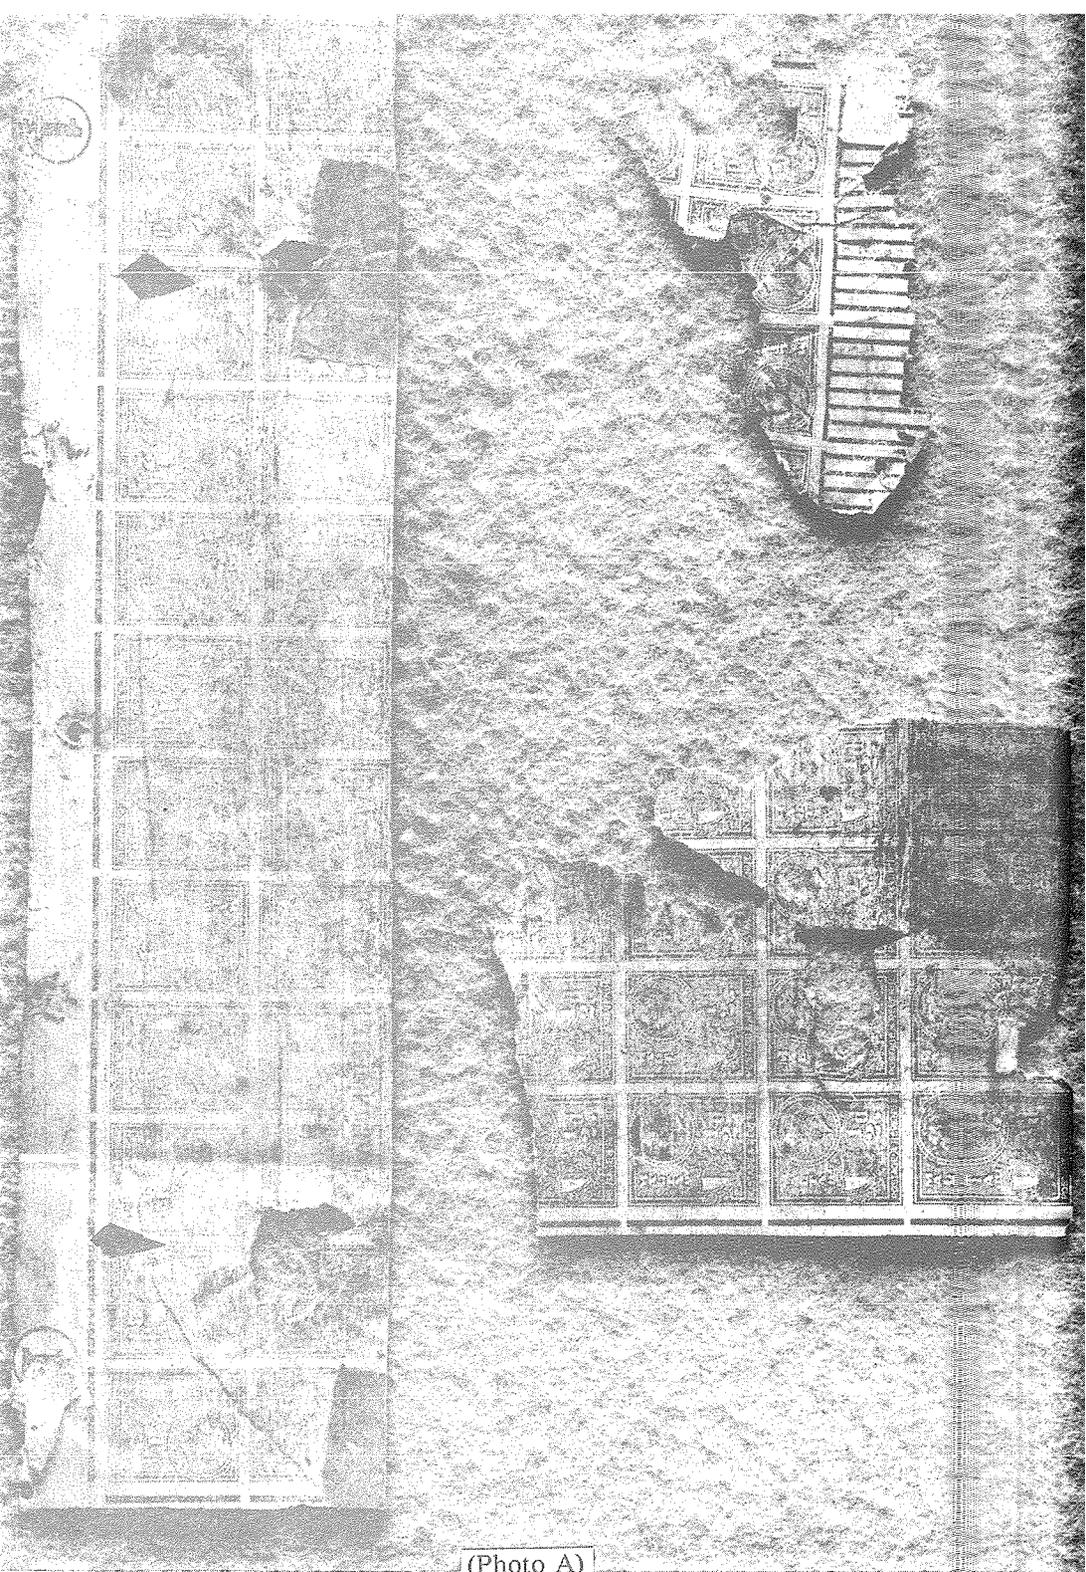
adhered to the back of the plate, but a bit adhered to the printing board. (Photo A)

This paper contained on its reverse a form for Malta Lotto tickets printed in English and Maltese. (Photo B)

Several data suggest that the paper was deliberately printed rather than an offset from ink that was left wet. First, it was on the back of a printing plate which has been attached to a backboard. Therefore, it could not have casually received an impression during stacking of the printing plates. An impression could have been received only had the plate been removed from the backing board and wet ink on the plate contacted the paper. It is improbable that an inadvertently printed piece of paper would have then been fastened between plate and backing board before the plate was nailed down.

The placement of a sheet between plate and backing board is a normal shimming operation to slightly raise the level of the type in the printing forme. The Malta Lotto form which appears to have been used during printer's makeready would not be expected to be at hand in the security printer's shop in London. It would have been more economically printed at the Government Printing Office in Valletta. However, since the plates were defaced before leaving London, and the image on the lotto forms is predefacement, clearly this printing occurred in London.

A probable explanation is that waste from each colony's security printing was kept segregated for purpose of accountability. For whatever reason the lotto tickets had been printed in London, the excess Malta lotto sheets were used for the makeready during a printing of the 1/2d 1930 issue.

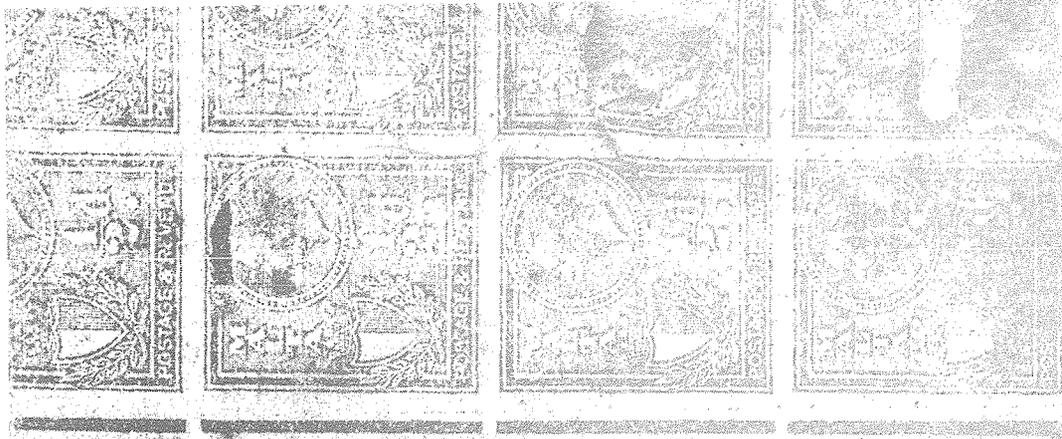
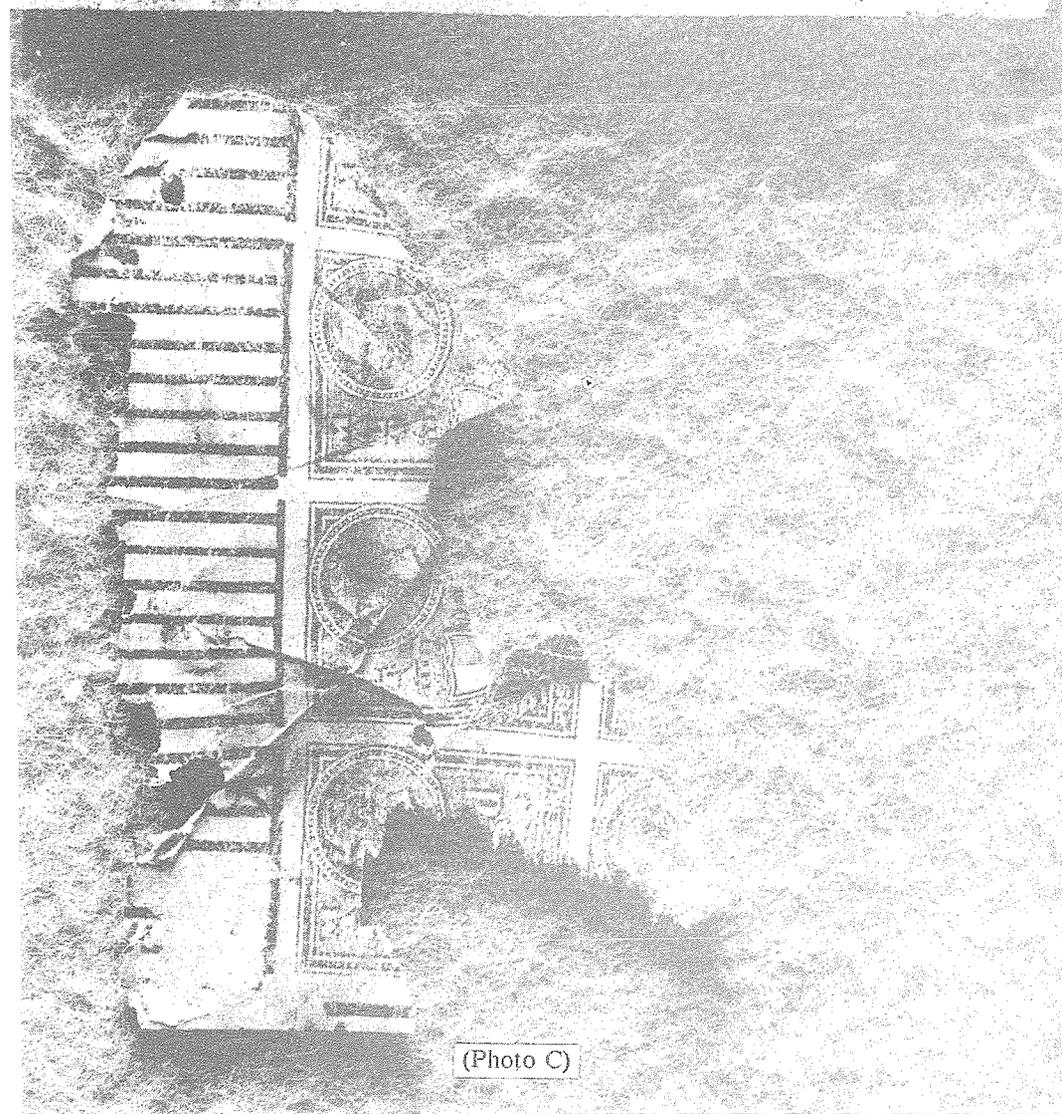
Secondly, several razor cut diamond-shaped openings appear in the paper. These are of the type normally made by a printer after a trial image has been pulled in order to place the trial sheet atop another image and check the registration in different areas. It is improbable that a casually placed interleaving sheet of scrap from paper would contain these neatly cut holes. (Photo C)

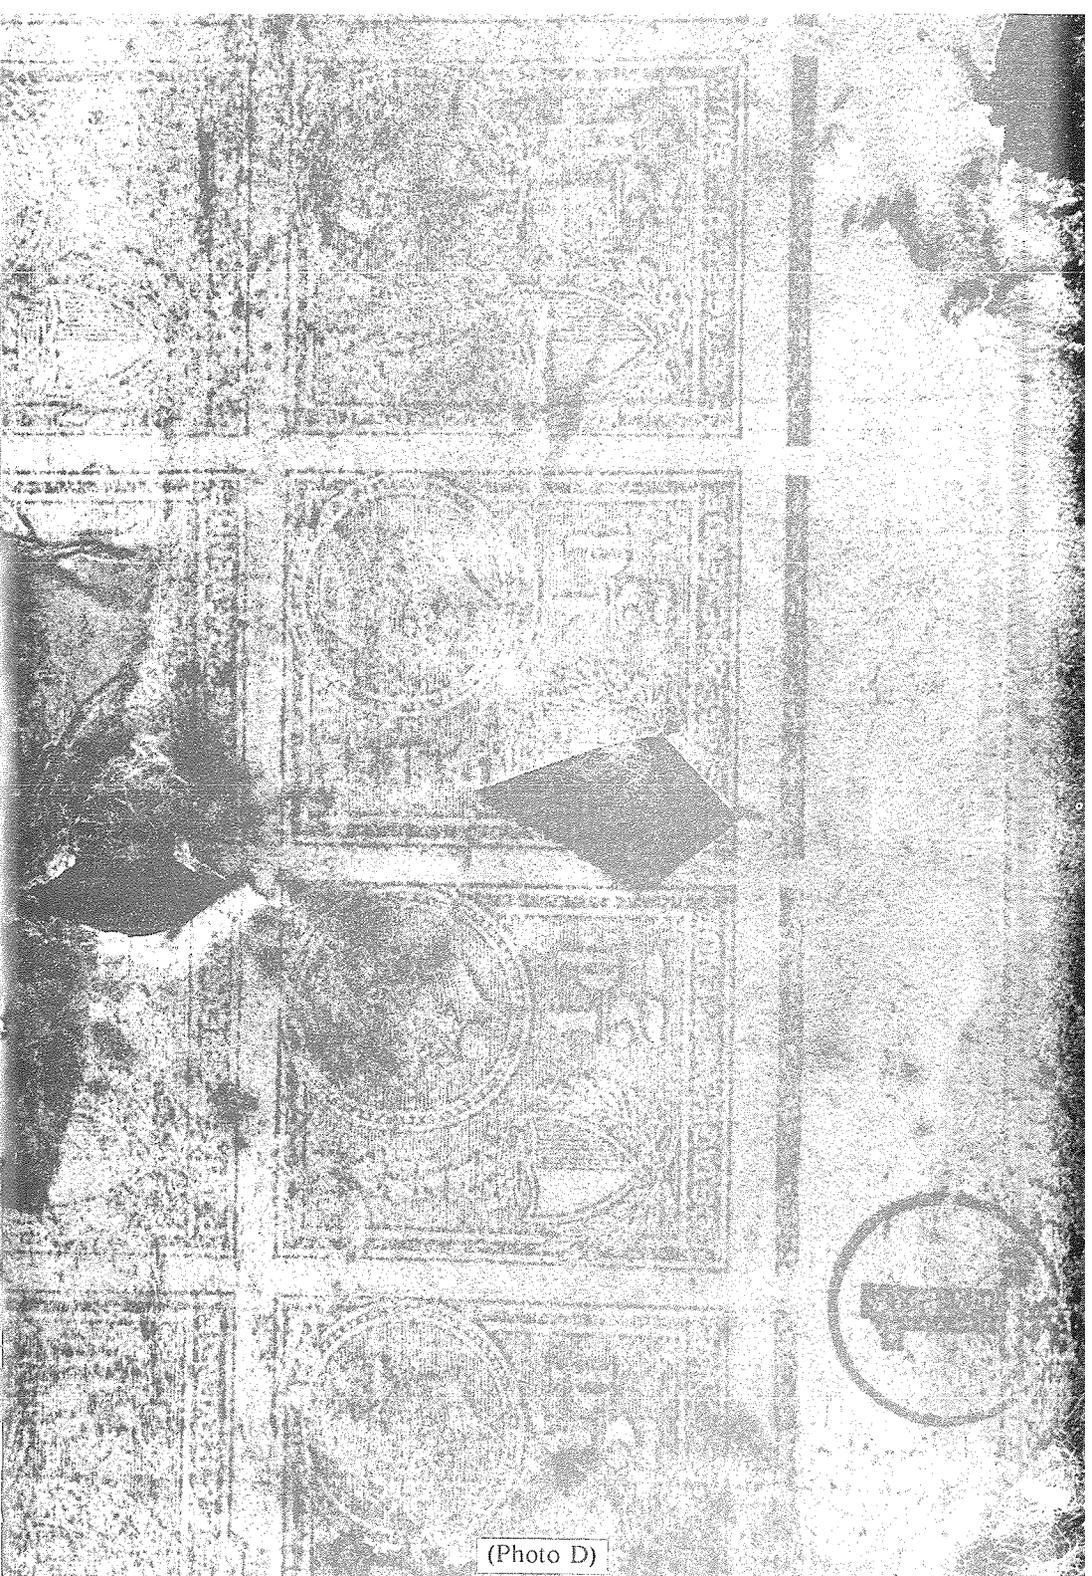
Finally, the image is, although faint from aging, even and quite strong in the border portions. This type of image requires extreme pressure even with fresh ink. If this were ink that had stayed on the plate since it was inked in London, with the Malta form placed on it after the plates were shipped to Malta, it is highly improbable that this type of image could have been printed. (Photo D)

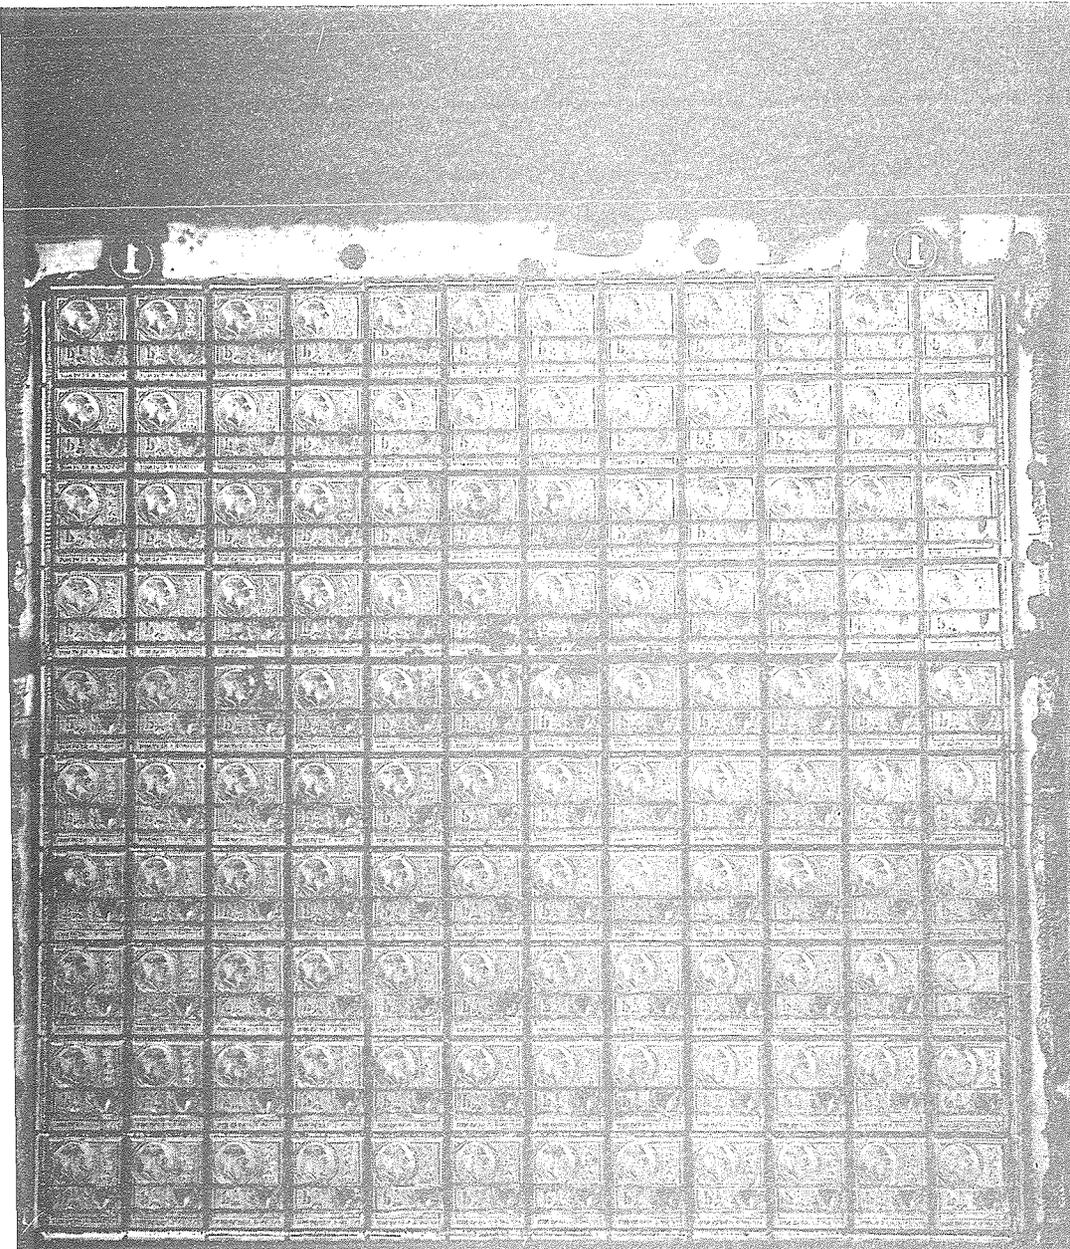
(Photo No 58)

(Photo No. 58) - The top pane printing plate is also similar to that of the 1/4d. It also contains remnants of yellow/green ink; and, also on the back are remnants of the neatly-printed pane of stamps in the yellow/green ink.

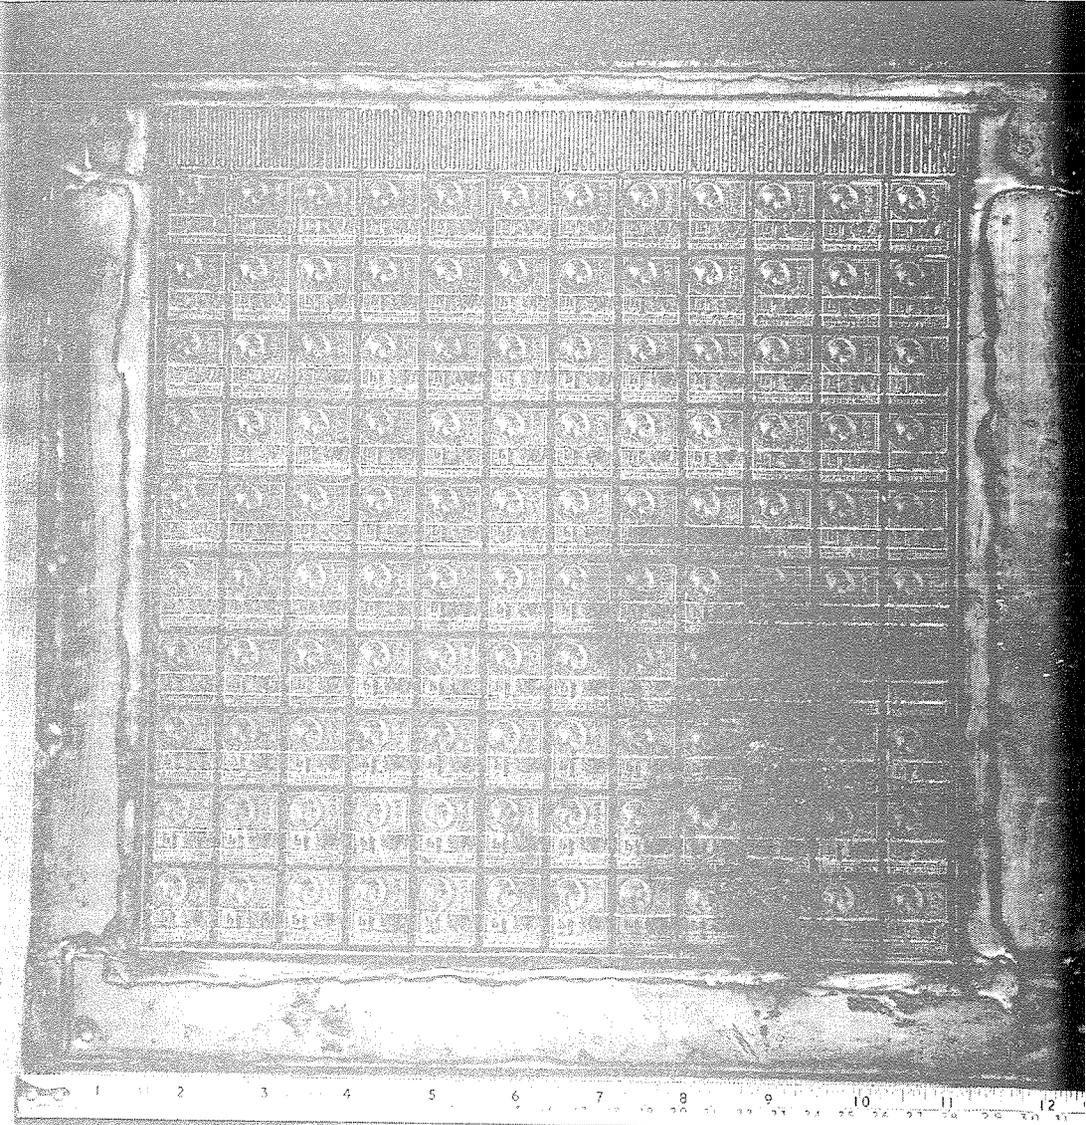
(Photo No 59)

1d (Photo No. 59) - The unnumbered single pane is as the 1/4d.

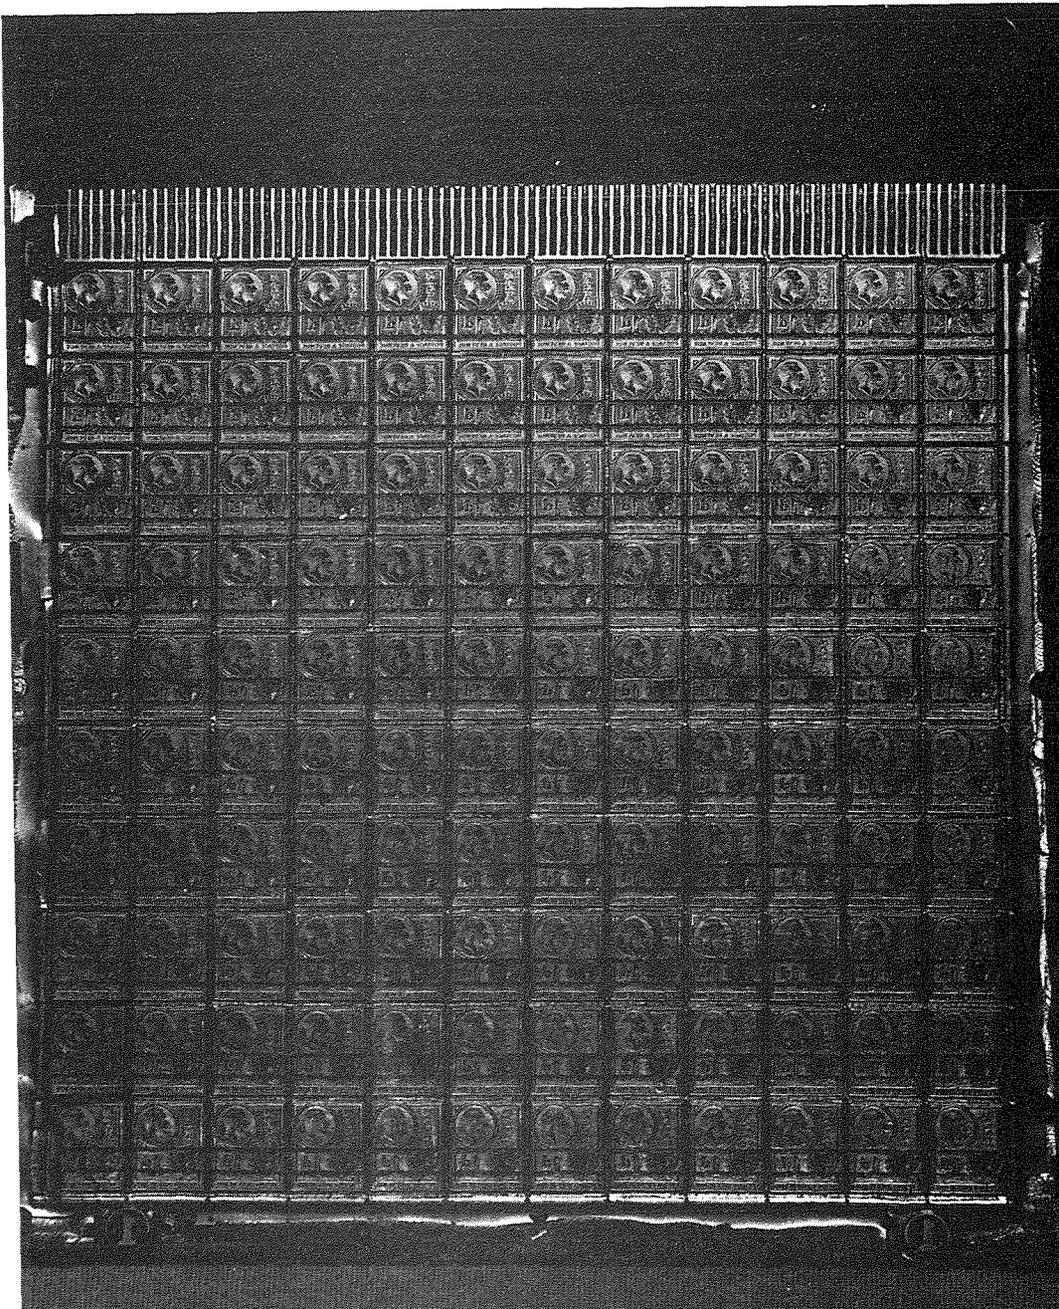
(Photo No 60)

(Photo No. 60) - The bottom pane is as described. Individual stamp printing cliches have been replaced in row 4, No. 6, and row 9, No. 12.

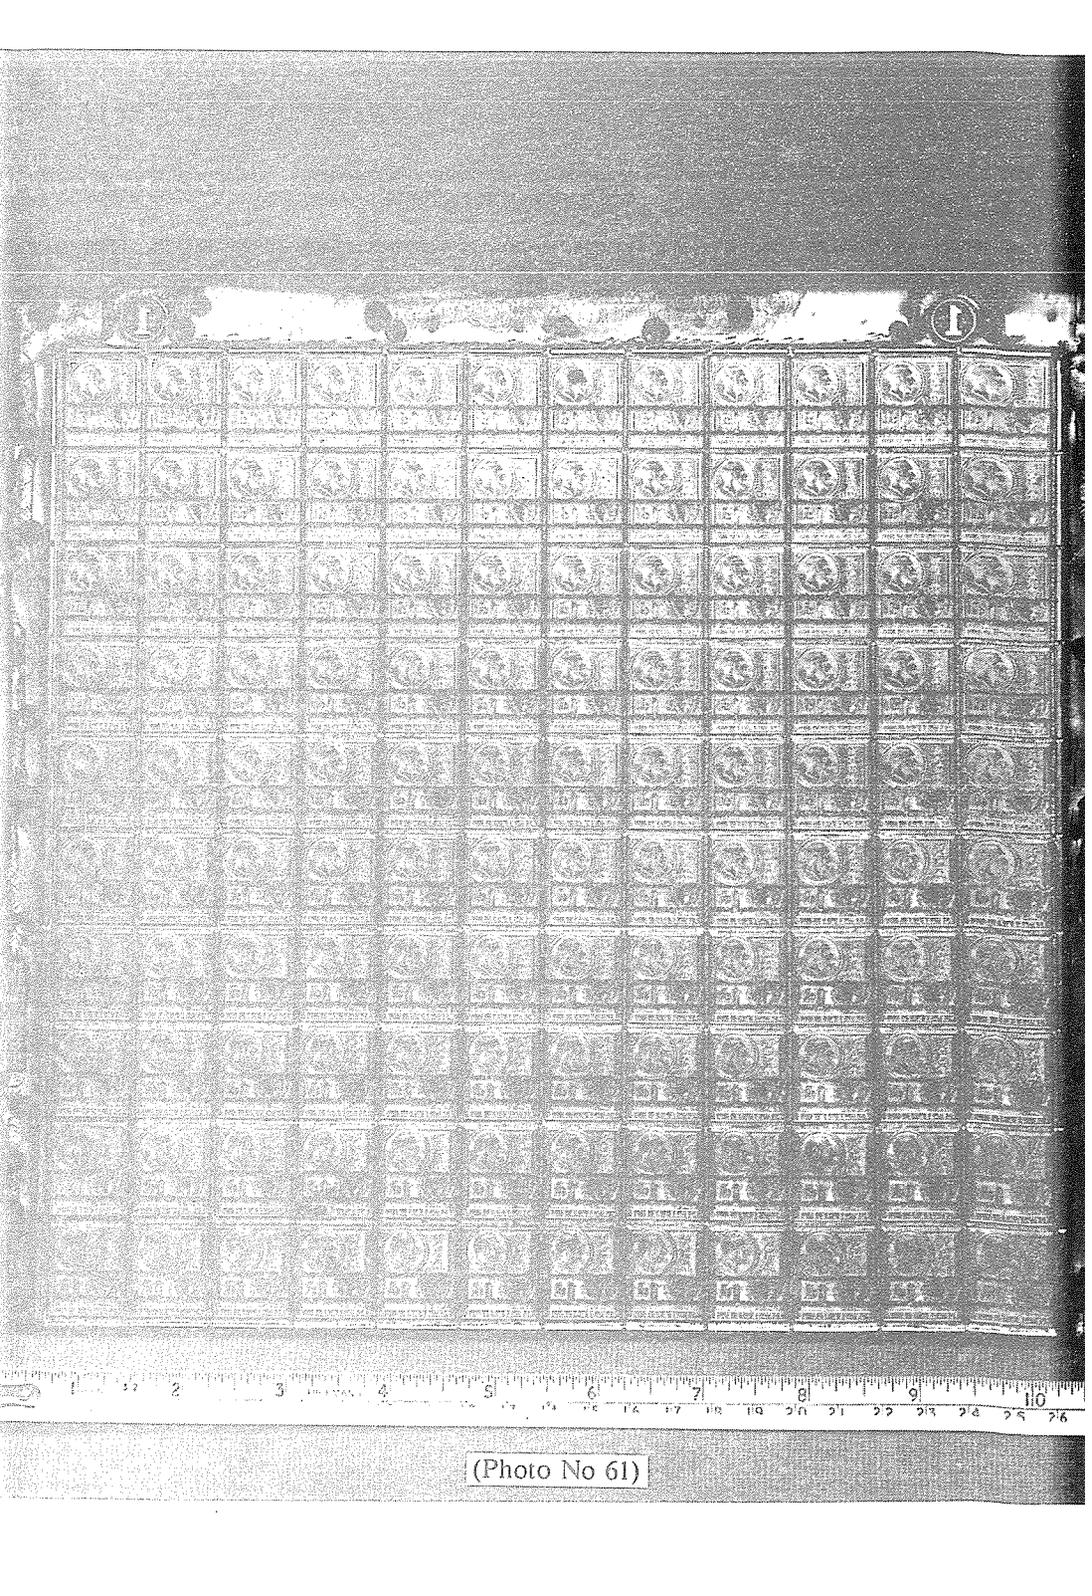
(Photo No 61)

(Photo No. 61) - The upper pane is as described for the 1/4d. Stamps were replaced at row 2, No. 2.
