H̄uqoq – 2019

Jodi Magness, Shua Kisilevitz, Matthew Grey, Dennis Mizzi,
Jocelyn Burney, Karen Britt and Ra'anana Boustana

31/12/2020
Preliminary Report

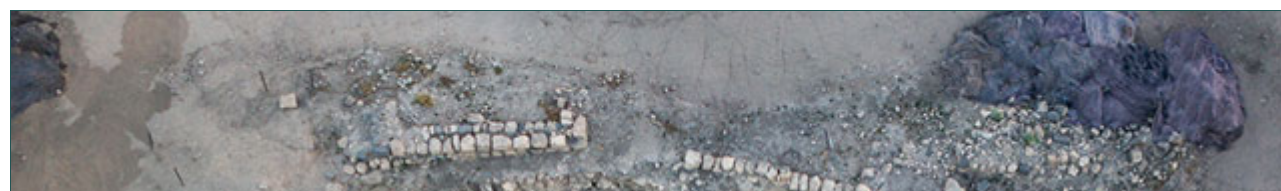
1. Aerial view of Area 3000 at the end of the 2019 season; north is at the top.
(Images//G2-19-1a.jpg)

Excavations this season continued in Area 3000 (Fig. 1), where there are five main occupation phases: a Late Roman synagogue (early fifth century CE); a Late Medieval public building (fourteenth–fifteenth centuries CE), which reused the Late Roman synagogue; a rebuilding and expansion of the Late Medieval public building (fifteenth century CE); installations and a few scattered walls built after the Late Medieval public building had gone out of use and was pitted and robbed out (sixteenth–eighteenth centuries CE); and houses belonging to the modern village of Yakuk from the late Ottoman–modern periods (nineteenth–twentieth centuries CE, up to 1948). In addition, walls belonging to a pre-synagogue structure were discovered below the northwest corner of the Late Medieval public building. The following discussion describes these phases from the earliest to the latest, proceeding within each phase from north to south to east.

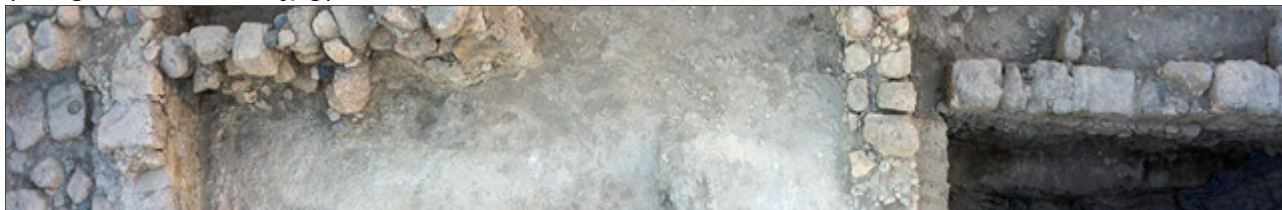
2. Aerial view of pre-synagogue walls under the northwest corner of the Late Medieval public building; north is at the top.

The Late Roman synagogue was not the earliest structure built in Area 3000. In 2018, the tops of two walls were exposed under the foundations of its north and northeast stylobates (Magness et al. 2019 (http://www.hadashot-esi.org.il/Report_Detail_Eng.aspx?id=25419)). In 2019, two walls forming a corner were discovered under a floor in the northwest corner of the Late Medieval public building (Fig. 2). One of these walls was cut by the west wall of the Late Roman synagogue, indicating that it predates the synagogue. Only the foundations of these walls are preserved, with the uppermost course of one of them incorporating a threshold made of two stone blocks. These foundations are built of unhewn fieldstones alternating between courses of large and small–medium-sized stones. The function and date of the structure to which these walls belong are unknown as no associated surfaces were discovered. Like the pre-synagogue walls discovered in 2018, the two walls discovered in 2019 are oriented differently from those of the synagogue and the Late Medieval public building.

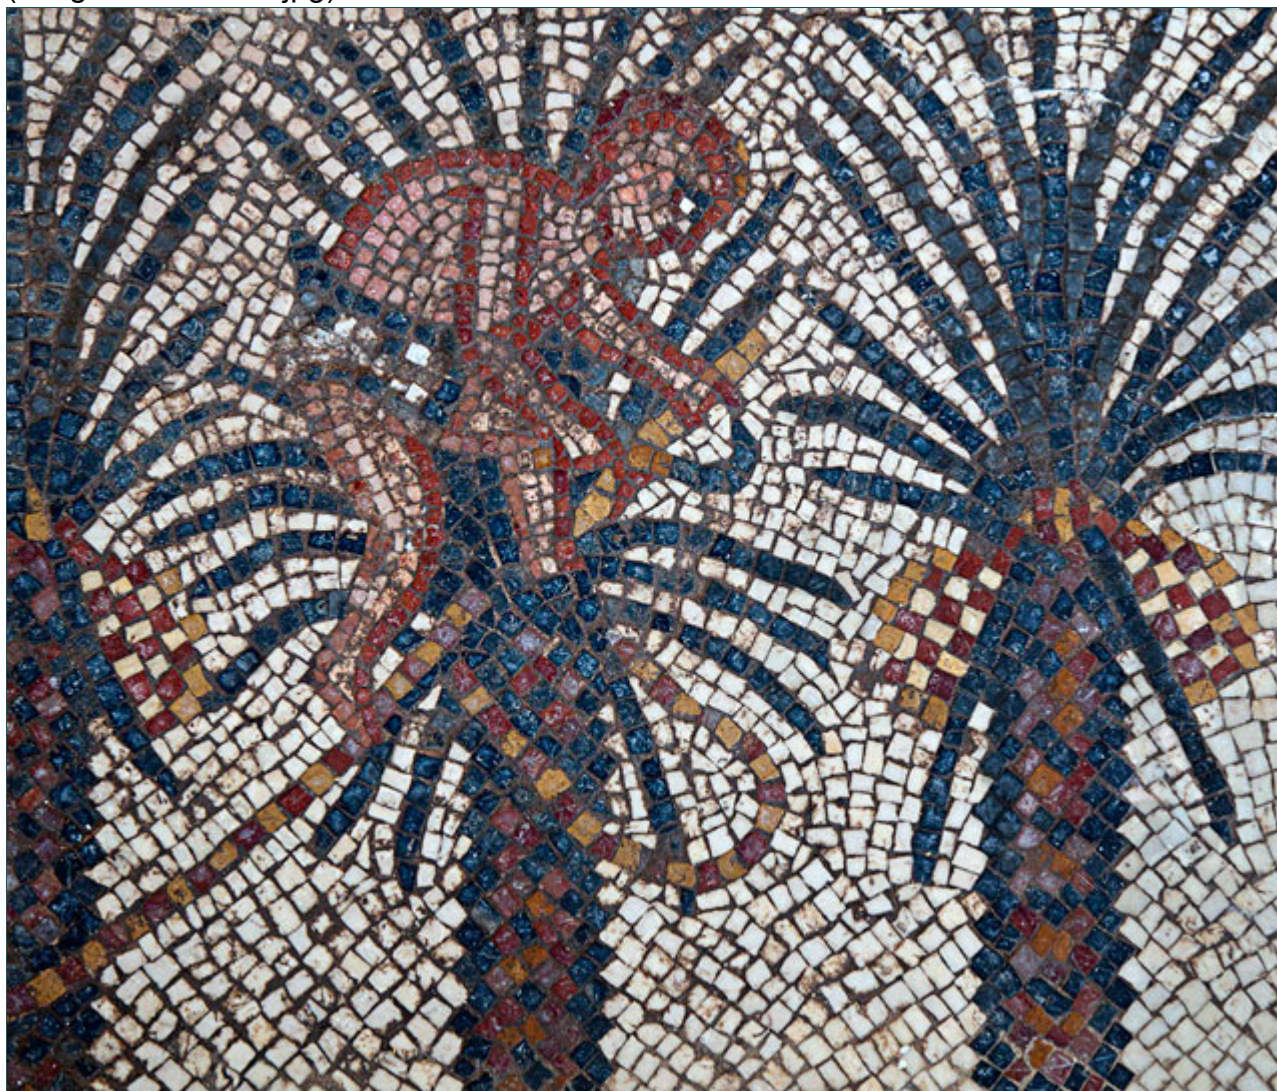
3. Detail of the 'Elim' mosaic.
(Images//G2-19-3a.jpg)

The ‘Elim’ Mosaic (Fig. 3), which lay at the north end of the synagogue’s west aisle, to the south of the panels with the ‘four beasts of Daniel’s vision,’ was fully exposed this season. A small section of this mosaic was initially uncovered in 2015 ([Magness et al. 2016a](http://www.hadashot-esi.org.il/report_detail_eng.aspx?id=25060&mag_id=124) (http://www.hadashot-esi.org.il/report_detail_eng.aspx?id=25060&mag_id=124)).

The mosaic is a large, framed panel that originally covered the entire width of the west aisle. However, due to damage caused by the collapse of the building’s superstructure, the robbing out of the Late Roman west stylobate to its east, and the construction of the Late Medieval west stylobate to its west, the mosaic is incompletely preserved.

The panel is divided into three registers, which are referred to here as the west, middle and east registers. The east and west registers were conceived as two pendants containing scenes that mirror each other. The west register depicts a row of date palms and three agricultural workers engaged in activities related to date harvesting. At one end of the register, a male figure dressed in a loincloth climbs a tree using an omega (zip-line). A small vignette near the center of the register shows a worker standing amid palm fronds at the top of a tree. He cuts the clusters of dates using a small scythe-like hand tool and slides them down the rope to a worker standing on the ground. The middle register depicts a walled city with a gate, identified by a Hebrew inscription above (“Then they came to Elim”; ויבאו אילמה) as biblical Elim described in Exodus 15:27—“Then they came to Elim, where there were twelve springs of water and seventy palm trees; and they encamped there by the water” (וְשָׁם שְׁתַּיִם עֶשְׂרֵה עֵינֹת מַיִם, וְשִׁבְעִים) (על-הַמַּיִם וַיִּבְאוּ אֵילְמָה תְּמָרִים; cf. Numbers 33:9). A man carrying a jar on his shoulder is about to enter the city through the gate, presumably returning to the city after filling the vessel with water from the springs. In the rest of this register, wells constructed of ashlar masonry representing the city’s twelve springs alternate with palm trees. The east register depicts a row of date palms, exactly like its pendant counterpart on the west side of the panel. Two agricultural workers engaged in activities related to date harvesting are depicted near the center of this register.

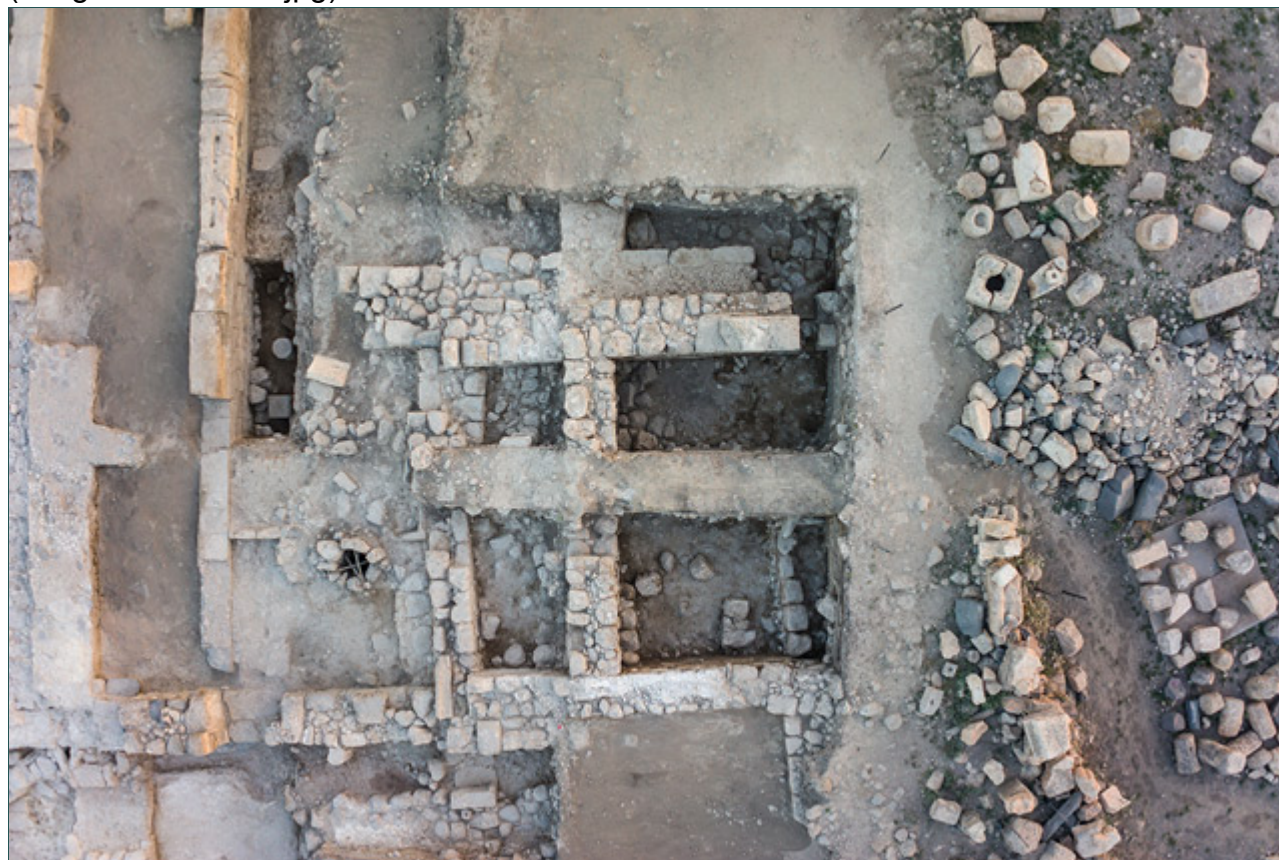
4. Aerial view of the Late Medieval vaulted building to the east of the synagogue; north is at the top.
(Images//G2-19-4a.jpg)

include the reconstruction of the pi-shaped structure and the laying of a new, less substantial floor in the southwest corner of the nave, probably coupled with the replastering of the building's entire floor. Parts of the walls were rebuilt, in some places from the bottom course up, and rooms were constructed around the west, north and east sides of the building. It is unclear whether a catastrophic event, such as an earthquake, precipitated these modifications, which seem to mark a change in the building's function. Deposits of roof tiles found to the north and south of the building are attributed to this phase, presumably having been disposed of after the structure was damaged. A newly opened extension of Area 3000, to the east of the synagogue/public building, revealed five walls, apparently from this late phase of the Late Medieval public building. These walls belong to a large vaulted structure that was attached to the building's south wall (Fig. 4). No associated floors or foundations have yet been found.
