THE FLORIANA LINES

The Entrenched Bastion on the enceinte composed of St. Philip's Bastion, St. James' Bastion and St. Luke's Bastion.

'The Conservation of the Baroque Heritage'

Denis A. Darmanin

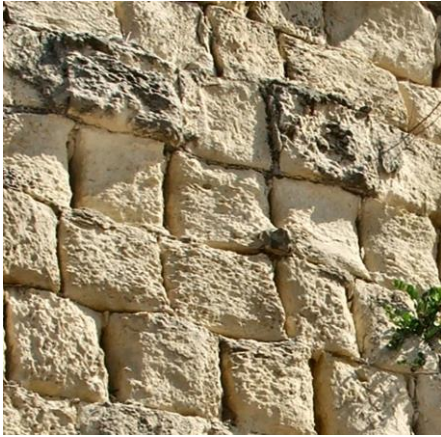
Fig. 10. Crumbled masonry on left scarp.

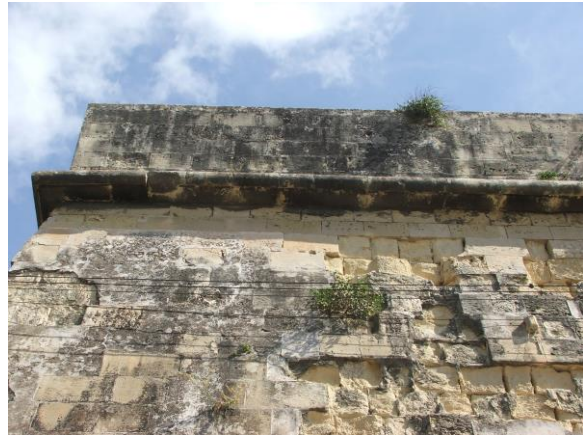
Fig. 11: Delamination, powdering, crust and growth.

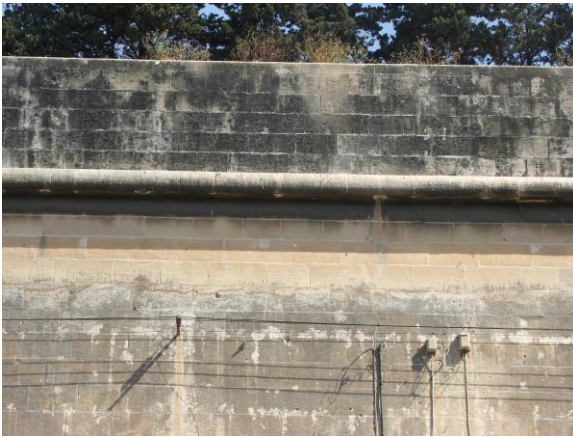
Fig. 13: Black crust and growth on parapet and cordon and accretions on scarp.

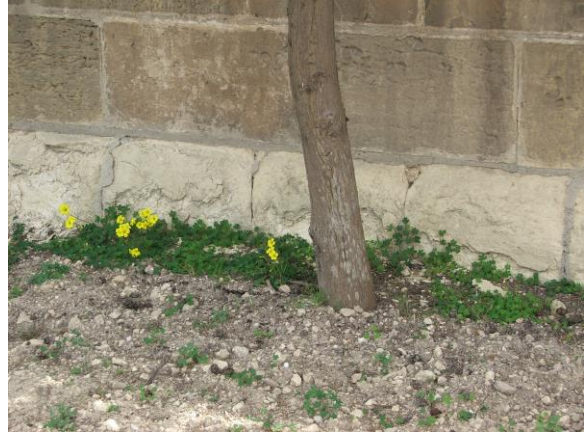
protrude from the corner of the parapet's base and the ground. It is obvious that both the trunk and roots are causing damage. The exposed stone that remains from the banquette is powdering in most places.

Fig. 16: The remains of the banquette and trees growing in such a delicate location.

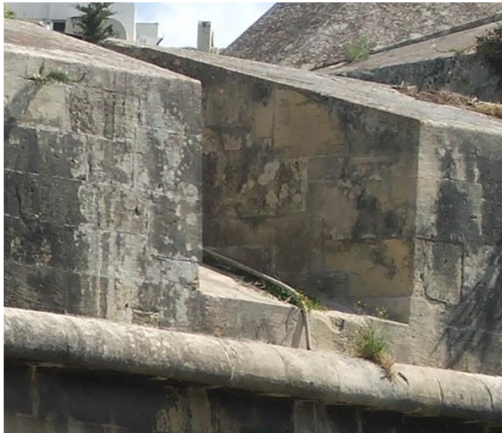
Fig. 20: Algae and lichen growth on parapet well as accretions and slight breakage.

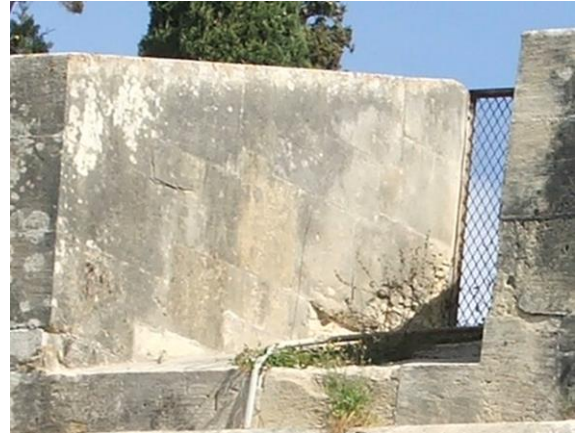
Fig. 21: Cheek of the second embrasure with as algae at upper and external levels and breakage.

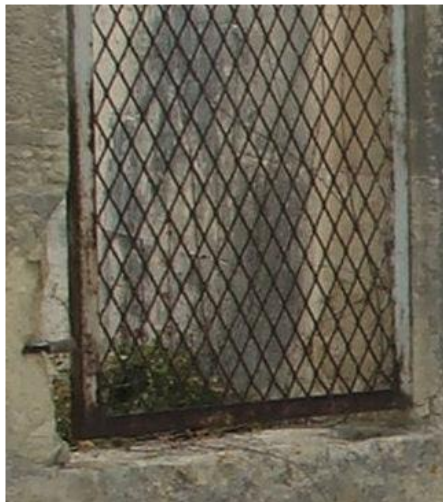
Fig. 22: broken and crumbling stone and cheeks caused by rusted safety mesh.

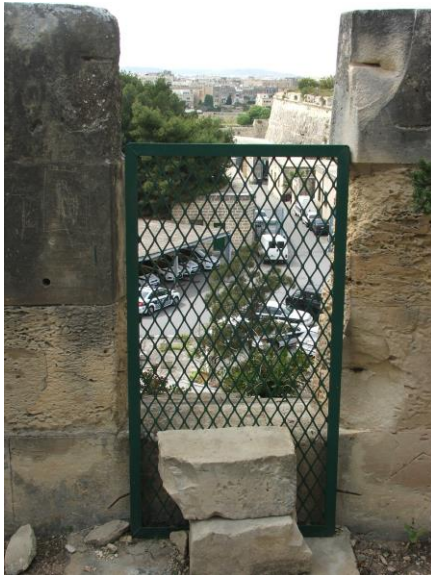
The two embrasures on the right are not exposed to traffic as much as those on the left but are also suffering their share of deterioration. The cheeks are heavily encrusted with pollution and also bio-deterioration. Algae and lichen growth is very evident on all the masonry features. The metal mesh once placed for safety has rusted and caused the thin stone at the opening of the crenellations to break. One mesh has fallen off its stays.

Fig. 24: Broken stone due to rust expansion and early alveolar decay.

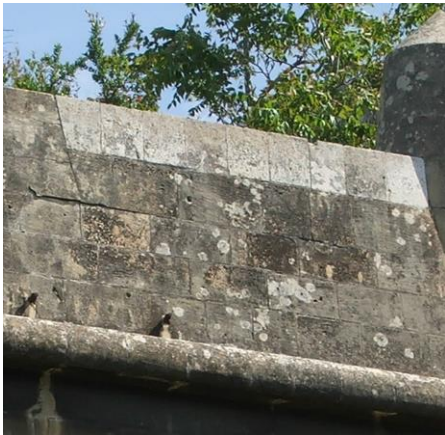
Fig. 30: Face section of left batardeau.

The batardeau on the left face has been partially altered. A machinegun post was erected on its rear section abutting St. Luke's Bastion. There is also a dame in the middle which is uncertain whether this is also an original British addition or erected when the machinegun post was built. The roof is made of reinforced concrete. Some algae were noted on the edge of the apex but it's mostly covered with lichens and fungi.

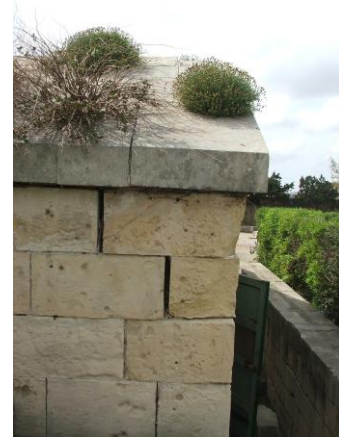
Fig. 37: Close-up of damage.

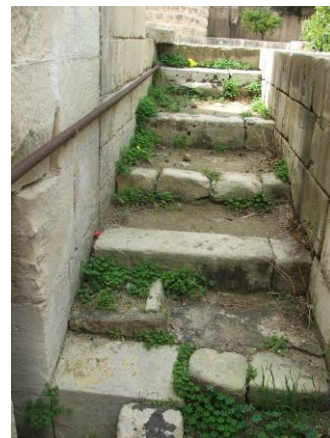
Fig. 39: Breakage due to accretions.

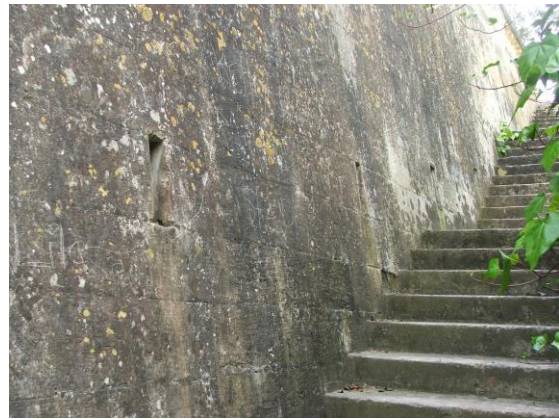
Fig. 41: Lichen, algae and fungi on left stairs and counterscarp.

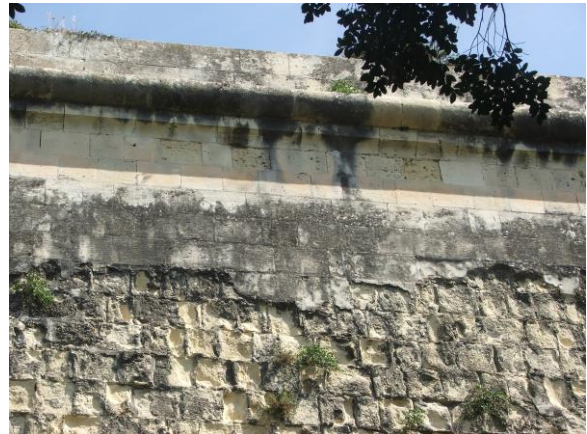
Fig. 44: Alveolar and other erosion, black crust and algae along face, cordon and parapet.

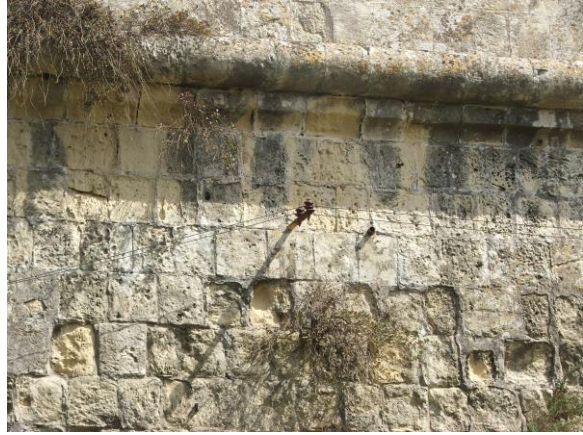
Fig. 49: Algae, black crust, growth and accretions along the right scarp.

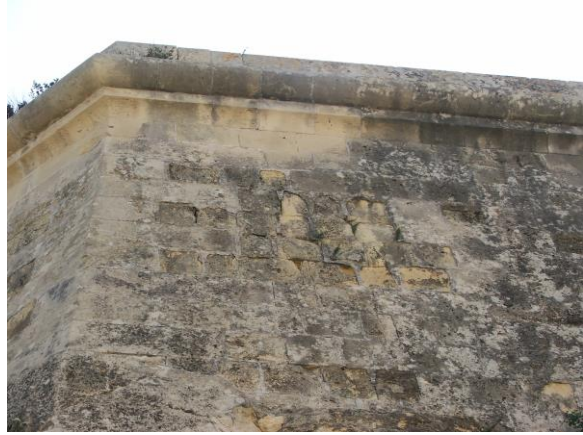
Fungal growth, black crust and eroded stone.

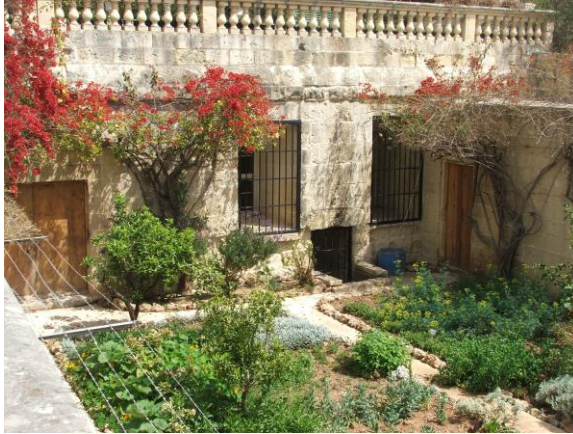
Underground stores and pump room.

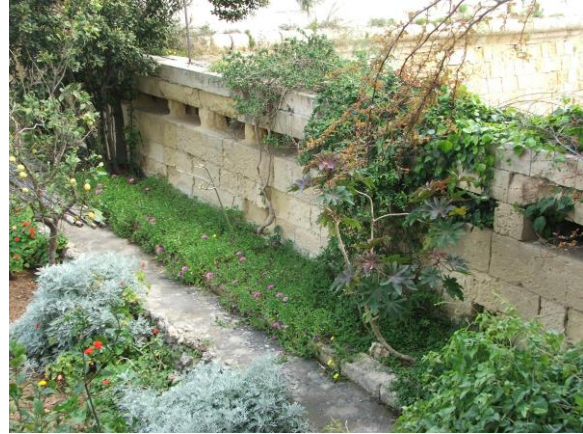
separating the loop-holes are badly deteriorated and the face and crest are infested with creeping shrubs which are also effecting the capping stones.

Eroded and infested musketry loop-holes.

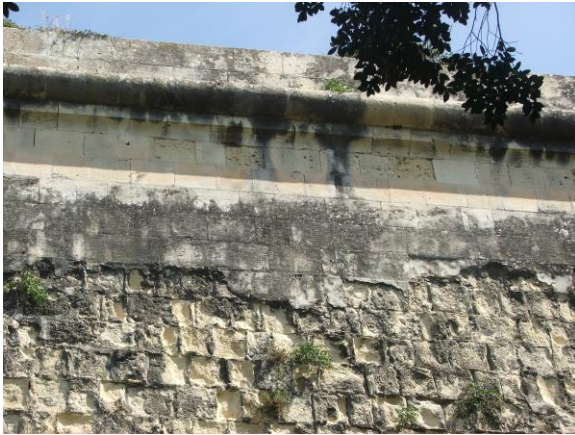
The right scarp of St. Luke's Bastion is hidden behind large *Ficus Nitida* planted below and only the upper section is visible. The part hidden behind the trees is in constant shade and possibly suffers from some form of micro-climate. Exfoliation and powdering, even in the rock-hewn face, is greater here than in other place, to the extent that much of the powder remains entrapped due to the trees and retains humidity, as well as aiding plant growth.

Delamination, black crust, powdering and growth.

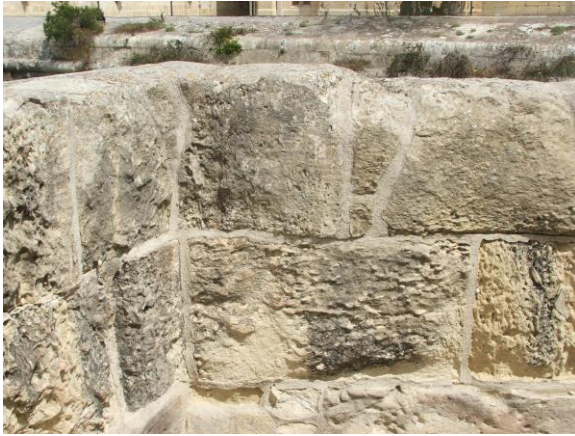
Internally, the parapet spots various damage resulting from war, alterations, bad practice and neglect. On the parapet on both orillions, strong evidence of pointing with the use of cement and coarse sand has been noted. The left section is also heavily pock-marked with shrapnel dating from the war. When the banquette was

Cement pointing on corner of left shoulder.

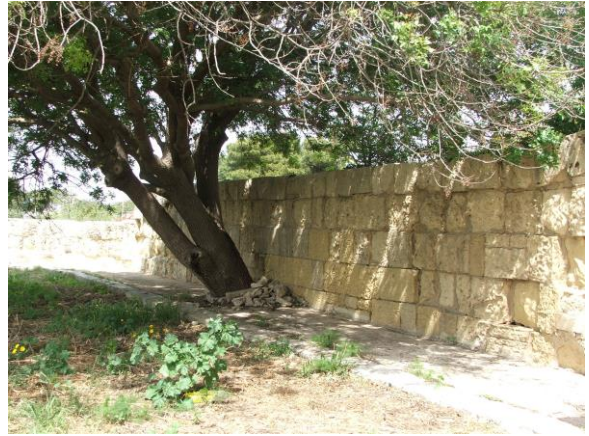
removed, trees were planted along the parapet, which now have thick trunk and strong roots and are a constant danger to the parapet.

Trees in a sensitive corner and cement pointing.

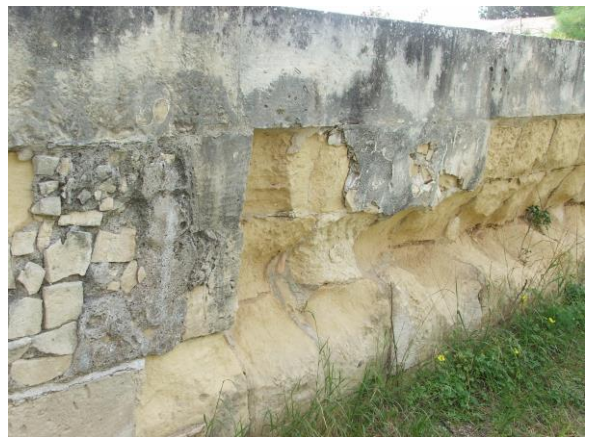
Erosion, cladding and rendering inside parapet.

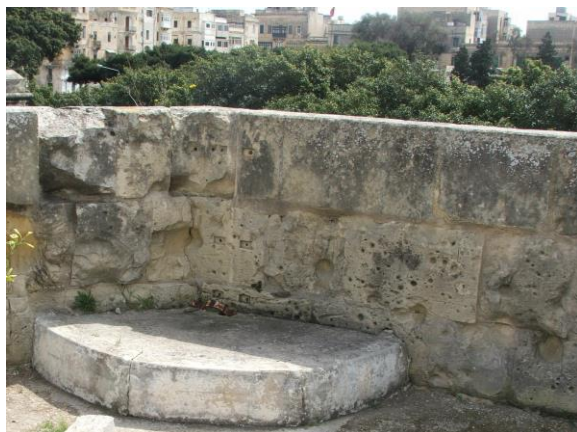
Shrapnel damage on orillion's parapet.

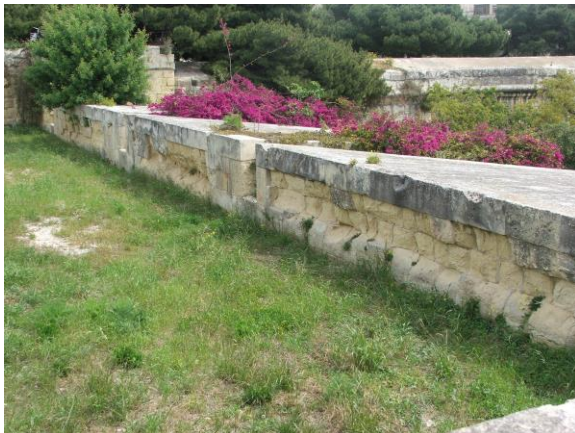
Badly eroded parapet and missing banquette.

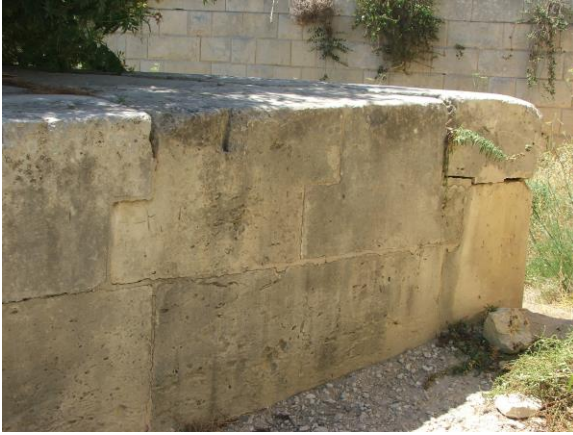
Dislodged quoins on the face of an embrasure.

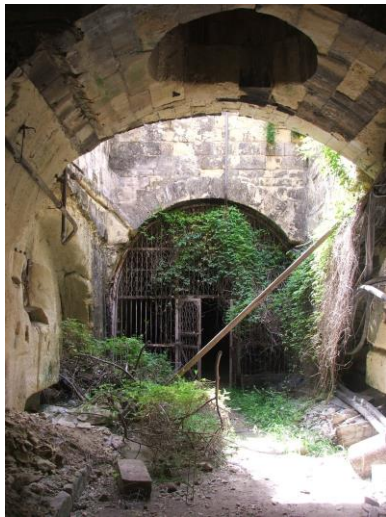
Aperture created in the ditch for the railway.

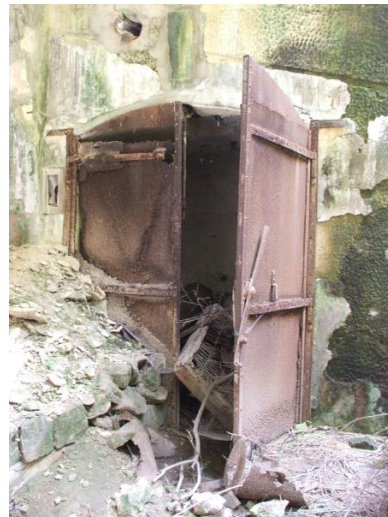
Moss encrusted walls, neglect and debris.

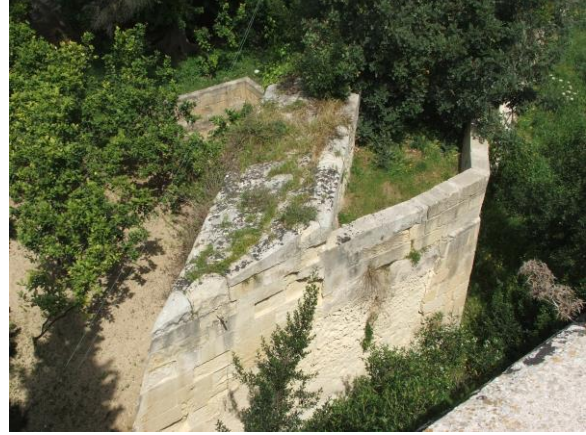
Much of the right claw of the tenille is badly suffering from broken, eroded and dislodged masonry, and many stone have fallen into the drop-ditch. Apart from the heavy vegetation that growing on the crest, the trees that grew in the 'orchard' have caused great fissures in the structure.

Close-up of the drop-ditch on the left.

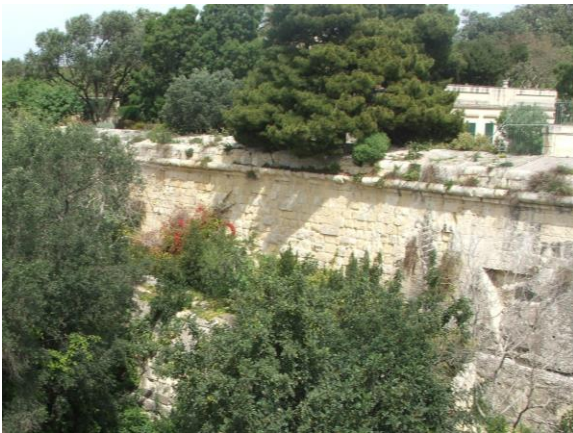
The face of the curtain is probably the most eroded face from the entire entrenched bastion. Many of the stones are powdering, exfoliating and breaking up after cracking. I am qualified enough to state the reason, but its either due to the poor quality of the stone or because its location has made it subject to the 'wet-dry' process and due to the salt crystals being kept active and breaking the stone. Its bottle-neck location also makes it vulnerable to wind effect.

The deteriorated masonry face of the curtain.

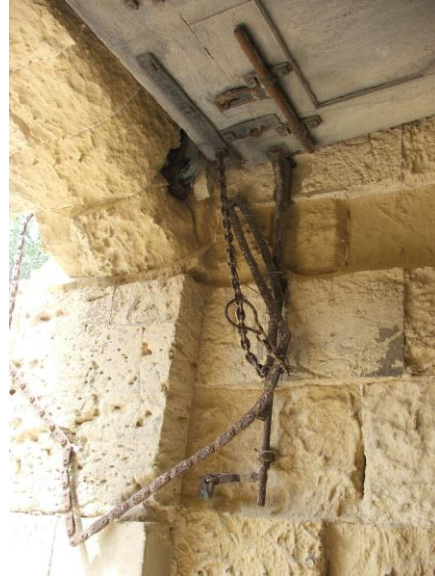
Eroded masonry and rusting fittings.

The curtains masonry on the face around the sally port is heavily eroded and badly powdering in most places. Even the voussoirs of the arch itself and the vault, are just as eroded and those of the vault are voided and without mortar. The lower rock-hewn section is also eroded and alveolar erosion is also common here. There are numerous accretions, especially pipelines and cables, and other metal fittings have caused the stone to crack and break.

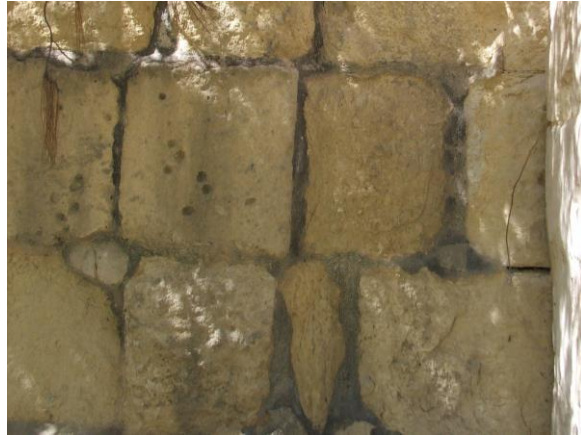
Cement pointing on the parapet's old fabric.

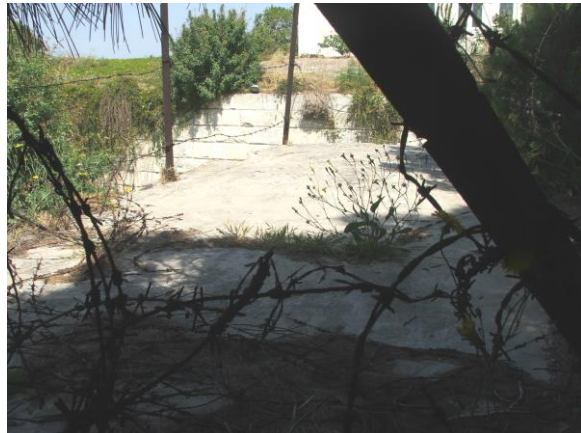
Metal staves and barbed wire on parapet.

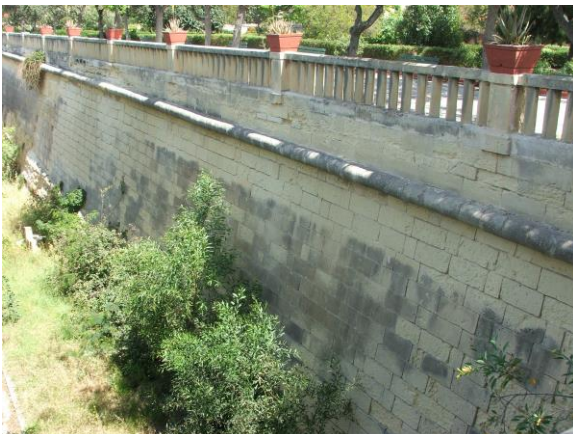
When the curtain was rebuilt after suffering severe damage during the war, it was just as an ordinary wall with balustrades rather than a parapet, set above a copy of the cordon. The stones used were the then standard '*kantun tad-disa*' and the original rock-hewn remains were used as foundations. These stones have since deteriorated and show extensive signs of powdering, alveolar erosion, loss of mortar from joints and black encrustation.

Deterioration on the modern 'curtain' face.

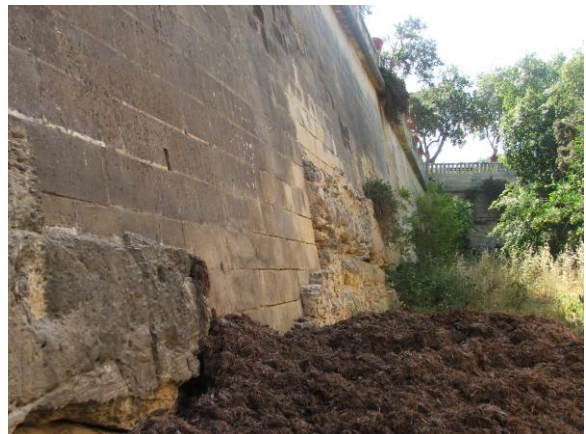
The space between the remains of the tenille and this wall has been serving as a manure pit and the acids from this animal excrement are seeping into the lower wall.

Manure pit in ditch near *Triq Notre Dame*.

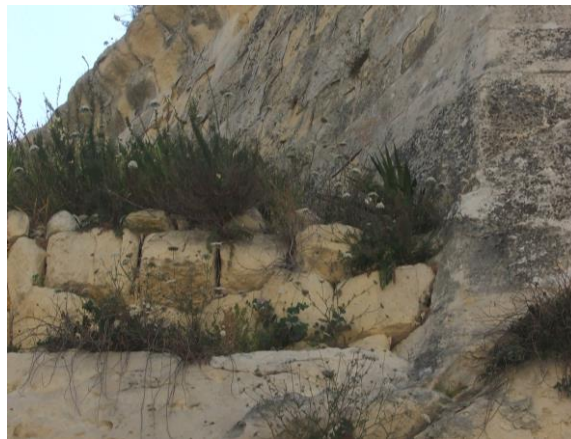
Badly eroded stones and overgrown with plants.

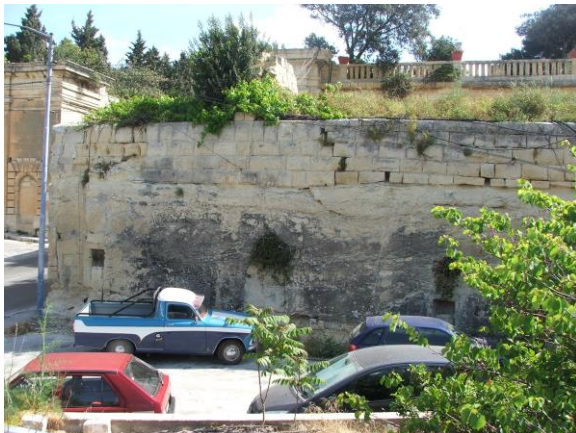
Black crust, crumbling masonry and plants.
