# Historical Land- Use and Streambank Erosion

Developing a local, process-based  
streambank restoration strategy

Claire Leverne

UNIVERSITY OF MALTA / JAMES MADISON UNIVERSITY

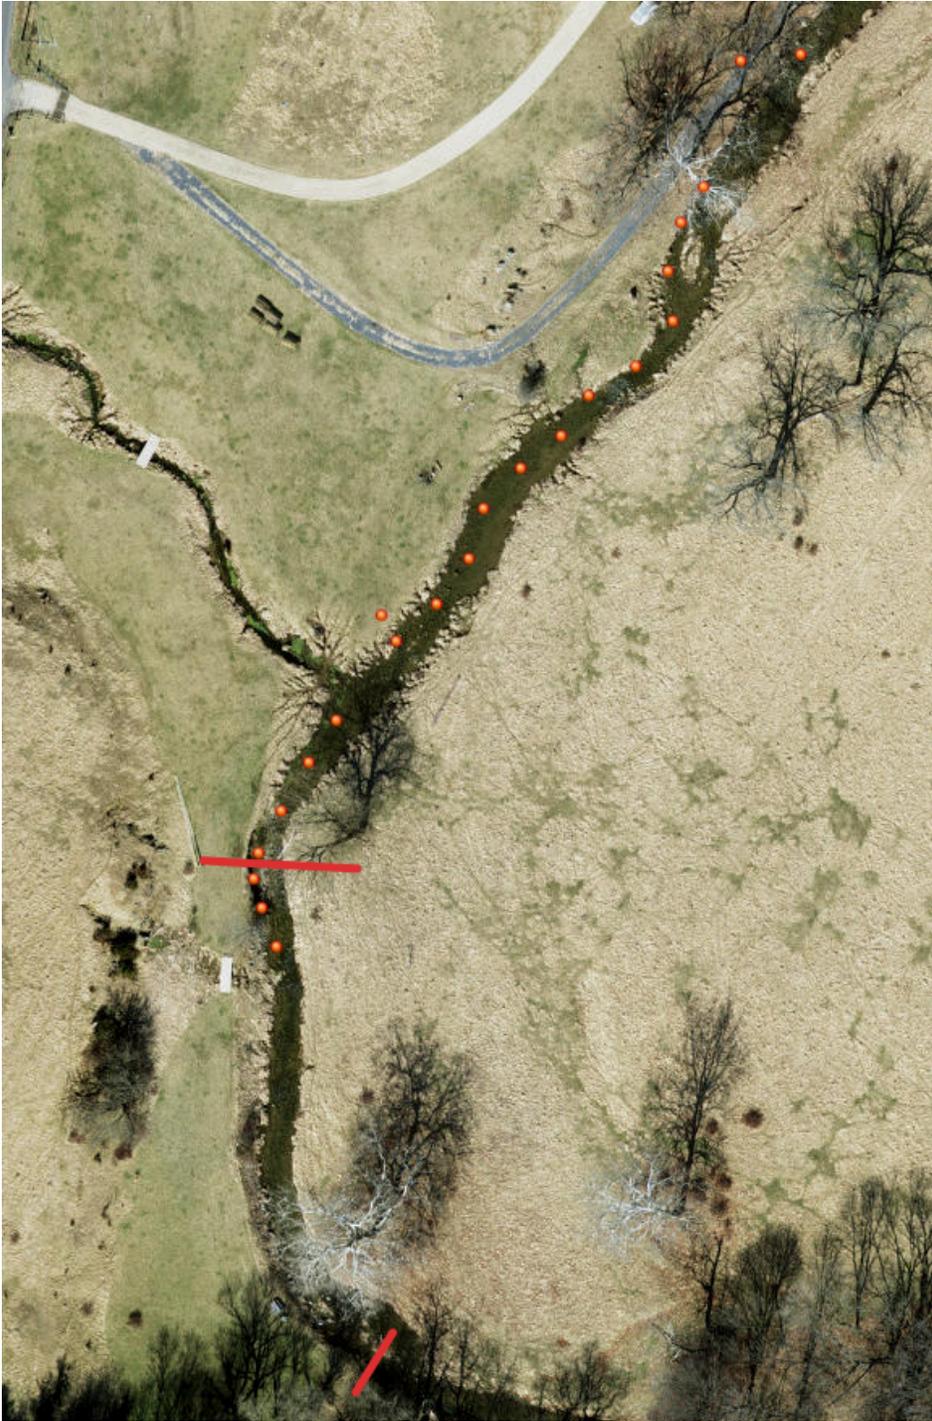
Figure 4: Survey locations.

Survey locations are shown in *Figure 4*. Longitudinal GPS locations are shown as points along 500 feet of the stream, upstream of the erosion site. Not all GPS readings for the longitudinal survey were accurate; some outliers may be noticed. The cross-section location of the eroded bank is shown here as a line in the center of the figure, and the reference cross section is shown at the bottom.

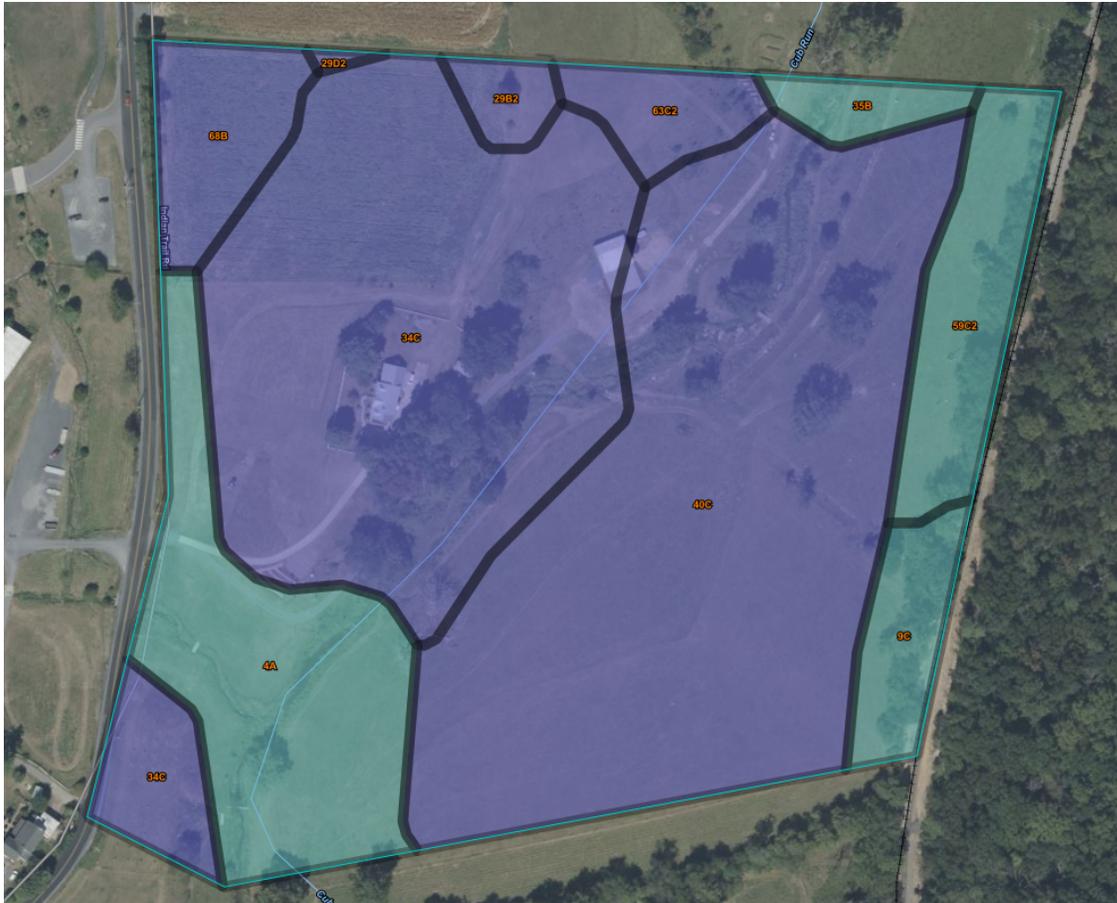
Figure 20: Hydrologic Soil Groups (HSG) for the site. Erosion is within area 4A. (USDA Web Soil Survey, 2025).

At the project site, soil directly surrounding the erosion site is listed under USDA Hydrologic Soil Group (HSG) C (Figure 20 and Figure 21), where group A has the highest infiltration and lowest runoff potential, and D the lowest infiltration and highest runoff potential (USDA NRCS, 2009). Group C is considered to have slower infiltration rates, so it is important to manage it for erosion and sedimentation particularly during construction
