The Restoration of St Cathaldus Chapel, Rabat

Conrad Thake gives a short history of the ancient chapel and describes the recent restoration of its exterior.

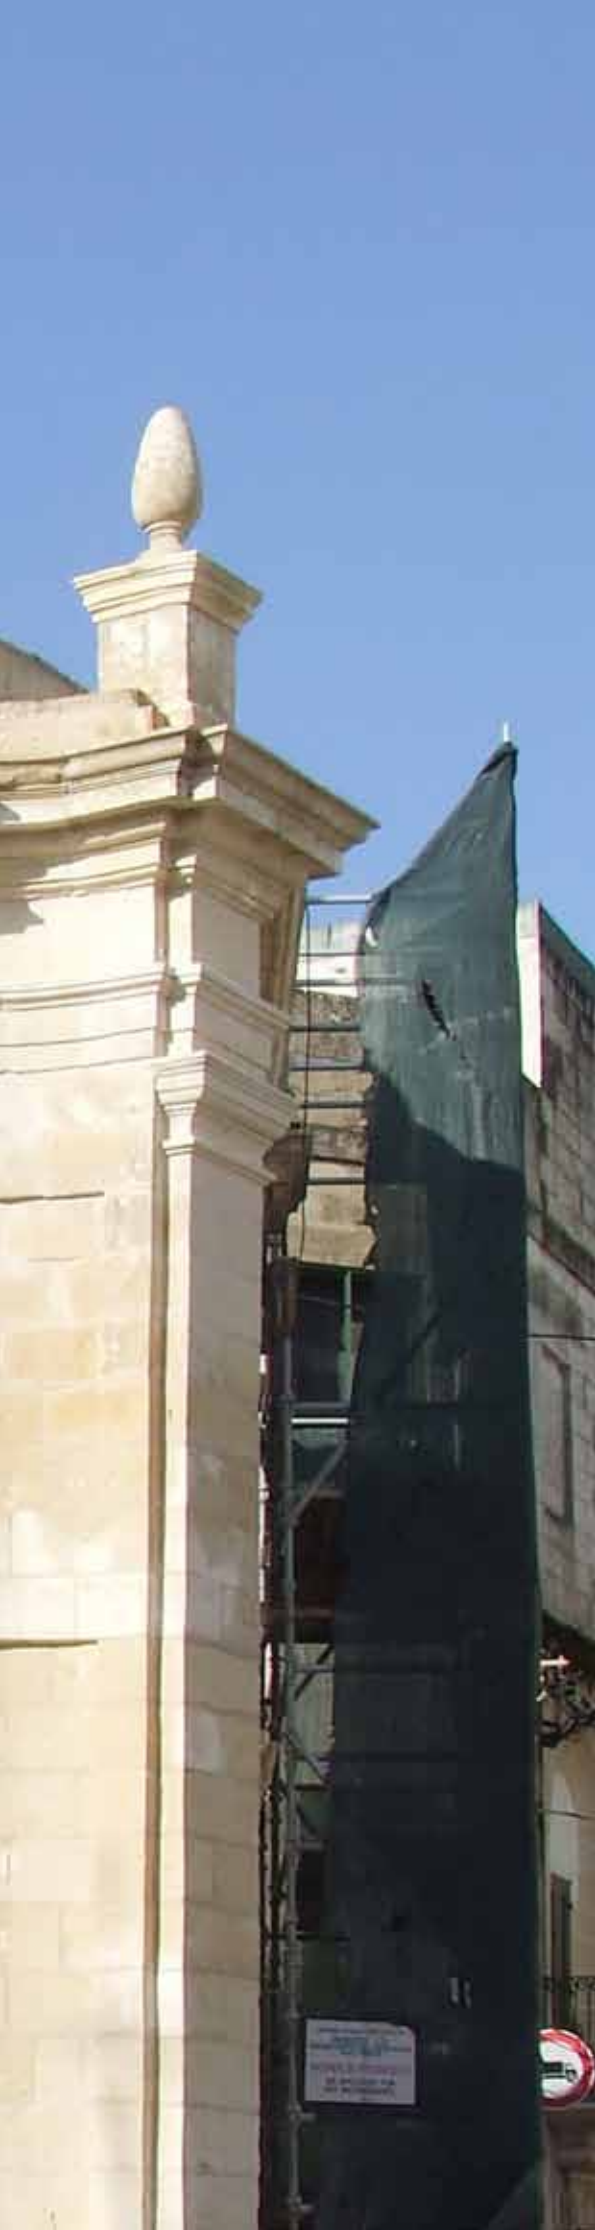
Saint Cathaldus chapel, Rabat (after restoration). (Photo credit Dr. Conrad Thake)

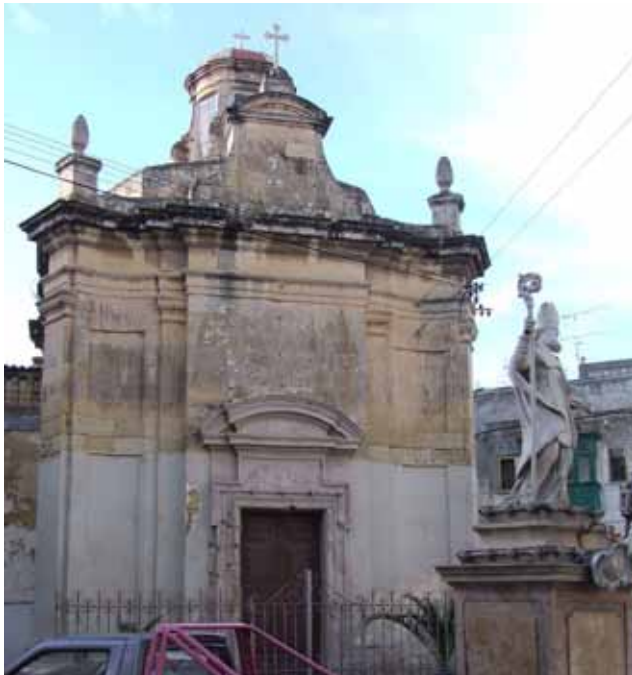
below:
Saint Cathaldus
chapel, Rabat (before
restoration)

Prior to its restoration, the building fabric of the church was suffering from several conditions which were having a long-term, adverse effect on the building. The most damaging was a thick layer of black cement-rendering and non-porous emulsion paint that had been applied to the lower part of the façade and had contributed to raising dampness and as a consequence the deterioration of the stonework. There were also expanses of stonework that had open mortar joints which were conducive to the percolation of water within the masonry walls. The stone mouldings around the main entrance portal were severely deteriorated and the stonework was flaking and in a powdery state. Also, the roof of the

church and that of the dome and lantern were very poorly maintained. The respective roofs need to be sealed so as to ensure that there was no water penetration. It was not only a matter of poor maintenance but at times also of insensitive intrusions such as the number of metal brackets supporting overhead electricity cables that were rudely hammered into the cornice of the chapel. Besides constituting a visual eyesore, the metal inserts gave rise to adverse spalling of the stonework.⁸
