The conservation project and archaeological excavation of the old Parish Church at Siggiewi – an intermediate report ¹

Paul C. Saliba

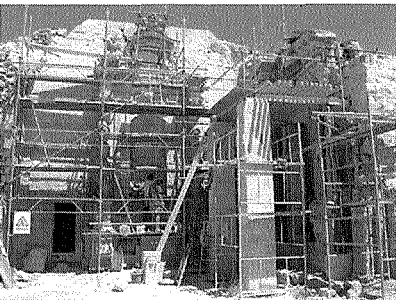
Plate 3. Erecting the scaffolding

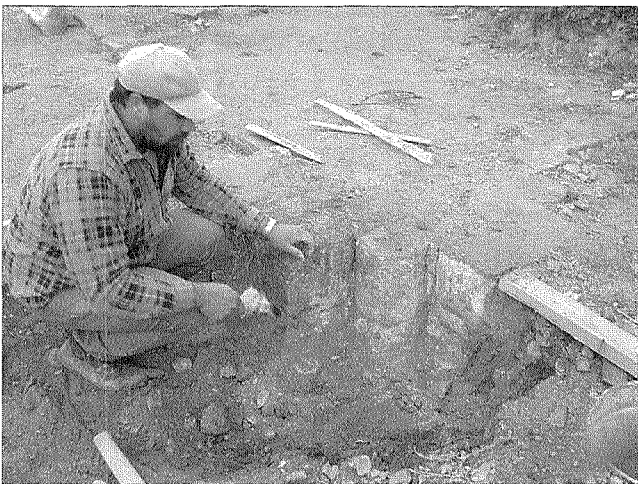
Plate 7. Unearthing wall structures near the southern transept

Removal of material was at first restricted to a number of trenches between the squares of the grid in different areas within the church, which were gradually joined into an open-area excavation. When possible all the material was removed cautiously with the sole use of hand tools (Plate 7).³² The newly-exposed parts of the church were recorded in drawings (Figs 2, 3, 7 and colour plate 4) and photographs. The excavation work was carefully documented, such as the all important find-spots and the roof collapse behind the main altar, within the choir area (Plates 5 and 6). All retrieved sculptured masonry was catalogued.

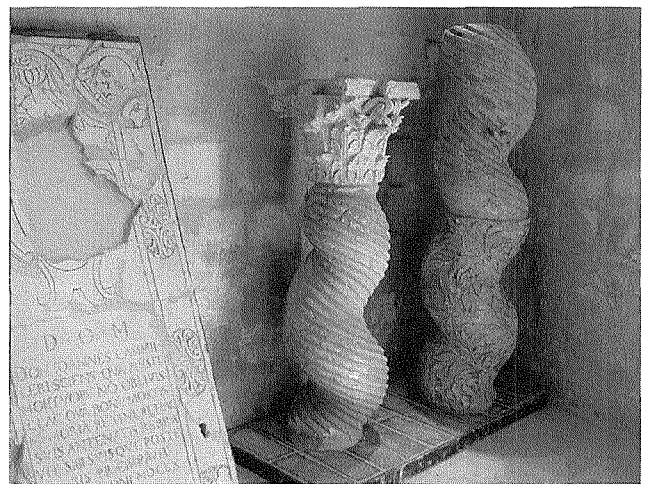
Plate 8. The site museum

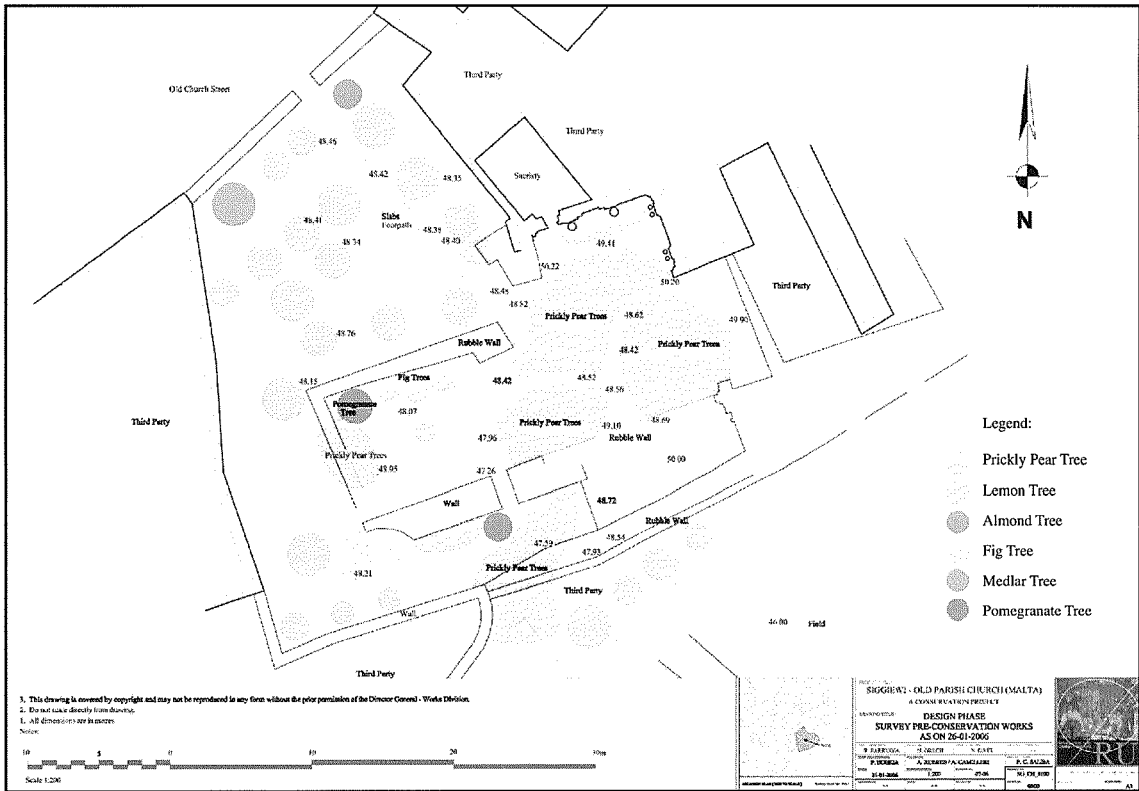
The site formerly occupied by the church and its immediate surroundings was used for agricultural purposes after having been converted into a field and a large orchard with mature fruit trees, prickly pears, fig trees and others (Plates 2; 9A; 9D; colour plate 2A; Fig. 4 and colour plate 3). These trees and other vegetation made it impossible to walk in the area originally occupied by the church. They were distorting its character, and roots were causing damage to the remains of the church. Some of the original masonry was reutilized for the making of a small terraced field within the site formerly occupied by the southern transept, while original stones were used for the erection of a boundary wall separating the abandoned field, originally the site occupied by the church, from the orchard.

The farmer who was occupying the grounds at the time had been utilizing the area originally occupied by the cemetery as a citrus orchard (Fig. 4 and colour plate 3), but had abandoned the church area originally converted into a field. The exposed standing structures of the church were left to collapse, crumble and deteriorate as a result of weathering by the elements (Plates 1 and 2). Some of the walls and structures were in a dangerous state and were in imminent danger of collapse (Plate 4). The derelict site, camouflaged by trees, thick vegetation, a small overlying terraced field and partly surrounded by a shabby old wall, lost all its historical and archaeological context. Few people were aware that this was the site of the old medieval parish church of Siggiewi. In some areas the remaining walls were totally covered by creepers hiding all evidence that a building once stood on site (Colour plate 2A).

Fig. 4. Survey pre-conservation/excavation works

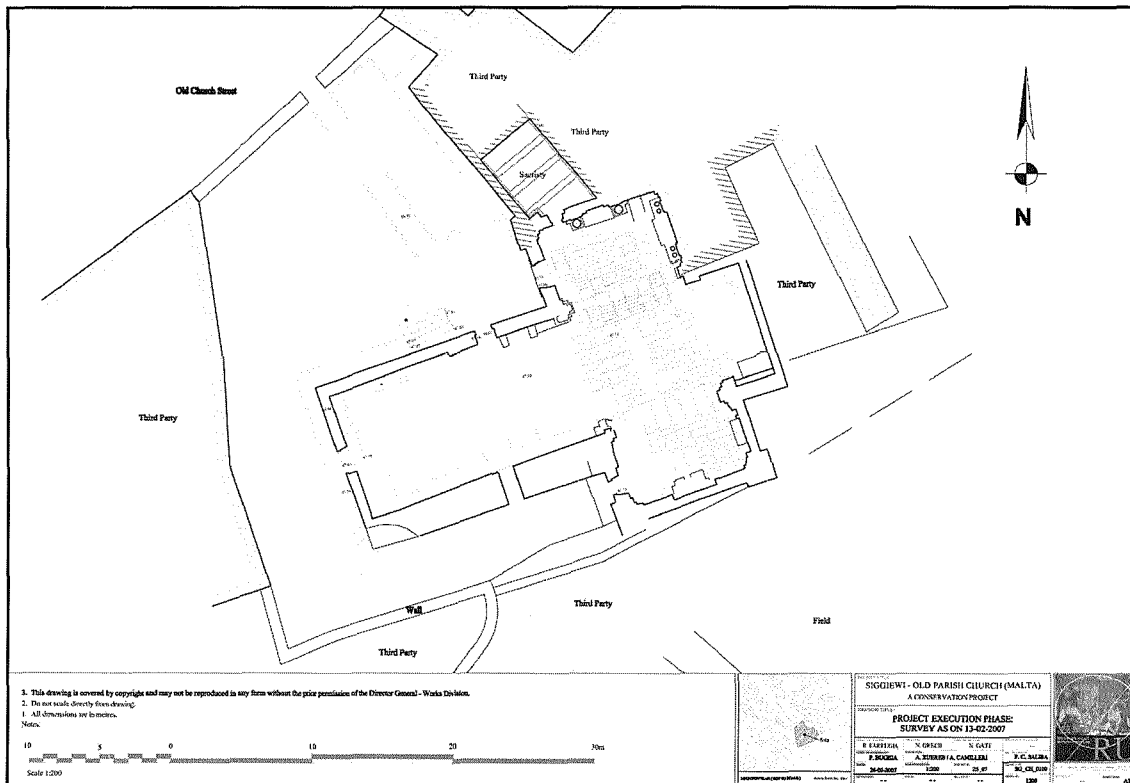
The second phase was to clear the site of debris and to carry out a scientific archaeological excavation.³⁰ The demolished church stonework which was deemed to be of particular interest (Colour plate 1B; plates 5 and 6), such as sculptured stone, vaulted rib voussoirs, and others lying above ground level, was collected and catalogued while the overlying infill and worked but plain masonry were carried away. The topsoil was roughly levelled out, except for the areas abutting the internal walls of the church, which were slightly higher. However, the original floor of the church was evidently lower than street level when compared to the floor level of the vestry, which is still standing (Fig. 6).

Fig. 6. Survey during conservation/excavation works

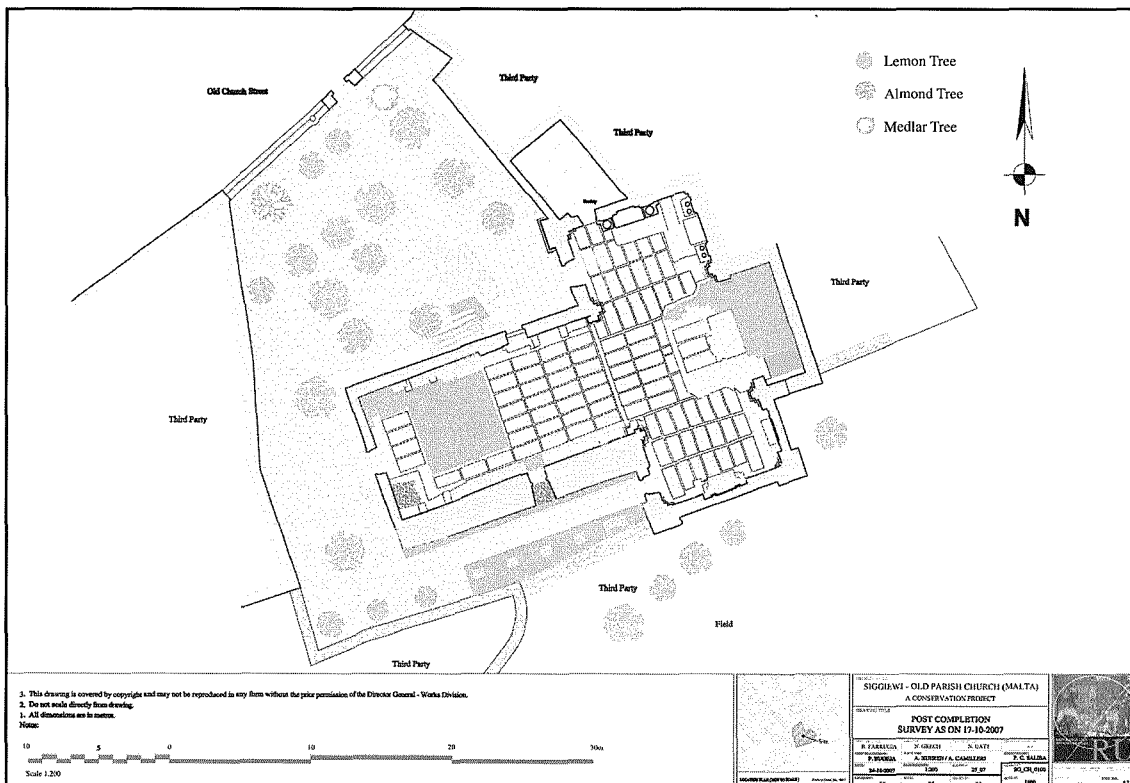
The excavation revealed that the final plan of the parish church (Fig. 7 and colour plate 4) had five external doors. These consisted of the main entrance, two side entrances situated respectively along each longitudinal elevation of the nave and two other entrances, each leading to one of the two transepts. The remaining part of a staircase, which originally led to the roof of the church, was found encased within the thick buttressed wall. Ruben Abela commented that the side entrance along the northern wall of the nave must have been the main entrance of a church owing to the fact that the lower part of the architrave bears a fragment of Melitan moulding.³⁸ If Abela's suggestion is correct, the present area of the nave must have originally been the space occupied by two churches with their axes perpendicular to one another. The earliest parish church occupied the western half of the nave while the Visitation church was erected in the space occupied by the eastern half of the nave. This might also explain why the surviving wall consists of two separate halves (Plate 9D). All this is conjectural and may only be confirmed through further archaeological excavation.

Fig. 7. Survey post completion

Latin inscriptions dated 1660 were discovered in the north transept. The floor of the church was completely covered with tombstones (Fig. 7 and colour plate 4) but most were broken and the graves were filled to the brim with stone, soil and debris.⁴³
