Josianne Cassar

Read my hips, for longer

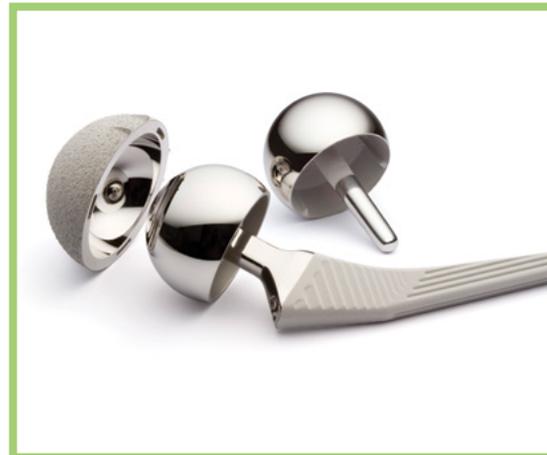
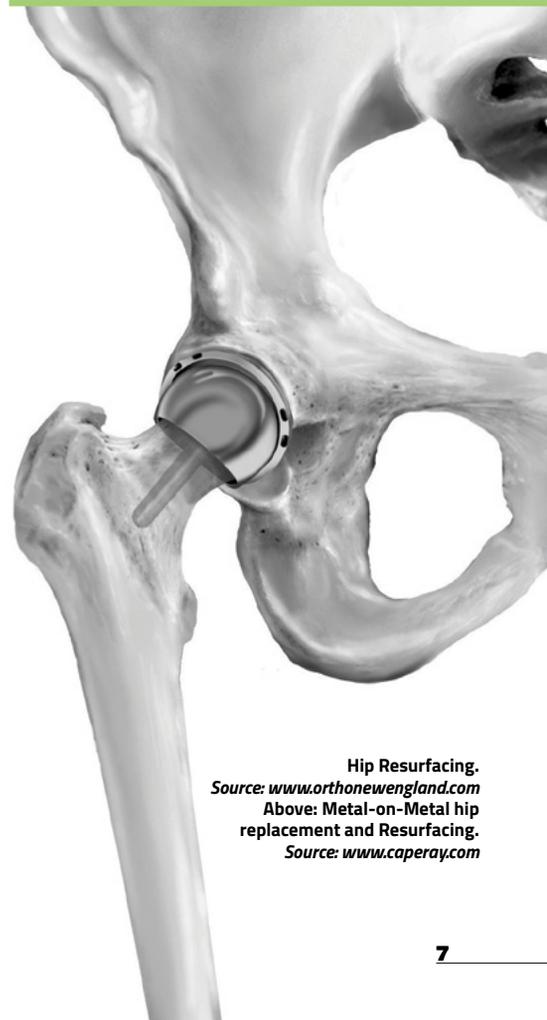
Hip Resurfacing.
Source: www.orthonewengland.com
Above: Metal-on-Metal hip replacement and Resurfacing.
Source: www.caperay.com
