**A study into the effect of ground movement on the deformation of  
typical local structures consisting of load-bearing HCB walls and  
reinforced concrete in-situ slabs**

Dissertation submitted to the Faculty for the Built Environment, University of Malta in part fulfilment of the requirement for the attainment of the degree of Master of Engineering (Structural Engineering)

June 2025

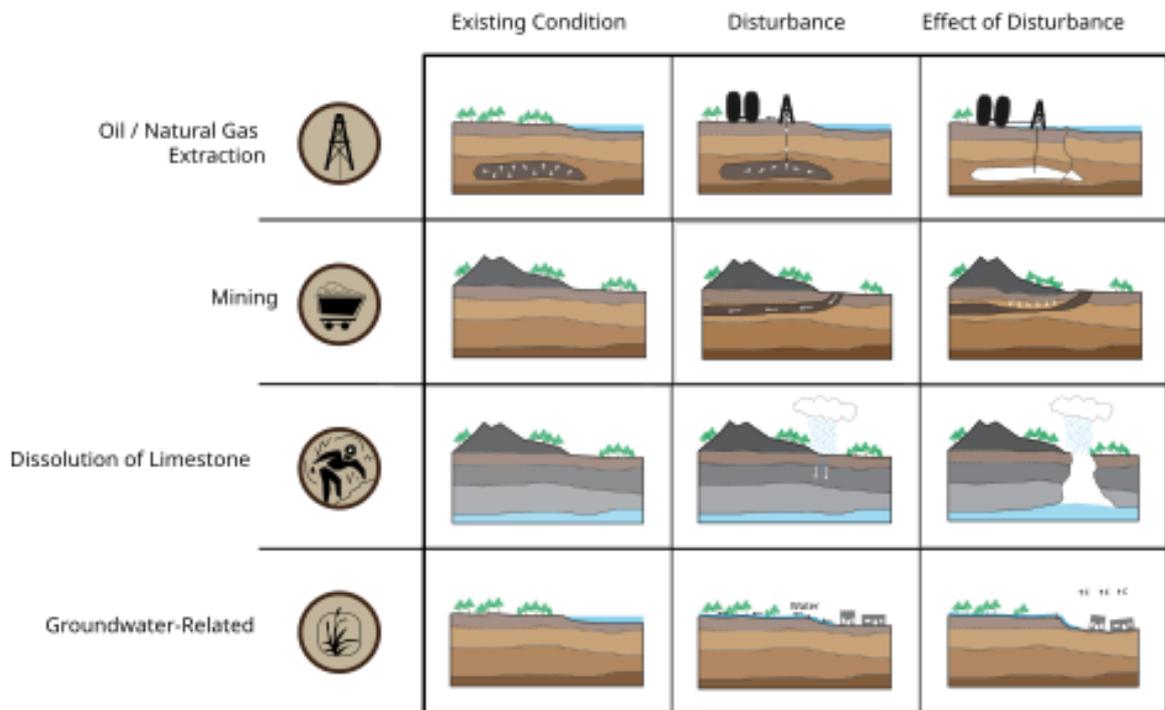
**Figure 2:2 - Different factors leading to subsidence (Dickinson P.R. & Thornton N., 2006)**

Settlement can also be triggered by external factors such as the removal of supporting materials beneath the ground (e.g., groundwater extraction or tunnelling), natural processes like the dissolution of soluble rocks leading to sinkholes, and tectonic activity, as shown in Figure 2:2. As a result, subsidence may occur suddenly or gradually, depending on the extent of the disturbance to the ground and the nature of the ground itself. These factors typically have a more significant impact on the surrounding environment, as they affect a larger area. Settlement caused by these factors is also known as subsidence (Dickinson P.R. & Thornton N., 2006).

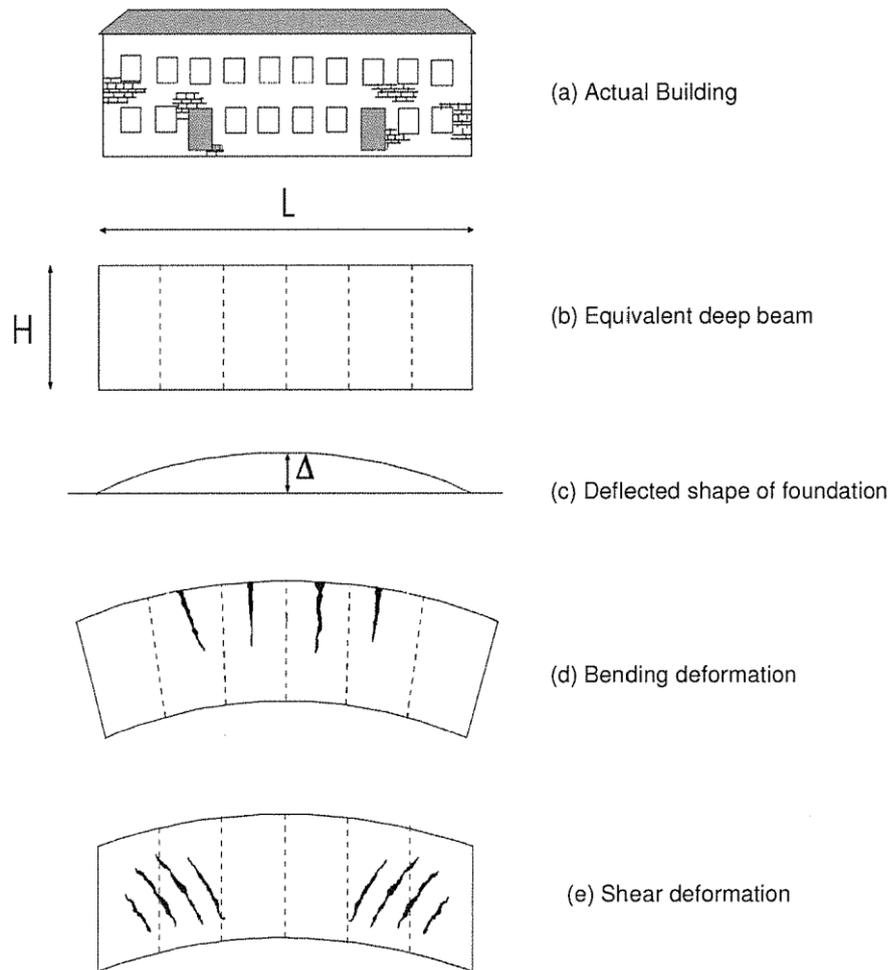
**Figure 2:5 - Equivalent Elastic Rectangular Beam**

Burland J. B. and Wroth C. P. (1974) tested the concept of limiting tensile strain by modelling a building as a simple, weightless, equivalent elastic rectangular beam with length L and height H. The deflected shape of the beam is assumed to be known. The mode of deformation does not influence the value of tensile strain; however, it does affect the distribution of strains, as the way in which a building deforms will clearly indicate where tensile strains will arise. Sagging and hogging profiles may lead to either bending deformation, shear deformation, or a combination of both. The primary challenge lies in establishing the deflection criteria for initial cracking once the limiting tensile strain is reached within the beam.

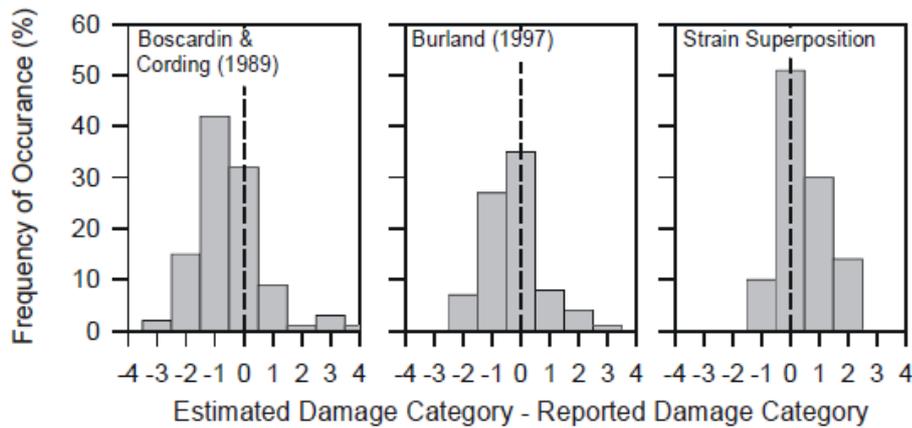
**Figure 2:9 - Comparison of the damage category estimation methods**

Boone S.J. (2001) suggested a strain superimposition method that examines how ground movement affects walls by considering how the walls deform, as shown in Figure 2:9. The main advantages of the strain superimposition method are that it does not rely solely on graphical charts depicting modes of deformation; instead, it accounts for differences in building geometry and all modes of deformation. Crack widths are directly calculated, allowing for comparison with damage classification, and the approach enables the evaluation of building distortions using fundamental geometric and engineering principles.

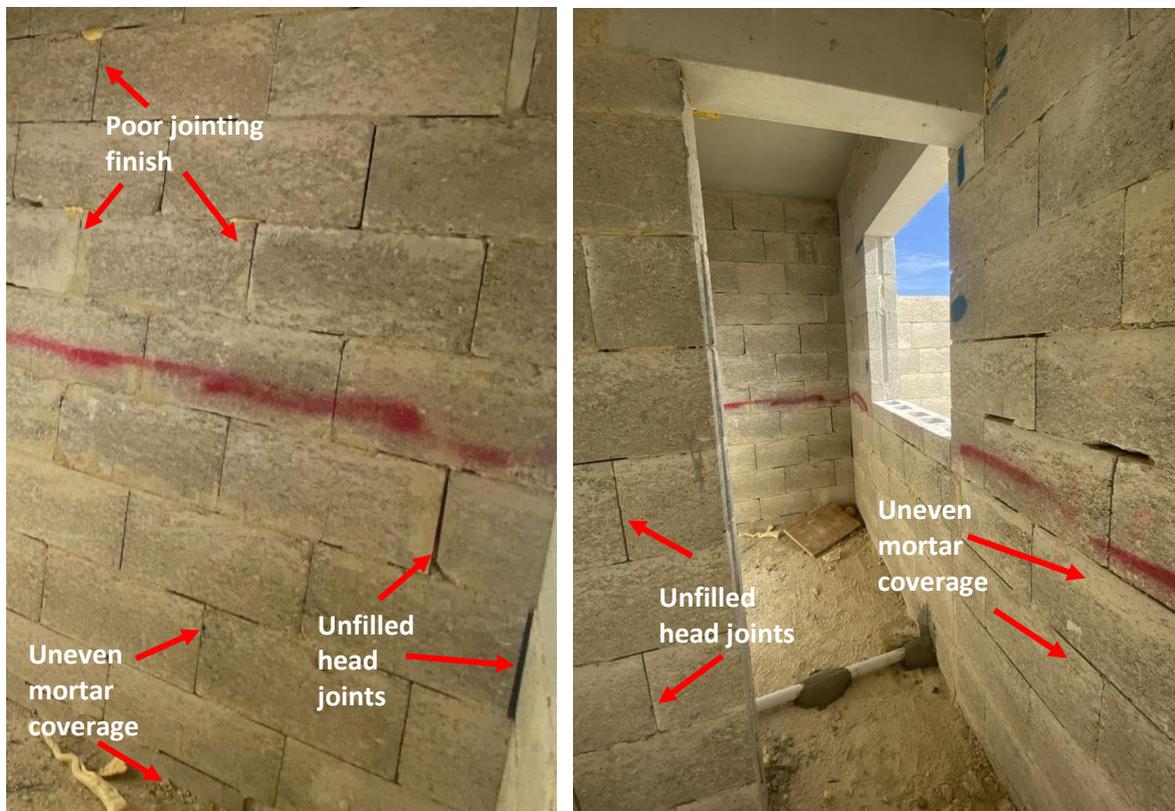
**Figure 3:9 - Unfilled head joints, uneven mortar coverage & poor jointing finish**

Post-construction, other issues include uneven or excessively thick mortar layers and poorly finished joints, both of which negatively affect the structural performance of the masonry, as shown in Figure 3:9.

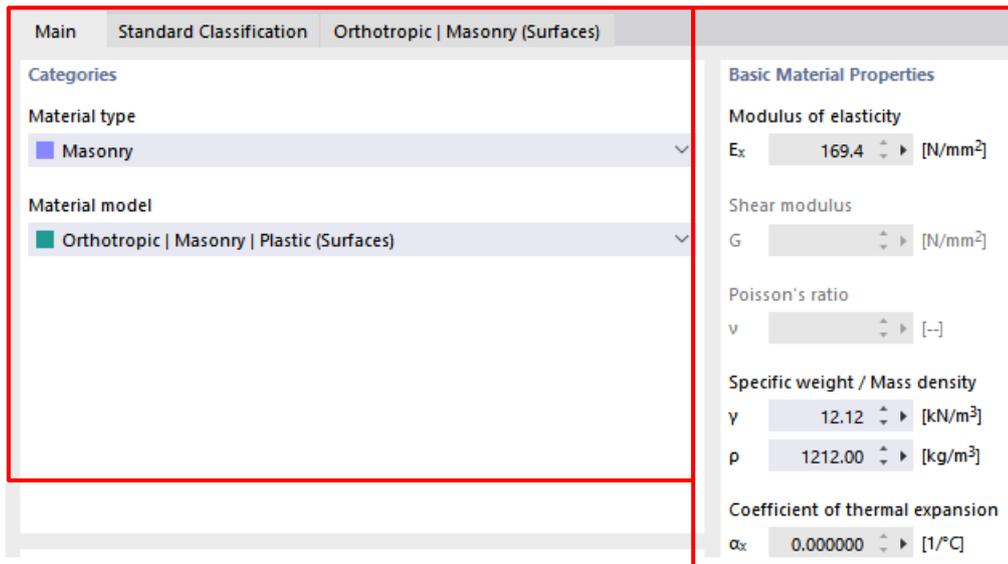
**Figure 5:1 - Screenshot from RFEM6 showing the Orthotropic Material Model**

As shown in the Basic Material Properties on the right-hand side of Figure 5:1, the mass density value was obtained from local hollow concrete block manufacturers (Attard Bros.) (see Appendix E), while the remaining values were left as default, as recommended by the software.

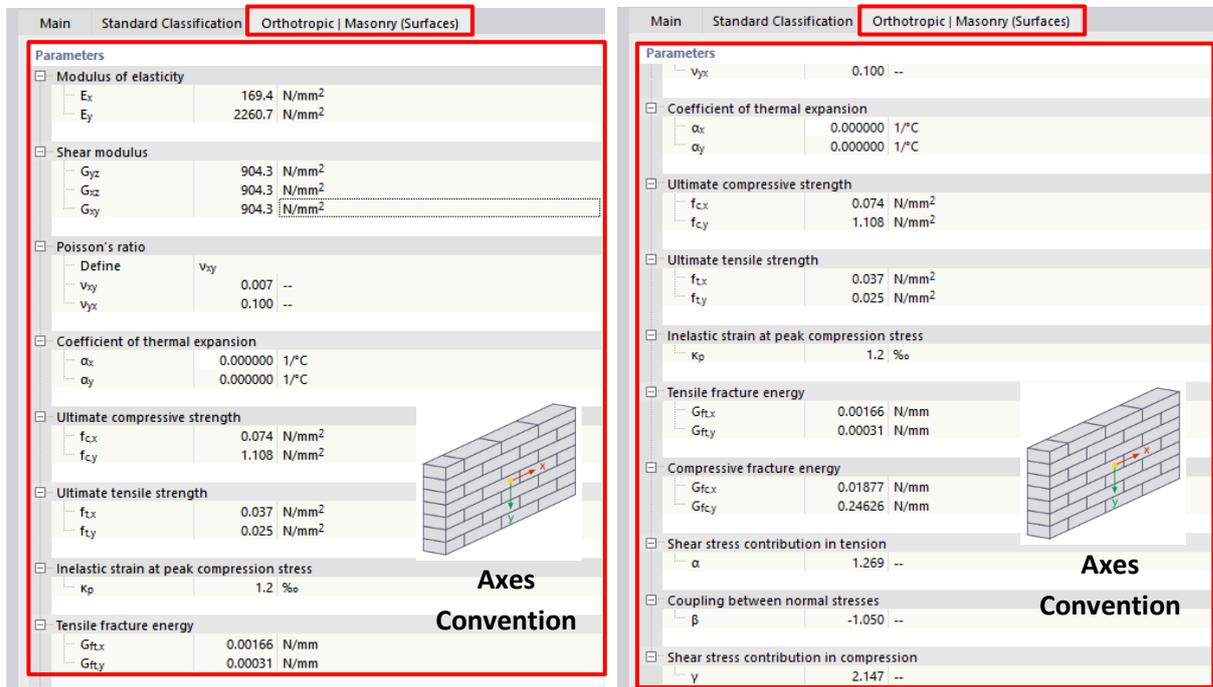
Figure 5:3 - Screenshot from RFEM6 showing the averaged properties of an Orthotropic Material Model as calculated by the program

After entering the above-mentioned properties of the mortar and block, the program automatically computed specific behavioural characteristics for the resulting homogeneous material, as shown in Figure 5:3. These properties represent an average of the combined block and mortar attributes.

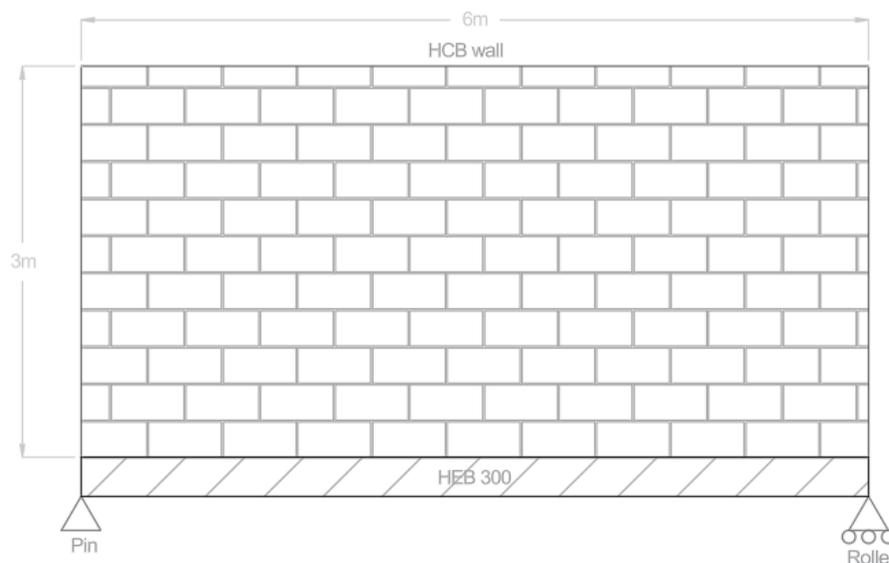
**Figure 5:13 - Simply supported beam subjected to the load of a masonry load-bearing wall**

In this step, the same beam and support conditions were used; however, the beam was loaded with an HCB wall instead of an imposed load, as shown in Figure 5:13. The bending moment, shear force diagrams, and deflection of the steel beam under the wall's load were compared with hand calculations. The results obtained from the modelling were significantly different from the hand calculations, indicating that the beam and wall were not behaving as intended. During this phase, the behaviour of the wall and beam was studied to identify factors affecting the overall "system." The main issues encountered during this process are outlined in Section 5.3.4.1.

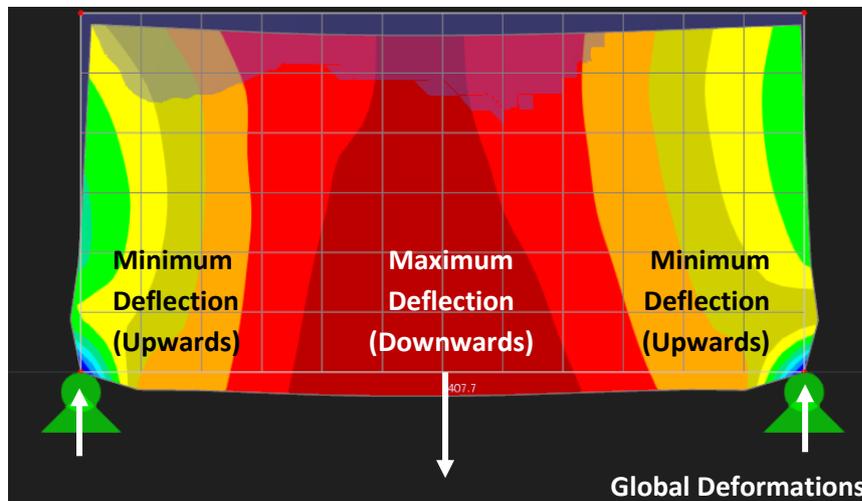
**Figure 5:14 - Masonry wall supported by nodal supports at both ends**

Two primary issues arose during the modelling process. The first involved the beam element supporting the masonry wall. Initially deemed unnecessary, the results revealed that without the beam element, the masonry wall behaved like a "jelly," with supports penetrating the wall, as shown in Figure 5:14. This demonstrated the beam element's critical role in the model.

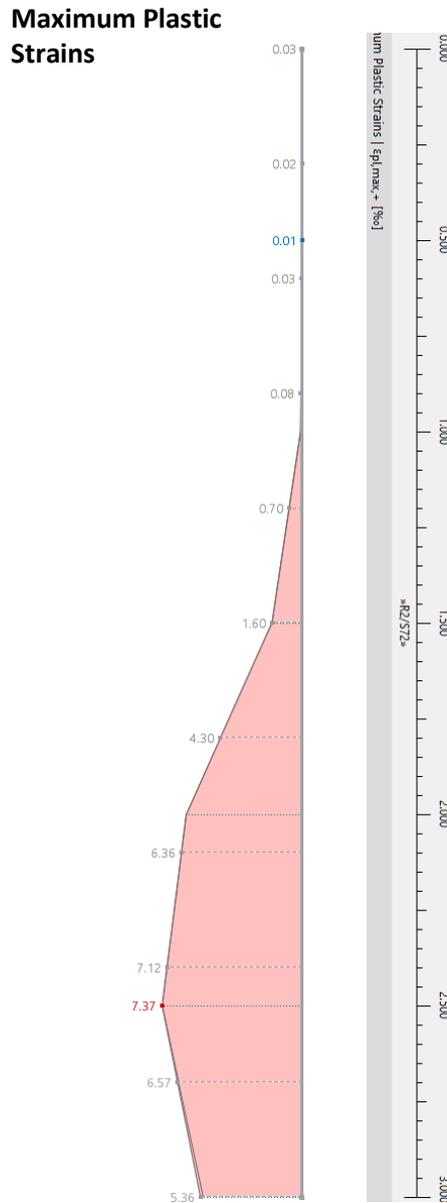
**Figure 5:23 - Maximum plastic strain distribution through a wall section**

A transverse section through the centre of the wall reveals that the maximum plastic strains are relatively low near the top of the wall ( $x = 0$  m), and extend approximately 1 meter downward (Figure 5:23). However, the plastic strains increase more rapidly between  $x = 1$  m and  $x = 3$  m, corresponding to the lower section of the wall (Figure 5:23). In fact, the plastic strain distribution diagram shows that plasticity begins to develop approximately one-third of the way down from the top of the wall.

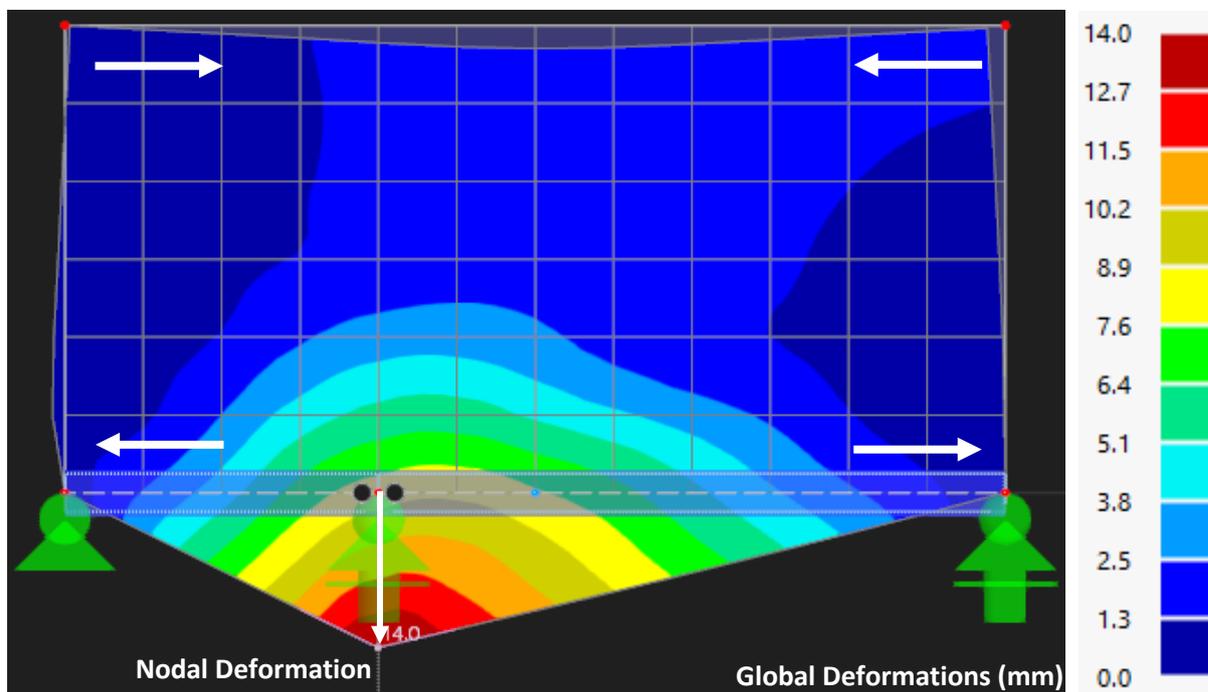
**Figure 5:26 - Deformations experienced by the masonry wall**

The global deformation pattern of the numerical model provides a clear visualisation of the damage sustained by the wall during nodal deformation. As settlement progresses, the wall gradually follows the downward displacement of the central support, as shown in Figure 5:26. With increasing nodal deformation, tensile stresses develop within the wall, initially causing the formation of small, isolated cracks. As these tensile stresses intensify, the cracks begin to widen and coalesce, eventually forming larger, more significant fractures.

It is also important to observe that the global deformation remains relatively uniform from the top of the wall to approximately mid-height. However, a sharp increase in deformation is noted in the lower half of the wall. This observation aligns with the initiation of plastic strains at roughly one-third of the wall's height (measured from the top), indicating that the upper portion of the wall remains within the elastic range and does not undergo plastic deformation. As a result, the most significant deformations occur in the lower region, where plastic behaviour is dominant, as shown in Figure 5:26.

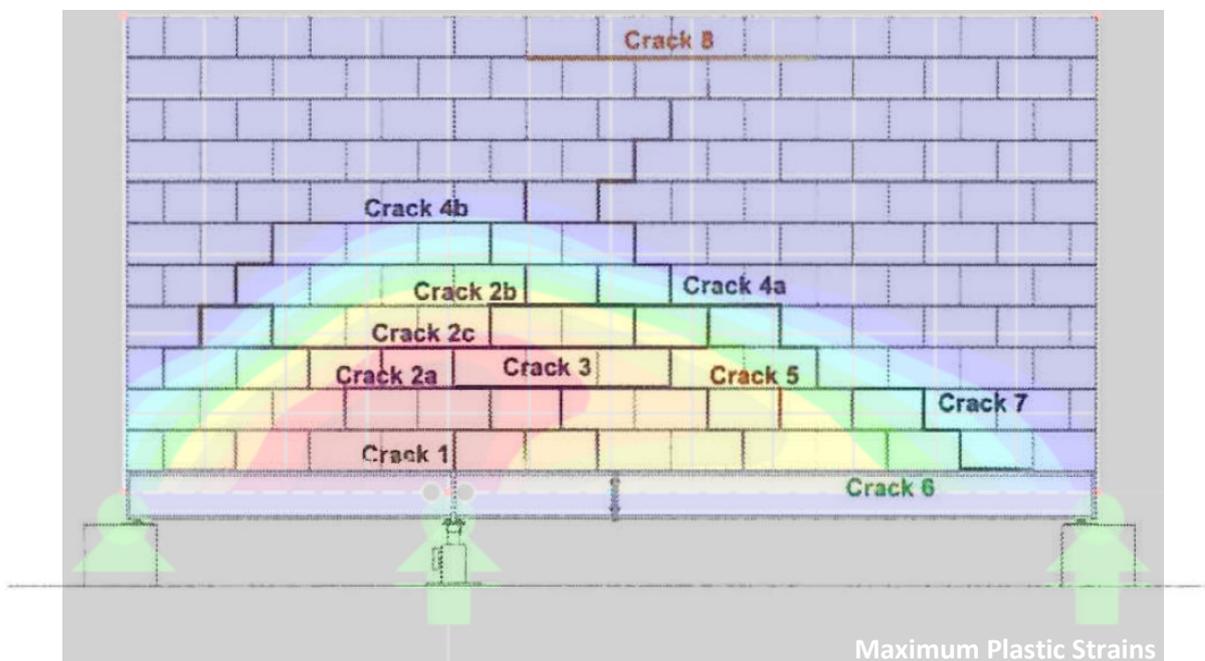
**Figure 5:28 - Crack formation in the wall setup described by (Mifsud J., 2012) superimposed over the Maximum Plastic Strains experienced by the numerical model**

A direct comparison between the numerical model and the experimental results presented by Mifsud (2012) was carried out, albeit to a limited extent. In Mifsud's study, measured crack widths were reported, whereas in the present study this was not feasible, and only strains could be recorded. Consequently, the comparison was instead based on the observed crack formation patterns. The results show reasonably good agreement between the experimental findings and the numerical model, with the cracks reported by Mifsud (2012) aligning well with the formation of eccentrically arched strain contours. Moreover, the height of the arch (measured from the beam) is very similar, as shown in Figure 5:28. One can argue that the numerical model of the wall did not fully capture all the cracks experienced by the wall, as 'crack 8' from Mifsud J. (2012) is not shown in the plastic strains of the numerical model. One reason for this is since in RFEM6, macro modelling is used, where an equivalent material is used as a substitute to the masonry wall made from mortar and blocks. This means that some accuracy is lost, and thus and to capture all the cracks, discrete element modelling is required.

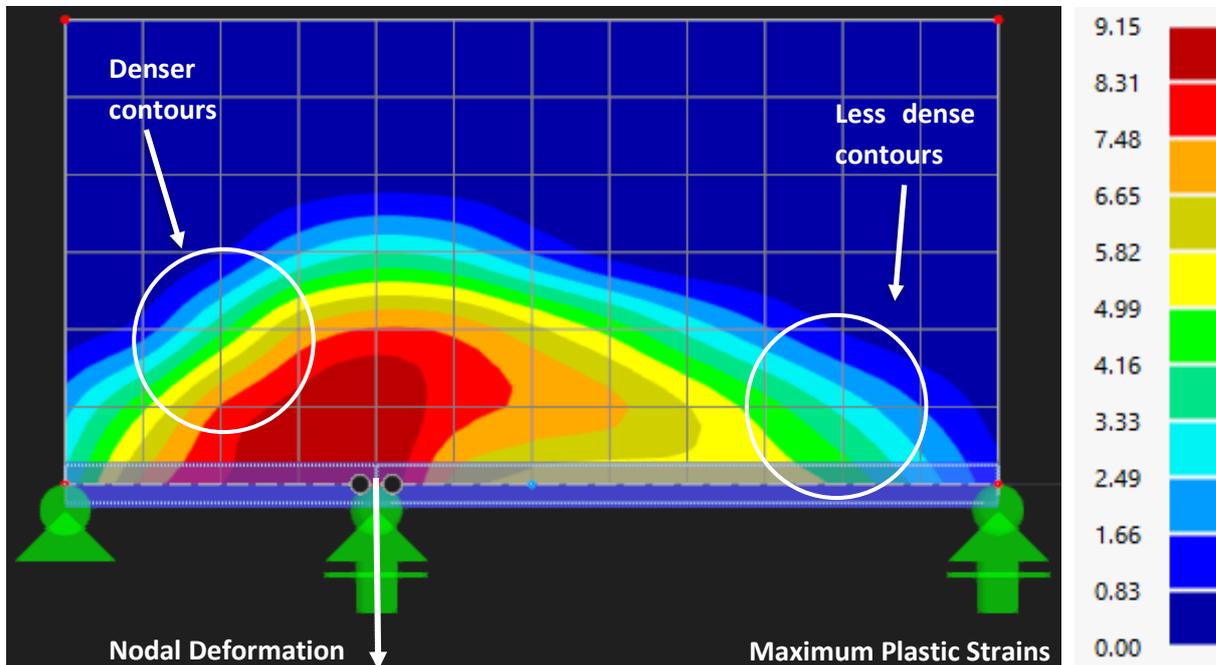
**Figure 5:29 - Arched contours in the regions of Maximum Plastic Strain**

Mifsud J. (2012) argues that a rotation considered critical for one span may not be critical for another. For instance, achieving the same crack width requires the short span to undergo only half the rotation of the long span. This means that even though the long span rotates less, it can still fall into a worse damage category because the span is longer. In the numerical model, however, this is challenging to visualize, as the cracks are not explicitly depicted. Instead, the arched strain contours appear less dense (more spaced out) on the left side and denser (less spaced out) on the right side, hinting how limited rotation can still generate considerable strains in the wall, as shown in Figure 5:29.

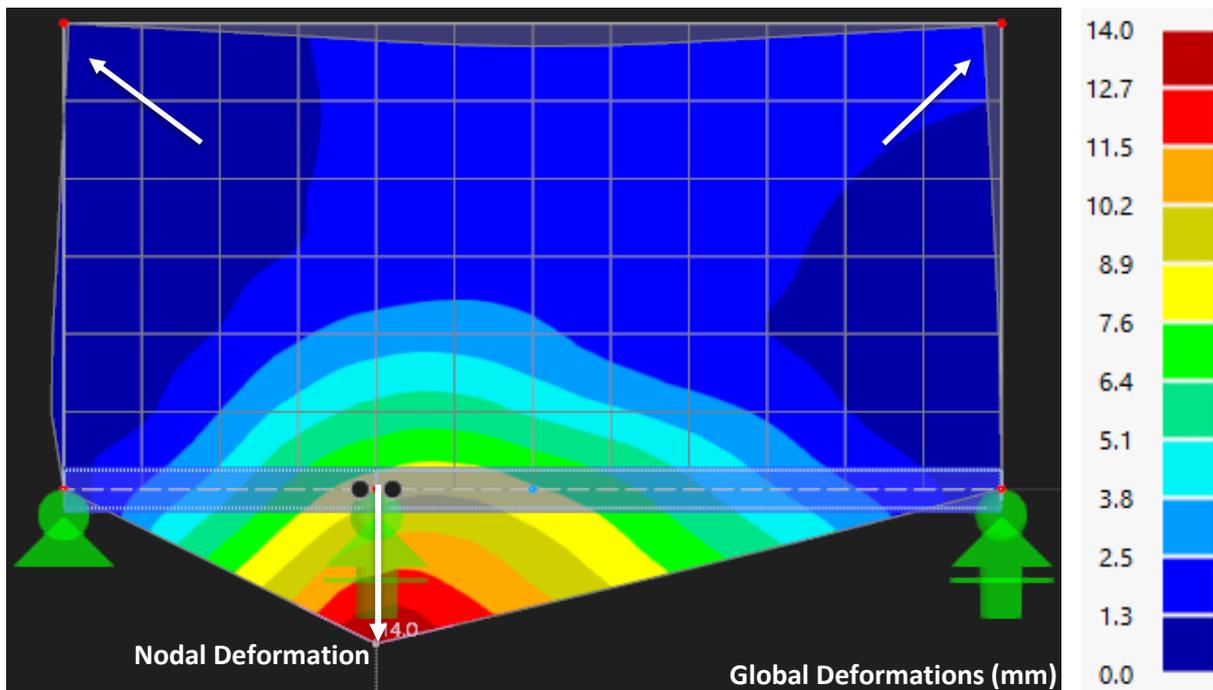
**Figure 5:30 - Deformations exhibited by the masonry wall**

Comparison of the in-plane displacement values recorded by the dial gauges 2 and 3 in Mifsud J. (2012) and the same value from the numerical model indicates some discrepancies. The values of dial gauge 3 in Mifsud J. (2012) and the numerical model seem to be very close to each other, however, the values of dial gauge 2 do not. This is clearly illustrated by comparing the readings of dial gauges 2 and 3 in Figure 5:30 & Figure 5:31. In Figure 5:31, dial gauge 2 records a greater plane displacement than dial gauge 3, whereas in Figure 5:30, the opposite is observed.

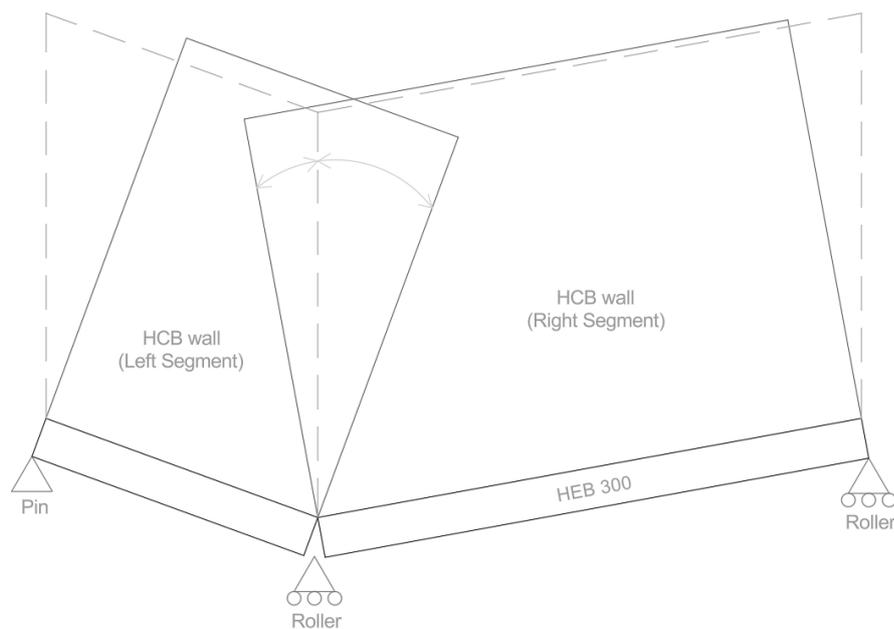
**Figure 5:32 - Distortion experienced by the masonry wall**

There is an alternative interpretation of the deformations observed in the numerical model, in contrast to what was previously explained. Consider that the wall can be conceptually divided into two sections at the location of the nodal deformation. If we assume that this nodal deformation occurs and the wall segments are free to tilt, the left segment will rotate clockwise (towards the right), while the right segment would rotate anticlockwise (towards the left). Given that the nodal deformation is eccentrically located towards the left, the right wall segment possesses a greater mass. As the right wall tilts, it tends to exert a lateral force, pushing the left segment further in the same direction it is already tilting. This interaction results in overall distortion of the wall system, as shown in Figure 5:32. This could explain an apparent inconsistency: although it was expected that the portion of the wall resting on the short-span beam would undergo the most significant rotation, the model shows that it actually experienced the least deflection. In contrast, the upper portion of the wall on the right-hand side exhibited greater deflection, likely due to the lateral force imposed by the more massive, tilting right segment.

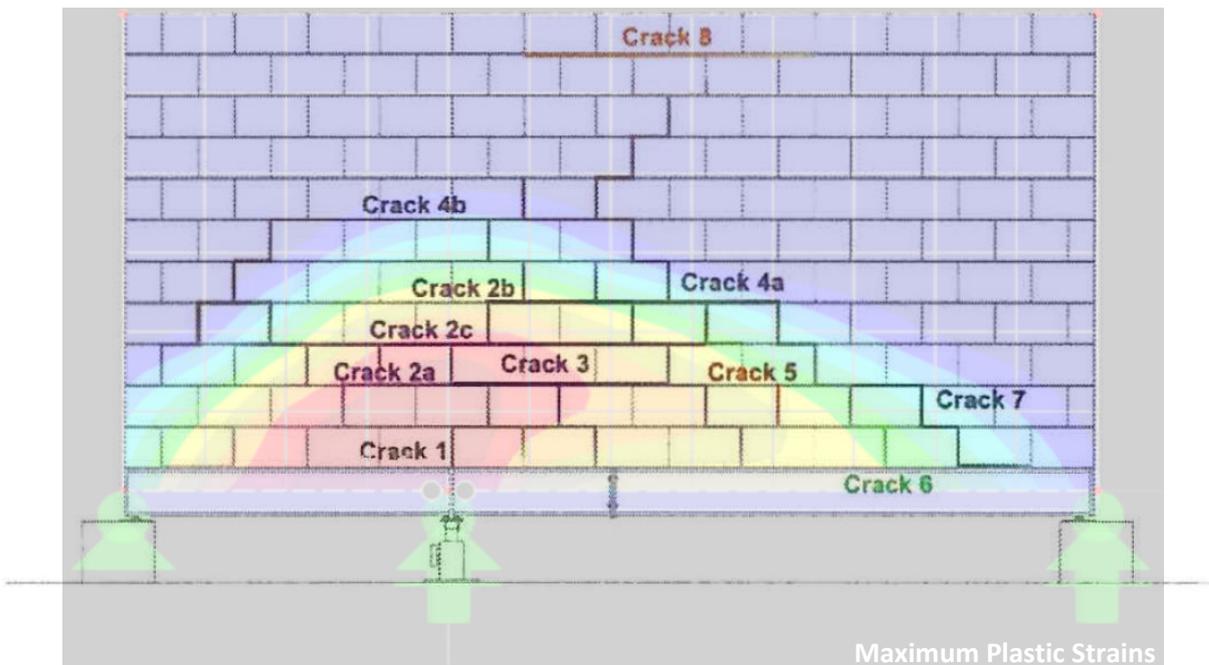
**Figure 5:33 - Crack formation in the wall setup described by (Mifsud J. , 2012) superimposed over the Maximum Plastic Strains experienced by the numerical model**

Another important observation that should be made is that part of the wall closest to the nodal deformation experiences the greatest degree of tensile stress and therefore the strain in that region is considered to be the highest when compared to the strains in other parts of the wall. This was exhibited both by the numerical model where the arched red contour was at the location of the nodal deformation as well as in the observations by Mifsud J. (2012) stating that “Cracks 1,2,4 exceeded the serviceability limit category. Crack 5 remained quite unaltered throughout the tests and could be either the result of drying shrinkage of the finish, the effect of a 4m span serviceability deflection or some minor structural movement”. In fact, cracks 1,2,4 are very close to the location of the nodal deformation, whilst crack 5 is further away from the nodal deformation and thus the effect of the nodal deformation is ‘less effective’, thus the strain in that area is much less and as a result the crack width is not considerable and was unaltered during the gradual nodal deformation. This means that there is also agreement between the results of the two models, once again. This is illustrated in Figure 5:33.

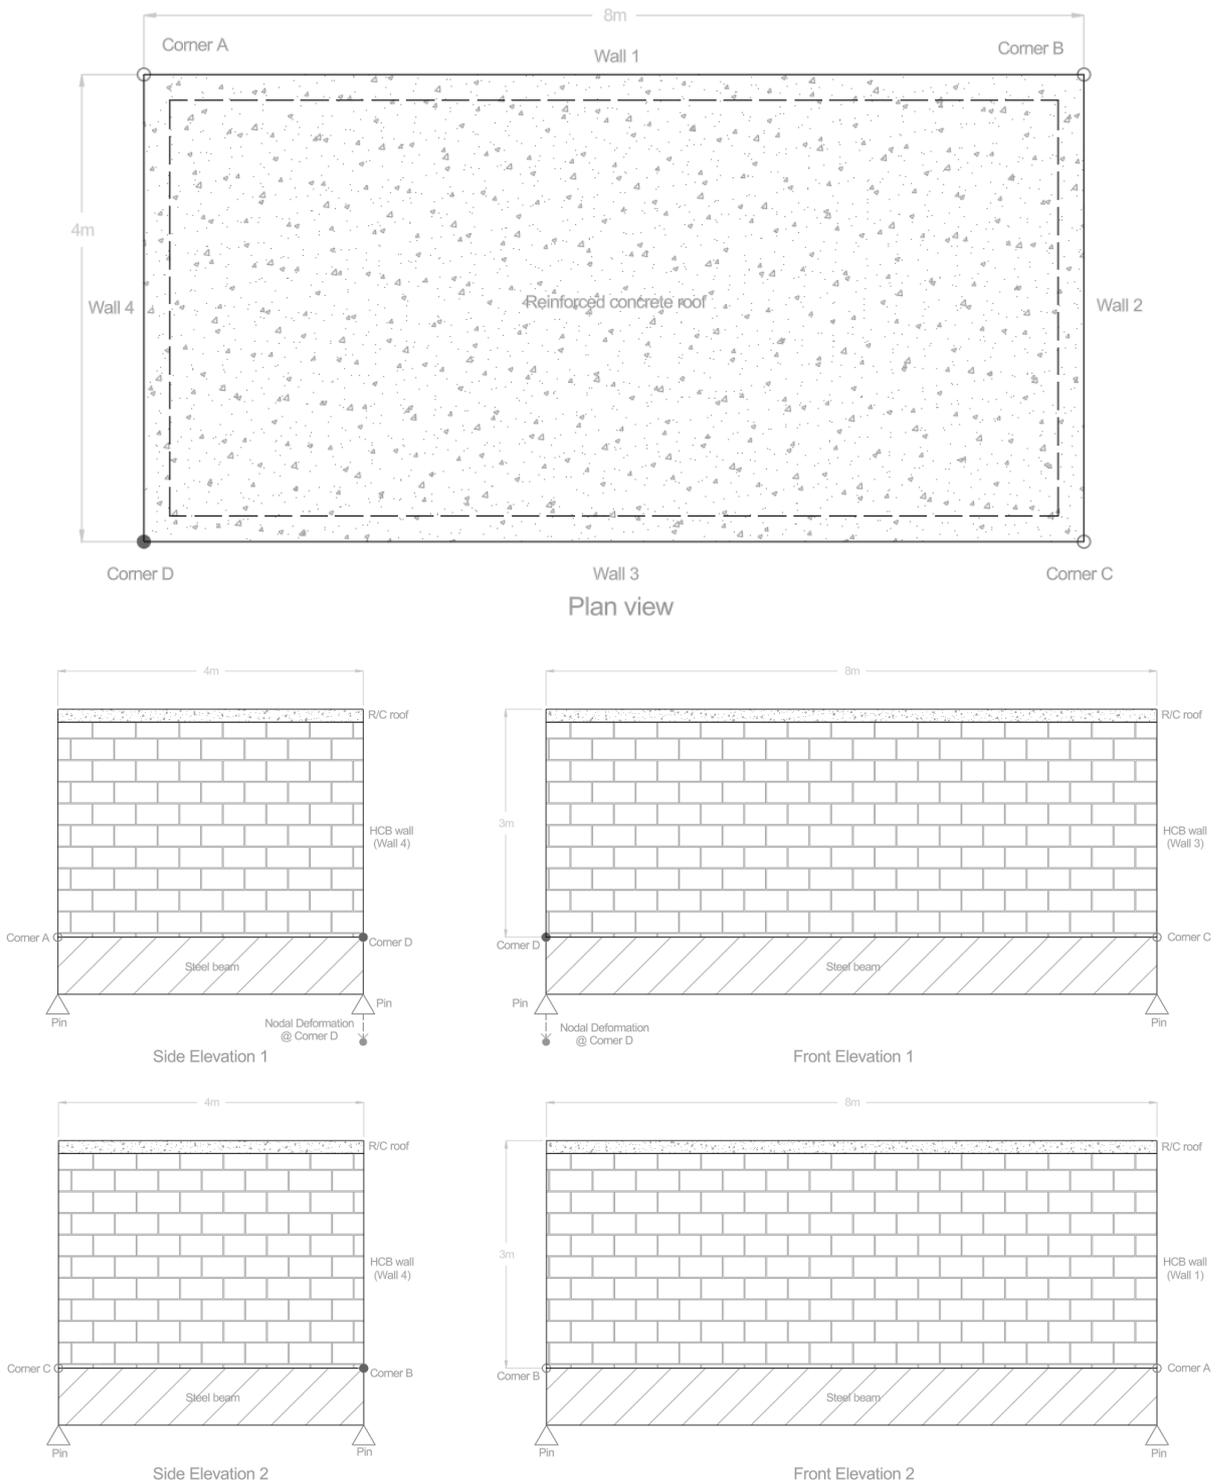
**Figure 5:34 - Drawings of the single-storey room**

A nodal deformation was applied to one corner of the room, with the aim of studying the overall deformation of the room and the formation of stresses in the walls. Modelling a room presents different challenges compared to those encountered in Sections 5.3 & 5.4, and these are listed as follows;

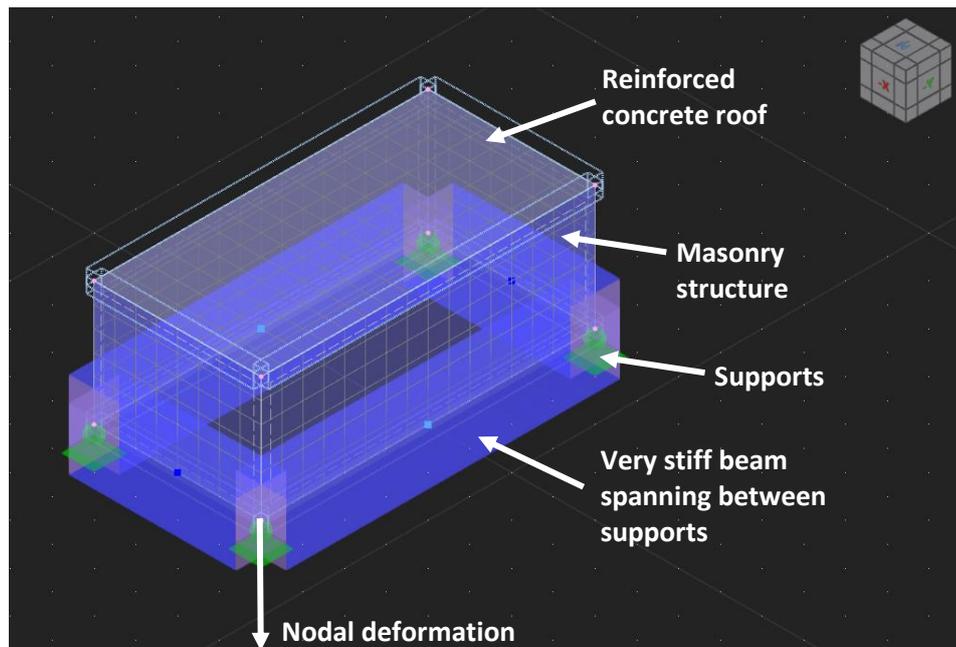
**Figure 5:39 - 3D model of the room's structure**

in Figure 5:39. This ensures that any strains experienced by the wall are solely generated by the nodal deformation. This eliminates the possibility of strains forming in the wall because of bending in the beam.

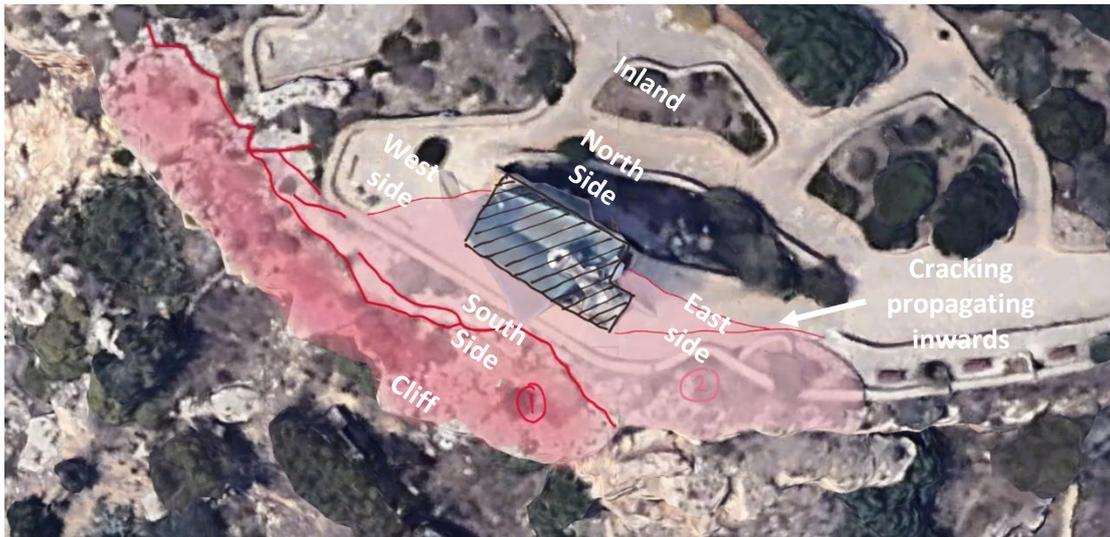
on both the eastern and western sides of the structure, as shown in the Figure 5:41. These cracks are narrower than those at the edge, suggesting that the damage is spreading inward. It is therefore assumed that similar subsurface cracking exists beneath the structure, potentially forming a continuous fracture line between the eastern and western cracks.

**Figure 5:41 - Cracking in the ground: 1)Thick red lines indicate wide tension fissures near the cliff edge, 2)Thin light red lines represent narrower cracks beneath the structure**

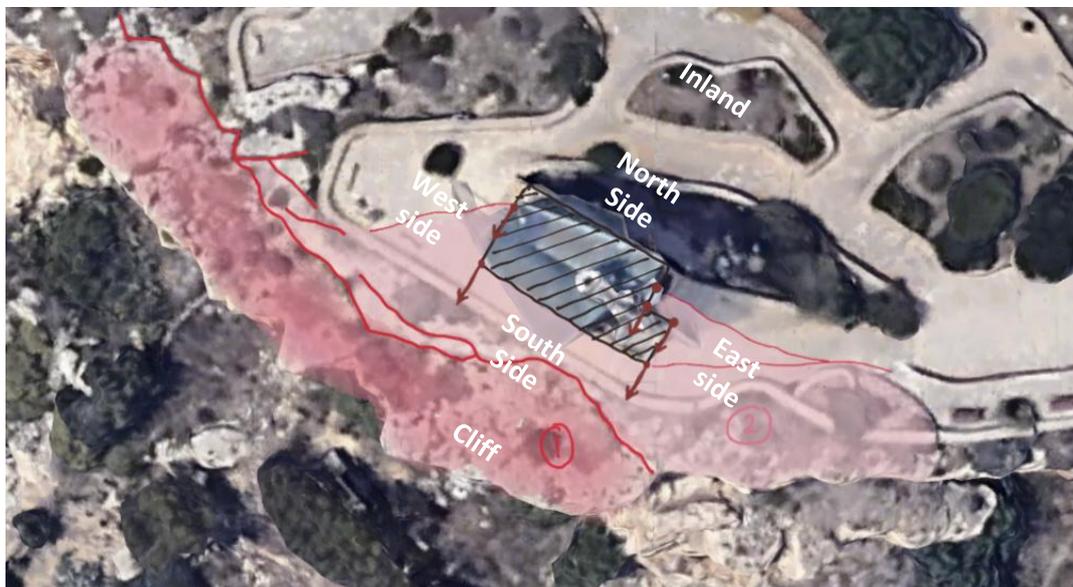
Additionally, the mapping of cracks and site photographs proved useful in identifying which supports should be assigned nodal deformation in the model, as well as estimating the angle at which this horizontal deformation should be applied, as shown in Figure 5:44. The deformation values were determined through a trial-and-error approach, as the objective of the exercise was not to calculate the exact nodal deformation experienced by the structure.

**Figure 5:44 - Ground crack mapping and locations within the structure where nodal deformations are applied**

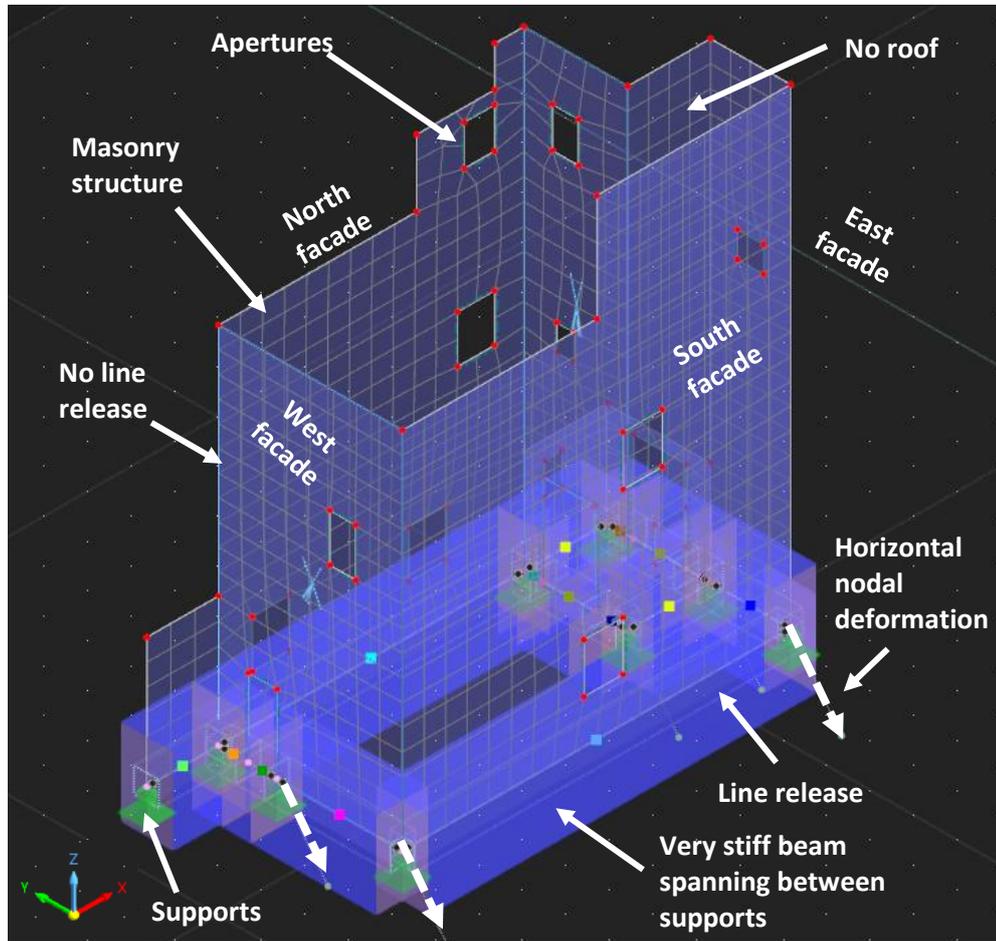
Figure 5:45 - 3D model of Ta' Kenuna Tower

On the other hand, the first similarity is that the foundation concept remains unchanged: the masonry walls are supported by very stiff beams, which are pin supported at their ends, mimicking the existing foundation system beneath the actual tower (Figure 5:45). Also, to simulate pin connections, rotational releases were applied at the ends of the beams, preventing moment transfer. This avoids the introduction of hogging moments into the masonry walls, which could exacerbate deformation. Another similarity is that a line release was introduced between the masonry walls and the supporting beams, allowing independent behaviour of the two components and preventing unintended composite action (Figure 5:45). The final similarity is that no releases were applied between orthogonal walls, ensuring compatibility and enabling the walls to function together through tying action (Figure 5:45).

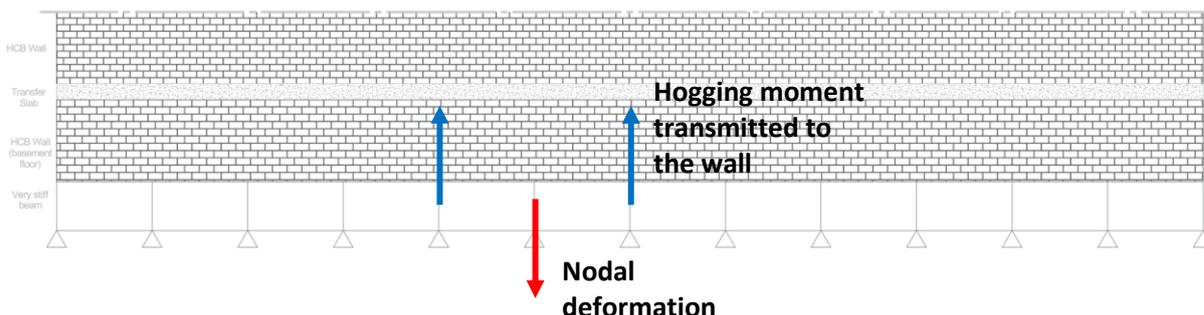
**Figure 5:63 - Moment connected beams supporting the masonry wall**

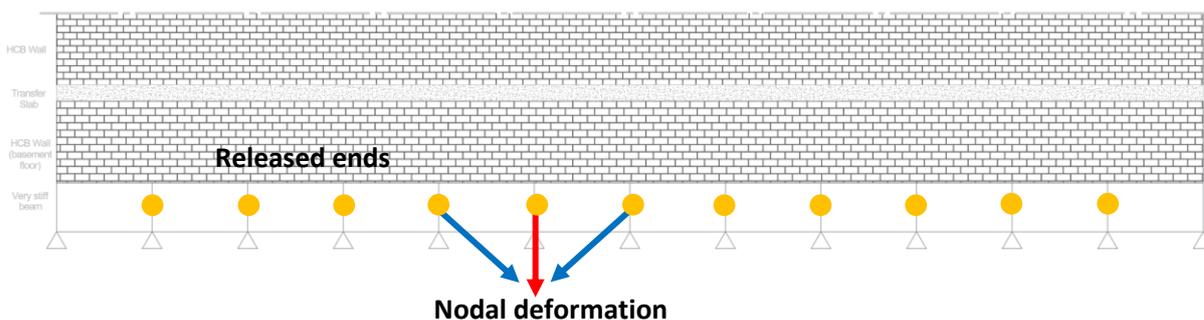
**Figure 5:64 - End releases applied to the ends of beams in contact**

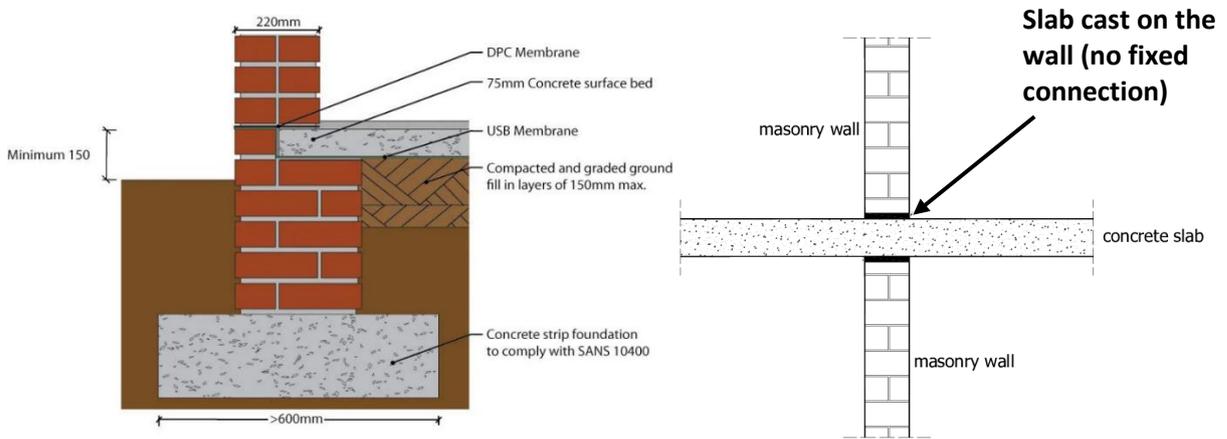
**Figure 5:65 - Application of the line release between the masonry wall and the strip foundation & the masonry wall and the reinforced concrete roof**

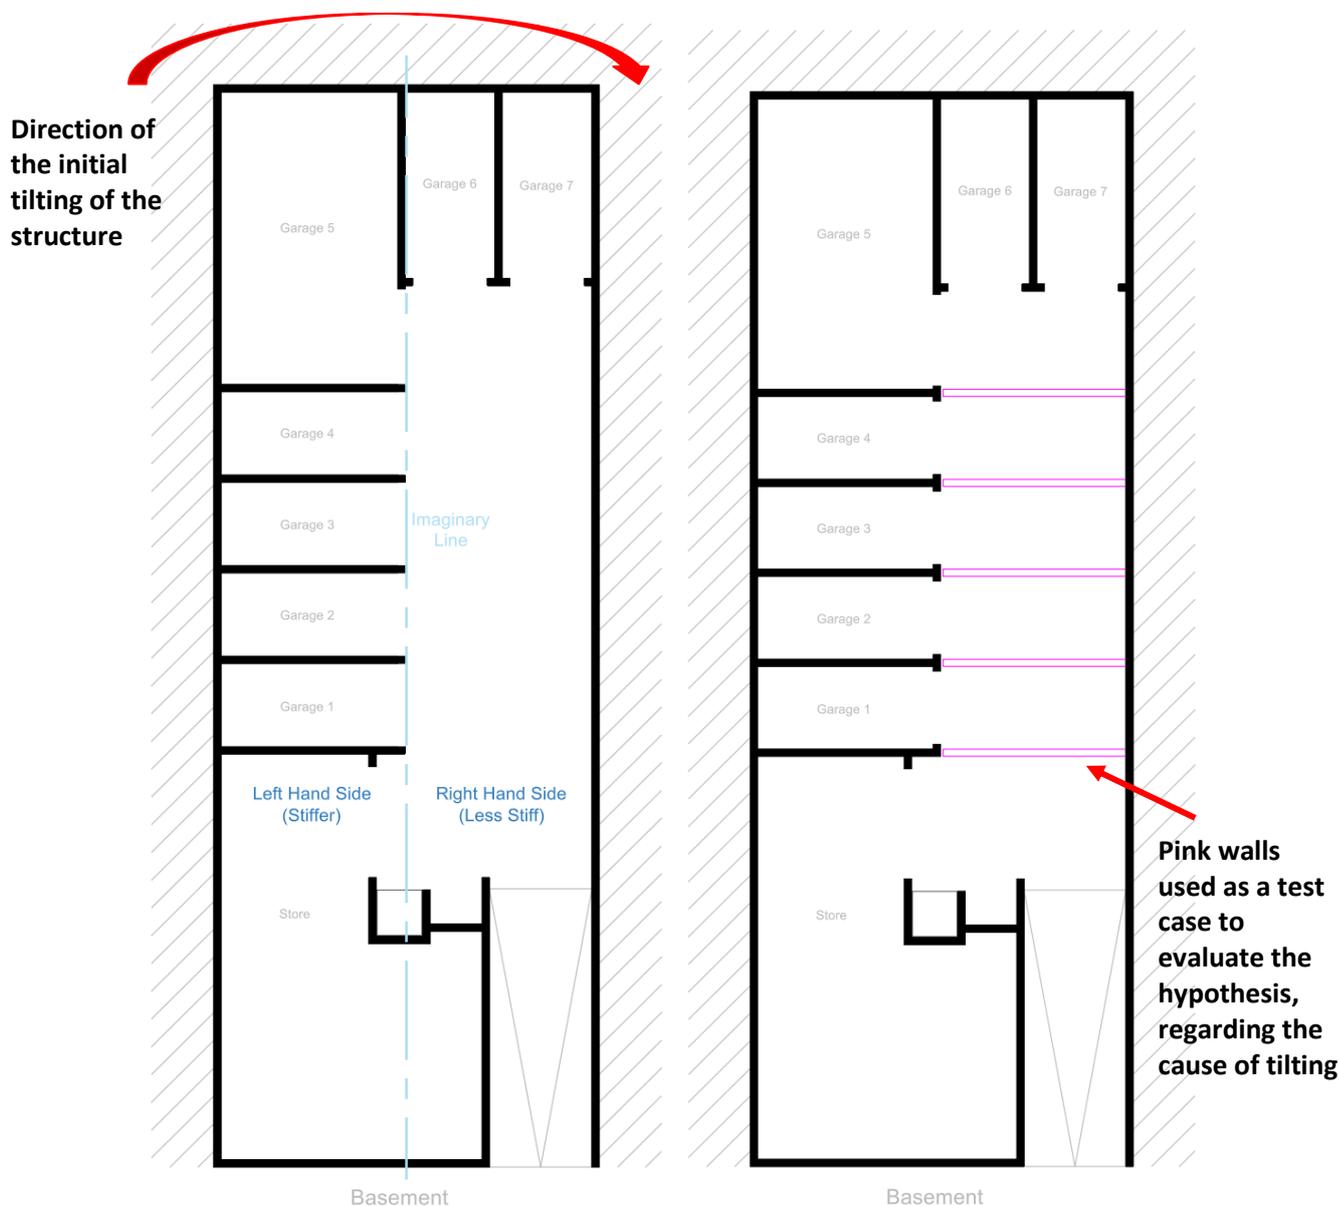
**Figure 5:68 - The first image illustrates the variation in structural stiffness and the direction of tilt indicated by the red arrow, while the second image highlights the mirroring of the orthogonal walls shown in pink**
