**A study into the effect of ground movement on the deformation of  
typical local structures consisting of load-bearing HCB walls and  
reinforced concrete in-situ slabs**

Dissertation submitted to the Faculty for the Built Environment, University of Malta in part fulfilment of the requirement for the attainment of the degree of Master of Engineering (Structural Engineering)

June 2025

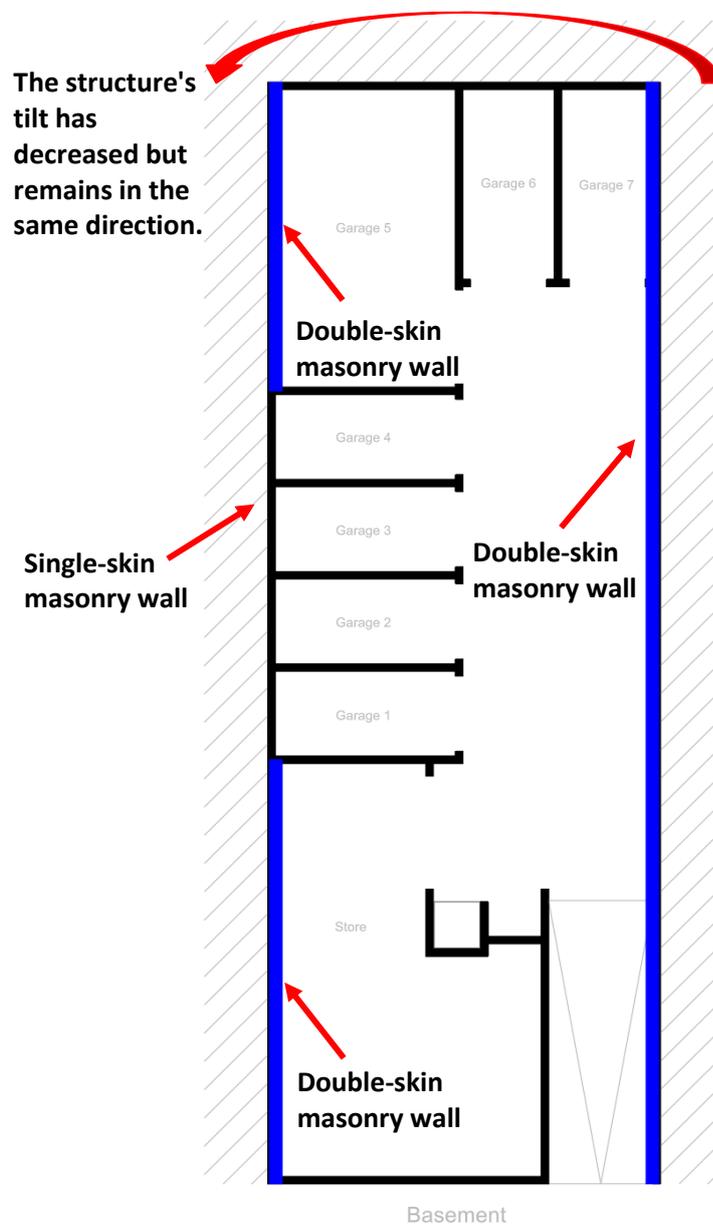
**Figure 5:72 - The use of double-skin walls (blue) for long-spanning walls, while retaining single-skin walls (black) for shorter spans**

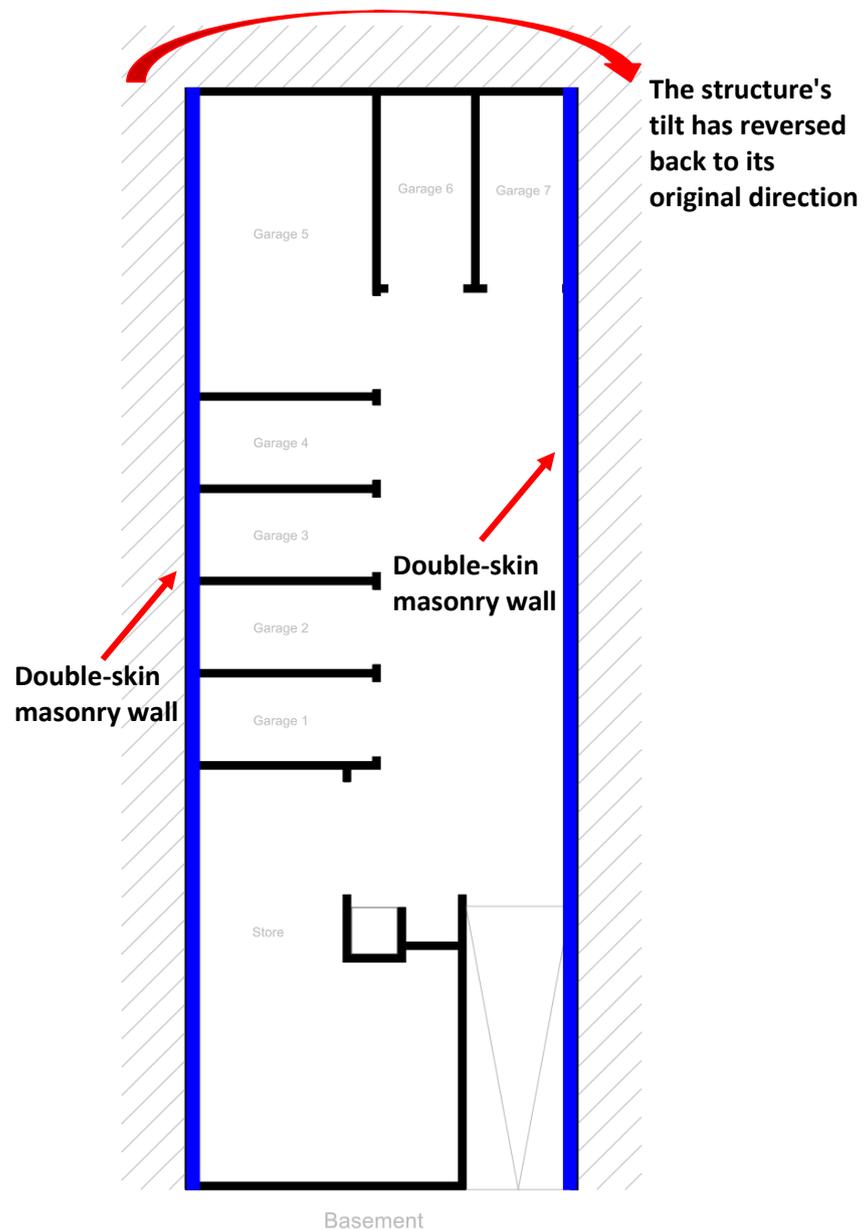
**Figure 5:73 - Replacing the single-skin wall in the central region of the left-hand side wall with double-skin walls**
