Designing a Bathing Area Management Plan - a template for Ramla Bay, Gozo

Ramla Bay, Gozo, reflecting a high recreational potential within a very natural and largely undisturbed setting.

Anton Micallef

January 2003

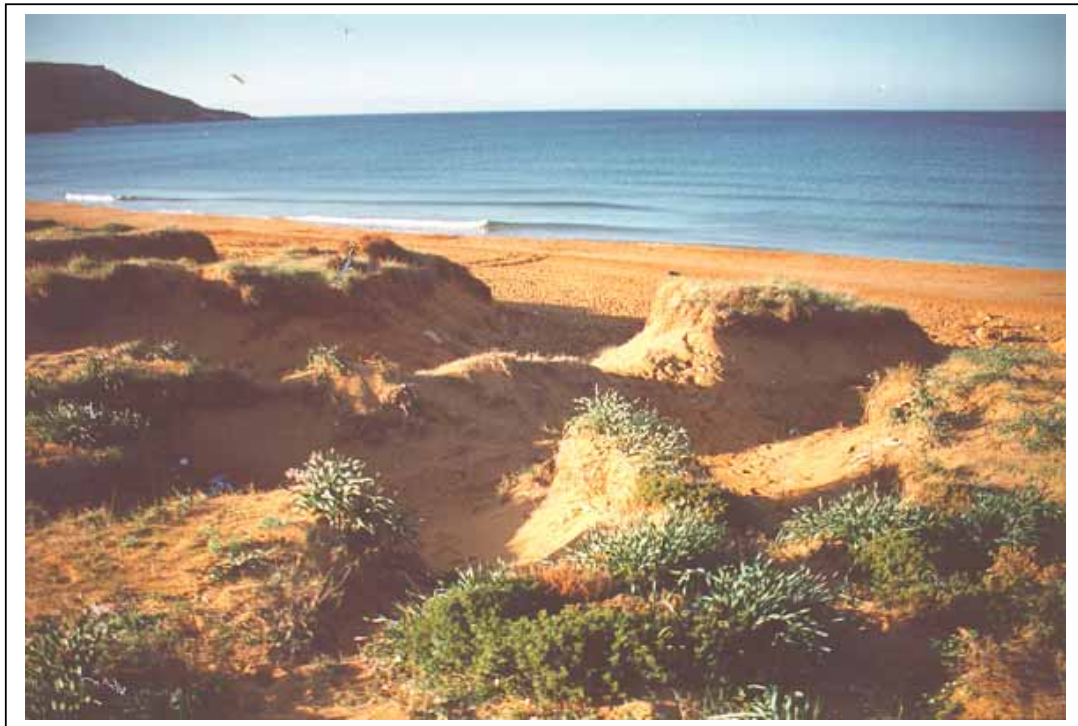
Plate 1: Highly degraded dune system at Ramla Bay, Gozo.

Evaluation of the **substantive dimension** (Appendix III, Table 3) reflected that the issues considered for Ramla Bay were highly specific to the beach in question. This was attributed to the opportunity of evaluating an on-going pilot project on integrated management of this site. In this context, analysis of the substantive dimension for Ramla bay reflected the important management role played by the Gaia Foundation at this site. The *site-specific nature* of the substantive dimension analysed for Ramla Bay was reflected by the specific consideration of the extremely degraded but nonetheless locally important sand dune remnants at this site (Plate 1). In this context, it was recommended that the problem of encroaching farming on the dune remnants should be addressed.

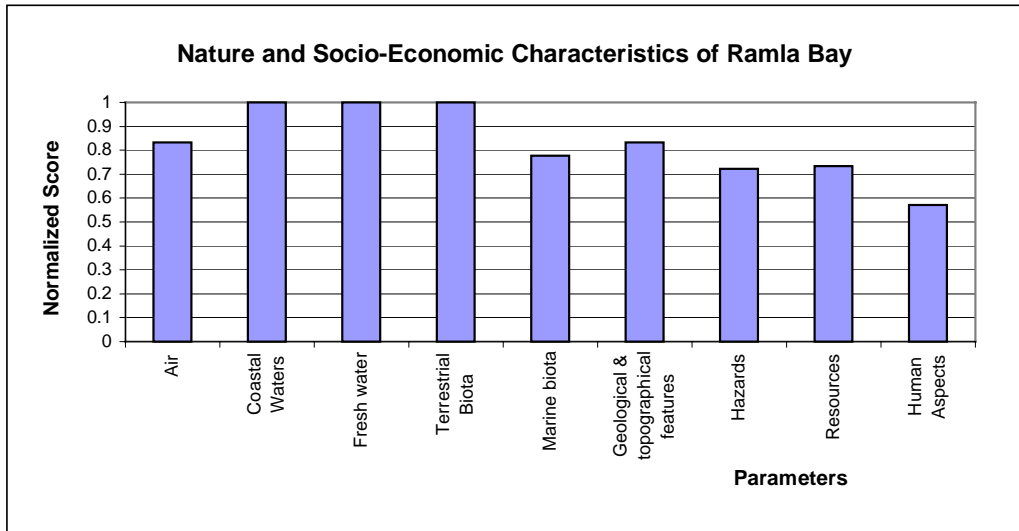
Figure 1 describes the Function Analysis results for Ramla Bay, reflecting generally high scores allocated to environmental parameters and low values to human aspects. Some site-specific characteristics are evident, for example the low value allocated to the air quality parameter at Ramla Bay (Figure 1) may be linked to the impact of an upwind municipal waste disposal site. Similarly, the high value allocation to the freshwater parameter may be attributed to the large water catchment area influencing this site.

Figure 1: Graphical representation of normalized scores allocated for bathing area-related parameters at Ramla Bay, Gozo.

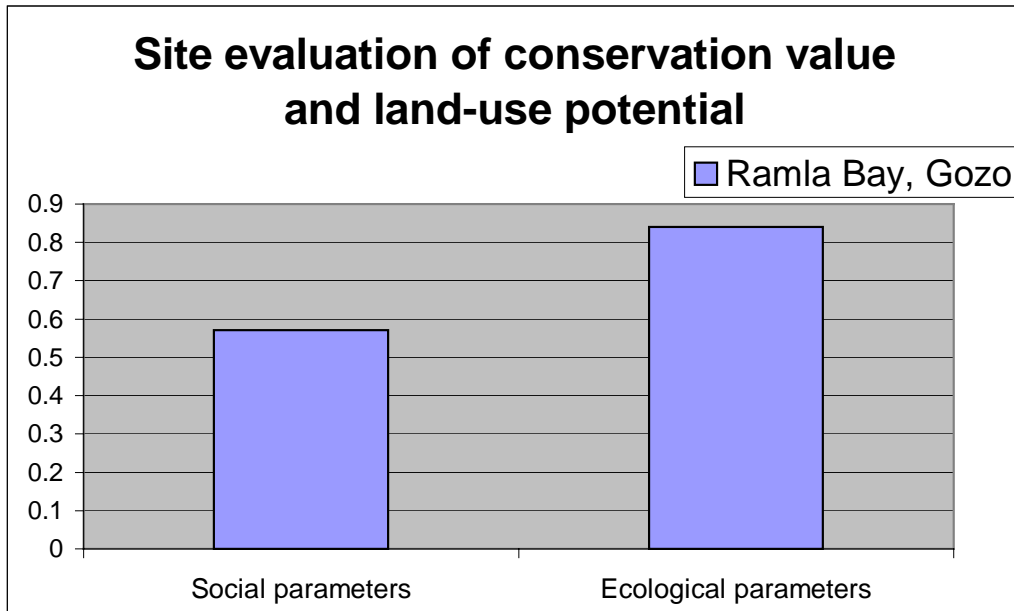
Figure 2 describes the overall conservation value versus the use/development potential of the bathing area at Ramla Bay, reflecting high conservation value and low use/development potential.

Figure 2: Comparison of conservation and use/development values at Ramla bay, Gozo

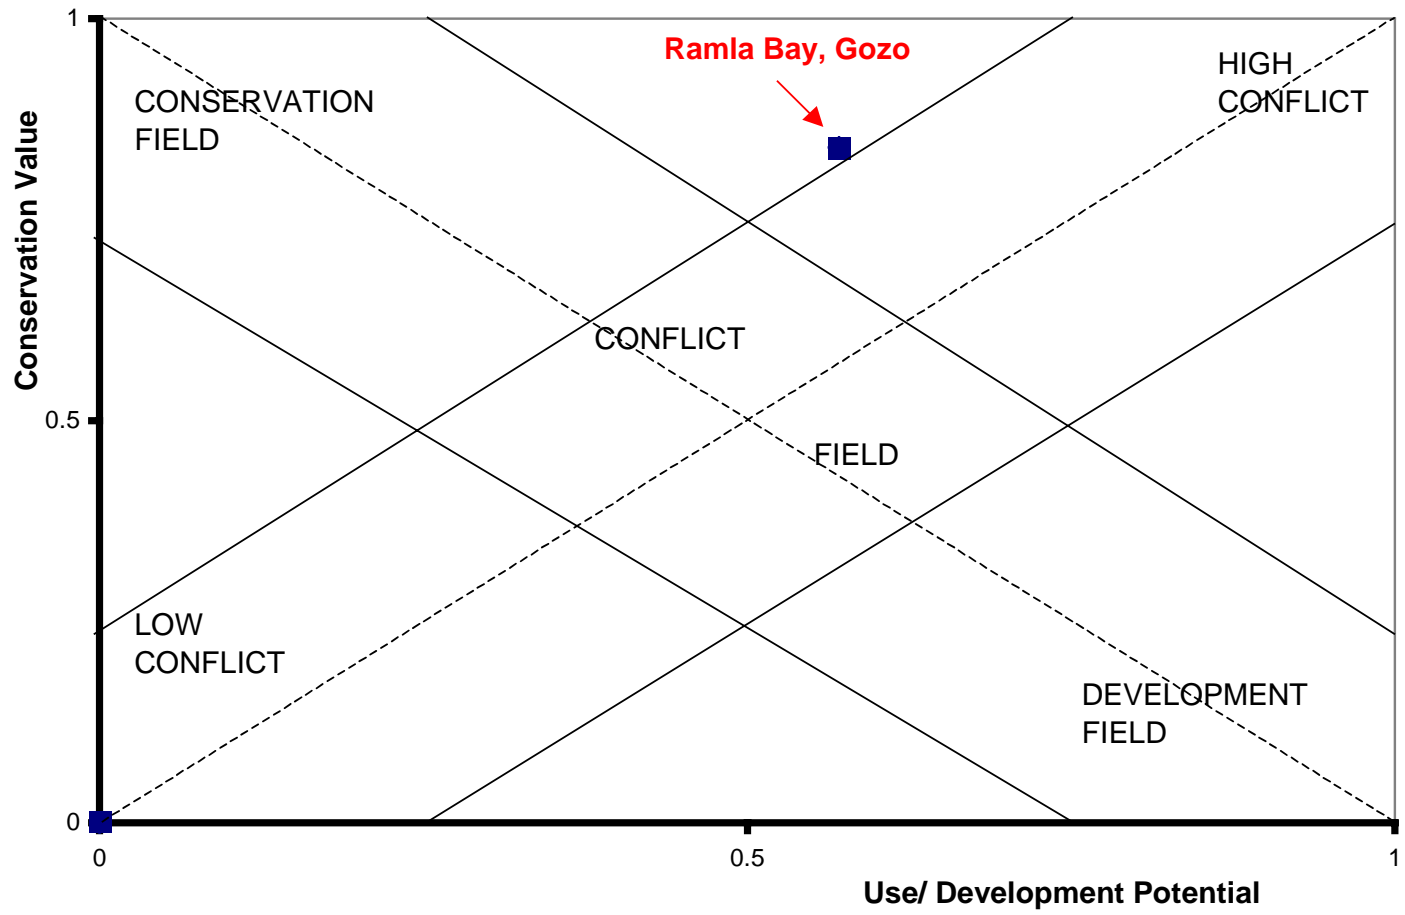
Conservation / Use/Development Matrix

Figure 3 shows the total normalized scores for conservation value and use/development potential for the Ramla bathing area plotted as a matrix that allows site evaluation and development of Integrated Coastal Area Management (ICAM) strategies as well as a potential for subsequent site comparison with other bathing areas (Micallef & Williams, *in press*). The latter would be particularly useful when considering a national bathing area management framework.

Figure 3: Position of Ramla Bay bathing environment within the Conservation / Development Matrix

The high conservation value rating allocated to Ramla Bay may be attributed to the ecologically important though albeit highly degraded sand dune remnants identified at this site (Plate 1). The high conservation value awarded is well supported by its status as an Area of Ecological Importance (AEI) and nomination as a potential marine conservation area. A Conservation Order currently being sought for Ramla Bay will also offer further protection to this site through stipulation of site-specific regulations. The position of Ramla Bay within the conservation value / use-development potential matrix indicates that an improvement in conservation value may be achieved at this site. In this respect, a management plan having high conservation bias is advocated. These results are complementary with the findings of the bathing area classification where the Ramla Bay bathing area was awarded a high rating (4 out of a possible 5 Stars).

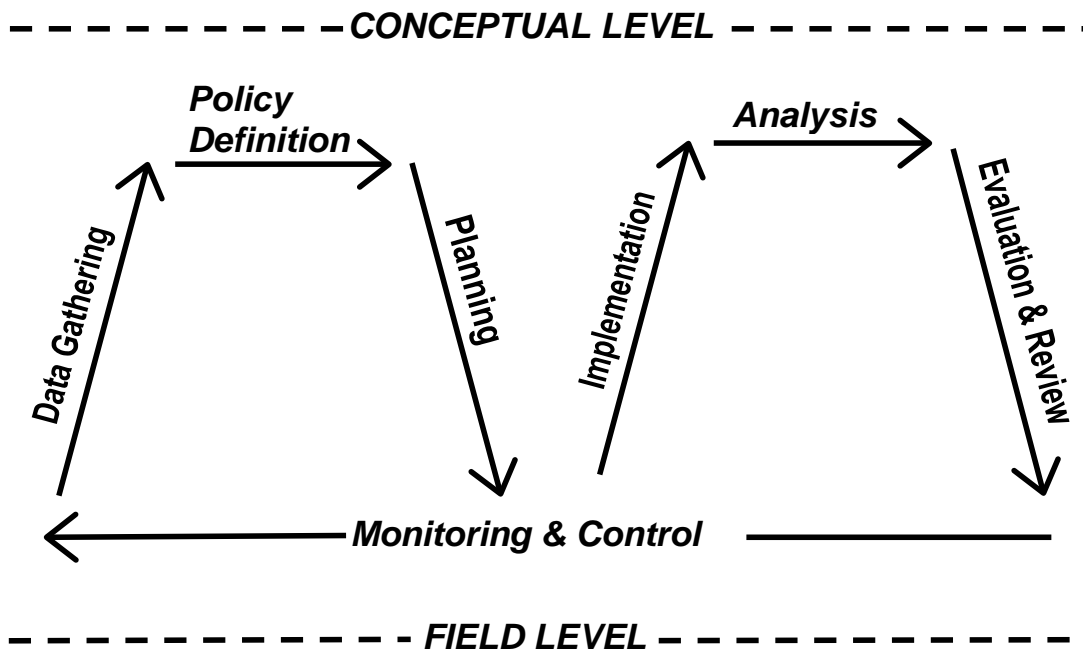
Figure 1: The Malta (M) Model for bathing area management.

Figure 1 describes how the model envisages policy definition and analysis phases at the conceptual level and the monitoring and control phase at the field level. The remaining phases naturally involve both conceptual and field

In the **Planning Phase** described by Figure 1 (above), the management committee should identify a working hypothesis through evaluation of possible options/solutions as presented by appropriate bathing area management guidelines (see recommendations in section 4.1) and adopt an action plan that defines a pilot management programme based on this proposed management model. In this context, recommendations emanating from the Dimension Analysis carried out in the Data gathering phase and decisions taken at the policy definition phase should be integrated within the planning process. It is also recommended that bathing area classification is carried out in this phase as an aide to the development of the pilot plan of action.

In Figure 1, the ***Analysis Phase*** involves processing of preliminary results obtained from the pilot-scale project. It is recommended that suitable data processing techniques and software are identified or developed in advance so as to facilitate this phase of the model. In this connection, the development of novel survey questionnaires and use of specific software packages (such as the Social Sciences Statistical Package - Norusis, 1993) were found particularly well-adapted for gathering and processing data related to beach and rocky shore user preferences and priorities.
