THE FLORIANA LINES

The Entrenched Bastion on the enceinte composed of St. Philip's Bastion, St. James' Bastion and St. Luke's Bastion.

'The Conservation of the Baroque Heritage'

Denis A. Darmanin

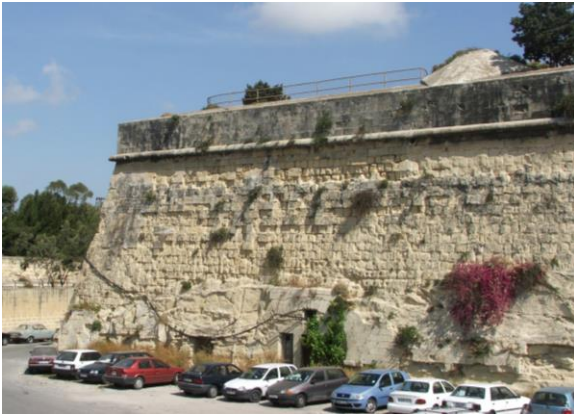
The sections of rock-hewn scarp emerging from the ditch are badly deteriorated due to composition differences in strata and formations, especially where fissured. Their principal deterioration is powdering due to weathering and salts, however, some of the strata is breaking and crumbling either due to the mass and weight that it is supporting or because the deterioration process here is quicker than in the rest of the surrounding rock due to the rock being much friable. There have been a number of interventions in the past, mainly the use of masonry blocks to occupy the void left by the deteriorated fabric.

Fig. 7: The salient end of St. Philip's left scarp.

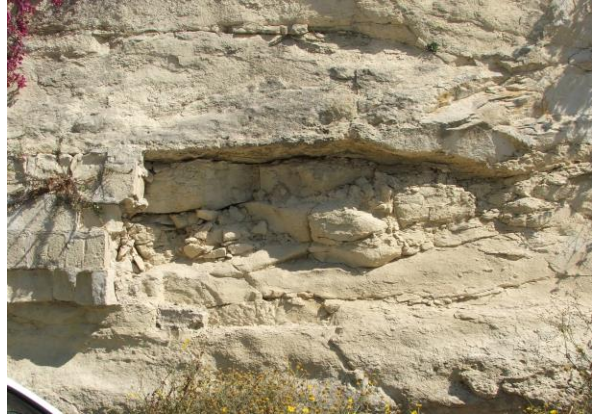
Fig. 8: Fragmented rock strata on left scarp.

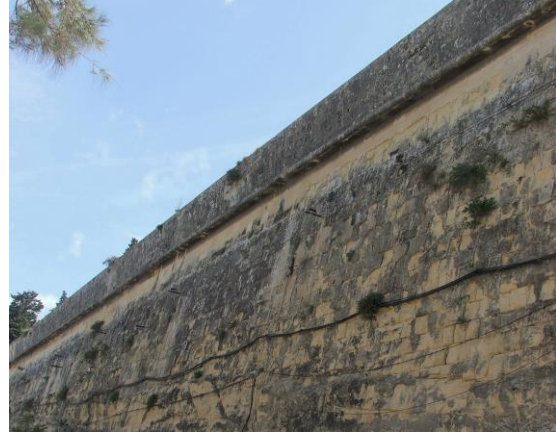
Fig. 13: The heavily encrusted right scarp.

Similar deterioration is much evident on the right scarp, which on the other hand faces the strong North Westerly winds. The masonry and rock-hewn elements do not have as much as a deteriorated surface as on the left scarp, but they have a higher concentration of deposits and encrustation. This could also be because this side only has about a third of the face composed of masonry. The stone blocks can be noted as well into the stage of losing their patina and delamination is evident in many parts; to the extent that it is quite possible that the skin and patina are detached from the rest of the stone.

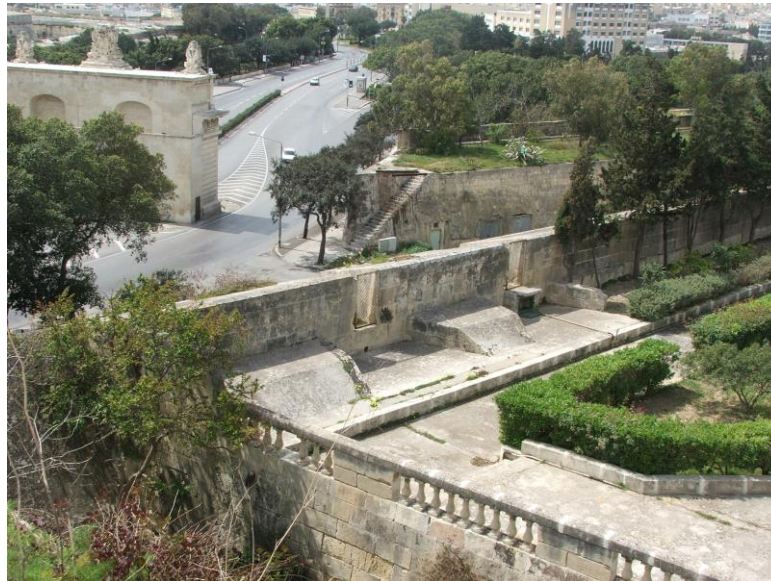
Fig. 17: The two left embrasures with the only section of banquette.

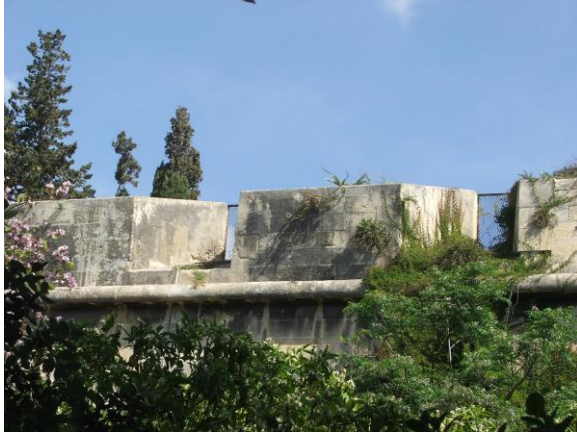
Fig. 18: The two left embrasures hidden behind trees.

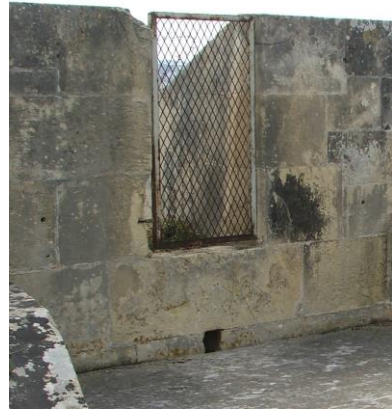
Fig. 19: Rear showing algae growth.

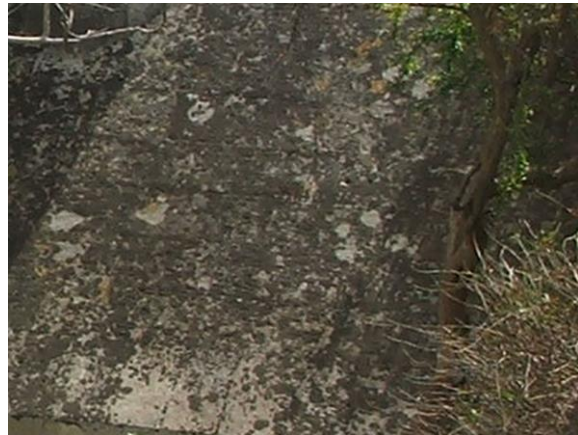
Fig. 31: Lichen and fungi on the internal slope.

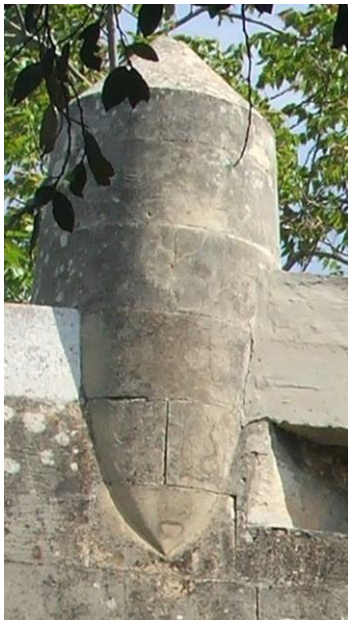
Fig. 32: Lichen and crust on dame.

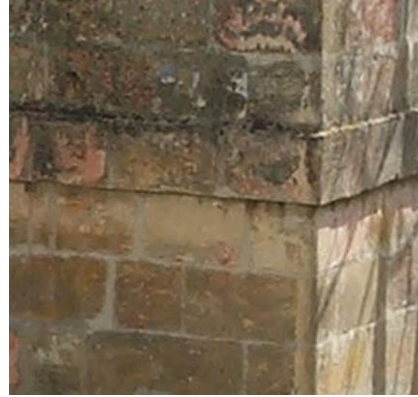
Figs. 34 and 35: Machinegun post structure showing Lichen, algae and fungal growth.

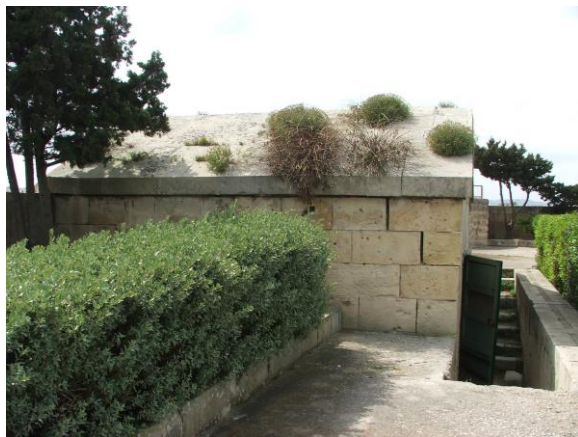
There is only one magazine on this bastion, situated along the left parapet. Many of the masonry blocks at front have shifted due to plants and their roots.

Fig. 36: Magazine with growth and open joints.

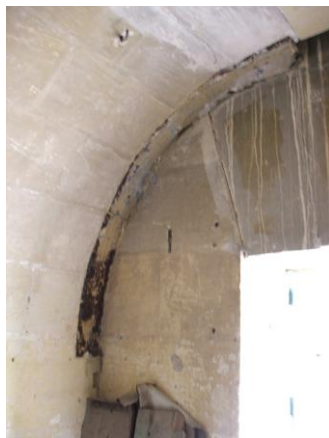
Fig. 38: Plant roots penetrating into magazine.

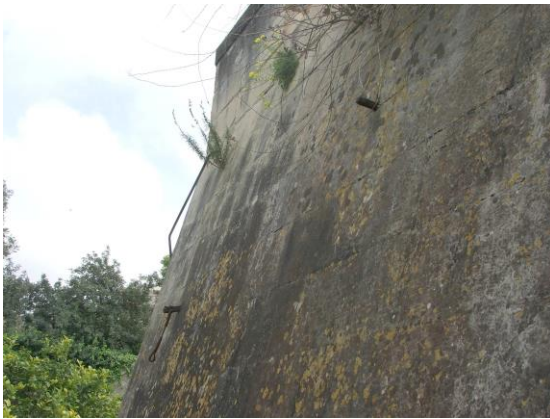
The counterscarp is not exposed to sunlight as much as the rest of the bastion and growth due to dampness is very present. Moss is the most common, with patches of lichens and algae. The stairs on each side are similarly effected. The underground magazine at centre is in a very good condition internally and only has minor breakage, mainly on the edges of the airing holes and loopholes. The magazine itself is in an excellent condition of preservation.

Fig. 40: Lichen, algae and accretions on left of counterscarp.

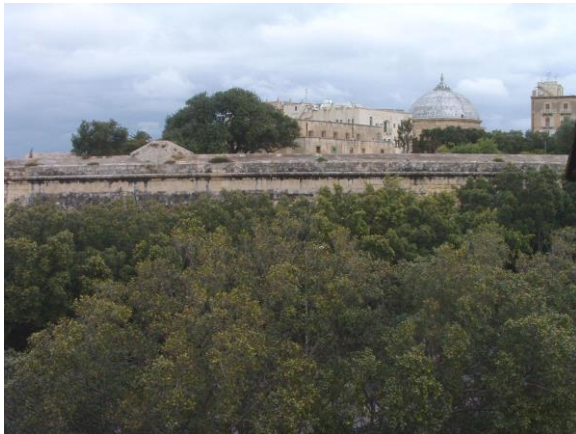
Along the left scarp of St. Luke's Bastion, *Ficus Nitida* trees were planted along the base of the lower section which have now grown to enormous proportion that they're practically hiding the beauty of the fortifications behind them, as well as creating a micro climate in the relatively small gap that remains; when existing at all. They also serve as a shelter for birds and pigeons to roost in the crevices on the scarp. Furthermore, they act as wind-breakers and shield flaking and powdered material from the masonry to remain trapped on ledges and in return to absorb moisture which is transmitted to the stone through its capillaries. However, in some places the same trees do not allow rain to hit the faces and therefore black encrustation is not washed off by natural causes.

Fig. 43: *Ficus* trees having grown as high as the cordon.

These trees are a visual intrusion and should be replaced with others that are more appropriate and especially of a controlled height. The argument is simple; which is the most important element, the trees or the fortifications? These trees are non-endemic and can be planted anywhere but fortifications are static and are our treasured patrimony! This problem has been properly attended to with relations to fortifications in a number of similar European locations¹⁰.

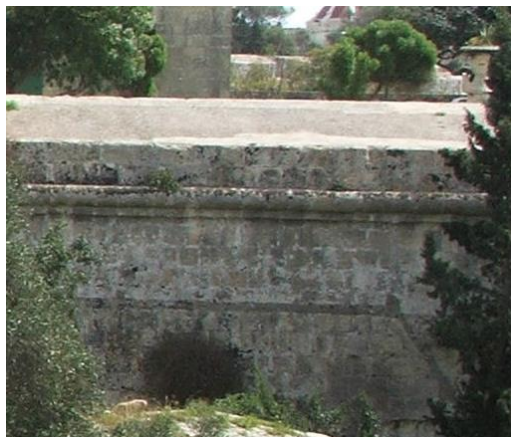
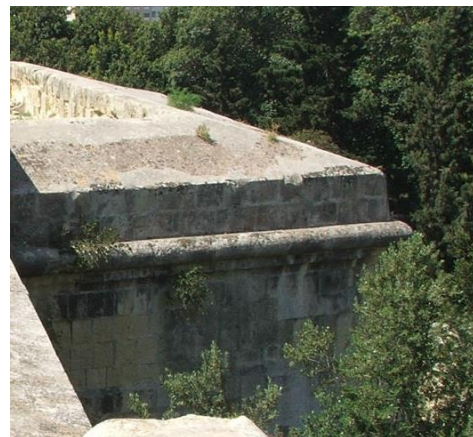
Figs. 52 and 53: Right flank, shoulder, cordon and parapet of St. Luke's Bastion. Very little deterioration but Lichen and algae growth and encrustation are more evident

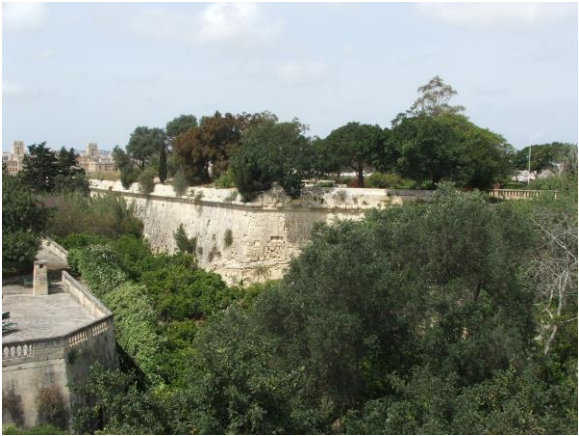
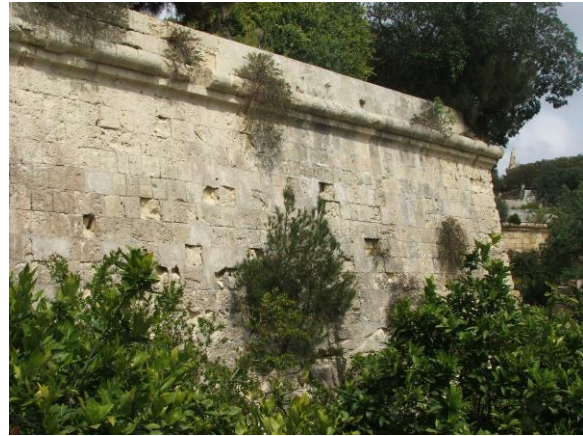
The left scarp is not as badly deteriorated as other bastions. It has a number of small fissures running along joints for a number of courses, powdering that is extensive in individual stones and the usual exfoliation and alveolar erosion, which is expected from such old masonry. Being close to trees, shrubs and other growth have a firm presence on the scarp and cordon, especially since left unchecked for years.

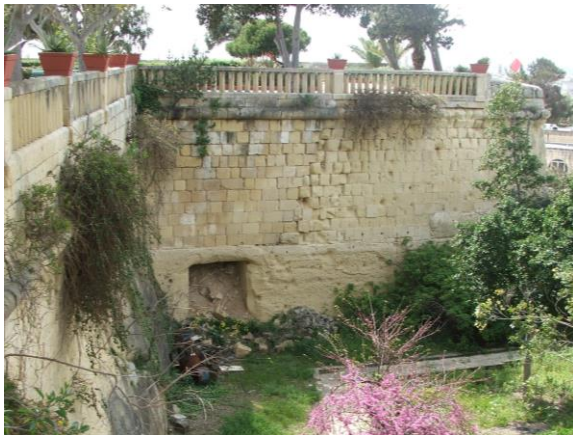
Location of former piazza bassa.

The former artillery *piazza bassa* on the opposite side was destroyed by the war. Shrapnel pock-marks are still evident. In its place, the orillion was changed into a shoulder and a mixture of the old and new stones were used. It seems that either by settlement or by moisture expansion, this part of the bastion is bulging outwards at the middle, where the masonry is dangerously eroded and crumbling. No attempt was made to match the size of the stones. The lower rock hewn face has remained well, albeit some powdering from weathering. In the corner, there is a doorway which is either presumed to have once been some underground store or a connecting passage. It is now filled with earth but worth investigating.

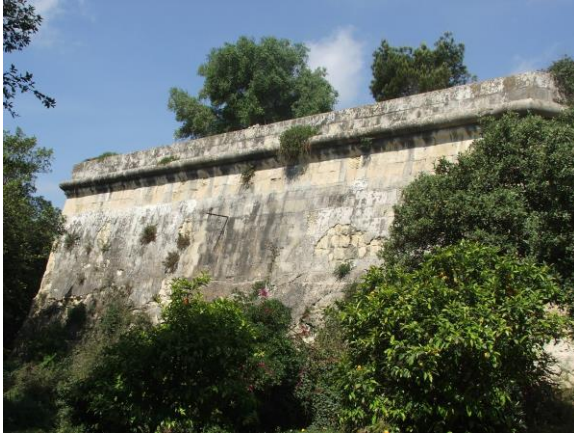
It seems that at some time, possibly when St. Anne's Gate was demolished, deterioration was rife and the entire should and orillion were rendered to resemble masonry with courses and joints. Large sections of this plaster have fallen and where it remains, it is voided at the rear or full of limestone powder from the decay.

Flank with rendering from below cordon to rock.

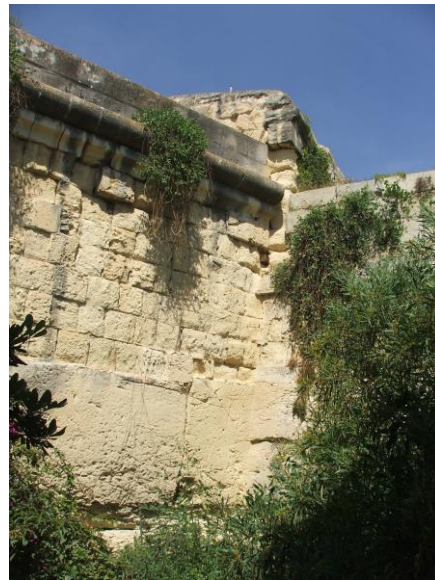
Corner where orillion meets *piazza bassa*.

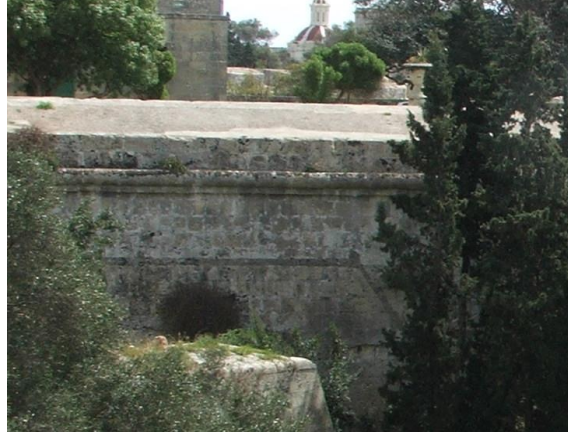
Polluted right shoulder and biological soiling.

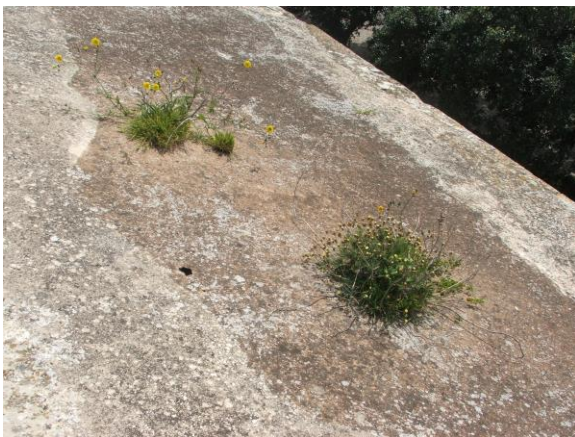
Algae, Lichens and shrubs growing on crest.

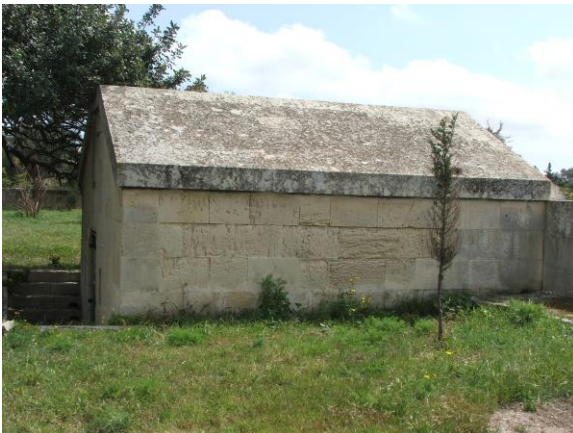
The left magazine has heavy biological growth and vegetation on its pitched roof, some black encrustation in its shielded parts and a strong presence of alveolar erosion of the side walls.

Alveolar erosion of the the right side.

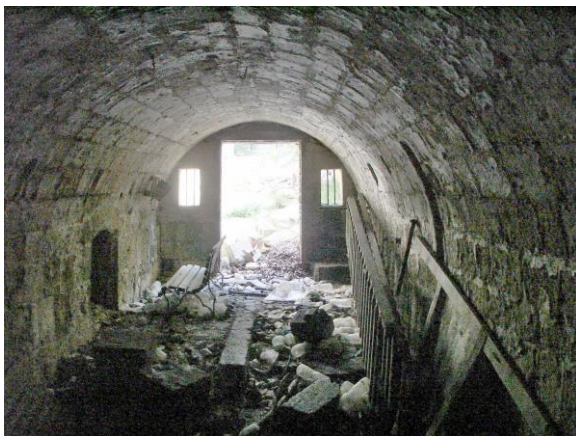
A biological sludge mixed with the patina.

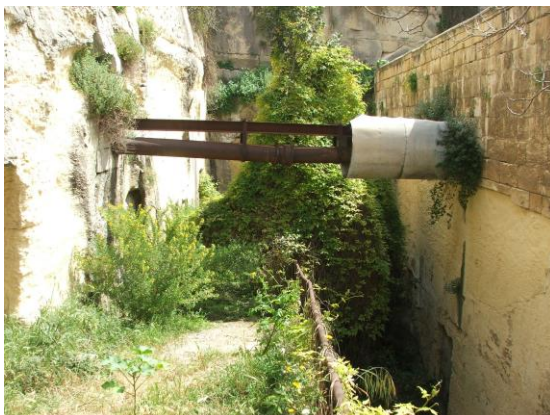
Accretions and past developments in ditch to accommodate railway station's requirements.

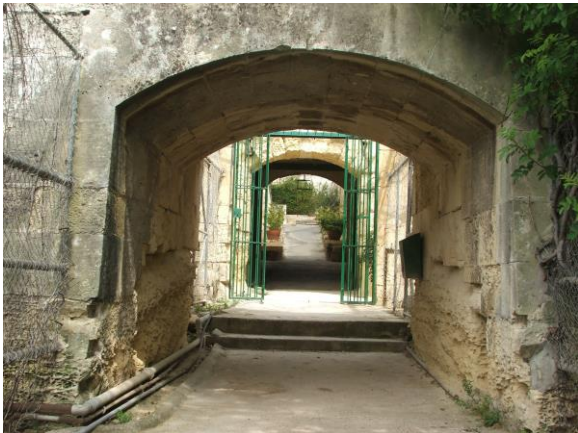
The tenille also has an arched passage, partially rock-hewn, in front of the sally port. Its masonry and rock have advanced deterioration inside the arch and various biological growth on the façade and rear.

Broken stone, accretions, erosion, encrustation and growth on façade.

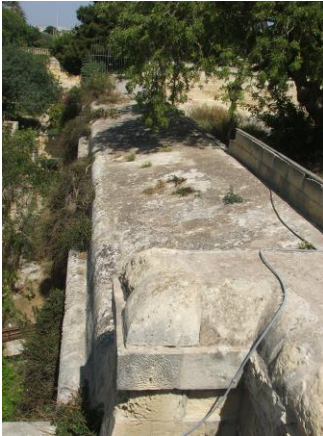
The parapet has a mixture of plant and biological growth, especially on the crest. The cordon has heavy deposits of black crust on the lower side and lichens on the exposed surface. It also has many cracked or broken stones especially at the mortar joints.

Plant and biological growth on the left end of parapet.

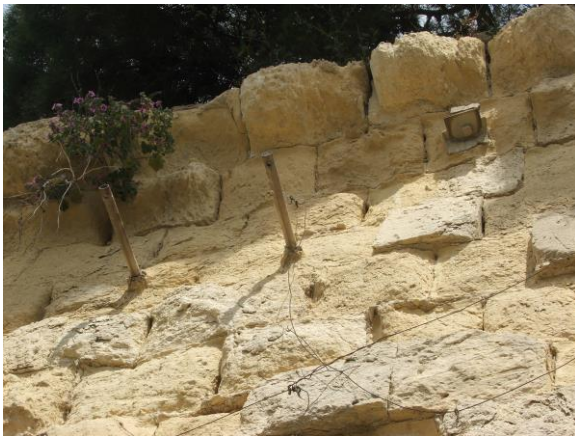
Eroded and broken masonry and accretions on curtain and cordon above the sally port.

The curtains masonry on the face around the sally port is heavily eroded and badly powdering in most places. Even the voussoirs of the arch itself and the vault, are just as eroded and those of the vault are voided and without mortar. The lower rock-hewn section is also eroded and alveolar erosion is also common here. There are numerous accretions, especially pipelines and cables, and other metal fittings have caused the stone to crack and break.

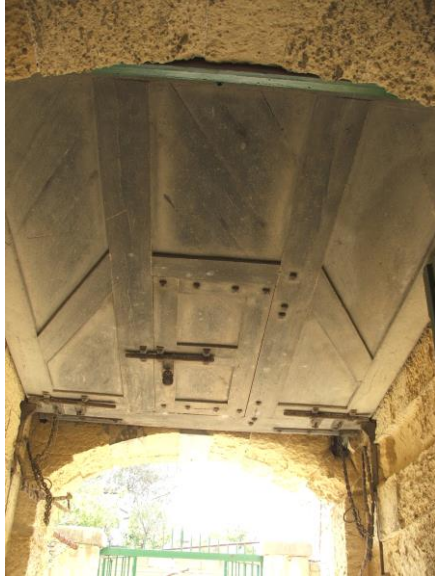
Early Victorian 'rising gate'.

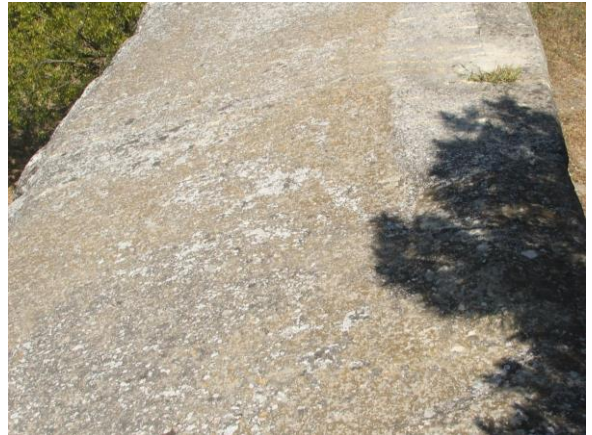
Lichen growth on the pozzolana on crest.

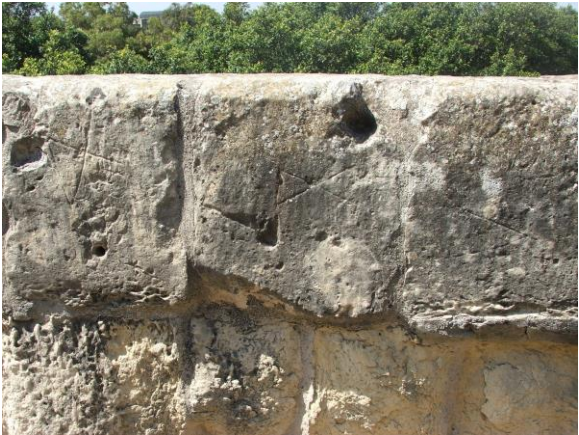
Alterations on this section of the curtain seem to have been ongoing as various types of masonry have been noted; even those from late 20th century. An interesting feature noted were mason's marks on three on the stones on the crest of the parapet. Cement has also been used in pointing, especially along the parapet's internal face.

Mason's marks visible beneath encrustation.

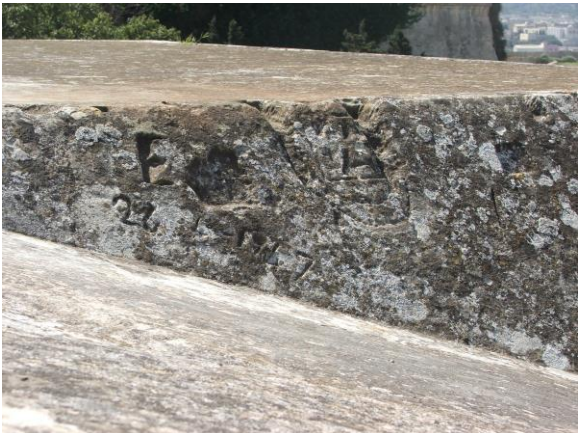
Lichen growth and graffiti on end pilaster's crest.

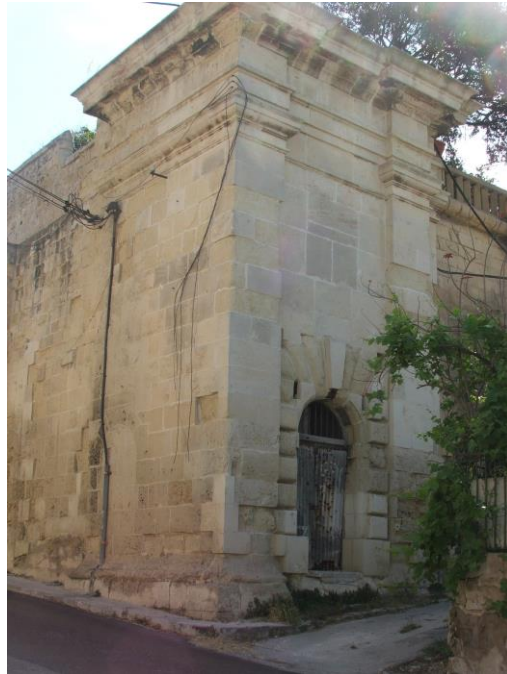
Remaining section of Notre Dame Gate.

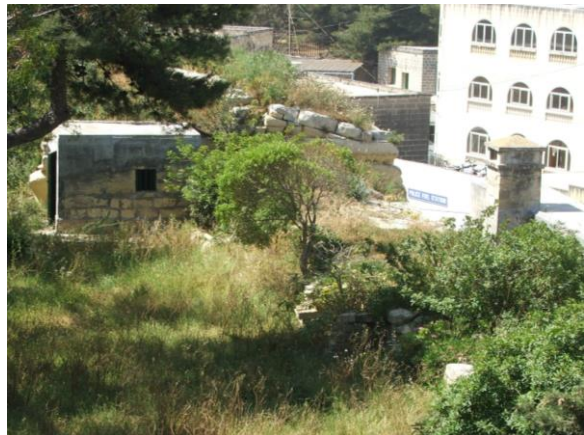
Overgrown grounds and remain of embrasure.

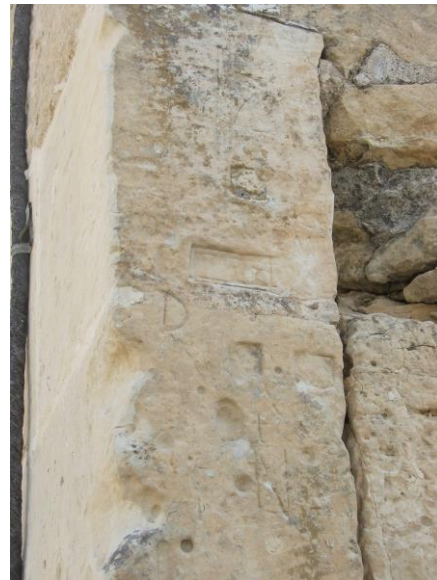
Black crust, crumbling masonry and plants.

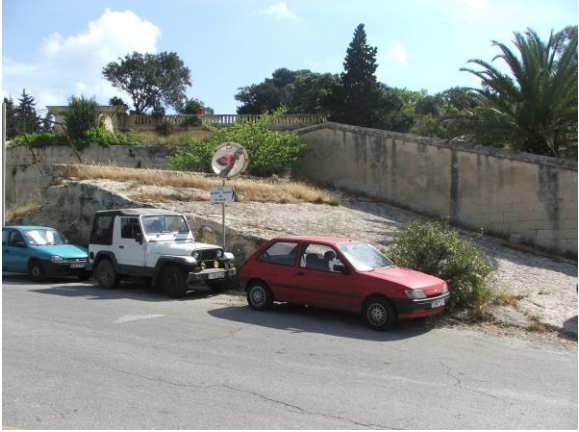
Other to plant growth, the rock and masonry are heavily covered with encrustations from pollution. The masonry on the covered way are cracked and have voided mortar joints. Some lichen growth was detected. The rocky slope is also subject to rubber mark from tires of vehicles that are parked on it, as well as some oil that drips from their engines.
